**CHELSEA WORKS, ST MICHAELS ROAD
KETTERING, NORTHANTS**

ARCHAEOLOGICAL BUILDING RECORDING

Document: 2016/183

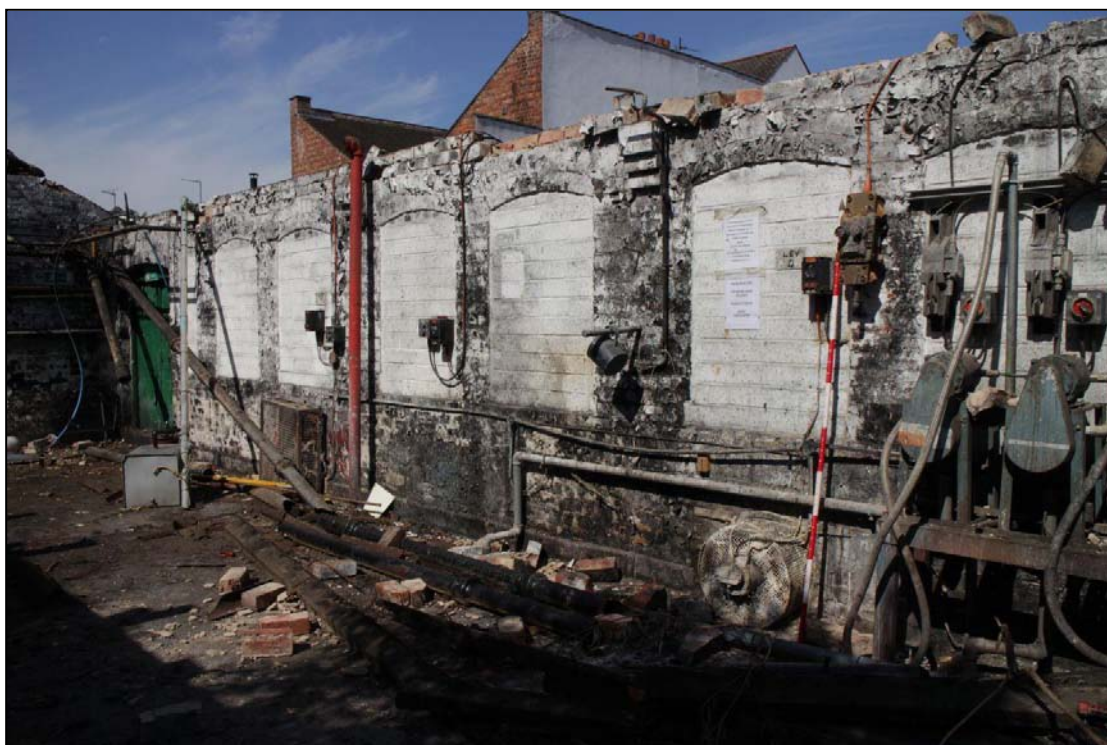
Image 28: Detached workshop 12

Looking north-west. Shows blocked windows in north wall with pumps at right hand side of image (scale 2m)

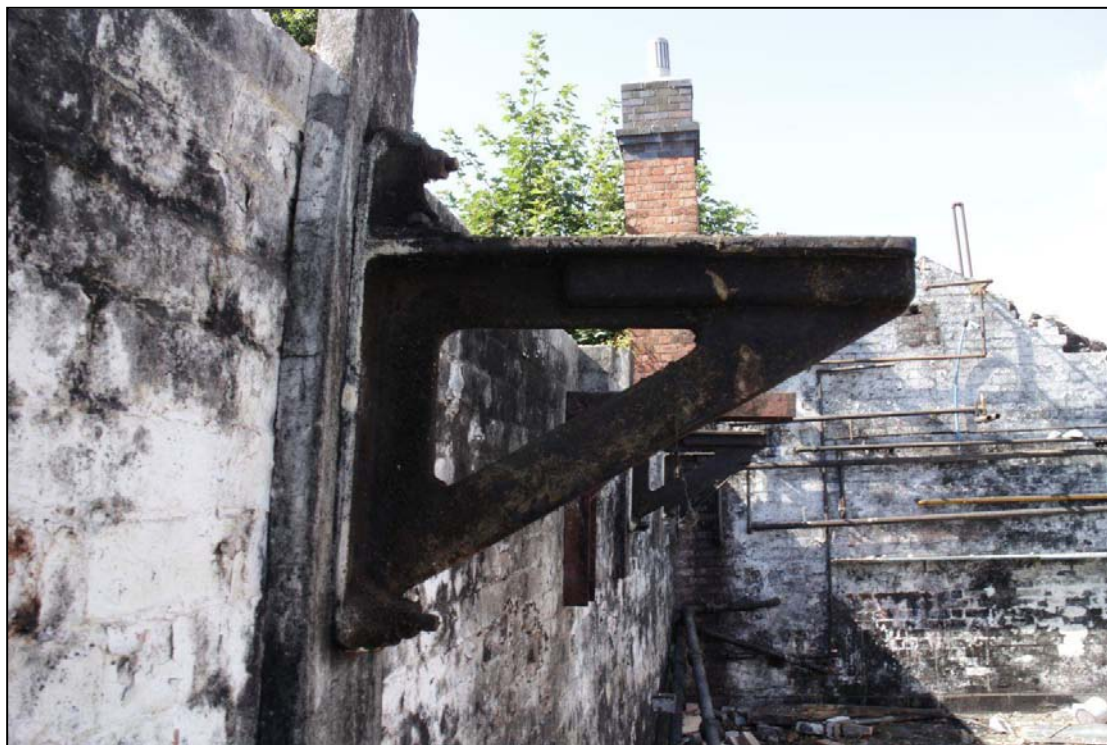
There was evidence for earlier machinery in the form of a row of 8 line shaft brackets fixed to the rear (south) wall (Image 30). Seven of these were in cast iron with bolted fixings to the wall and a slot on top for the attachment of a bearing. The other bracket was an addition or replacement that had been fabricated from steel channel.

Image 30: Detached workshop 12, Detail of line shaft bracket
Looking west showing cast iron line shaft bracket bolted to north wall
