**THE HEN HOUSE, DOVECOTE FARM,
ASTWOOD, MILTON KEYNES**

HISTORIC BUILDING RECORD

Document: 2017/96
Version: 1.0
June 2017

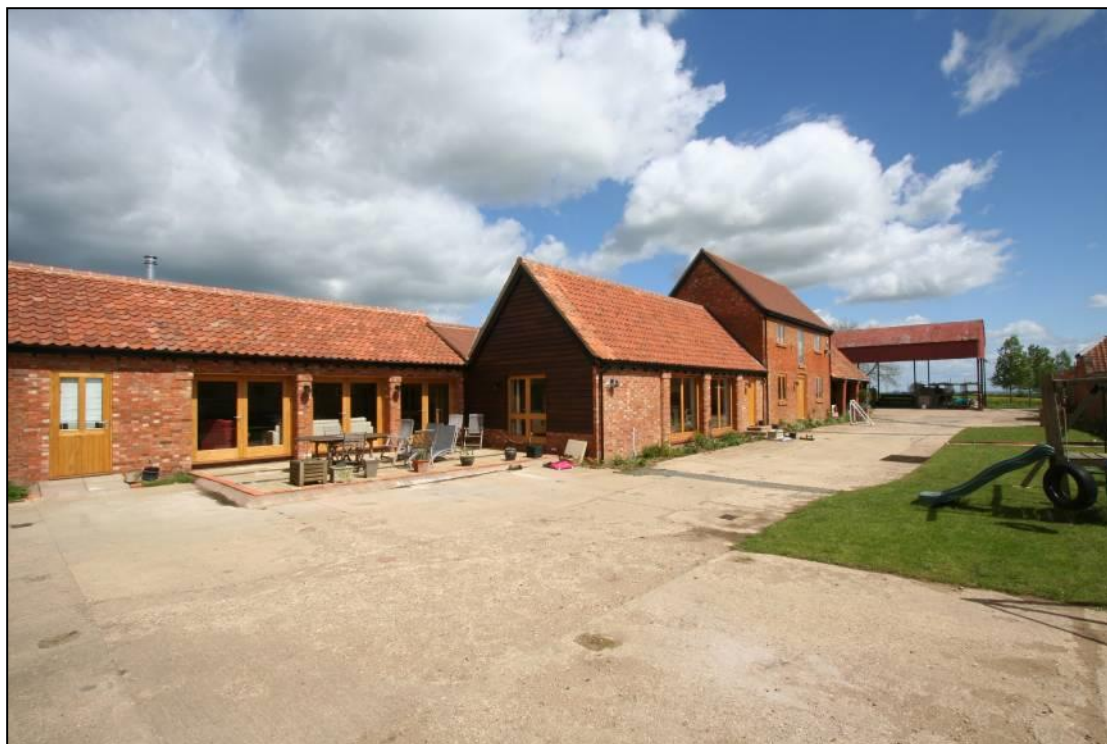
Image 1: General view looking north-east

Shows the existing residential conversion (Owl Barn) in the foreground with the Shelter shed (Hen House) visible at the far end in front of the Dutch barn.
(Image taken 2014)

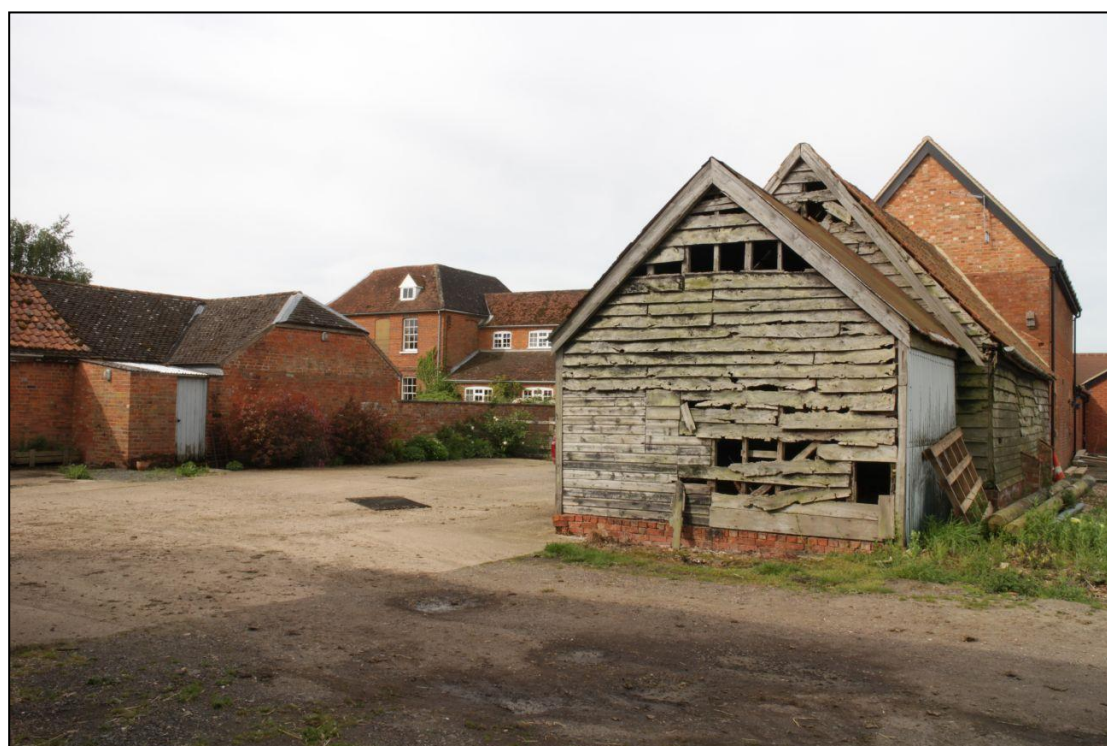
Image 2: General view looking south-west

Dovecote House, are another timber-framed and opened fronted stock shed and a brick building with half-hipped roof, now used as a garage (Image 2). As would be expected of open-sided shelter sheds, the open sides face south. The southern range of buildings open towards the house and it is likely that these were associated with stabling and carriage storage.

Shows the end of the storage shed (Hen House) in the right-hand foreground with the Dovecote farmhouse and other former farm outbuildings on the left

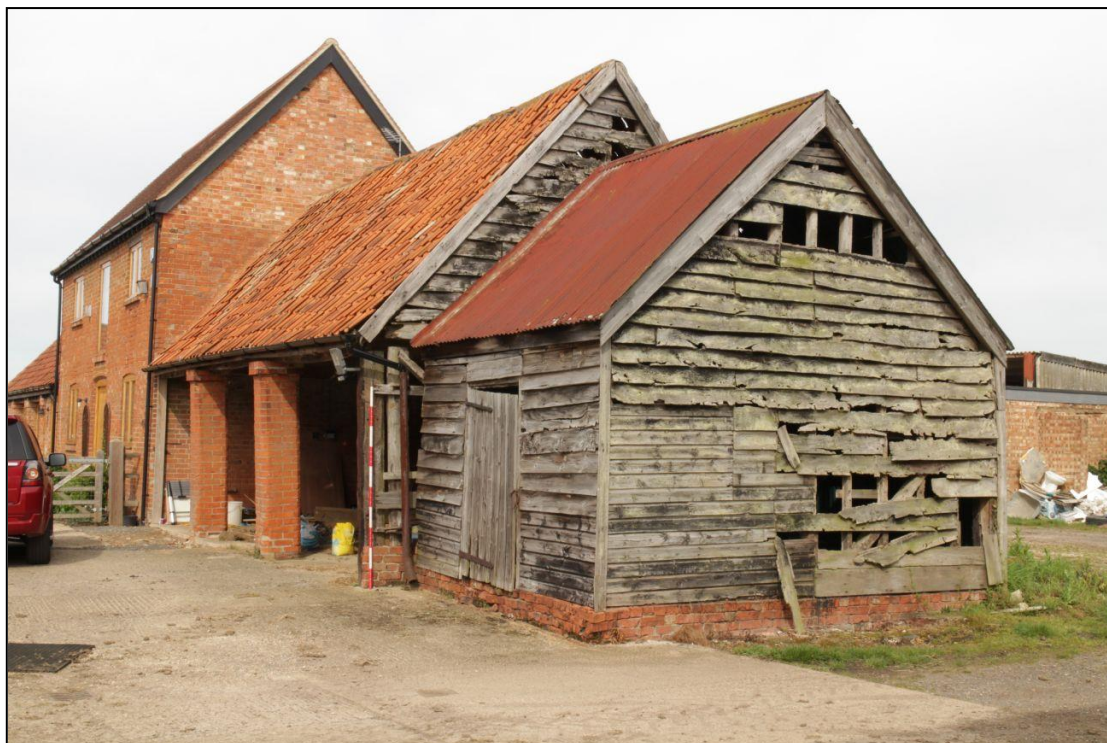
Image 3: General view looking north-west

The buildings described in the present report form part of the range on the northern side of the farmyard (Image 3). Prior to conversion this range comprised, from west to east: a single storey brick-built shed, a 3-bay open fronted shed in brick, a modern steel portal frame building (removed as part of the previous conversion works), a two-storey barn with high level taking-in door, another 3-bay open-fronted and timber-framed shed, and a small weatherboard clad shed. A structural survey undertaken prior to the conversion of the central and western part of this range suggests that the steel-framed building contained remnants of the brickwork foundations associated with a previous building. There is no evidence to suggest whether or not this building was timber-framed on a brick plinth or entirely brick-built. Opposite on the southern side and now forming part of the curtilage of

Shows front of storage shed (right), shelter shed (centre) and previously converted buildings (Owl Barn) on the left-hand side

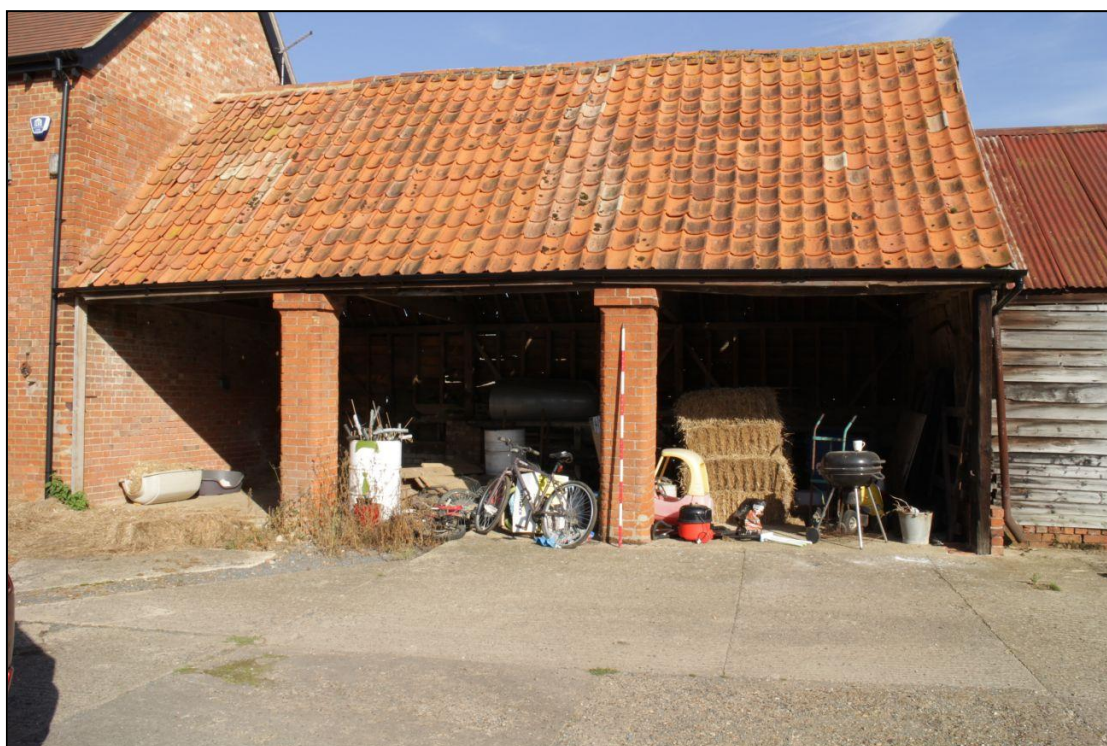
Image 4: Shelter shed, south elevation

The building is open on this side with the roof supported by two brick piers forming bays c.1.8m to 1.9m wide. The piers are c.460mm square with plain chamfered corners formed from moulded bricks. The two top courses of brick in the piers are slightly wider to form plain capitals. The top of the piers supports a wall plate and the south ends of the roof trusses. The eastern end of the wall plate is currently supported by a re-used railway sleeper, presumably replacing a decayed timber corner post.

Shows brick piers supporting open side and pantile roof (scale 2m)

Repairs in the south side of the building consist of modern brick in the top of the brick piers and a railway sleeper used to form a post at the southeast corner of the building. The modern brick in the piers may have been added to provide additional support to the ends of the tiebeams.

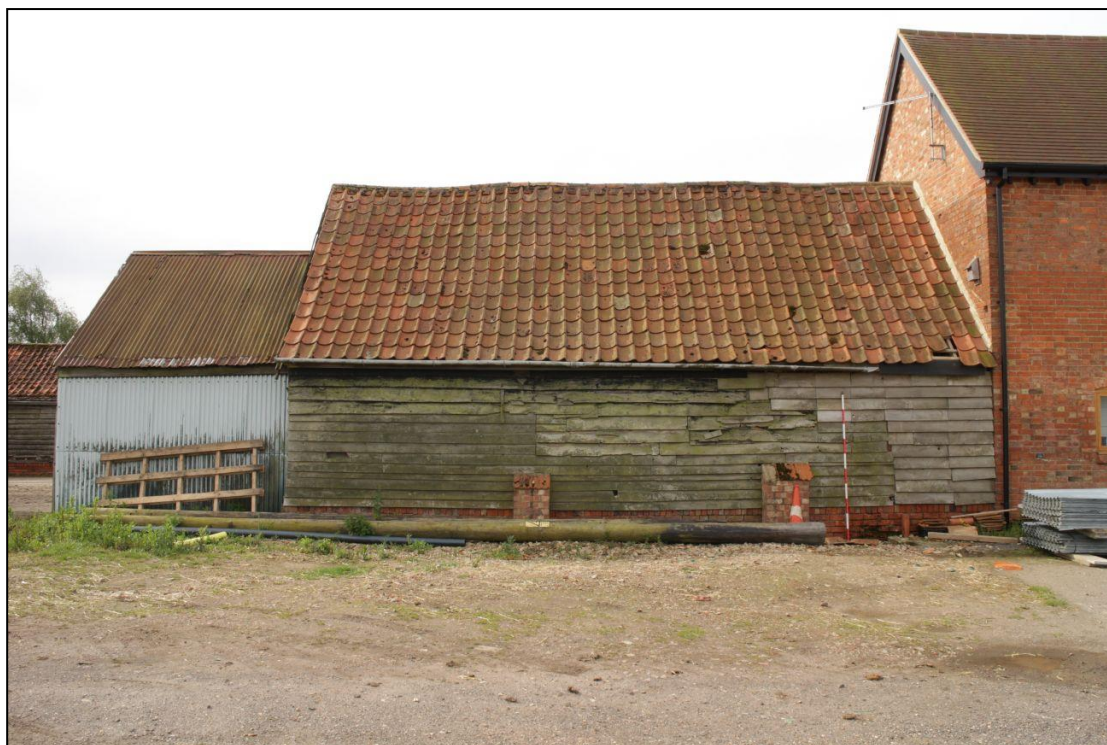
Image 5: Shelter shed and storage shed, north elevation

Shows metal cladding on storage shed and weatherboard cladding on rear wall of shelter shed (scale 2m)

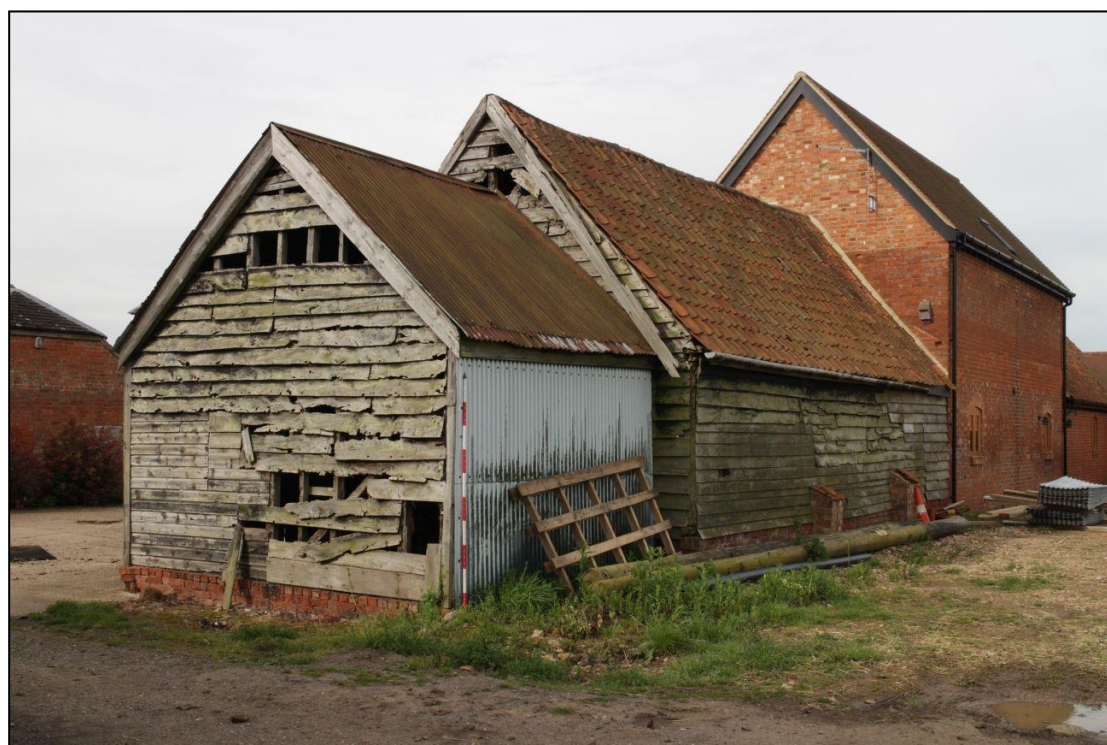
Image 6: General view looking south-west

Shows end and back of storage shed (left), shelter shed (centre) and previously converted buildings (Owl Barn) on the left-hand side (scale 2m)

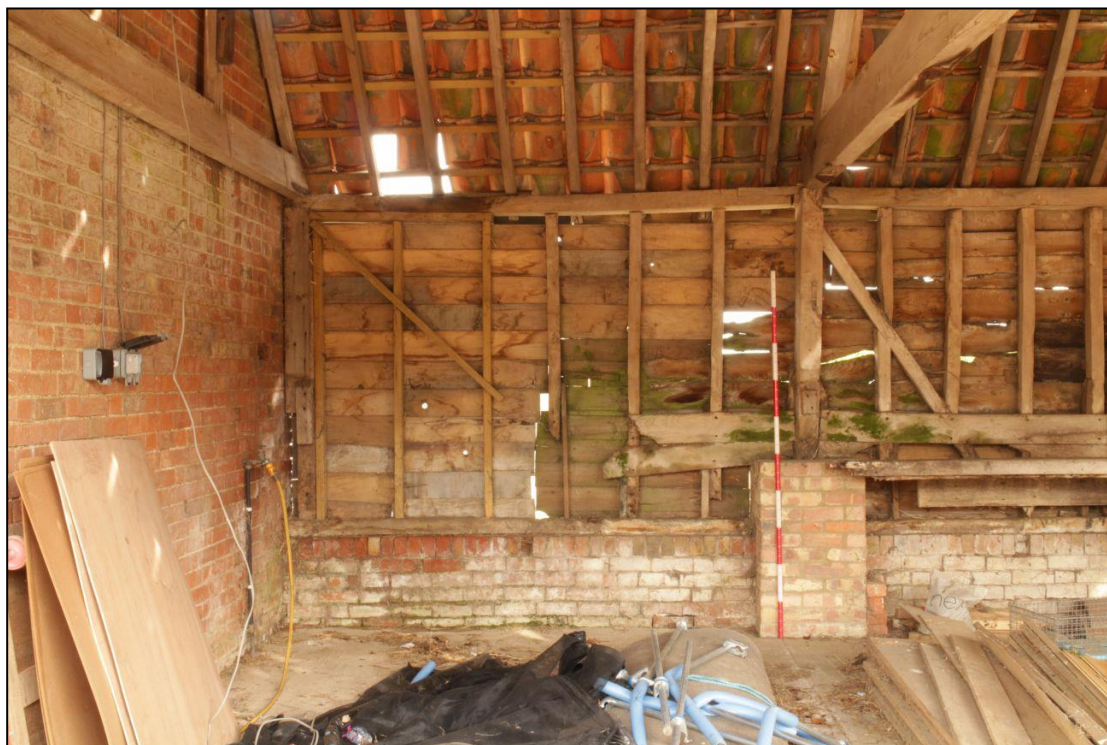
Image 9: Shelter shed, north wall, west bay

The rear wall of the shelter shed consists of a 500mm high brick wall supporting timber-framing with weatherboard external cladding (Images 9-11). The brickwork is laid in Flemish garden-wall bond with a header course at the top. The timber-framed section is supported by wall posts with jowled heads on the either side of the central bay and at the east end of the wall. Former braces between the wall posts and tiebeams are indicated by sawn off tenons in the two central wall posts and corresponding mortices in the tiebeams (Image 13). The wall framing consists of closely set studs with primary bracing. At the base the frame is on a sill beam and at the top the studs are tenoned into the wall plate. The wall plate is made up from three sections which are joined with side-halved and bridled scarf joints with nailed fixings (Image 12). Identical scarf joints were noted on the sill beam of the open-fronted shed forming part of the southern range and now part of the neighbouring property.

Shows repairs with new studs and weatherboard at left of image (scale 2m)

The repairs in the north wall comprise the construction of brick piers below the base of the main wall posts and repairs to the studding and weatherboards at the west end (Images 9 and 10). The brick piers are constructed in Fletton type brick. These piers are approximately 600mm square, project c.450mm into the interior of the building and c. 1m high. These piers were built to support the lower ends of the wall posts which are likely to have decayed.

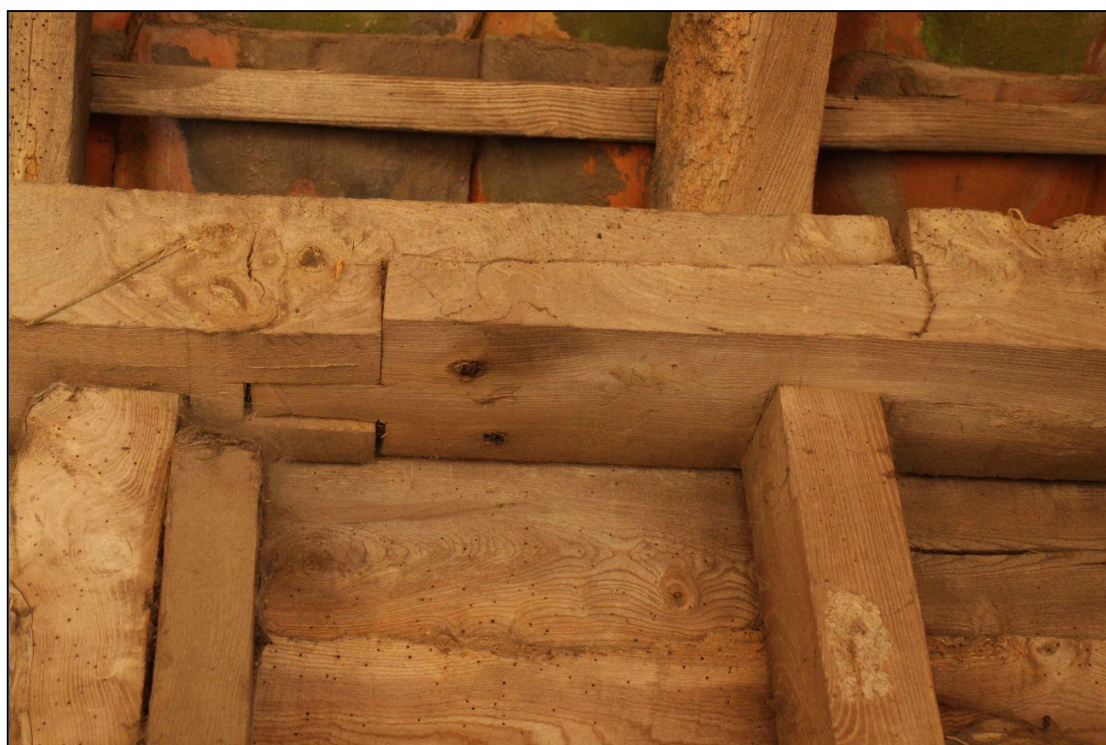
Image 12: Shelter shed, scarf joint in wall plate in north wall

The fixings used in the building are a mixture of pegged, bolted and nailed. The pegs and bolts occur in the kingpost trusses. The majority of the other joints appear to be nailed, eg the scarf joins in the northern wall plate.

Shows detail of side halved and bridled scarf with nailed fixings visible on underside

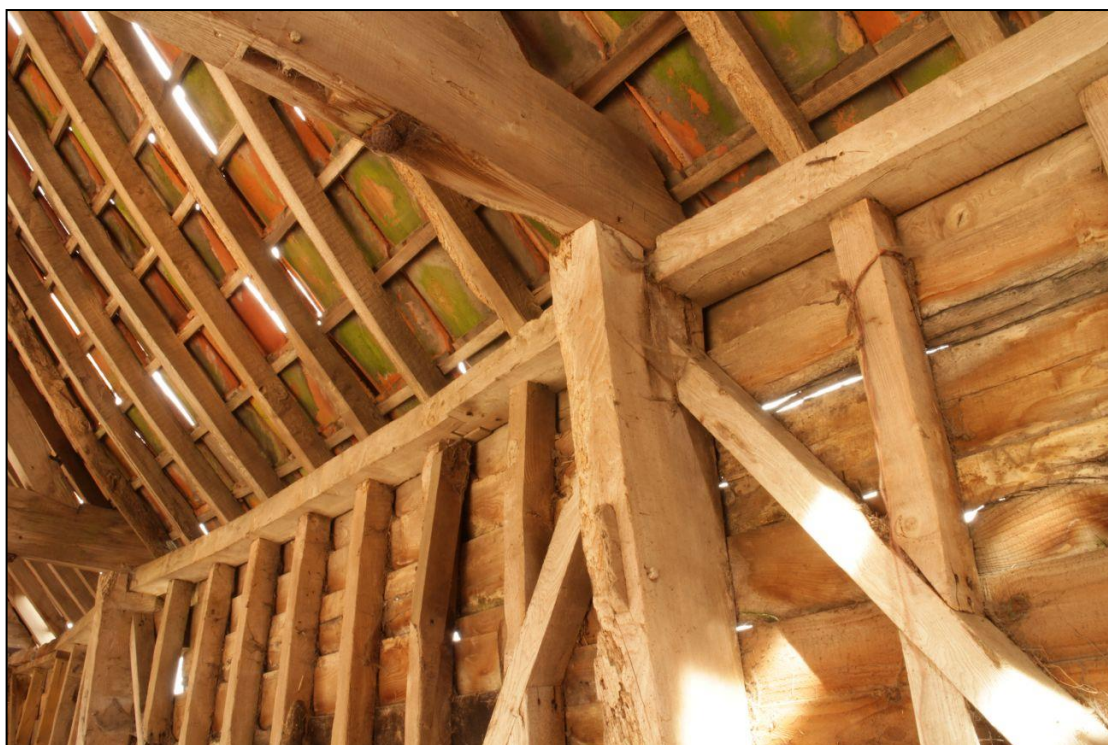
Image 13: Shelter shed, frame detail

Shows north wall at junction of post and tiebeam with empty mortice in underside of tiebeam indicating location of former brace

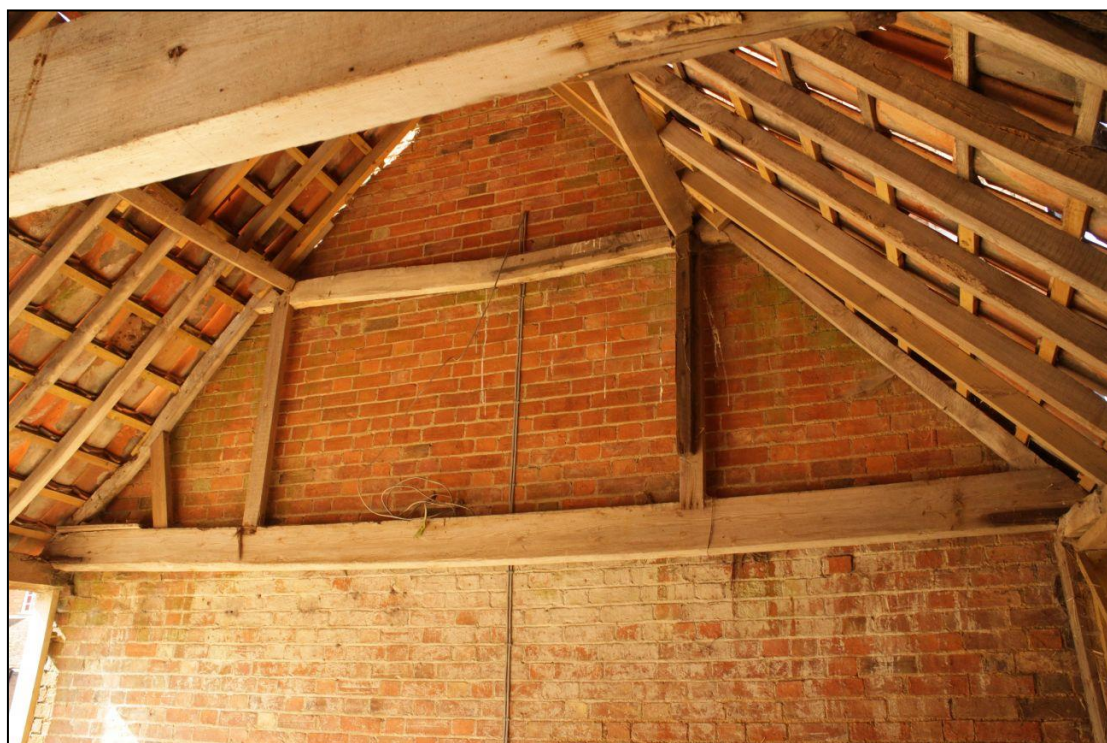
Image 14: Shelter shed, west end

At its west end the shelter shed abuts the adjacent two storey brick building (14).

Shows roof of stock shed abutting adjacent two-storey brick building

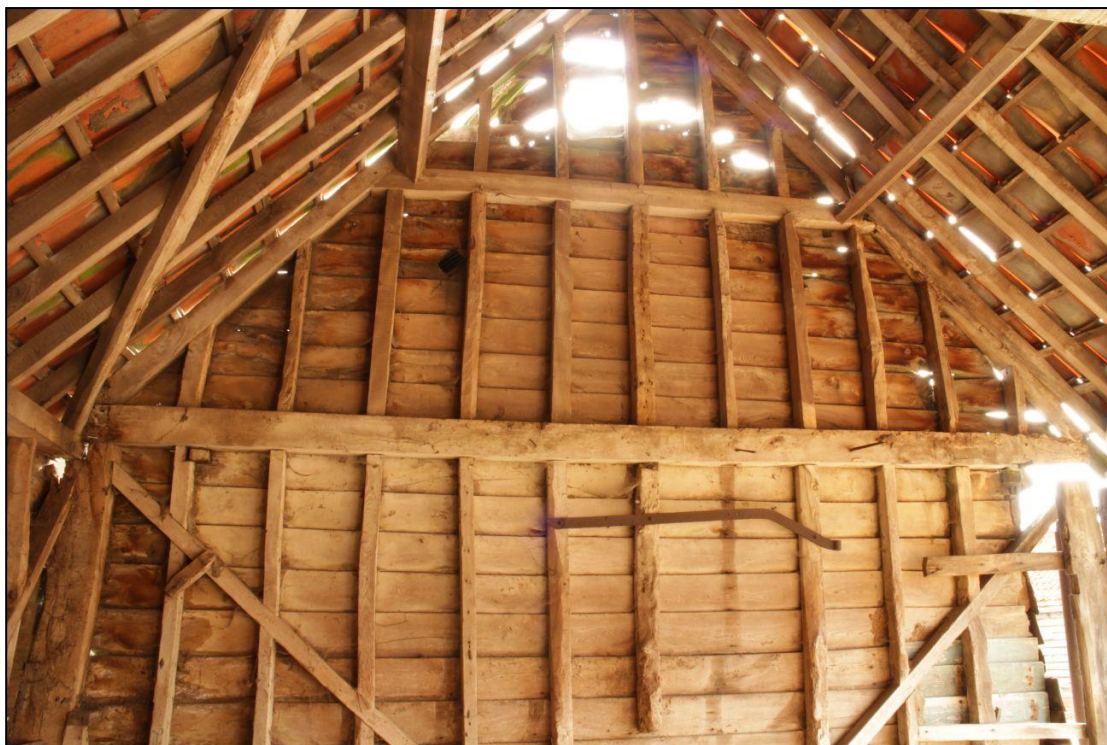
Image 15: Shelter shed, east end

The east end wall of the shelter shed is timber-framed with weatherboard cladding (Image 15). It stands on a brick sill wall matching that in the north wall, c.500mm high in Flemish garden-wall bond with a single header course at the top. The timber frame stands on a sill beam and consists of closely set studs with primary bracing in the lower part of the wall. In the upper part of the wall the studs are tenoned and pegged into a collar beam. The corner post on the south-east corner of the building has been replaced with a re-used railway sleeper. On the exterior some

At the east end the roof is supported by the timber-framed gable wall with clasped purlins (Image 15). At the west end the roof is supported by a tiebeam/collar truss with a pair of queen struts and clasped purlins (Image 15).

Shows framing of end wall

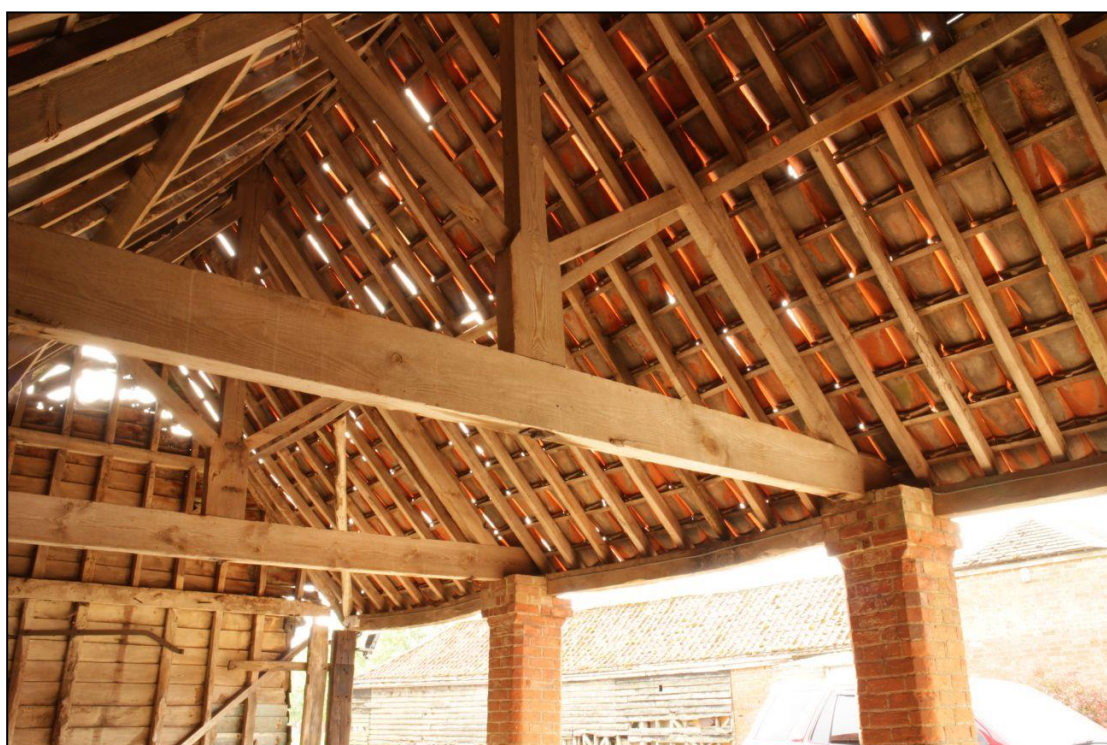
Image 16: Shelter shed, south side of roof

View looking south-east showing brick piers and roof structure

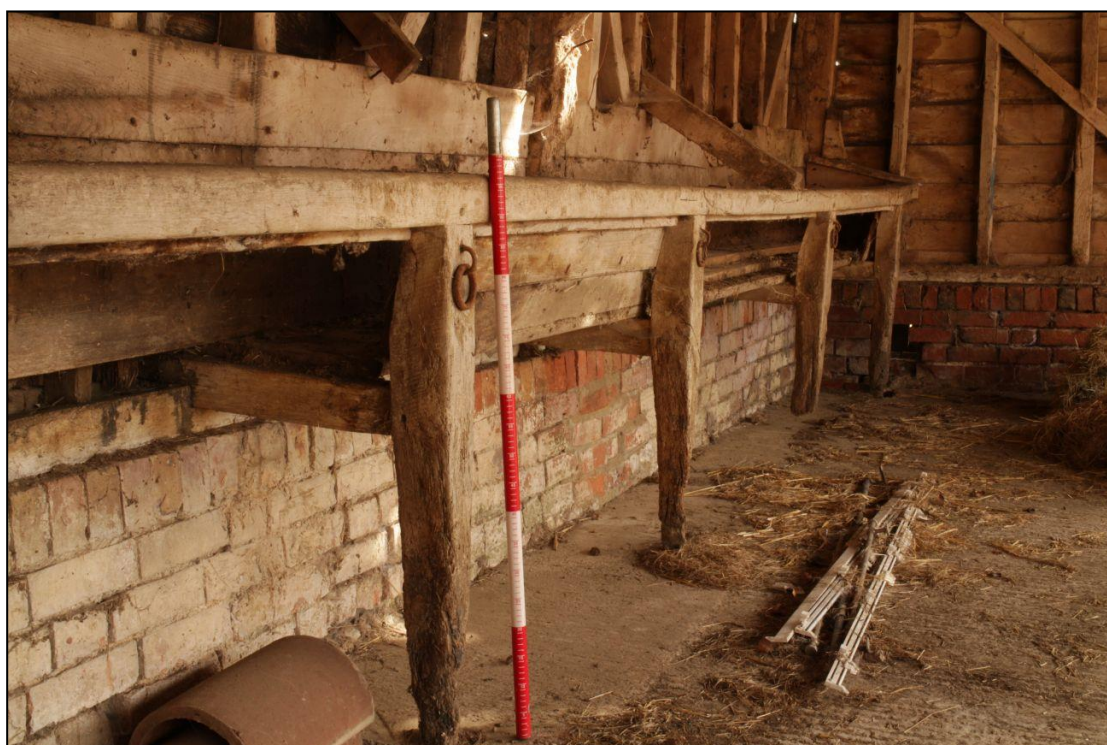
Image 18: Shelter shed, detail of feed trough

The remains of a feed trough extend along the rear (north) wall of the shelter shed (Images 18). A series of vertical posts fitted with tether rings support the horizontal rail that forms the outer edge of the trough. The base of the trough is supported by horizontal timbers tenoned into the backs of the vertical posts and ledged on the sill beam in the north wall. The trough is lined with planks forming a flush base with overlapping weatherboards lining the front and rear sides.

The trough is in poor state of preservation and has further deteriorated since an earlier survey (Albion Archaeology 2014). In the north bay of the building part of the trough has now collapsed and been removed. In the central and east bays the lower ends of the vertical posts have rotted away and the lining planks are partly decayed and detached. The pattern of decay is common in wooden feed troughs, particularly the rotting of the support posts at the front where they stood in a layer of straw and muck. In other farms, where troughs remained in use, they were commonly infilled with brickwork to replace the decayed timber.

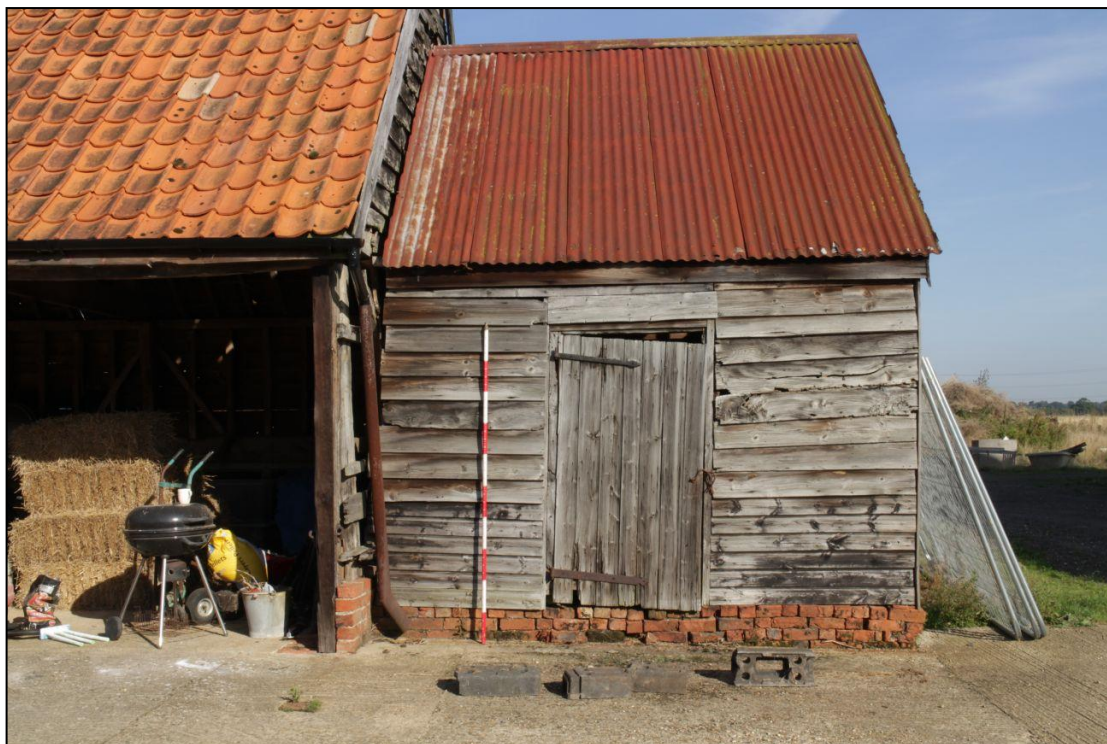
Image 19: Storage shed, south elevation

This is a timber-framed shed is attached to the east end of the shelter shed (Images 19 to 23). It stands on a low brick sill up to four courses high with a row of headers at the top. The north and south sill walls are loose and do not appear to be cemented. The south and east walls are framed with closely set studs and primary bracing with nailed fixings and external weatherboard cladding (Images 21 to 23). The west wall of the building is formed by the east end of the adjacent shelter shed. The north wall and roof are modern replacements in corrugated metal sheet.

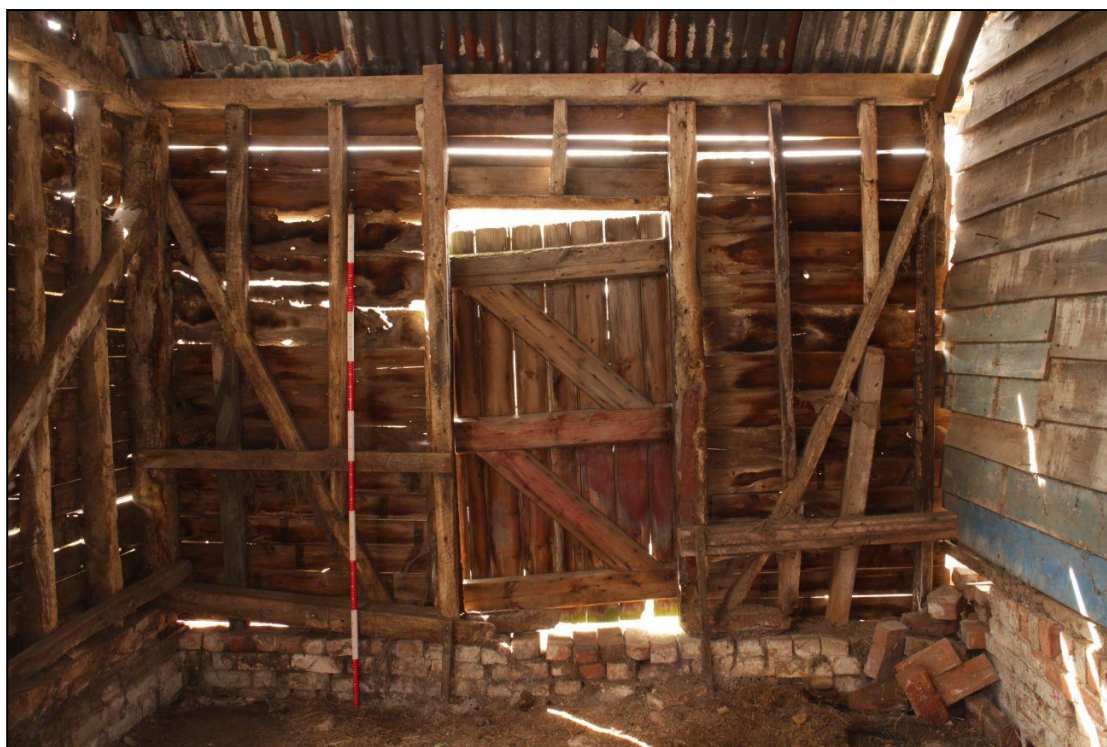
Image 21: Storage shed, south wall

A door in the middle of the south wall is a ledged and braced plank door (Images 21). It has seven narrow planks in pine with a beaded moulding, suggesting a relatively recent date. The two strap hinges on the outside of the door differ

slightly. The upper hinge is hand forged strap with a spear-shaped terminal in a pattern common up to mid 18th century. It may be an earlier fitting reused in this location. The lower hinge is likely to be a modern replacement judging from its more regular appearance.

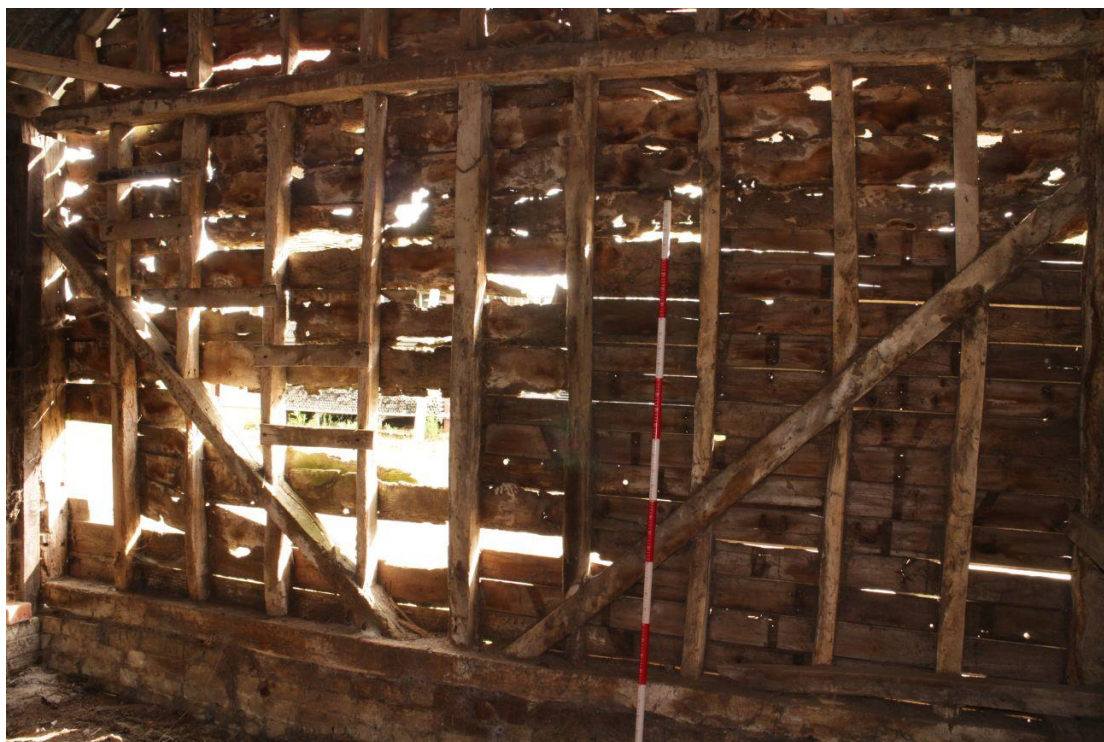
Image 23: Storage shed, east wall

The north wall of the shed had been completely replaced with corrugated metal sheeting attached to a simple timber-frame. The roof is a modern replacement covered with corrugated iron. The weatherboard cladding is decayed in places and lower part of the south wall and the lower left-hand part of the east wall have been renewed in modern shiplap cladding.
