**RIVER GADE RESTORATION WORKS
GADEBRIGE PARK (NORTH)
HEMEL HEMPSTEAD
HERTFORDSHIRE**

ARCHAEOLOGICAL WATCHING BRIEF

Project: GP3334

Document: 2018/135

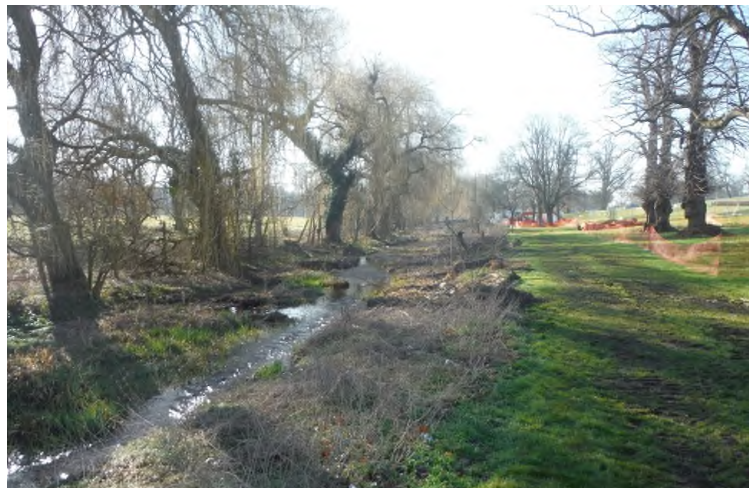
The tree thinning and weir removal were not monitored, although the remains of the weirs were still on site awaiting removal. They comprised 20th-century reinforced concrete blocks, most likely cast on site and when in situ measured approximately 2m wide by 5m long. Material observed from under the weir comprised ceramic building material (CBM), glass, aluminium drinks cans and small pieces of corroded metal (likely to be from the construction of the weirs) (Figure 3).

River channel and terrace cleared of vegetation and weir removed (looking SE)

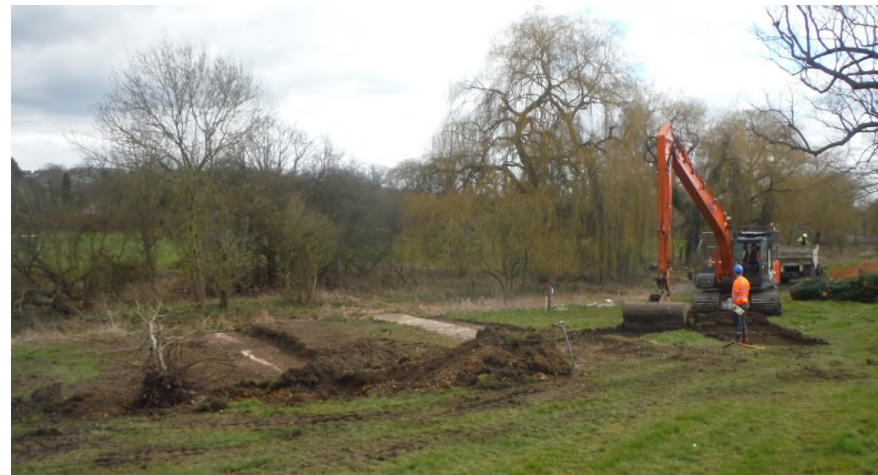
The wetland area was disturbed by two east-west, 20th-century concrete drains, 0.15m below the ground surface and measuring 1.7m x 0.5m wide. The southern drain was constructed of reinforced concrete slabs like that of the weirs and was most likely constructed at the same time. It was at least 1.3m deep. The smaller drain to the north was made of poured concrete with no sign of any reinforcement; it was up to 0.7m deep (Figures 2 and 3).

Within the wetland area a small tree was uprooted, disturbing an area approximately 2m by 4m. This revealed the top of the natural geology in places at a depth of c.0.5m. No archaeological features were identified within the disturbed ground (Figure 3).

Wetland area, with tree removed and modern concrete drains exposed; service trench being opened (looking SE)

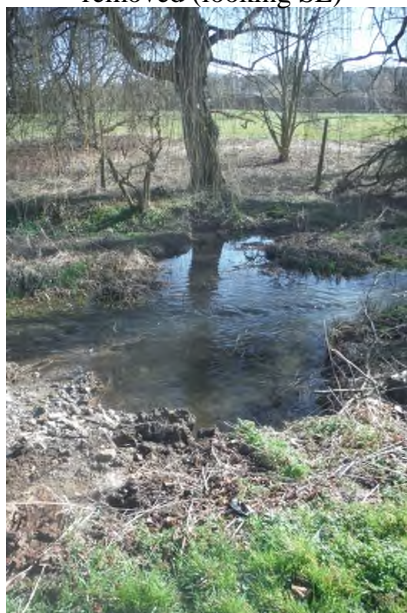
River channel with weir removed (looking east)

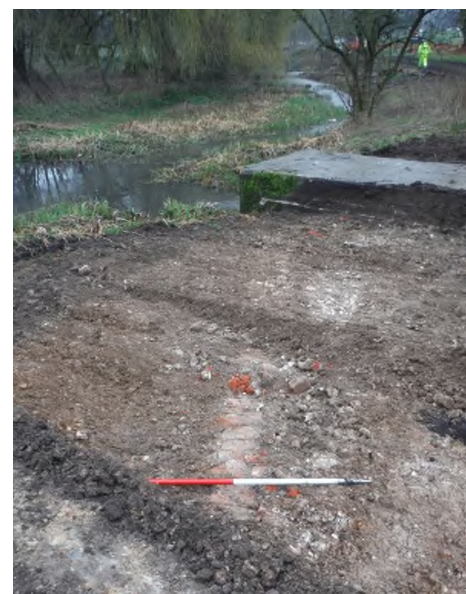
The wetland area was reduced by mechanical excavation, using a flat-edged ditching bucket. This revealed the terrace make-up layers and a post-medieval, brick-built drain (0.65m below ground level) on a NW-SE alignment. No other archaeological features or deposits of archaeological interest were revealed (Figures 2–4).

Brick drain between concrete drains in the wetland area (looking SE, 1m scale)

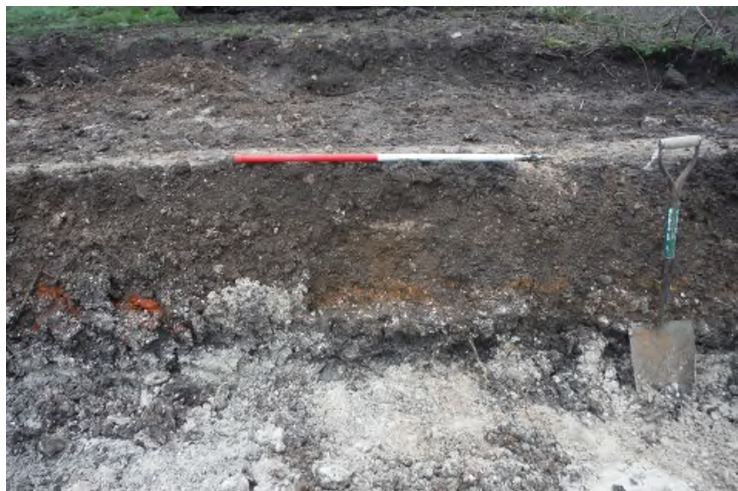
- dark grey-black turf (1), 0.15m thick, overlying various post-medieval make-up layers that levelled the area and created a terrace alongside the western edge of the river;
- make-up layer (2), mid-brown-grey chalk and silt with frequent small to medium stones, 0.2m thick;
- make-up layer (3), mid-yellow-brown clay silt, with moderate small to medium stones, 0.2m thick;
- make-up layer (4), mid-brown-yellow clay gravel, 0.1m thick;
- make-up layer (10), mid-white-grey, clay silt, with frequent small-medium chalk pieces, 0.1m thick;
- make-up layer (11), dark grey-black flint and silt, 0.18m thick;

Baulk section showing make-up layers (looking NE, 1m scale)

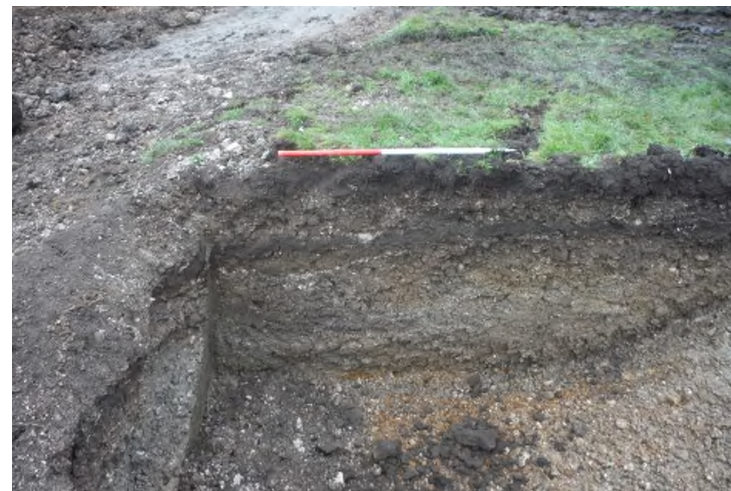
A small trench 2m wide by 4m long and up to 1.2m deep was excavated by machine with a flat edged ditching bucket to try to identify a possible electrical service close to the proposed wetland area. The soil horizons consisted of dark grey-black turf (1), 0.15m thick, overlying a 0.2m-thick make-up layer (2), used to create a terrace alongside the western edge of the river. The latter comprised mid-brown-grey chalk and silt with frequent small to medium stones. Below it was layer (15) — a dark grey-brown buried topsoil, was 0.1m thick and in turn sealed a 0.15m-thick mid-yellow-brown subsoil (16). The natural geology (14) comprised loose, light yellow-grey, gravel and sand (representing river deposits, up to 0.45m thick), overlying light blue-yellow clay and gravel (17) (Figure 4).

There was no evidence that the archaeological horizon had been truncated and it was largely undisturbed. The only feature identified was a large sub-circular post-medieval pit [5], at least 1.2m wide by 1.5m long and up to 0.7m deep, extending beyond the trench boundaries to the north and east (Figure 2, Section 1; Figure 4). The basal fill (6) contained animal bone, probably representing the disposal of an individual cow. Moderate small to medium fragments of post-medieval CBM were recovered from fills (6), (7) and (9).

Service test trench, baulk section showing pit [5] (looking east, 1m scale)

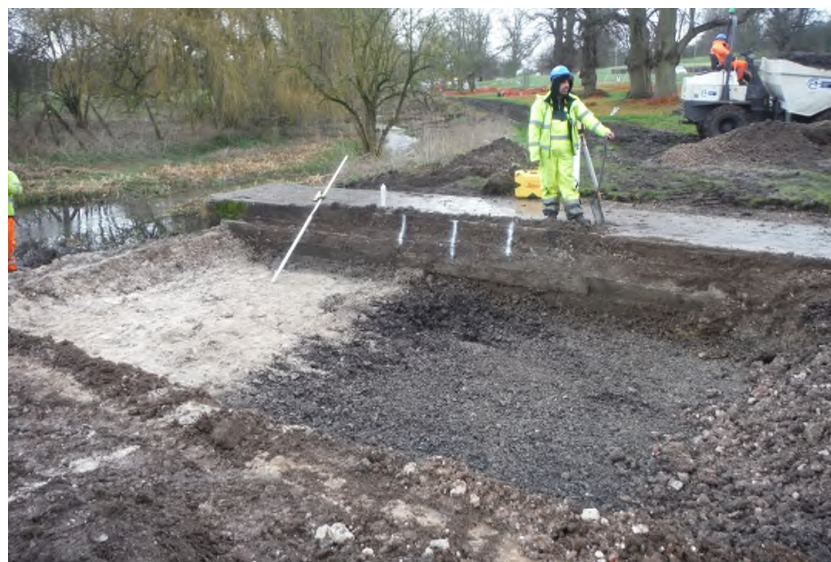
The natural geology (14) comprised river gravels that sloped down towards the river; they increased in thickness to the east (0.8–1.25m).

Natural geology shown to the right of picture, make up layers to the left and a large concrete drain to the rear (looking SE)
