**FEOFFEE ALMSHOUSES
AMPHILL
BEDFORDSHIRE**

**ARCHAEOLOGICAL OBSERVATION
INVESTIGATION, RECORDING, ANALYSIS AND
PUBLICATION**

Project: FF3351
HER search ref. no.: 201819/018
Museum accession no.: BEDFM 2014.43
OASIS ref. no.: albionar1-315728

Document: 2018/87
Version 1.0

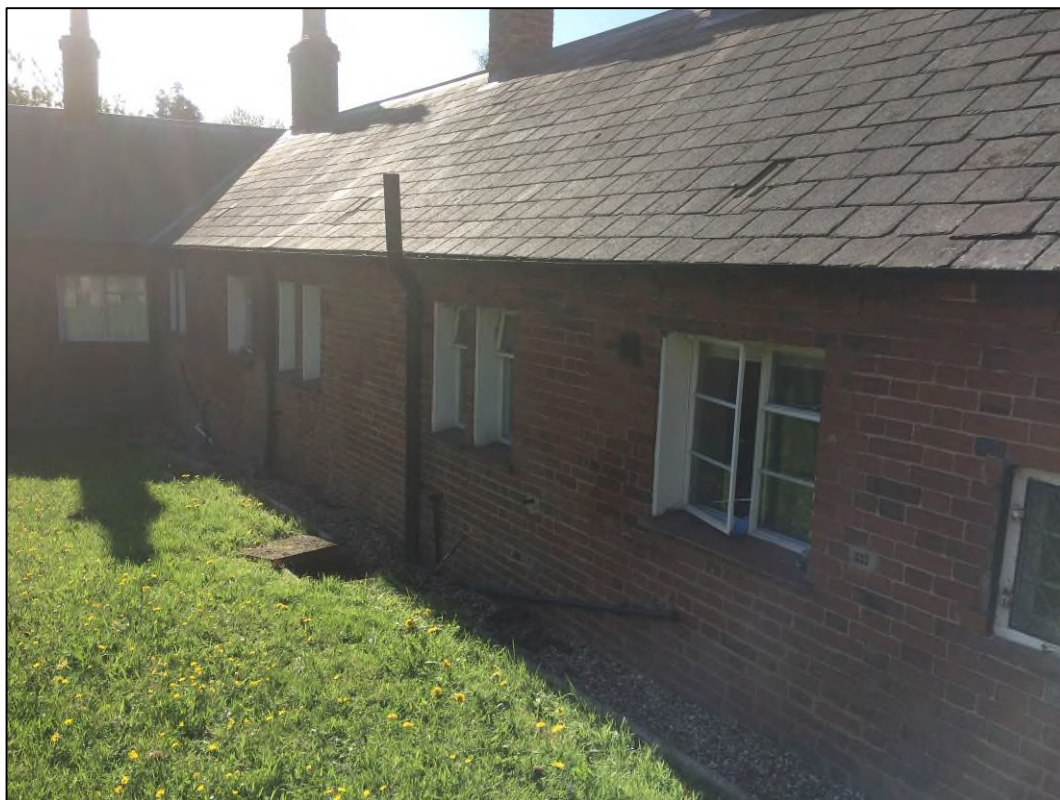
Plate 1: North side of No. 5 Feoffee Almshouses, prior to the works

The Feoffee Almshouses are located in the eastern part of Ampthill off Church Street and Rectory Lane in an area with archaeological interest. The site is situated within the medieval settlement envelope of Ampthill and within Ampthill Conservation Area. It lies on the southern boundary of the churchyard of St Andrew’s parish church, which dates to the 14th–15th centuries and is adjacent to the 14th–15th-century parish church of St. Andrew. The works were carried out at the southern periphery of the churchyard (Figure 1, Plates 1 and 2).

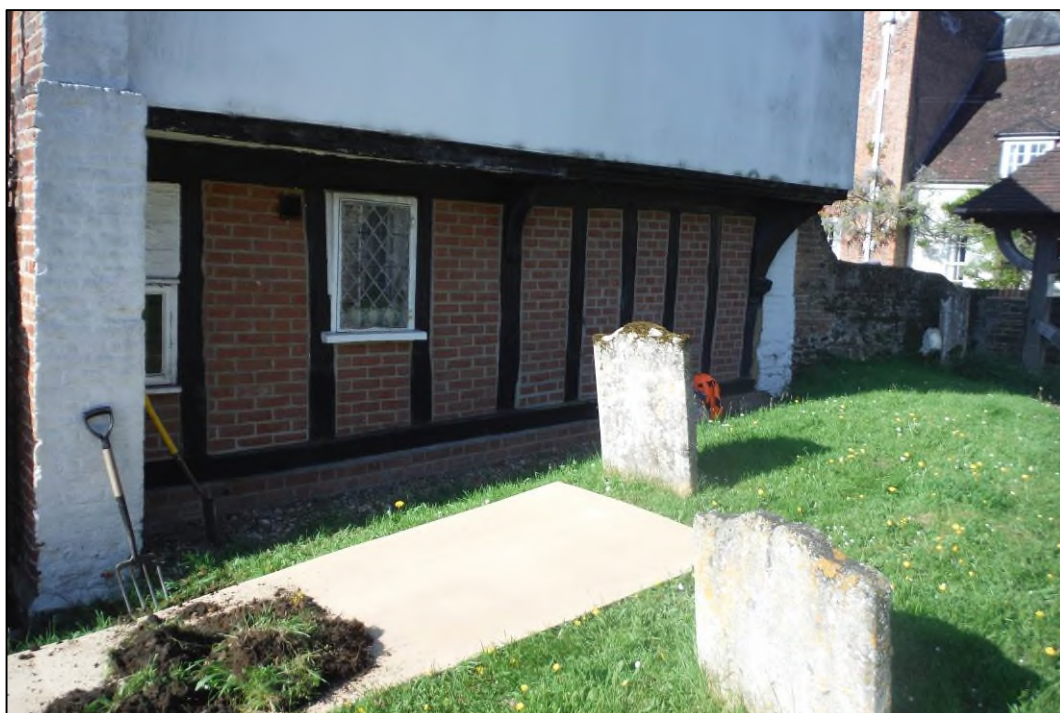
Plate 2: North side of No. 1 Feoffee Almshouses, prior to the works

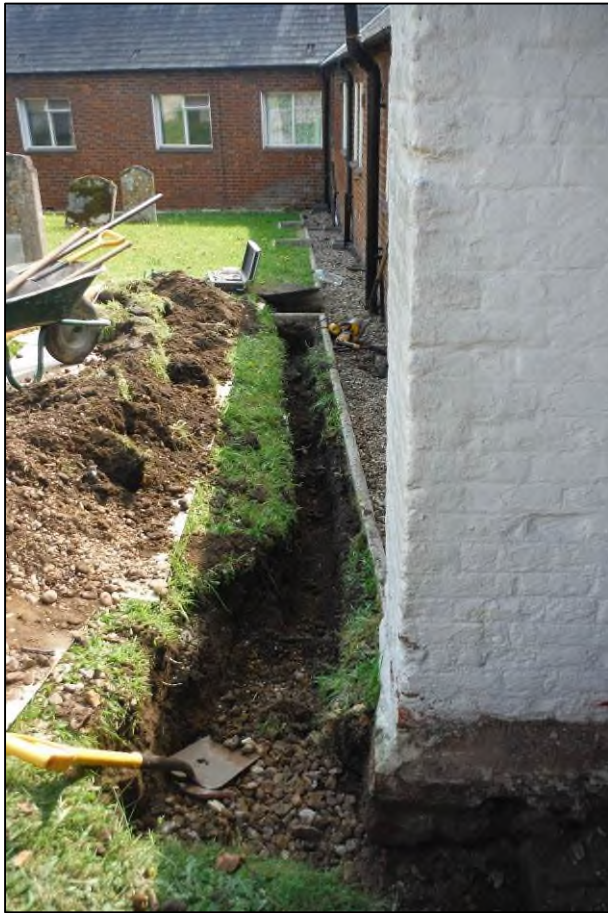
Plate 3: Foul-drain trench, looking east

The foul-drain trench was *c.*5m long and was aligned east-west. It was parallel to the concrete kerb north of No. 5 Feoffee Almshouses and turned south for *c.*1.2m towards the corner of No. 1 Feoffee Almshouses, where the trench cut into the area previously excavated in 1997.

The trench was excavated to a maximum depth of 0.55m at the existing manhole and to between 0.3 and 0.4m throughout its remainder. The terrain generally sloped down towards the east, so that there was a height difference of *c.*0.5m between the western and eastern ends of the trench. (Figure 2, Plates 3–6)

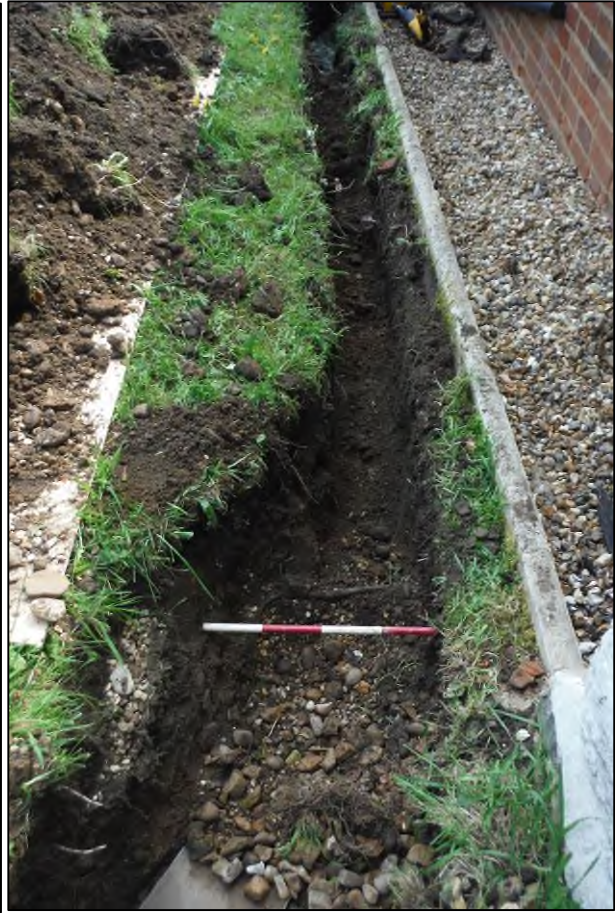
Plate 4: West end of foul-drain trench, looking east (scale 0.4m)

The limited depth of the excavation revealed only topsoil deposits on the main length of the trench. The deposits at the west and east ends of the trench had been disturbed in the 20th century in conjunction with either foundation works or other service installations associated with the Almshouses.

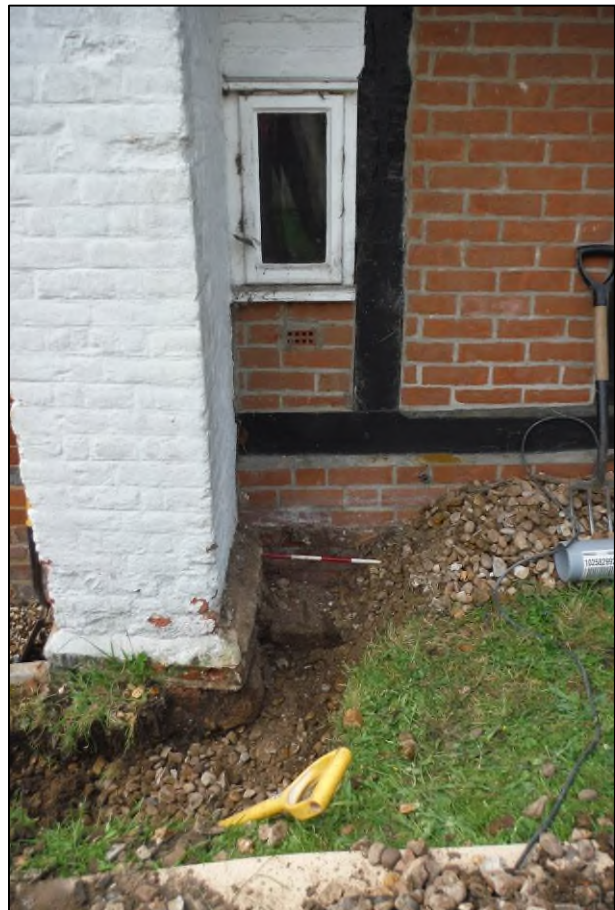
Plate 5: Western section of foul-drain trench, looking south (scale 0.4m)

The thickness of the topsoil (c.0.4–0.5m) is characteristic of a long-lived graveyard, in which the ground has been repeatedly dug over an extended period of time. The presence of disarticulated and fragmented human remains within the topsoil is characteristic of graveyard soils.

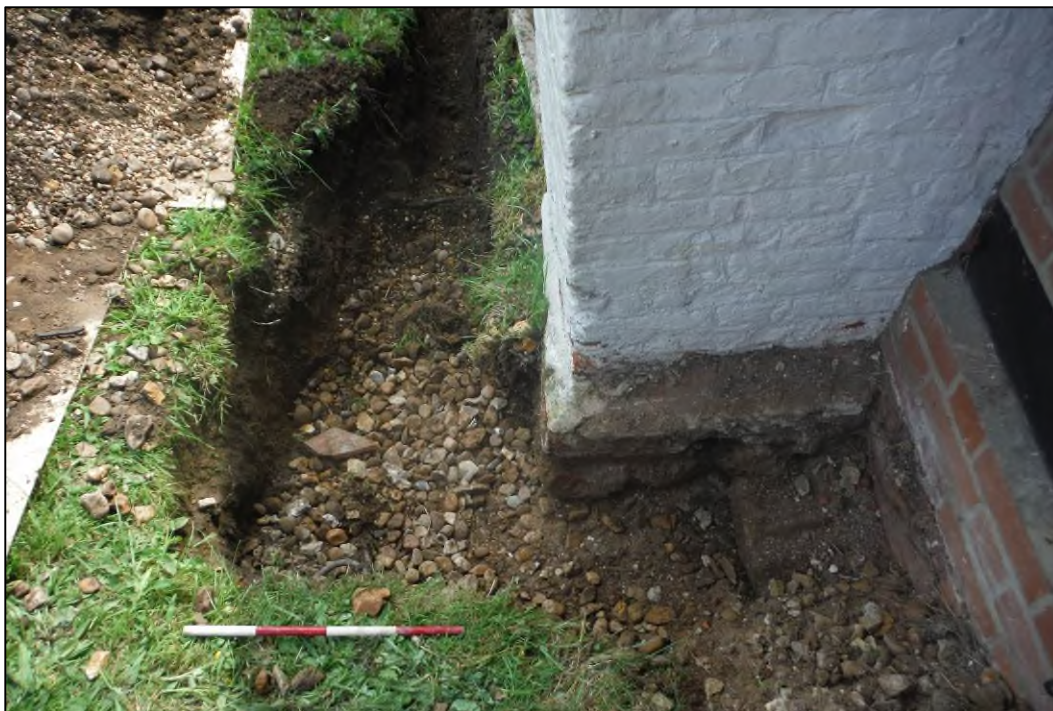
Plate 6: Western section of foul-drain trench, showing foundation of No. 1 Feoffee Almshouses, looking east (scale 0.4m)

The excavation only disturbed topsoil and previously dug soils around the existing manhole and the foundations of No. 1 Feoffee Almshouses, which was underpinned in 1997.

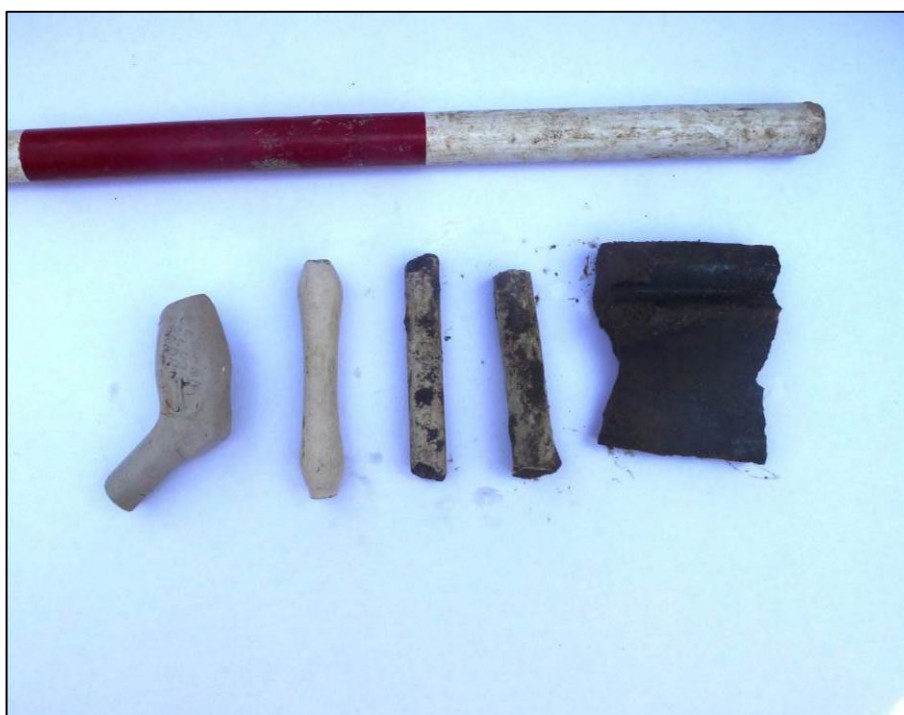
Plate 7: Post-medieval clay pipe, wig curler and pottery fragments from the trench (not removed from site) (scale 0.2m)

A small number of artefacts were retrieved from the graveyard soil during the archaeological observation and were reburied at the base of the trench. These comprised a small assemblage of disarticulated animal and human bone fragments as well as post-medieval pottery and clay pipe fragments and a pipe-clay wig curler (Plate 7). Wig curlers of this type have quite a long date range from around the mid-17th to the 19th century. The clay pipe bowl shows a worn but recognisable mulberry or orange tree pattern with remnants of rouletting around the top. Similar decorations are known from Bedford and have been dated to the late 17th to early 18th century (Baker et al. 1979, 242, 250, fig. 145.1035).

The more domestic finds (animal bone, wig curler, clay pipe and pottery) can be associated with use of the graveyard and the close proximity of the dwellings at the Almshouses.
