**CHURCH OF ST JOHN THE BAPTIST
CHELVESTON
NORTHAMPTONSHIRE**

**ARCHAEOLOGICAL OBSERVATION,
INVESTIGATION, RECORDING, ANALYSIS
AND PUBLICATION**

Project: CH3561
HER event no.: ENN109609
OASIS ref.: albionar1-365104

Document: 2019/131
Version 1.2

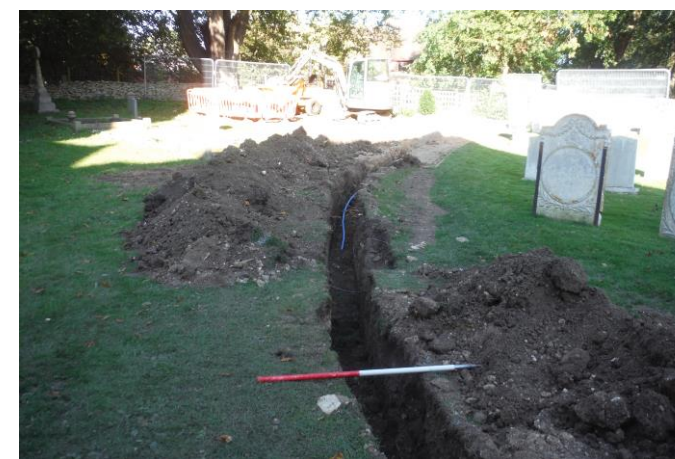
Plate 3: Trench 2 – general shot, looking NE (scale 1m)

Trench 2 ran from the north-east end of Trench 1 to the entrance to the churchyard, excavated as a slight arc on a broadly SW-NE alignment. It was *c.*21m long, *c.*0.8m deep and was widened to 0.3m in order to accommodate the telecom duct as well as the water pipe. An additional 0.2m-deep segment of telecom trench was hand-excavated along the north side of the chancel to the connection point (Figure 2).

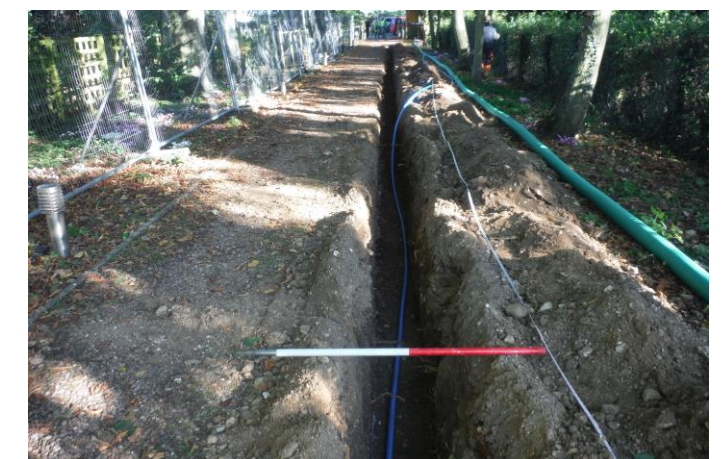
Plate 4: Trench 3 general shot, looking ESE (scale 1m)

Trench 3 was a continuation of Trench 2, excavated in a straight line from the churchyard perimeter wall to Caldecott Road, following the access path to the church. It was c.60m long, c.0.8m deep and 0.3m wide, accommodating both the water pipe and the telecom cable duct (Figure 2).

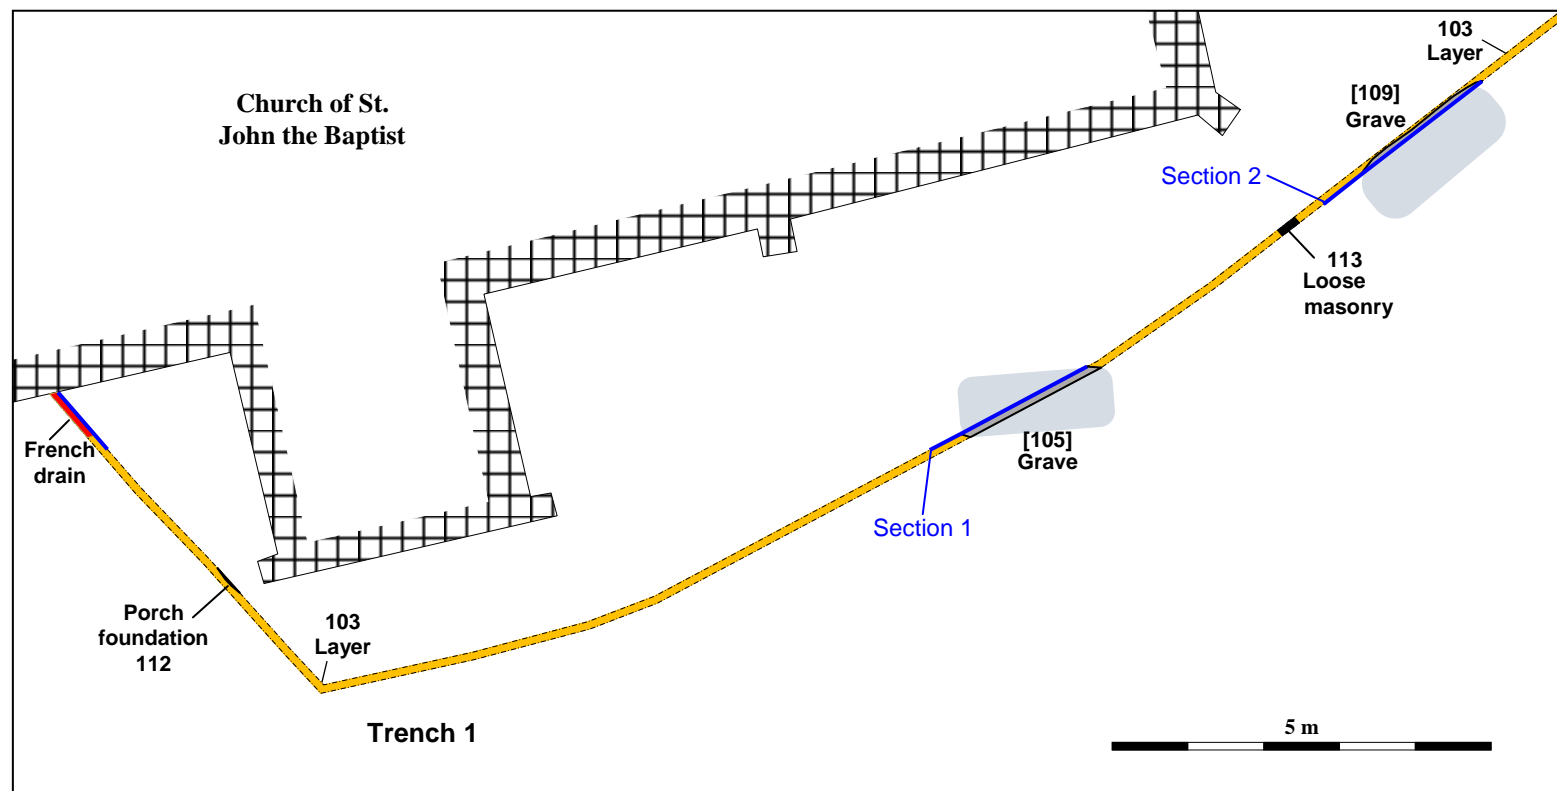
The vertical faces of the trench exposed slightly differing deposits with steep-edged, flat-based profiles that defined the two grave cuts [105] and [108] (Figure 3; Plates 8 and 9). The graves were cut from 0.3–0.4m below the current cemetery ground level and were *c.*0.8m deep.

Two broadly east-west aligned burials were partially visible at the base of the 0.30m-wide trench (Figure 3; Plates 13–14). During machining, the grave cuts were not discernible against the dark cemetery soil with the grave locations only being identified as bone was reached at the base of the trench.

An additional skull was located, visible as a void in the base of the trench (Figure 3). The skull probably indicates the location of a third east-west aligned burial.

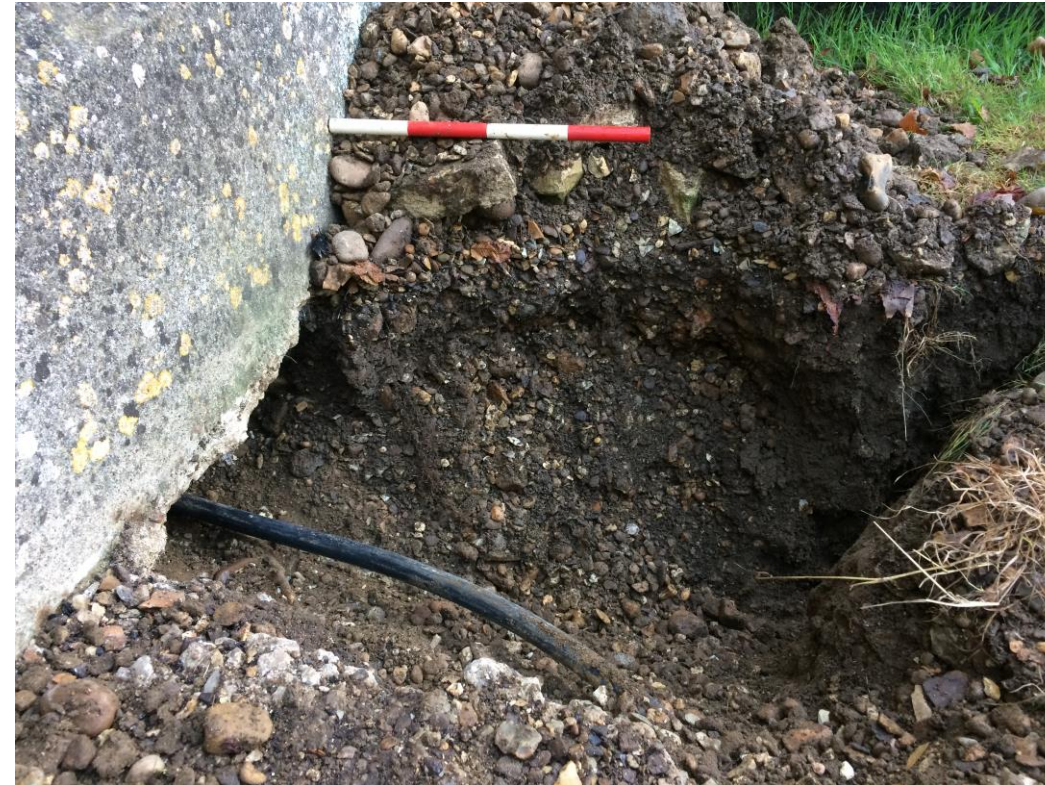
Plate 6: Trench 1 – water pipe connection point, old service pipe and gravel-filled French drain (scale 40cm)

The new trench sloped upwards at 45 degrees to the connection point, which was relatively 'high' at just below ground level. The south aisle foundations were not exposed, being hidden by the loose gravel of a modern French drain that borders the south aisle wall (Plate 6).

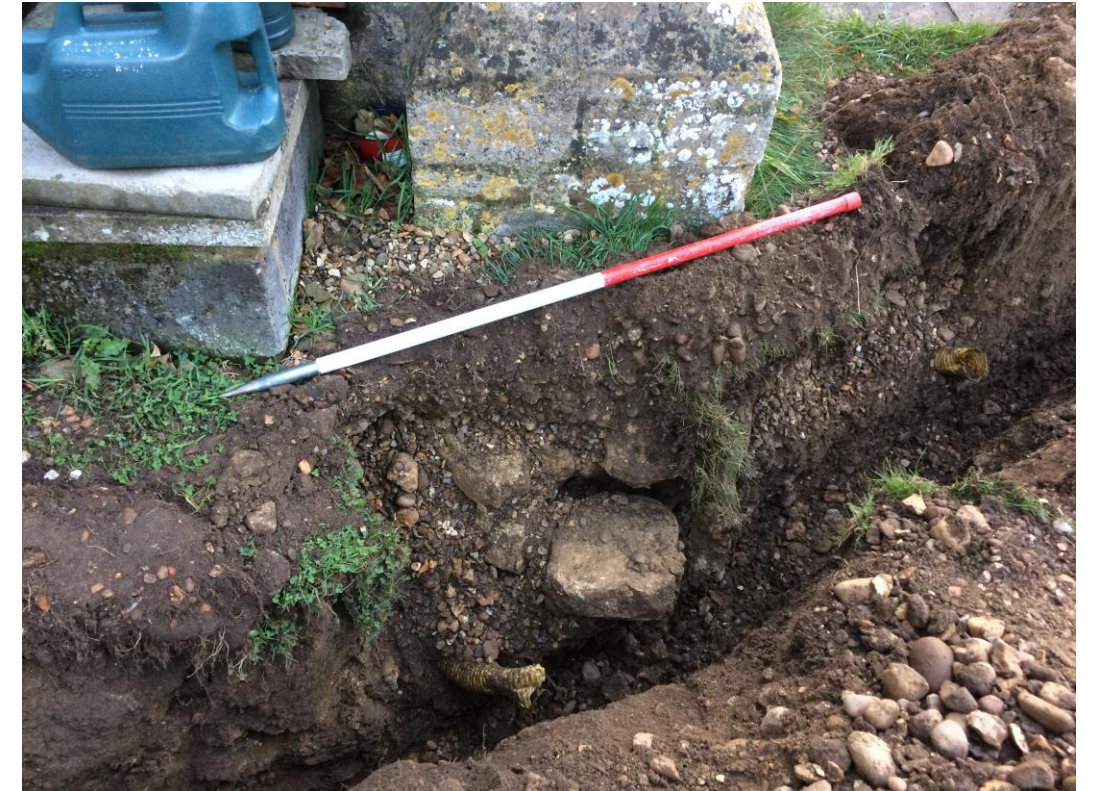
Plate 7: Trench 1 – porch foundation courses (112) (scale 1m)

The inside vertical face of the trench exposed the south-west corner of the porch doorway foundations (112), which were *c.*0.6m from top to bottom and *c.*0.3m wider than the porch doorway wall to the west. It is assumed that the foundation was constructed within a trench, the upper part of which has been destroyed by the modern French drain (Plate 7).

The foundation comprised roughly hewn limestone blocks, which ranged from 150mm x 100mm x 60mm to 160mm x 150mm 80mm. The blocks were arranged in a fitted, drystone-wall fashion with gaps infilled with silt.

The only part of the church foundations exposed by the service trench was at the south-west corner of the porch. The foundation was 0.6m deep and extended 0.3m beyond the porch wall; it comprised roughly hewn, unmortared limestone blocks.

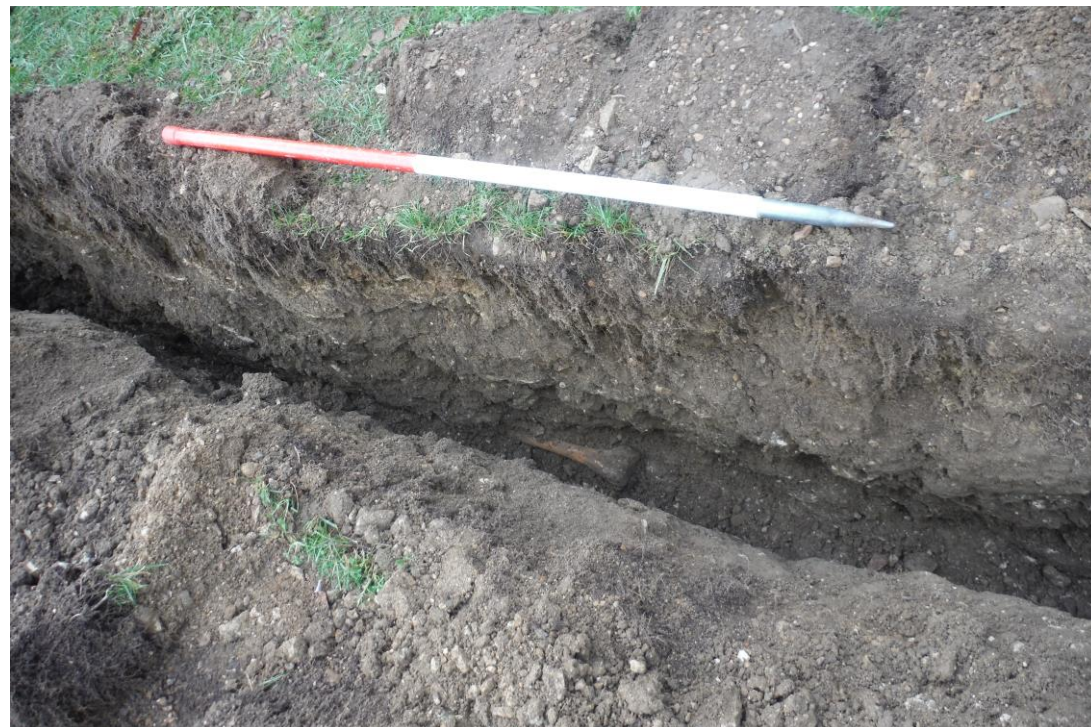
Plate 8: Trench 1 – grave [105], looking WNW (scale 1m)

Grave [105], as visible, contained an *in-situ* human femur (106). It was backfilled with a primary deposit of mid-brown-grey clay silt (107) and an secondary deposit of mid-orange-grey clay silt with moderate medium-sized limestone fragments.

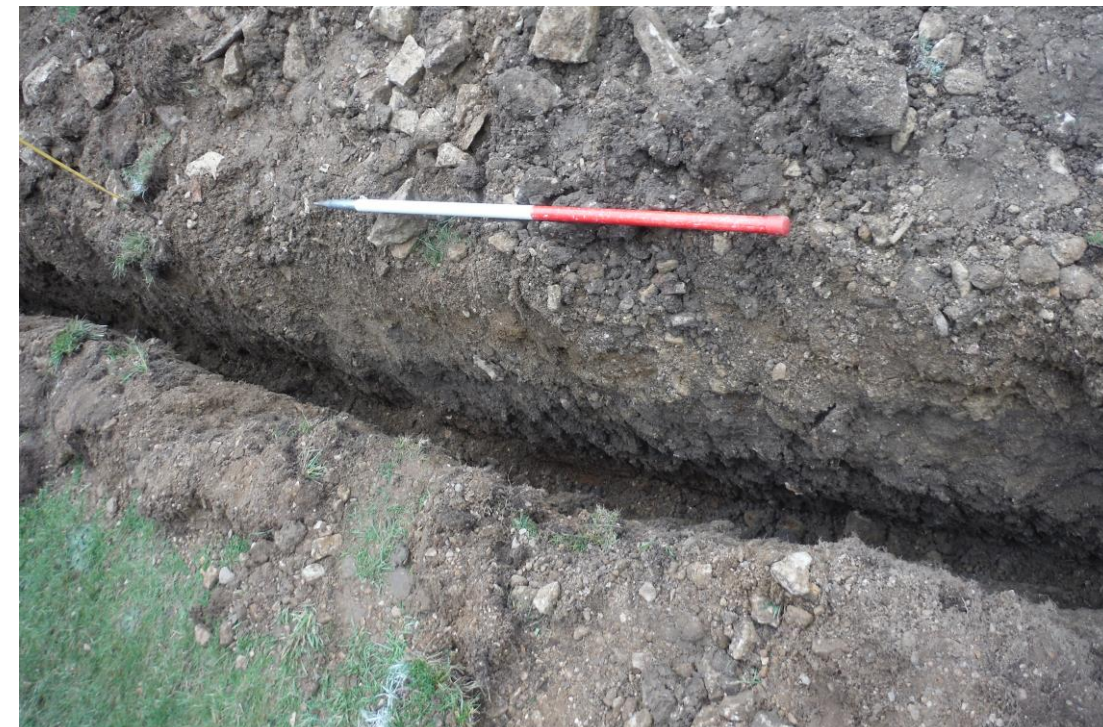
Plate 9: Trench 1 – grave [109], looking east (scale 1m)

Grave [109] contained a skull, femur and pelvic and spine fragments (110), which were disturbed by the narrow trenching bucket (Plate 10). It was backfilled with dark grey clay silt (111).

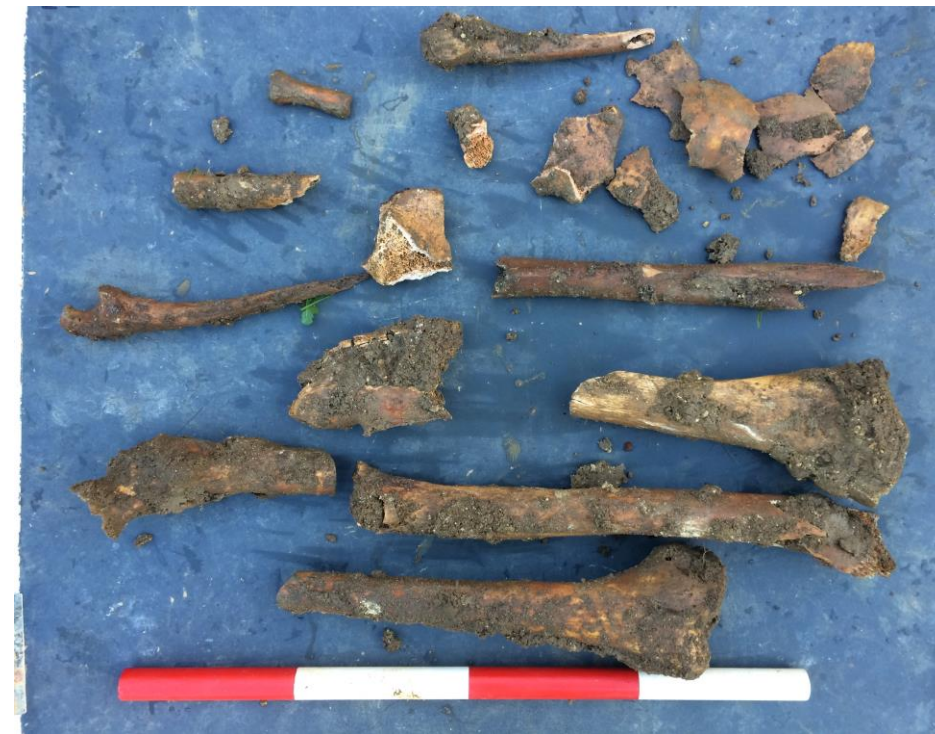
The 'cemetery soil' layer (103) was typical of cemetery deposits — a dark-coloured soil created over a considerable period of time by the disturbance and 'churning' of the ground by periodic re-excavation for burials. This process also causes human bone to be dispersed throughout the deposit (Plate 11). These rich soils are also subject to disturbance through 'worm action'. Identifying individual grave cuts within such cemetery soils is often impossible, as the graves are backfilled with the same deposit.

Plate 11: Trench 1 – disarticulated bone from cemetery soil layer (103)
(scale 40cm)

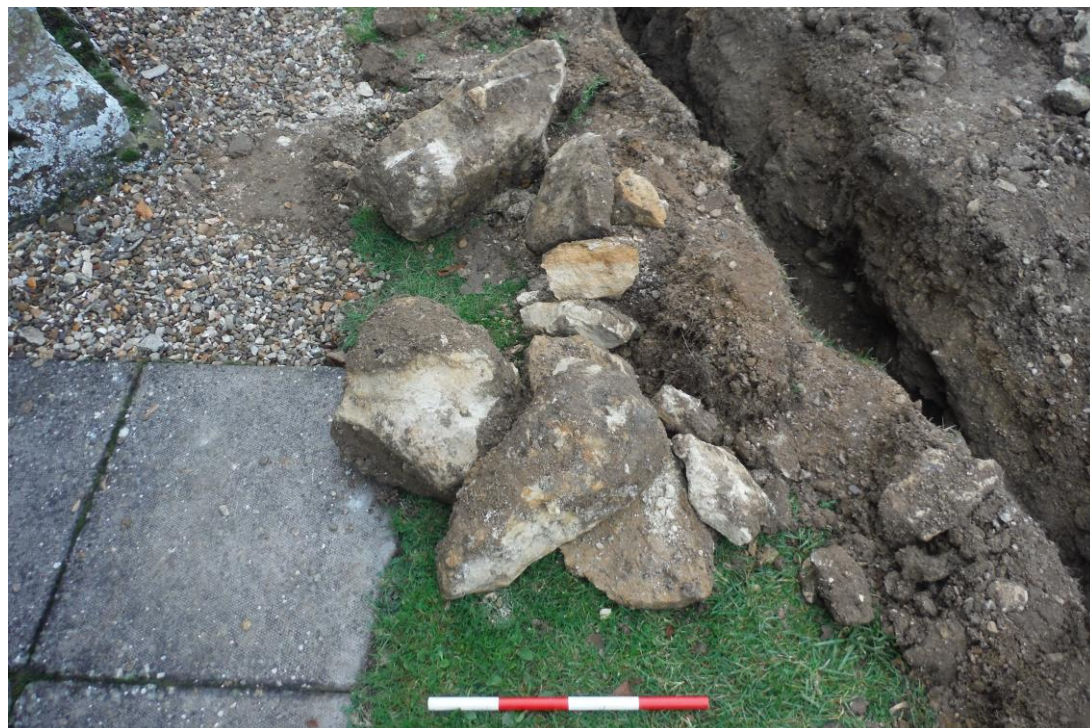
Plate 12: Trench 1 – group of large limestone fragments (113)
(scale 40cm)

A group of large limestone blocks were present at a location towards the south-east corner of the south aisle within layer (103). The blocks continued beyond the limit of the trench to the south-east but were not present within the north-west trench face (Plate 12). The unworked limestone blocks ranged from 100mm x 80mm x 70mm to 500mm x 350mm 150mm. The blocks were loosely grouped, not arranged as a structure and no mortar deposits were present. They are judged to be either a demolition or unused construction deposit.

No foundations or *in-situ* stonework were revealed elsewhere. A loose group of large stone blocks recorded within Trench 1 is judged to be a probable demolition deposit.

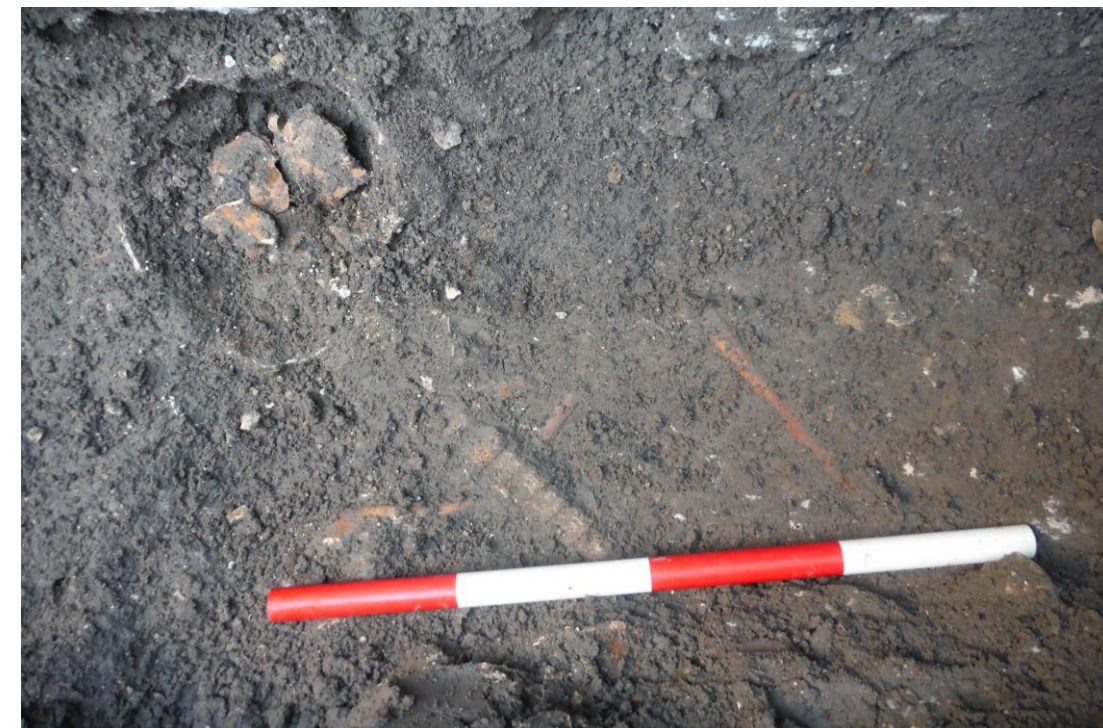
Plate 13: Trench 2 – grave [205], looking NW
(scale 40cm)

The revealed part of grave [205] contained a skull, spinal column, clavicles and left upper arm (206). The grave and was backfilled with a primary deposit of dark brown-grey clay-silt (207). The revealed part of grave [208] contained a skull and left upper arm (209). A pig jaw bone was also present in the brown-grey clay-silt grave backfill (211).

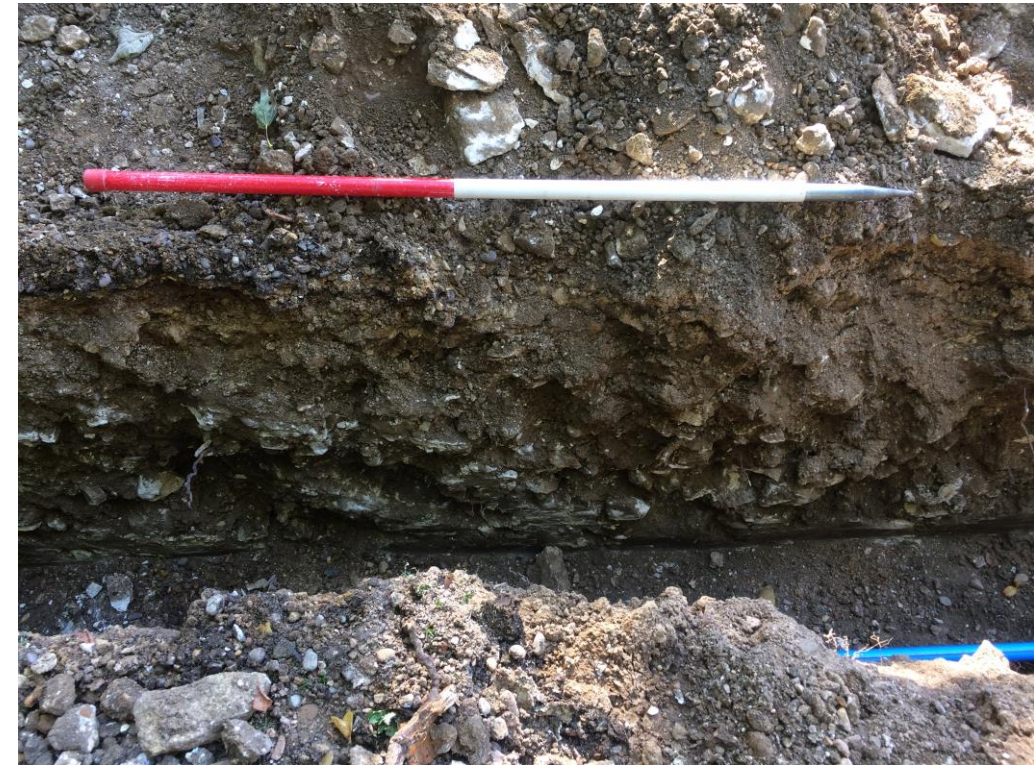
Plate 15: Trench 3 – layers (300), (301), (304), (302), looking north
(scale 1m)

- a block paving surface;
- a c.0.1m-thick levelling layer of silty sand and gravel (300);
- a c.0.27m-thick layer of mid-brown-grey sandy silt (301);
- a c.0.25m-thick layer of dark grey-black sandy silt with frequent medium and large limestone fragments (304), which intruded slightly inside the churchyard perimeter and continued down beyond the bottom of the trench (Plate 15).

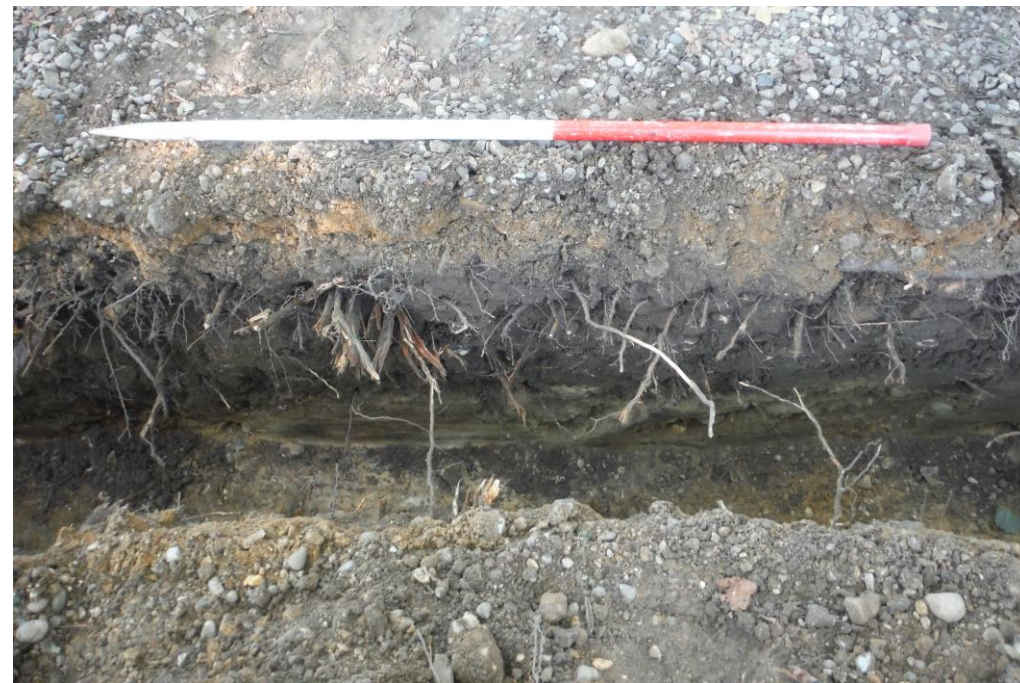
Plate 16: Trench 3 – layers (300), (301), (302), (303), looking NW
(scale 1m)

- a c.0.14m-thick surface and levelling layer of silty sand and gravel (300);
- a c.0.4m-thick layer of mid-brown-grey sandy silt (301);
- a c.0.14m-thick layer of dark grey-black sandy silt with occasional medium and large limestone fragments (302);
- undisturbed geological horizon of light yellow-orange sandy silt (303), revealed at the base of the trench (Plate 16).

Layer (304) was similar to the Trench 2 layer (203), but with frequent limestone fragments. The latter may represent wet-ground consolidation for an earlier, lower-level entrance point to the churchyard. Layer (302) is also interpreted as a ‘buried’ lower-level trackway/topsoil deposit.

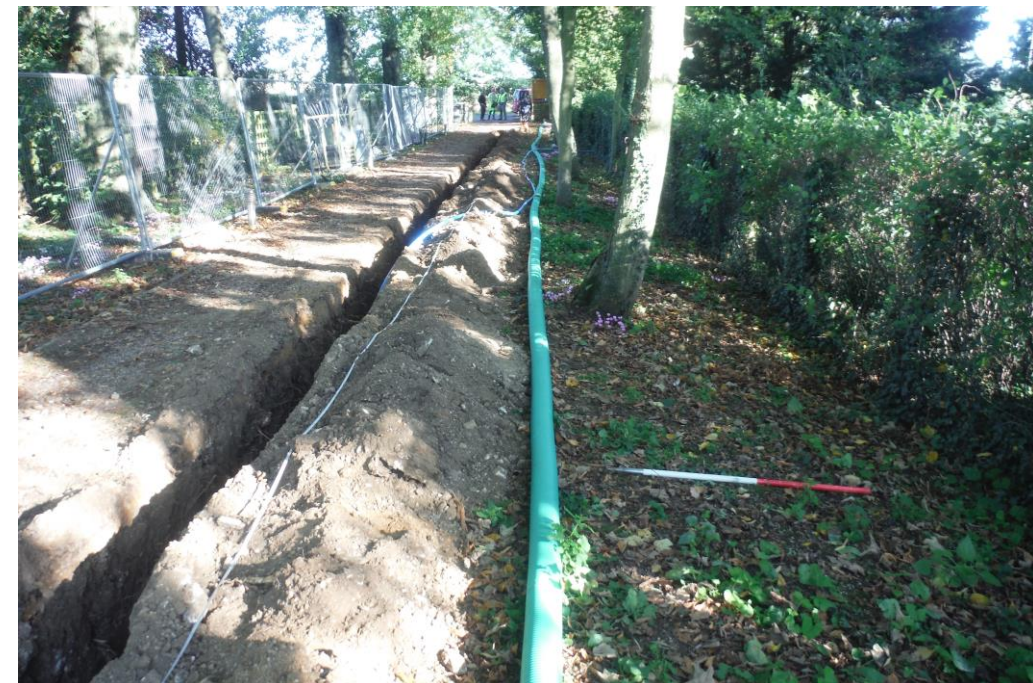
Plate 17: Trench 3 – general shot of the ground sloping away from the access path, looking ESE
(scale 1m)

Layer (301) contrasted notably in colour with the darker layers (304) and (302) beneath it. It appeared to be an imported make-up layer, designed to raise and level the entrance to the churchyard. It was noted that the ground along the southern edge of the access path dropped away fairly sharply at this point (Plate 17).

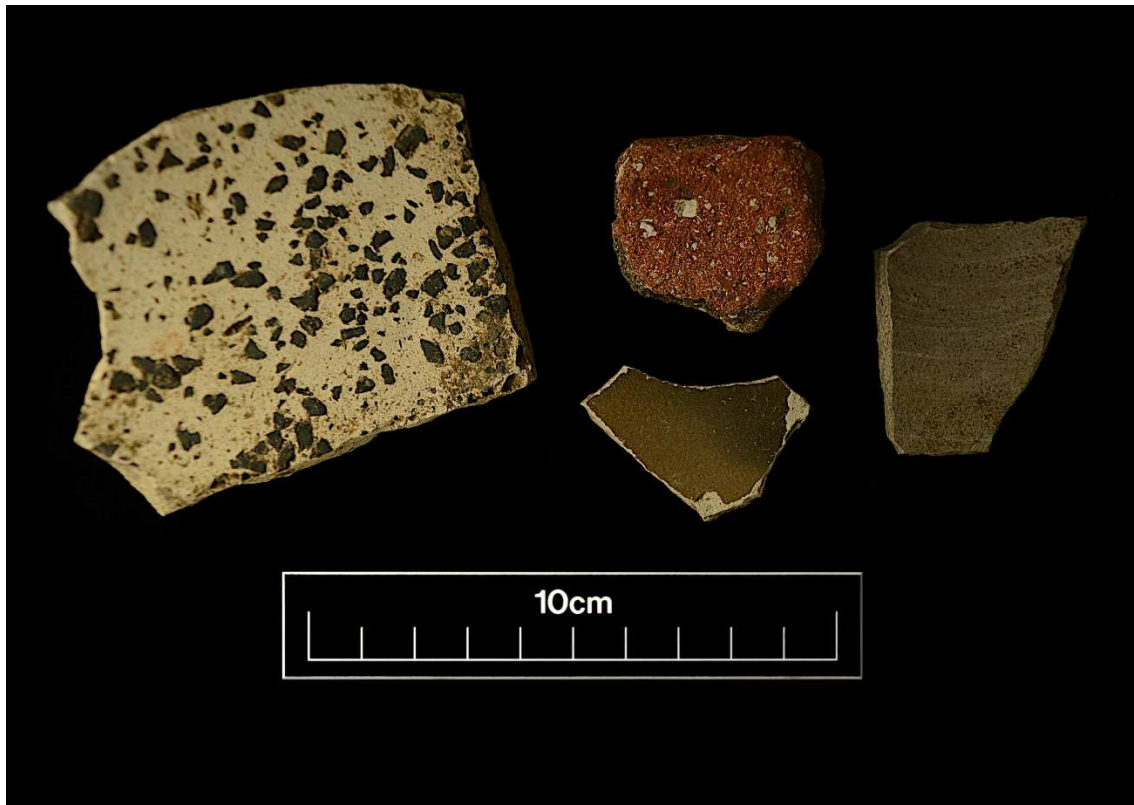
Plate 18: Residual Roman pottery from make-up layer (301)

Layer (301) contained occasional fragments of Roman pottery (Plate 18) and a roof tile fragment of late medieval/post-medieval date. As the layer is probably imported, the artefacts are considered to be residual items within a deposit of unknown origin. However, as with layer (203), the presence of the pottery sherds is suggestive of a Roman site in the immediate vicinity.

Seven unabraded Roman pottery sherds (208g) were collected from layers (203) and (301). They are well preserved, with a mean sherd weight of 30g, and comprise standard wares from local sources — principally the Nene Valley and possibly Harrold (north Bedfordshire); they date from the mid-2nd century onwards.

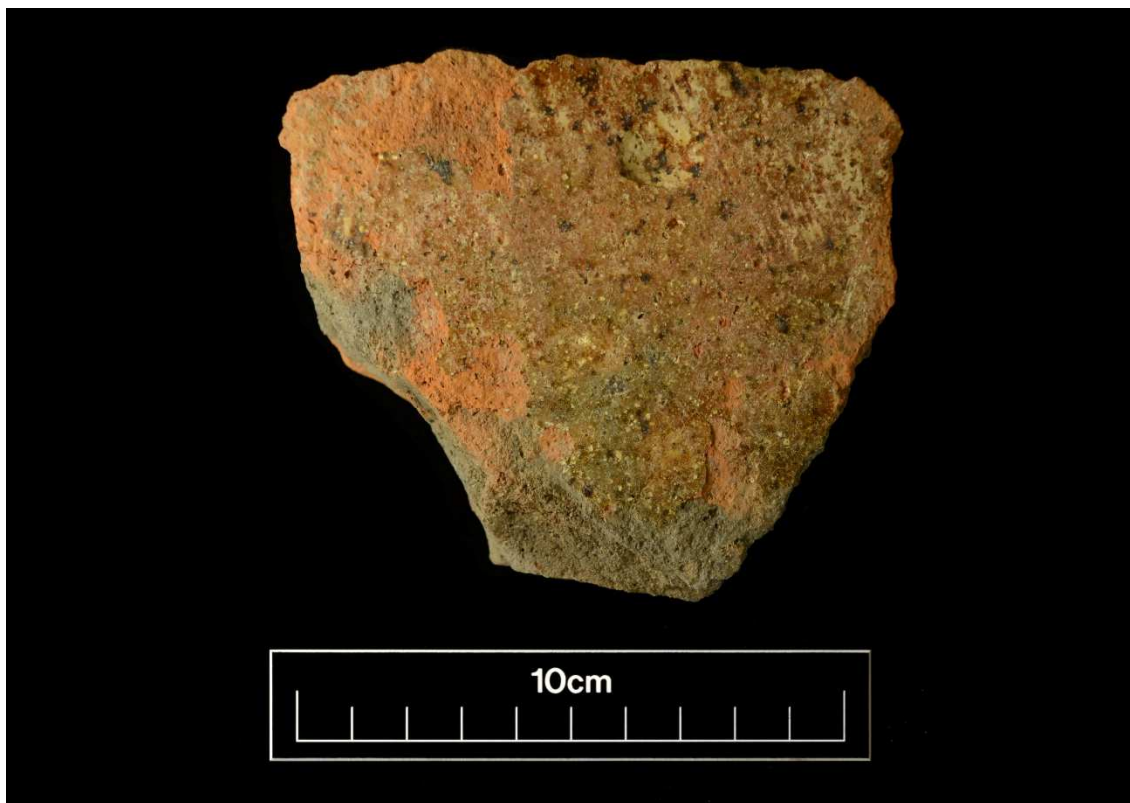
Layer (102) yielded sand-tempered single portions of an unglazed pavioir and lead-glazed floor tile (Plate 19), the latter with a slightly bevelled knife-trimmed edge. A piece of plain flat roof tile derived from layer (301). All are likely to be of late medieval or post-medieval date.

Plate 19: Late medieval/post-medieval lead-glazed floor tile from make-up layer (102)
