**THE WORKSHOP
MANOR FARM
BOLNHURST
BEDFORDSHIRE**

ARCHAEOLOGICAL WATCHING BRIEF

Project: MF3371
Document: 2022/17
Version: 1.0

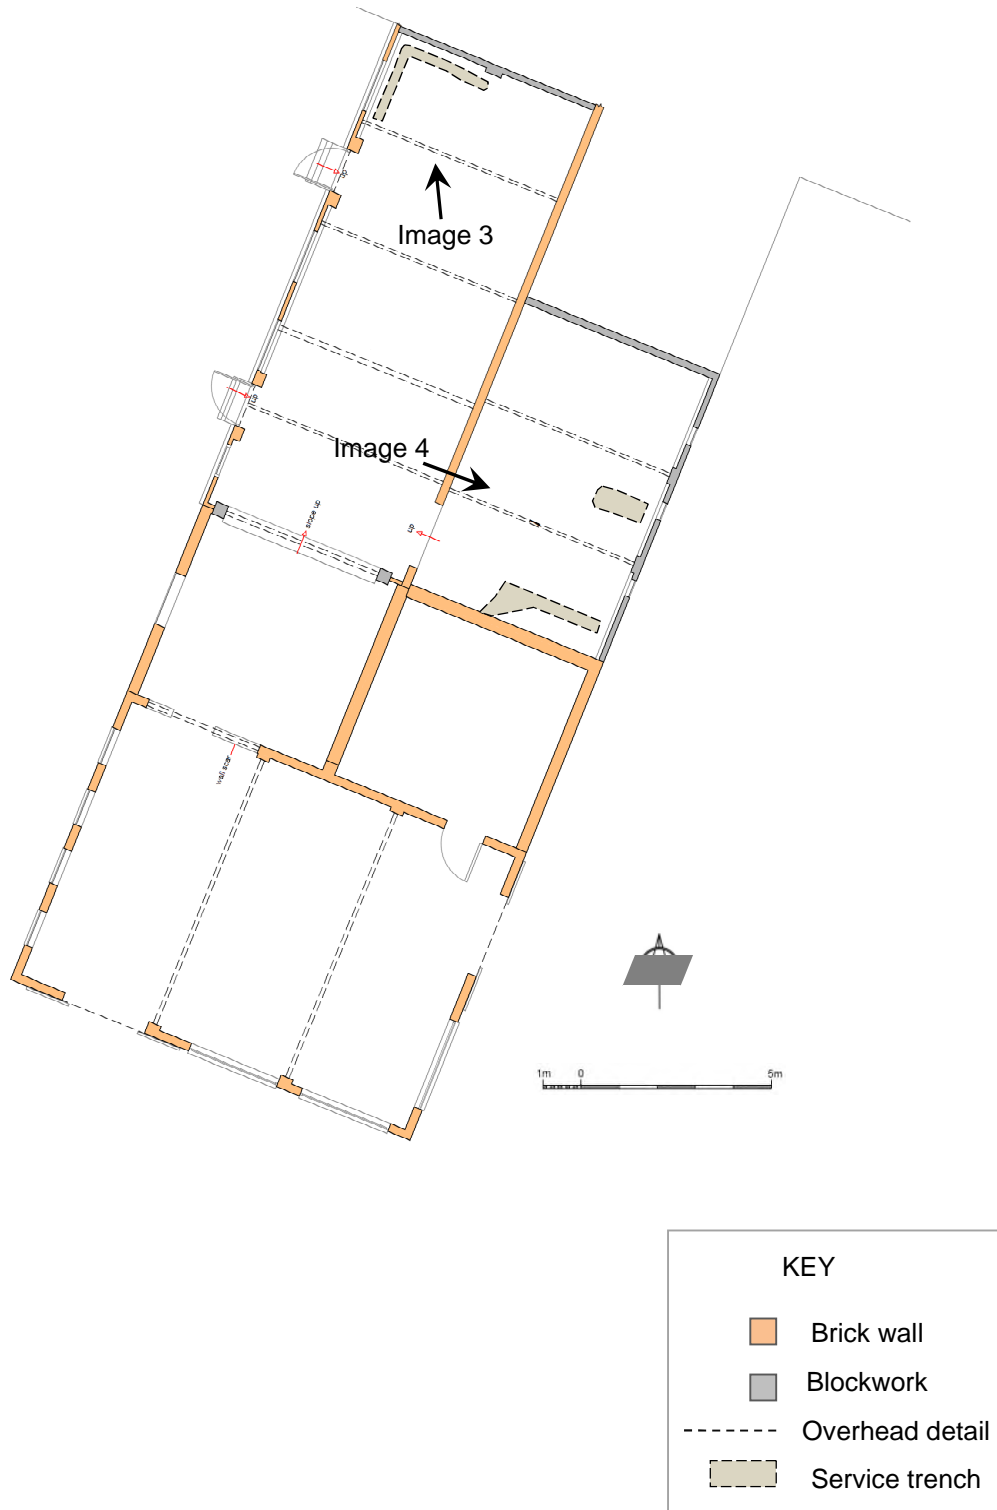
Figure 2: Service trench locations

The groundworks in the workshop were limited in extent. Floor levels were raised to provide the required insulation and new internal dividing walls were constructed in studwork. The observed groundworks consisted of three small trenches for the installation of services: one in the north-west corner; and two in the east side of the building (Figure 2).

The depth of the trenches varied, with most parts measuring 250mm or less. In a limited area next to the east wall the trenches were up to 400mm deep.

See Figure 2 for a plan of the workshop building, showing the locations of the service trenches. Photographic images showing the service trenches are included at the back of the report (Images 3 and 4).

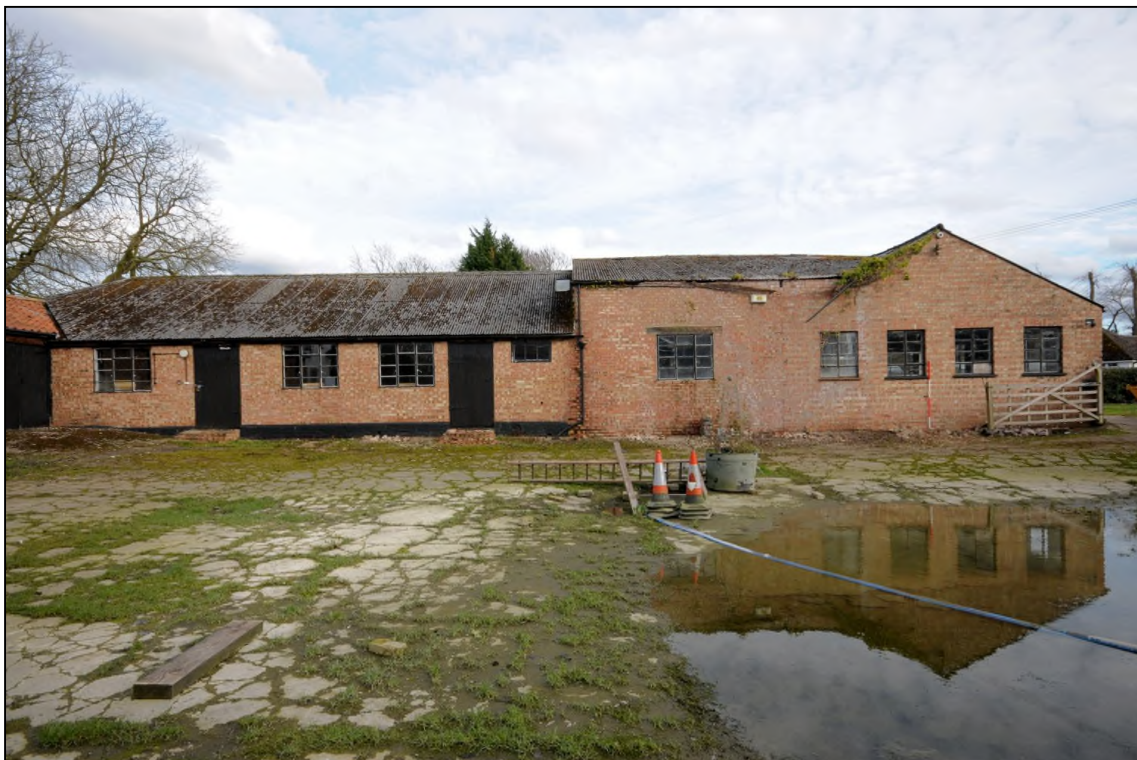
The workshop was constructed in the 1920s or 1930s and modified during the 20th century.

Image 2: West elevation of the workshop

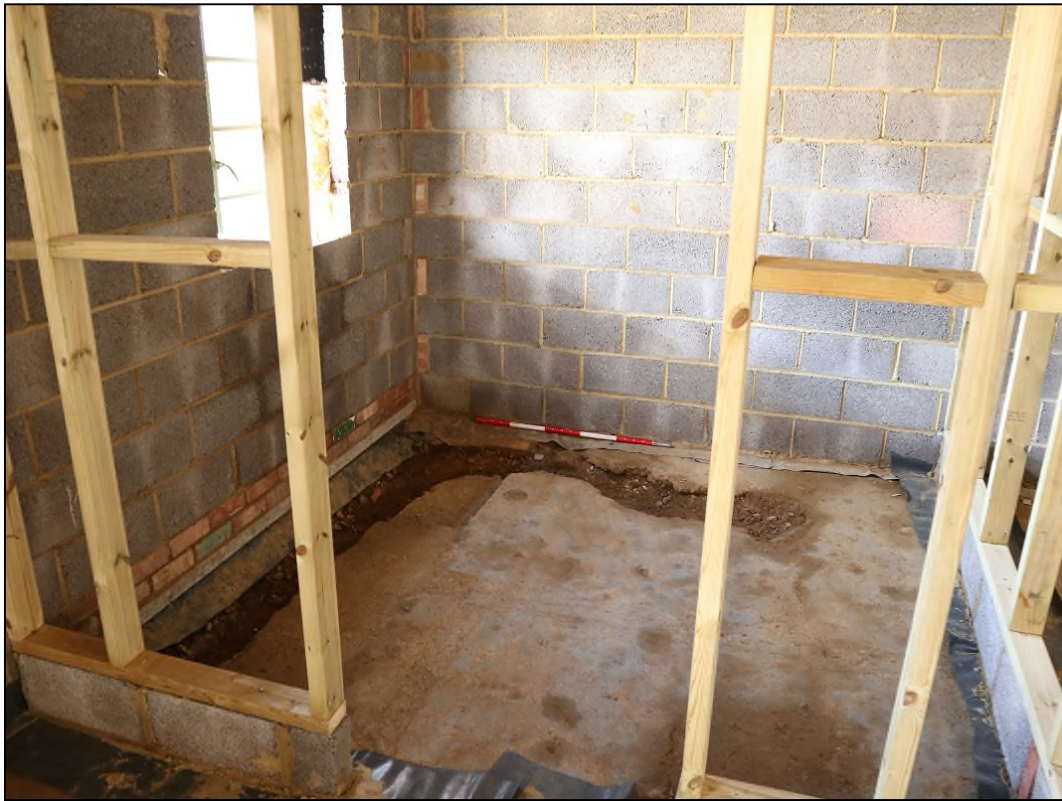
The floors were in concrete, between 100mm and 150mm thick. The trench in the north-west corner of the workshop contained a mid-red-brown, sandy silt with frequent stones and occasional fragments of brick. The two trenches in the east side of the workshop contained a layer of rubble beneath the concrete.

Image 3: Service trench in north-west corner of the workshop
(Looking north, scale 1m)

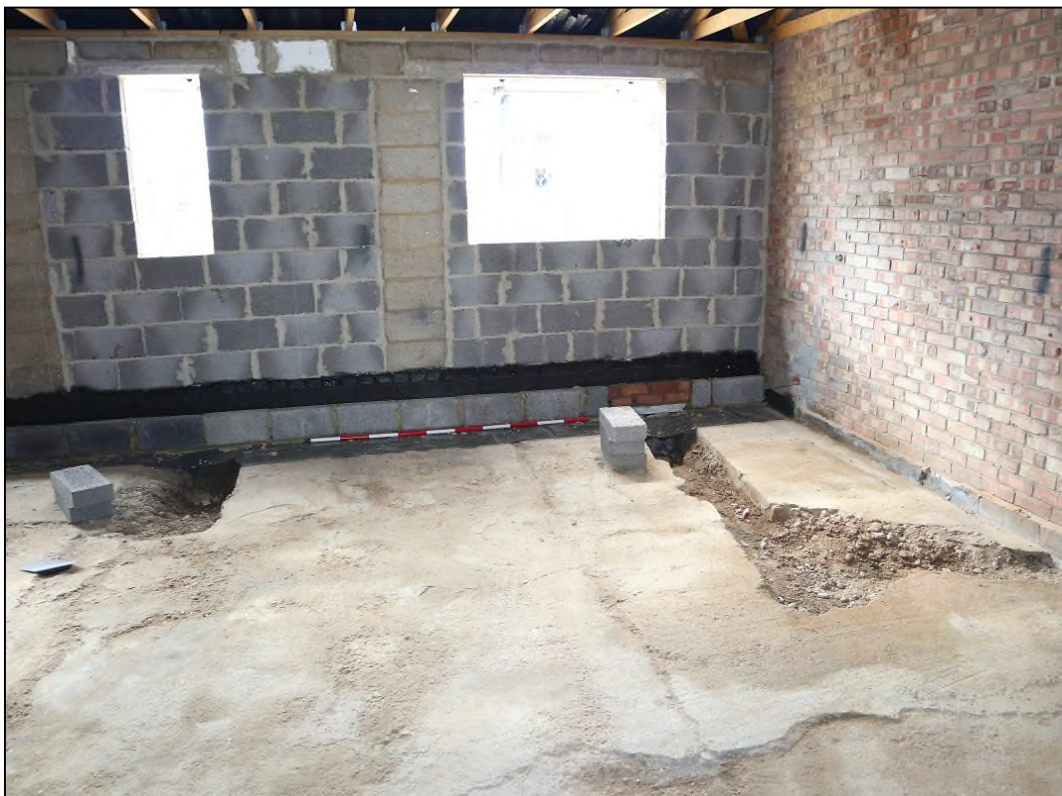
Soil layers predating the modern floor make-up were only observed in the deeper sections of the two eastern trenches, adjacent to the external wall. They comprised dark grey-brown, clay silt with occasional stones, probably derived from a former topsoil layer, buried by the construction of the building.

Image 4: Service trenches in east side of the workshop
(Looking south-east, scale 2m)
