**41-43 CAUSE END ROAD  
WOOTTON  
BEDFORDSHIRE**

**HISTORIC BUILDING RECORDING**

Project: CE3614  
Document: 2020/32  
Version: 1.0

Issue date: 27th May 2020

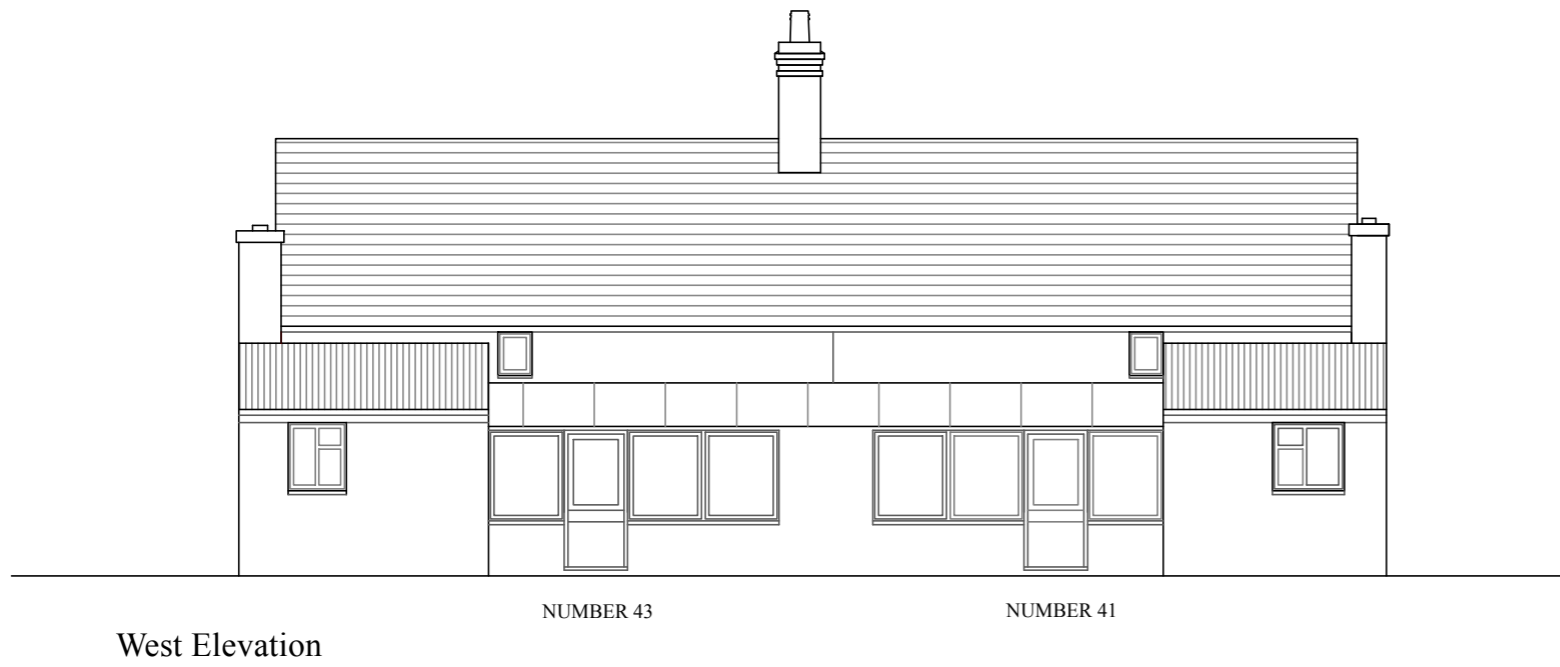
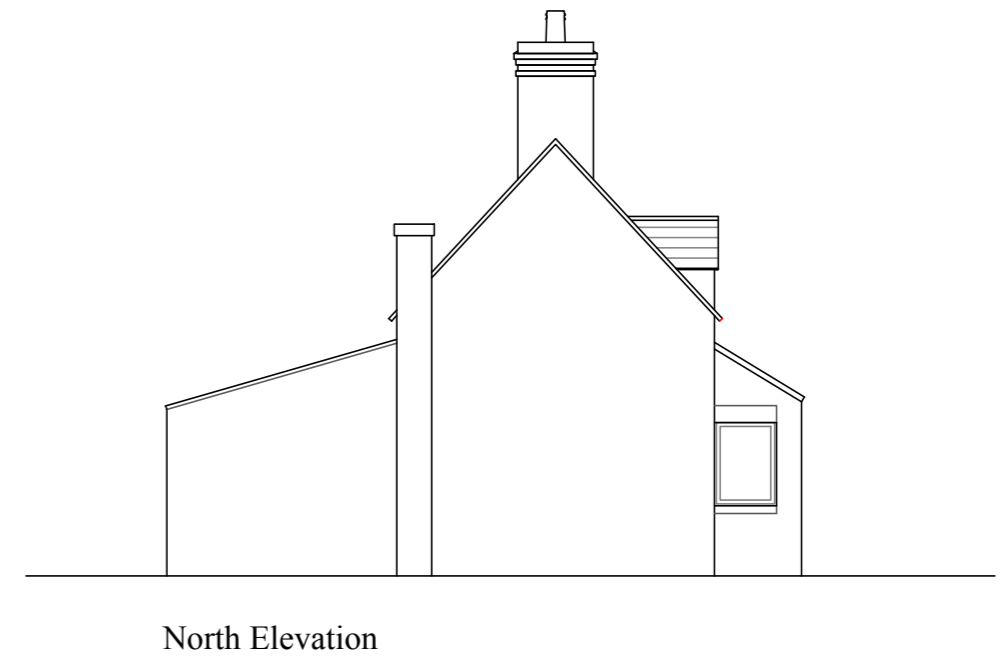
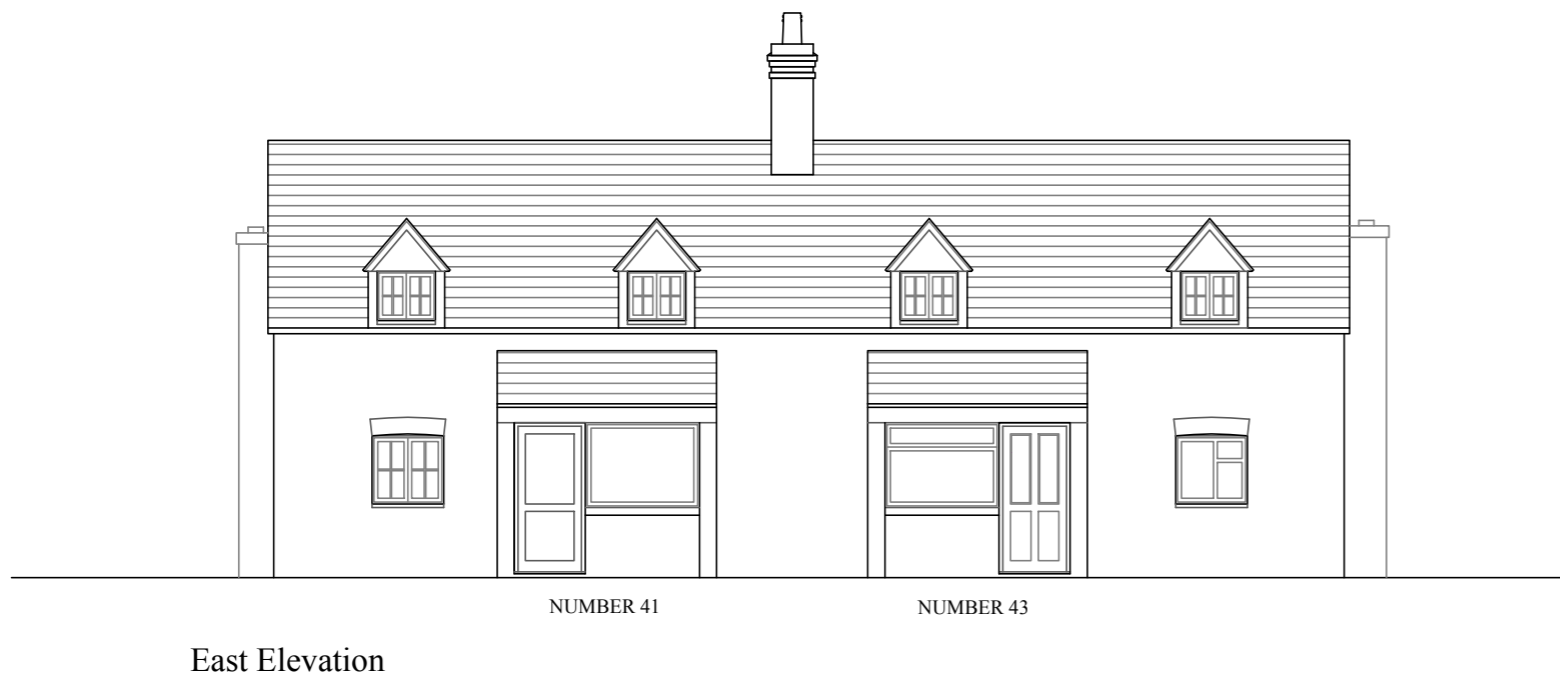
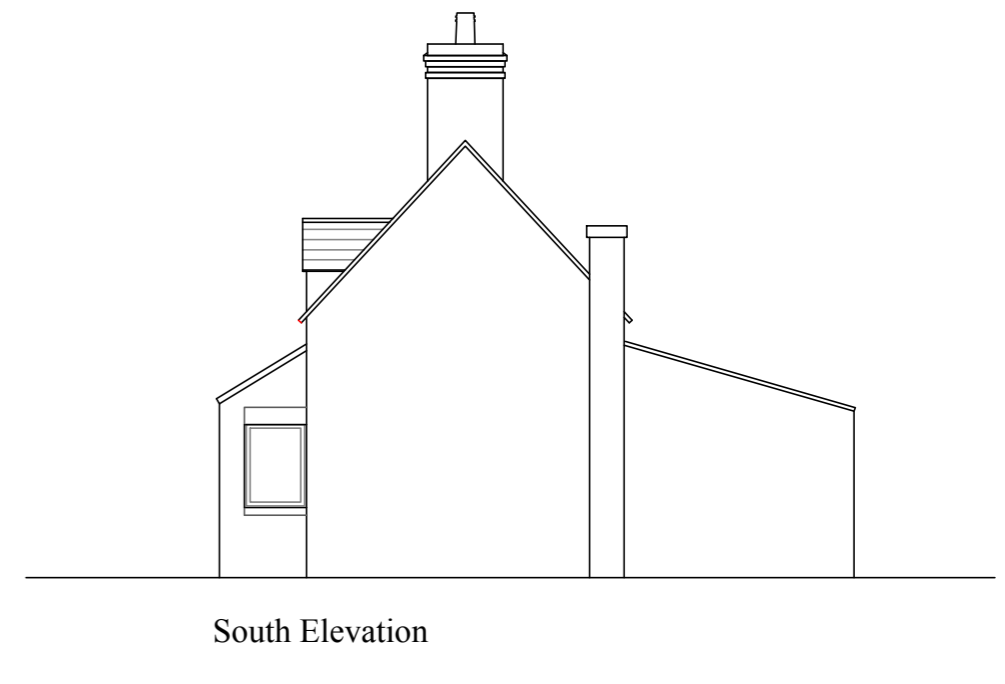
**Figure 5:** Elevations

The building consisted of a symmetrical pair of cottages with no. 41 on the left-hand side and no. 43 on the right (Image 1 and Figure 5). The elevation was in four bays of one and half storeys.

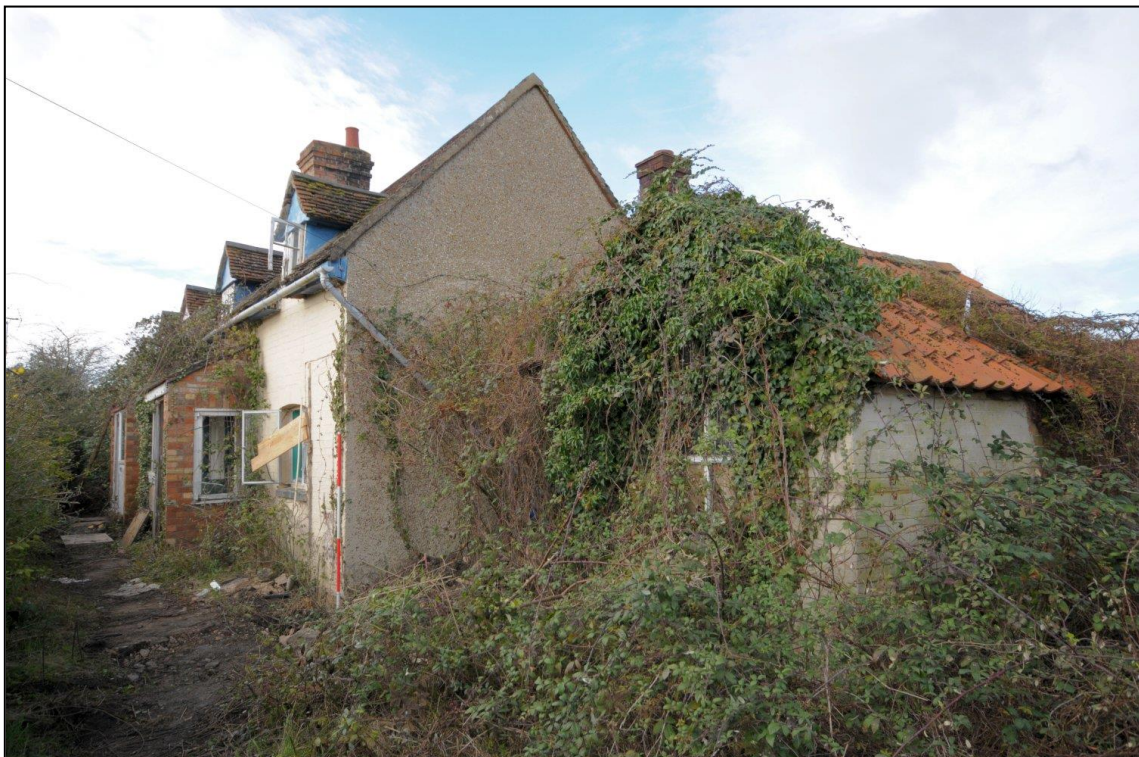
The end elevations were partially obscured by a combination of the adjacent outbuildings and plant growth (Image 2). These walls had no openings and were covered in cement render. The roof had a plain tile verge.

**Image 2:** North elevation  
North end of No. 43 with its shed to the right

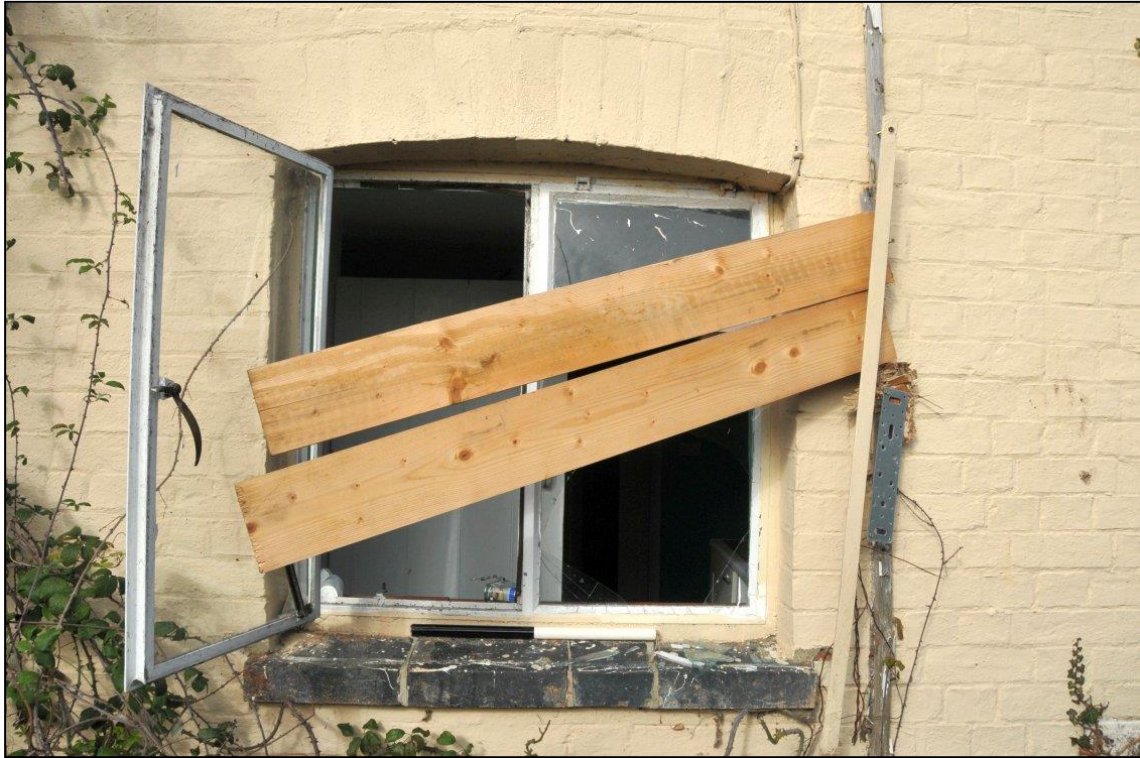
The ground-floor windows had segmental arches (Image 3). Porches had been added in front of the original front doorway and central window of each cottage (Image 5). The porches had brick side walls in reused bricks with a window in each side and with a door and window above a plywood panel in the front.

**Image 3:** South elevation, detail of window

Ground-floor window in right end of south elevation of No. 43

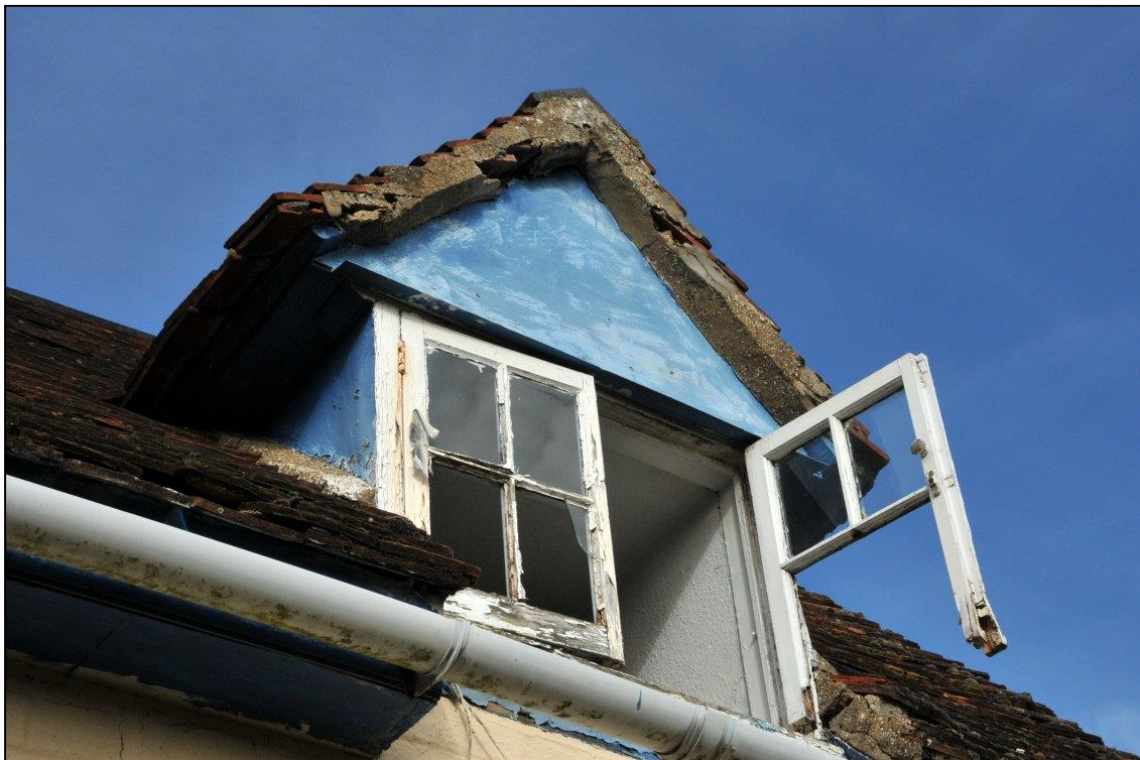
The attic storey had four dormer windows with tiled gabled roofs (Image 4). A central axial brick stack with four flues retained a single clay chimney pot at the time of the survey. The roof was in plain clay tiles with dark grey ridge tiles on the main ridge and the dormers.

**Image 4:** South elevation, detail of dormer window

Right-hand window of No. 43

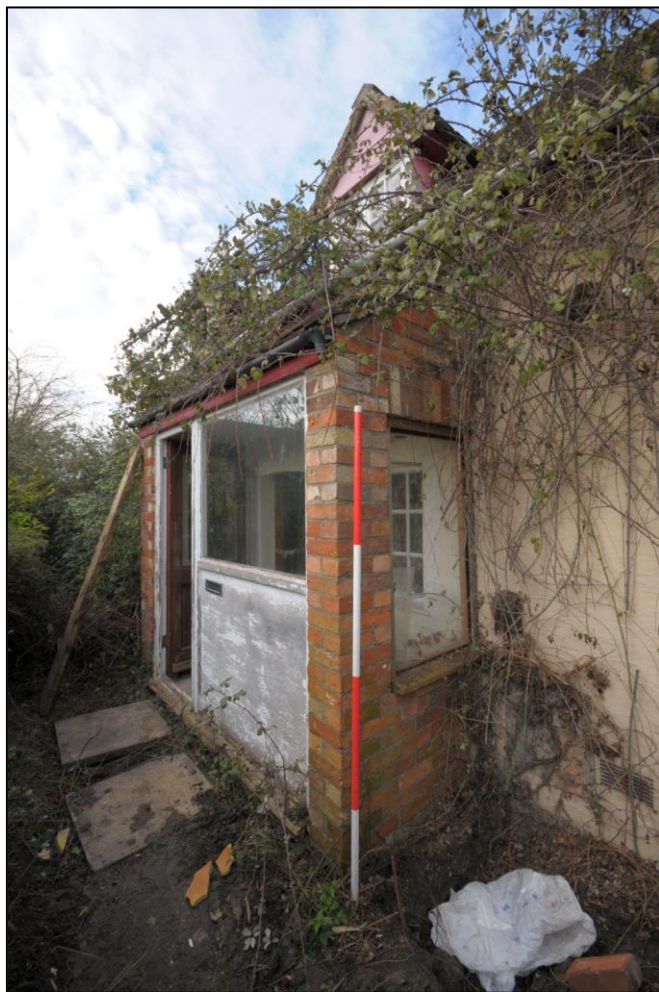
**Image 5:** South elevation, porch  
Porch of No. 41. (Scale 2m)

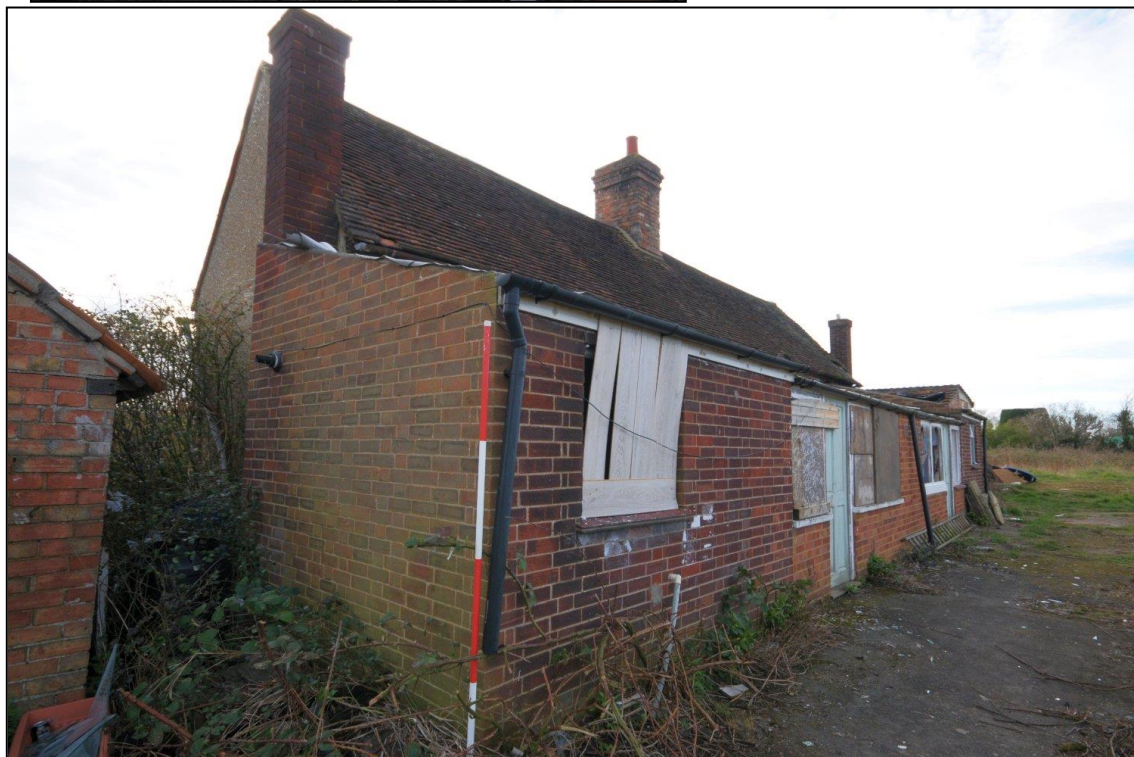
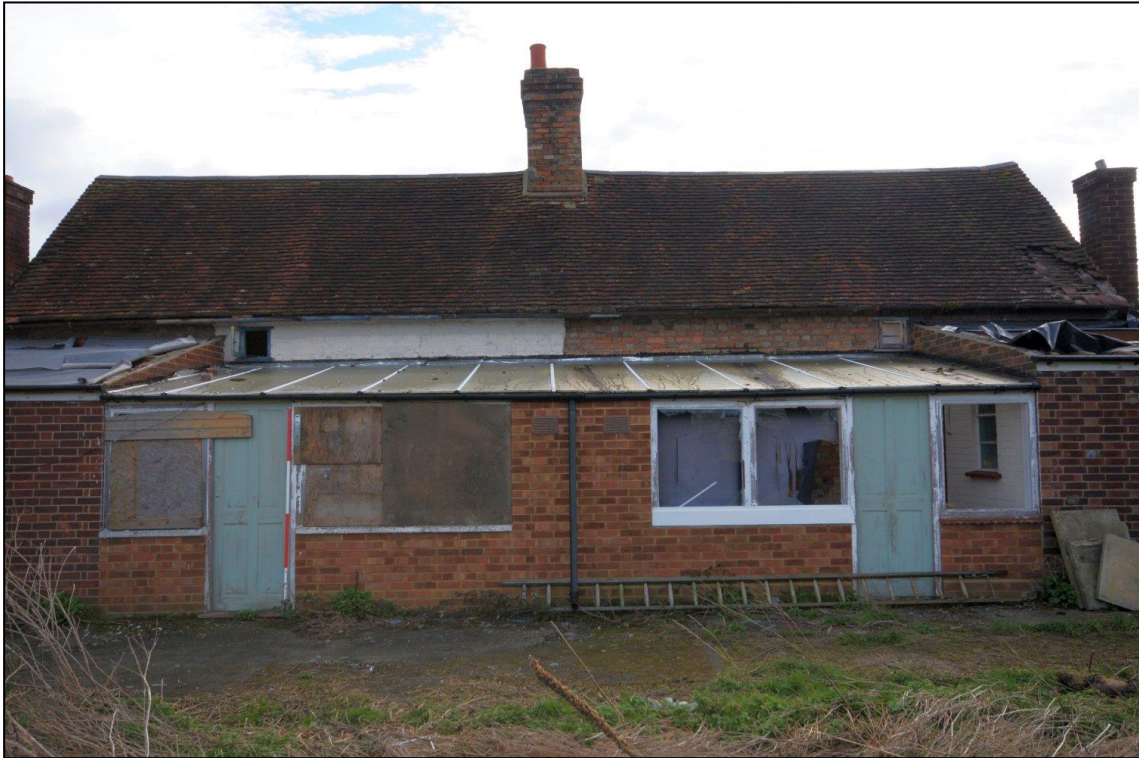
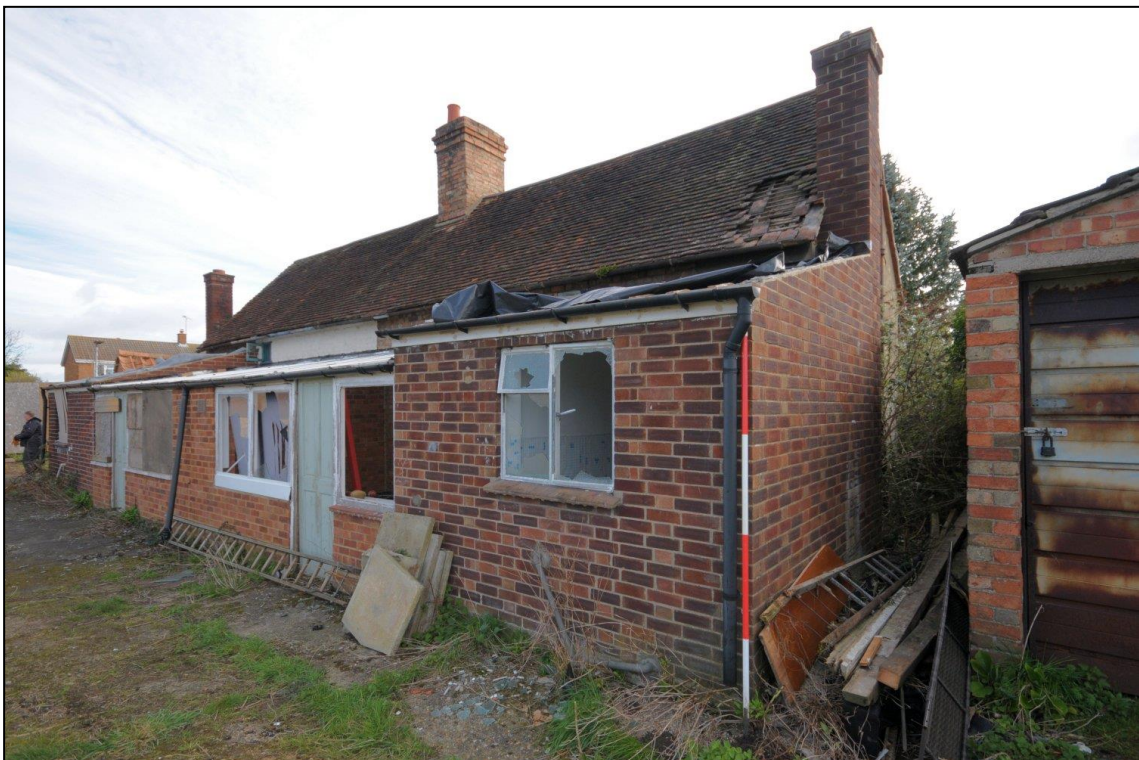
The rear elevation was mostly covered by a lean-to extension added in the late 20th century (Images 6–8). This extension had brick outer bays in a brownish brick with a single window in each and a central section forming a conservatory for each cottage. The conservatory was covered by a shallow pitch roof in acrylic plastic sheet.

**Image 6:** Rear elevation, viewed from north-west  
Lean-to extension of No. 43 in foreground (Scale 2m)

**Image 7:** North (rear) elevation

Lean-to extension, windows under eaves lighting stairs and the central chimney stack

**Image 8:** Rear elevation, viewed from south-west

Lean-to extension of No. 41 in foreground (Scale 2m)

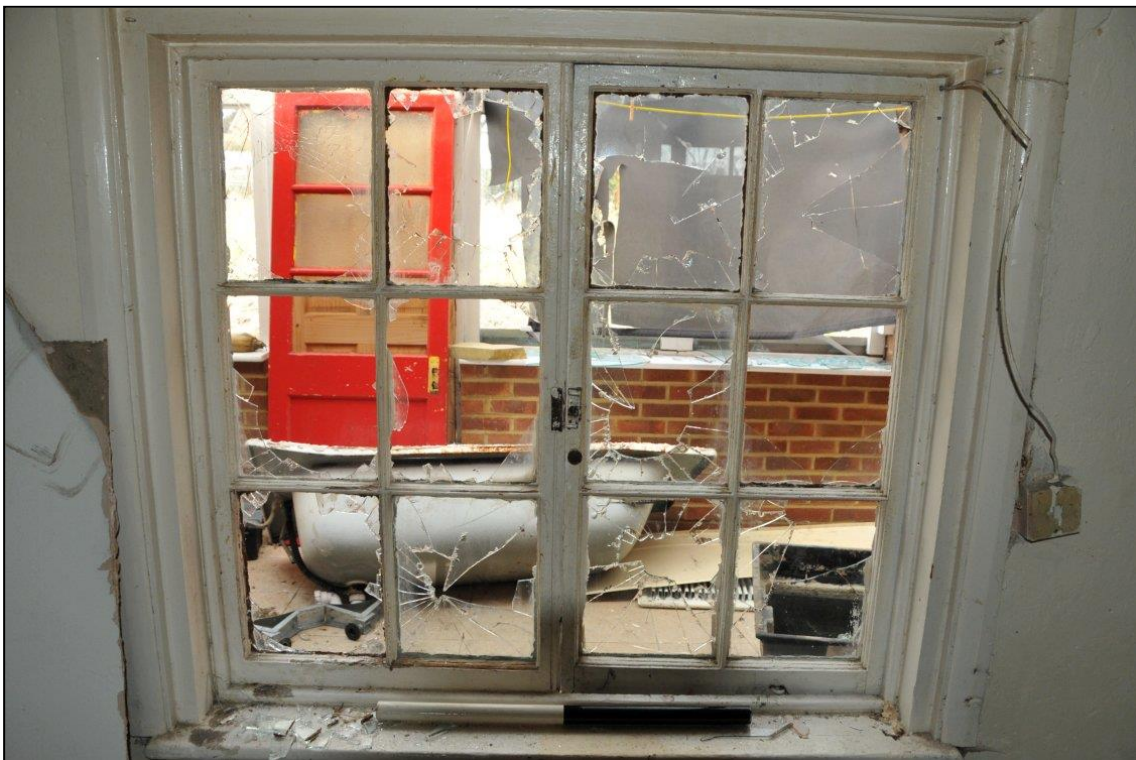
- Front door. Modern glazed door with safety glass.
- Door opening to kitchen. Door missing. Modern plain-chamfered architrave.
- Window in west wall (Image 12). Two-light casement with six panes in each. Narrow glazing bars with ovolo and fillet cross-section, suggesting early 19th-century date. A modern plain-chamfered architrave had been added around window.
- Mid-20th-century steel-framed window in east wall.
- Solid floor with modern parquet effect covering.
- Modern (late 20th-century) coal-effect fireplace with modern timber fire surround.

**Image 12:** No. 41, living room, detail of window in west wall

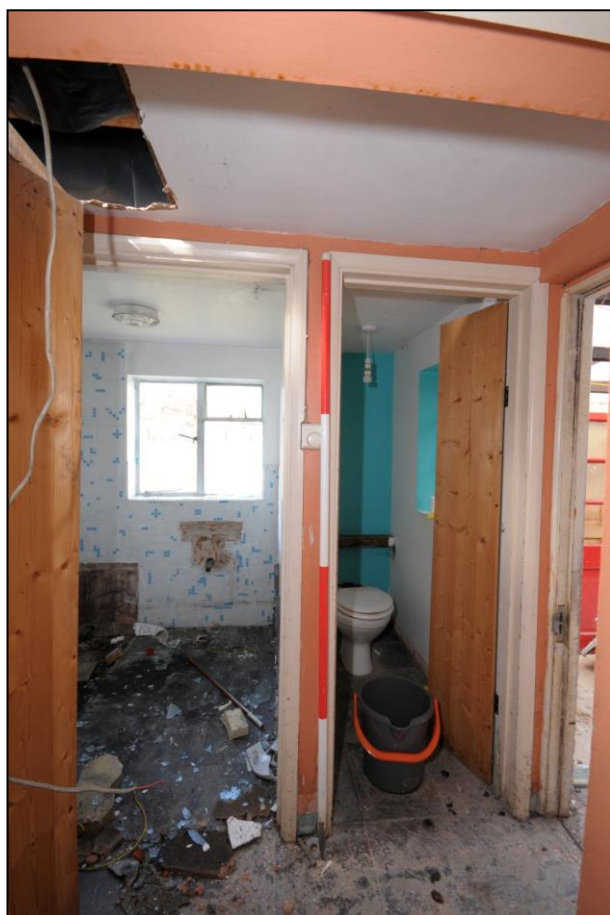
**Image 16:** No. 41, rear extension

The lean-to extension at the rear of no. 41 comprised a bathroom, W.C., boiler cupboard and conservatory (Images 16–20). The extension was accessed off the kitchen. In the conservatory the bare brickwork in the rear wall of the cottage was visible (Images 17–19).

Looking west, towards the bathroom and WC with door to conservatory at right (Scale 2m)

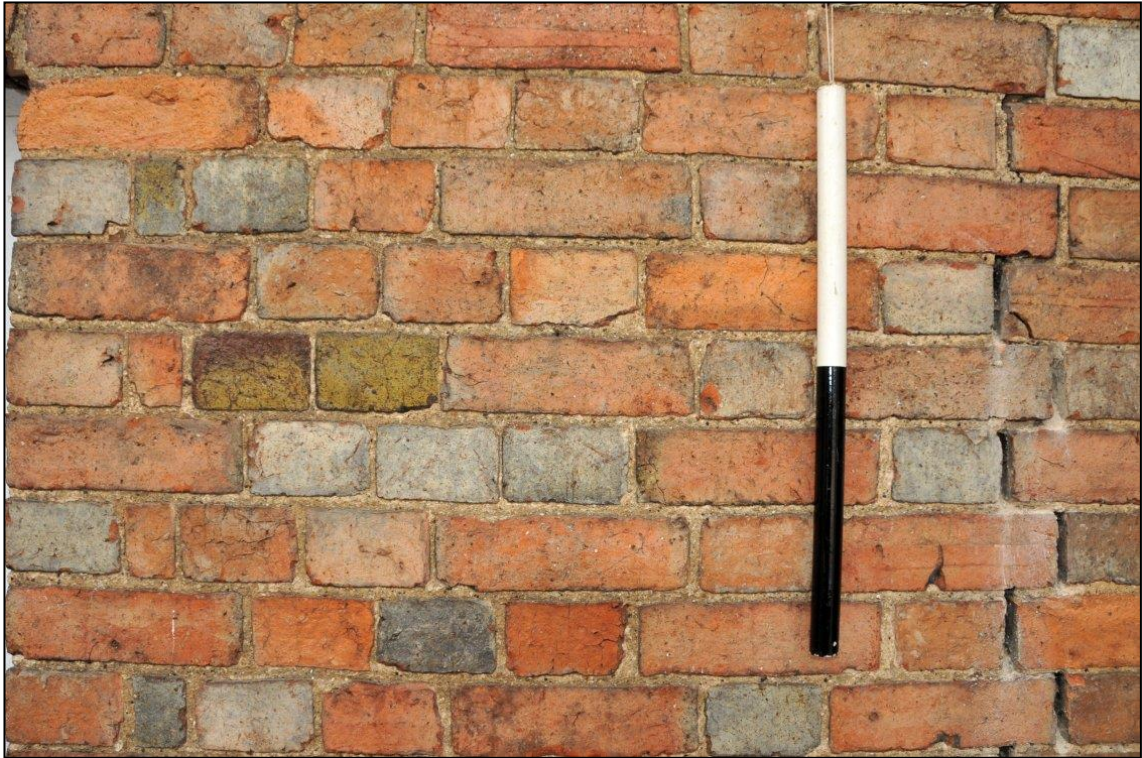
The brickwork in the two end elevations was covered by cement render. In the front elevation and the rear of no. 43 it was painted. The brickwork was most clearly visible in the rear elevation of no. 41 where the bare brick could be seen within the modern conservatory (see Section 3.6.3). This was in Flemish bond. The bricks were light red in colour with some vitrified headers in yellow, silvery grey or purplish colours. Some bricks had longitudinal pressure marks. Brick dimensions were: 220–225mm long, 110mm wide and 65–70mm high.

**Image 19:** No. 41, conservatory, detail of brickwork

Brickwork immediately to right of window in previous image (Scale 500mm)

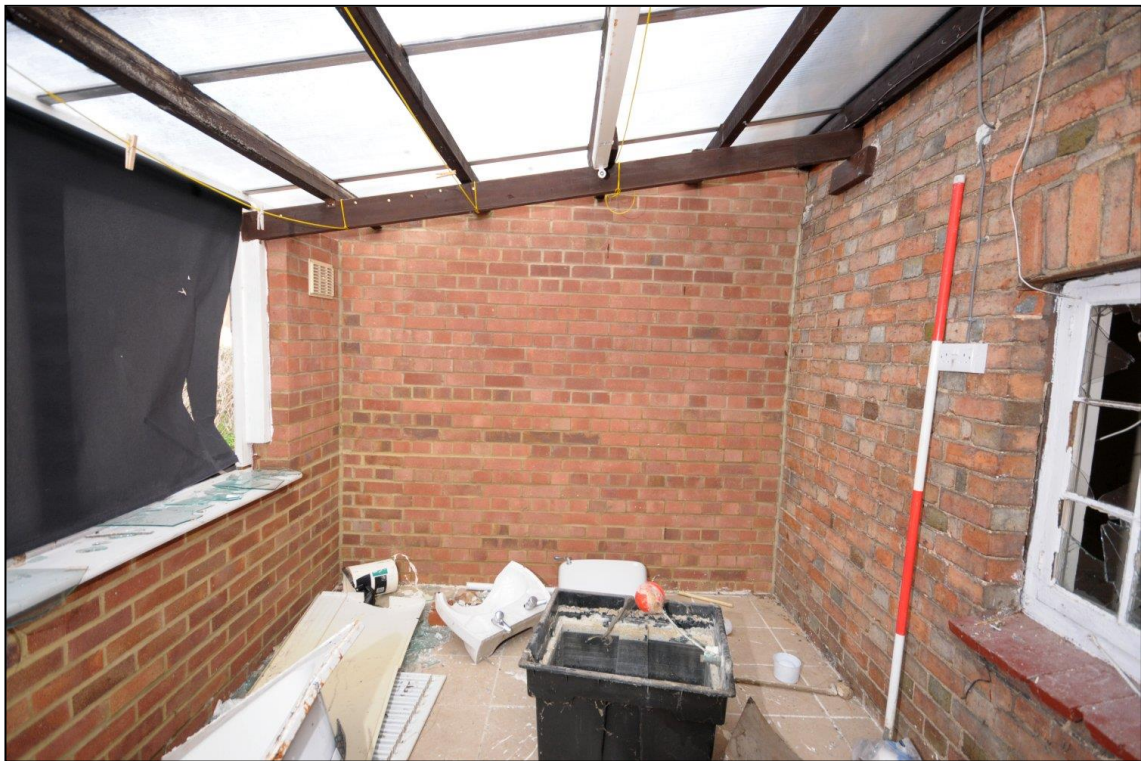
**Image 20:** No. 41, conservatory, looking north

Modern conservatory with rear wall of primary range to the right  
(Scale 2m)

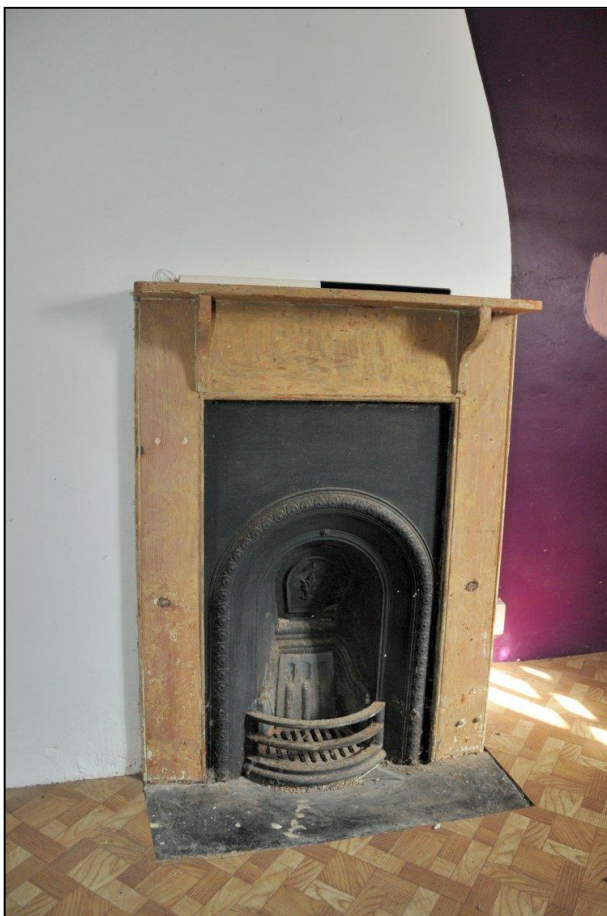
**Image 26:** No. 41, bedroom 1,  
fireplace  
(Scale 0.5m)

- Door off stair landing. Plank and batten door (see description in Section 3.5). Door architrave with ogee moulding.
- Window. Modern fitting. Two-light timber casement with heavy square-section glazing bars. Timber sill.
- Fireplace (Images 26 and 27). Arch plate register grate. This type was introduced around 1850, and became the standard bedroom grate during the second half of the 19th century (Eveleigh 2008, 10). The timber fireplace surround is in pine with narrow bead moulding on edges and mantelshelf on curved brackets. The surround retained traces of white paint.

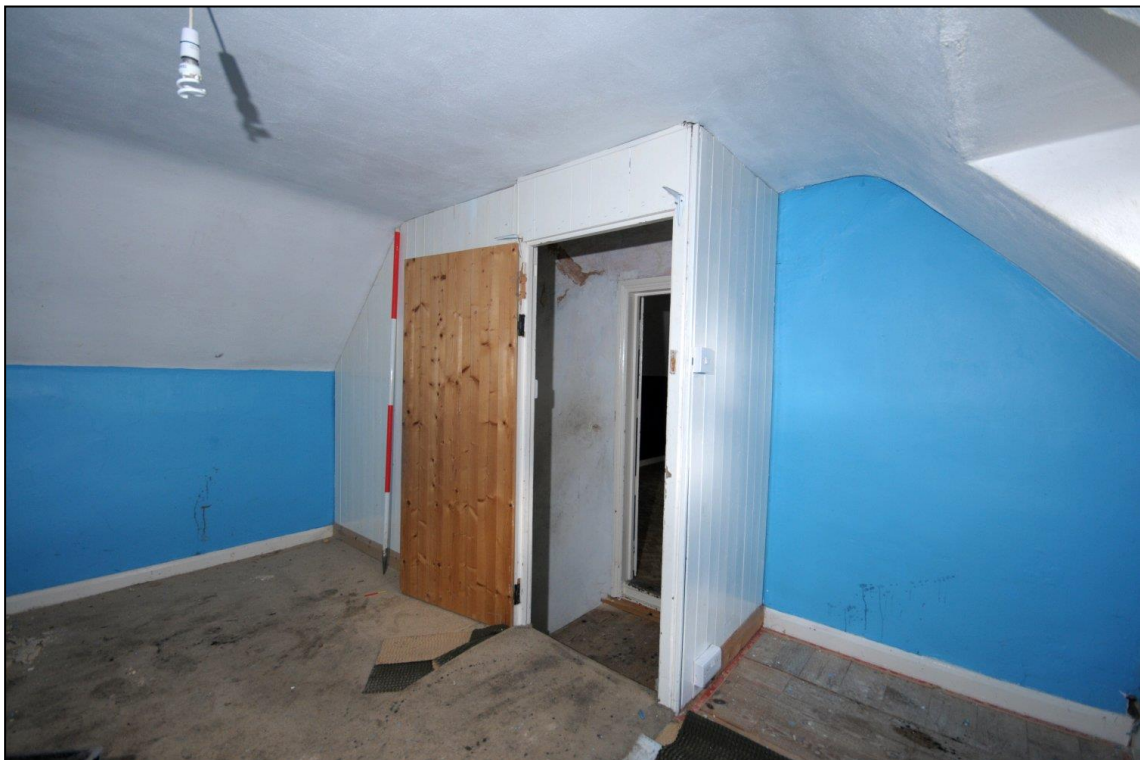
**Image 28:** No. 41, bedroom 2, looking north-west

- Door off stair landing. Modern plank door hung on plain doorframe with no architrave moulding.
- Window. Modern fitting. Two-light timber casement with heavy square-section glazing bars. Timber sill.
- Timber partition on north side of room, dividing room from stairwell (Image 28). Made from tongue and groove boards.

Boarded partition enclosing stairs (Scale 2m)

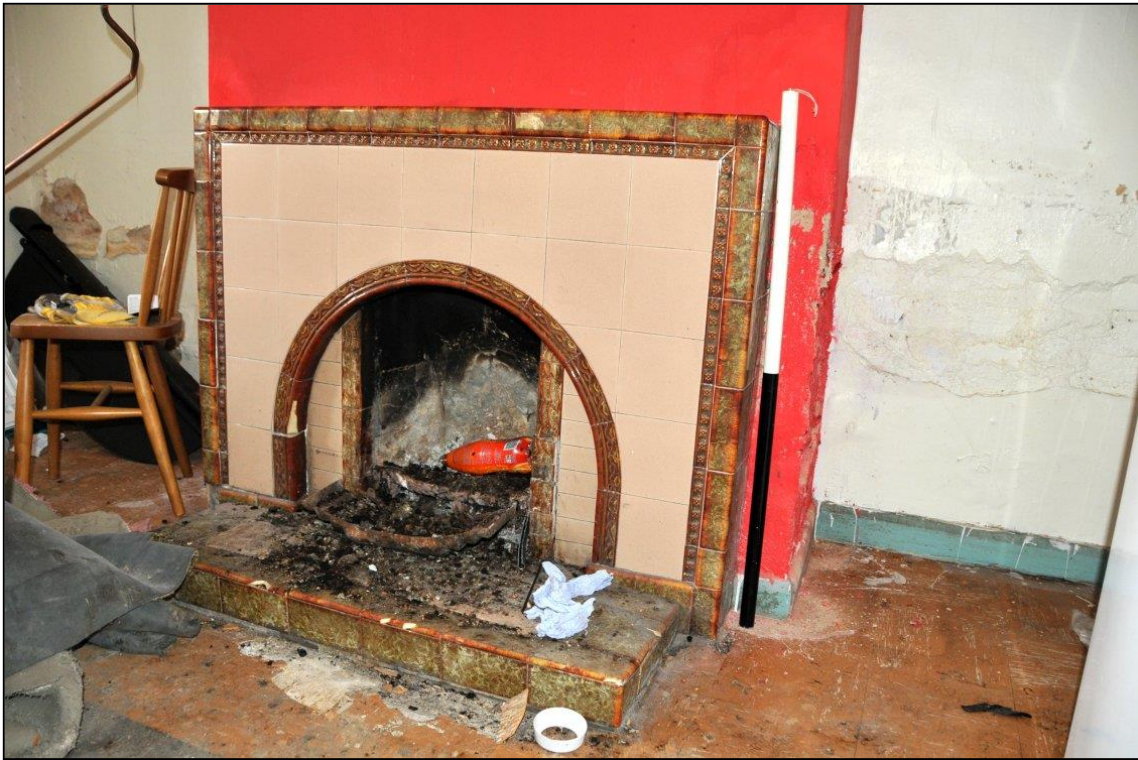
**Image 33:** No. 43, living room, fireplace

- Front door. Modern glazed door with safety glass.
- Door to stairs and kitchen. Plank and batten door (see description in Section 3.5) and door architrave with ogee moulding.
- Mid-20th-century, steel-framed window with tile sill in east (front) wall.
- Mid-20th-century, steel-framed window with tile sill in west (rear) wall.
- Solid cement floor with vinyl tile covering.
- Mid-20th-century fireplace with glazed tiles in cream and brown (Image 33).

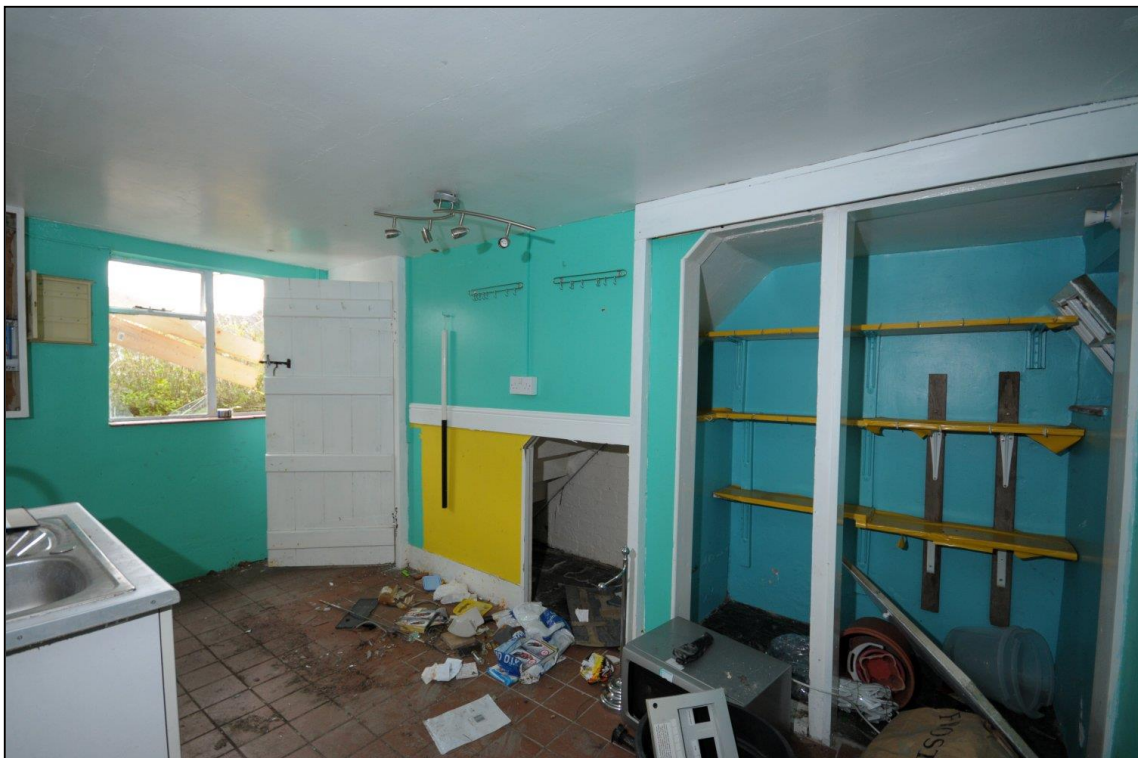
**Image 34:** No. 43, kitchen, looking south-east

- Door opening from stairs and living room. Plank and batten door (see description in Section 3.5), with plain, rectangular door frame.
- Doorway to rear lean-to. Door removed. Modern plain-chamfered architrave.
- Mid-20th-century, steel-framed window with tile sill in east (front) wall.
- Window in pantry. Small square bottom-hung, inward-opening window with four panes; glazing bars with ovolo and fillet-type moulding.
- Pantry. The southern side of the room, below the stairs was separated with a timber studding and ply or hardboard panels to form a cupboard and a pantry (Image 34).
- Floor. Solid floor with 20th-century (150mm square) red quarry tiles.

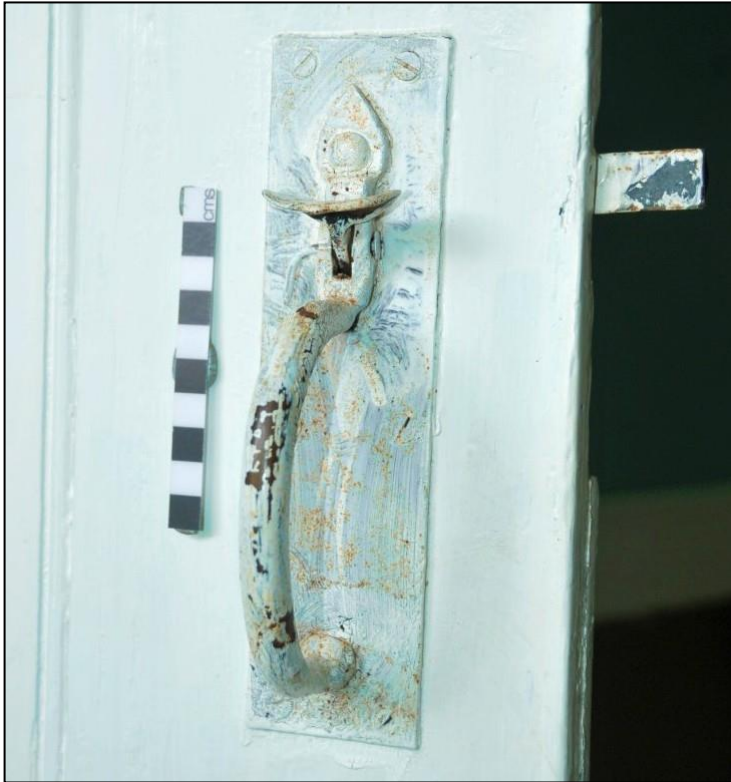
**Image 37:** No. 43,  
kitchen, door latch  
(Scale 10cm)

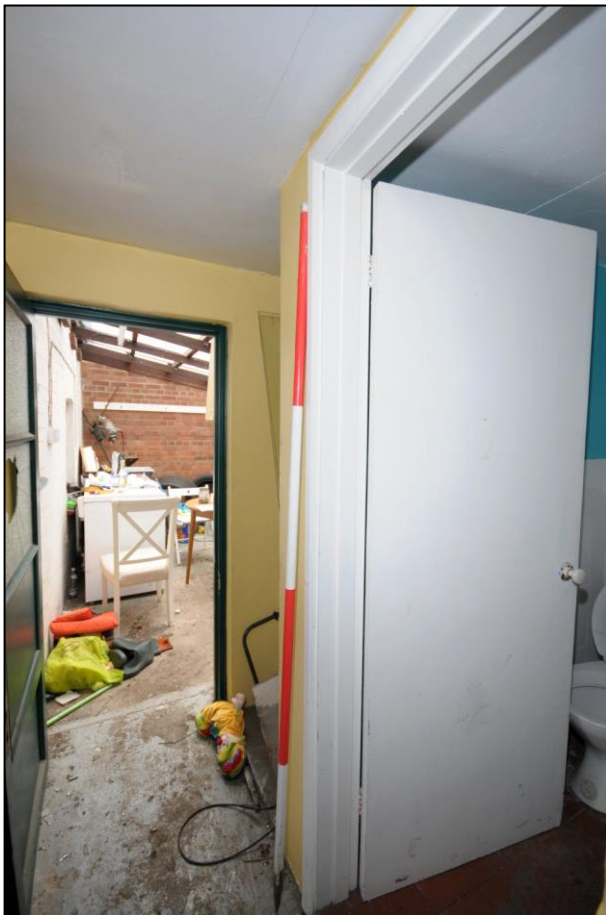
**Image 38:** No. 43, rear extension  
Looking south towards the conservatory  
(Scale 2m)

The lean-to extension at the rear of no. 43 comprised a bathroom, store, boiler cupboard and conservatory (Images 38 and 39). The extension was accessed off the kitchen.

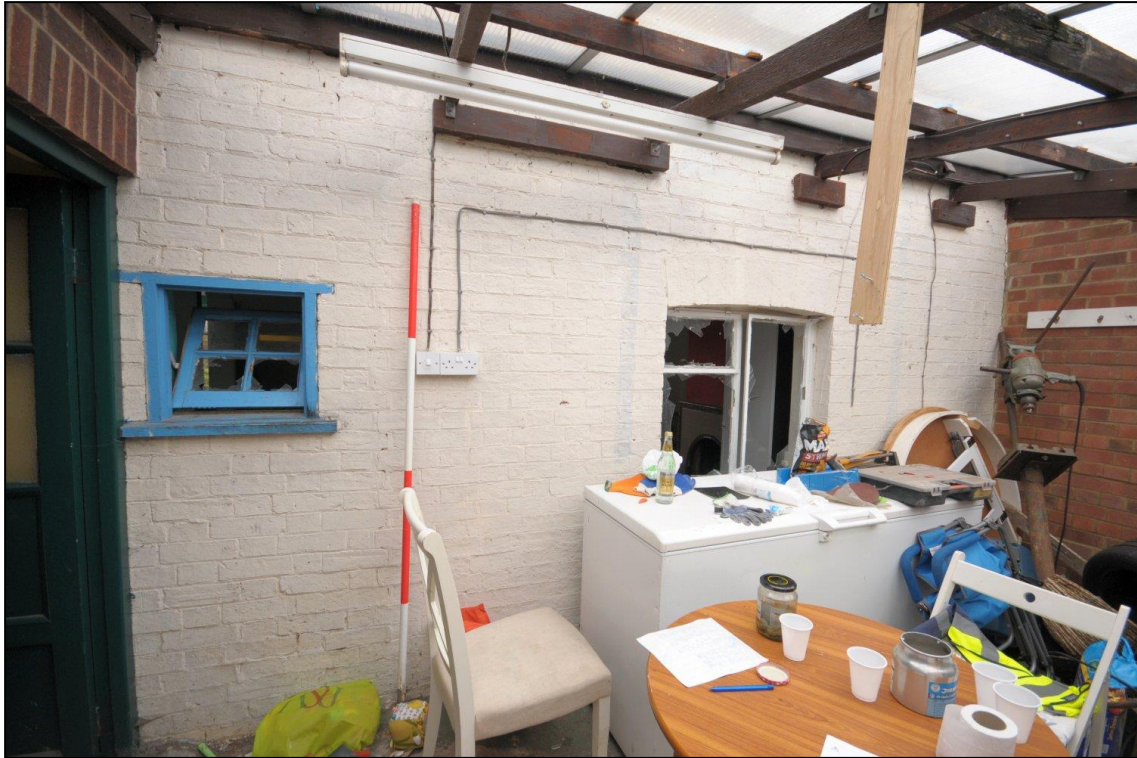
**Image 39:** No. 43, rear extension/conservatory

Looking south-east (Scale 2m)

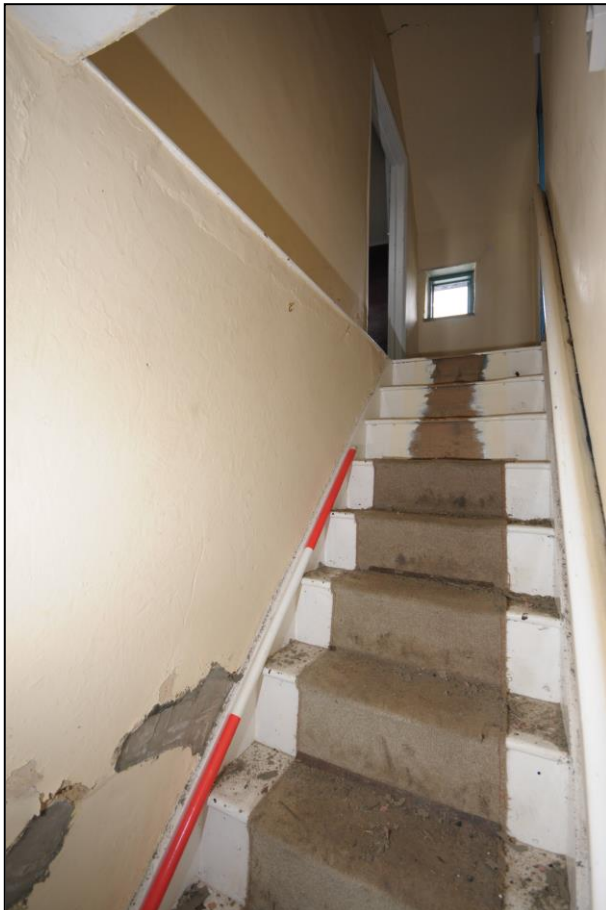
**Image 40:** No. 43, stairs, looking up

The stairs in no. 43 were accessed by a very small lobby area situated between the living room and kitchen (Images 40–42). The lobby at the foot of the stairs was separated from the living room by a plank door with an ogee moulded architrave, and from the kitchen by a plank door in a plain rectangular frame.

- Stairwell. South side of the stairwell formed by a brick wall. This was 250mm wide up to the first-floor level, and continued above that as a half-brick wall. The difference in width within the stairwell formed a 120mm-wide shelf along the side of the stairs. North side of stairwell was formed by a timber partition, separating it from the kitchen and bedroom 2. The internal face of the partition within the stairwell was lined with large sheets, probably hardboard.
- Window. The stairwell was lit by a small side-hung casement window with plain rectangular frame (Image 42). Cast-metal window stay, probably a mid-20th-century fitting.
- Landing. A small stair landing with a step of *c.*200mm up to bedrooms 1 and 2 on either side. The door opening to bedroom 1 had an architrave with an ogee moulding. The door opening to bedroom 2 was formed from plain rectangular section posts.

Looking south-west, showing small window lighting landing (Scale 2m)

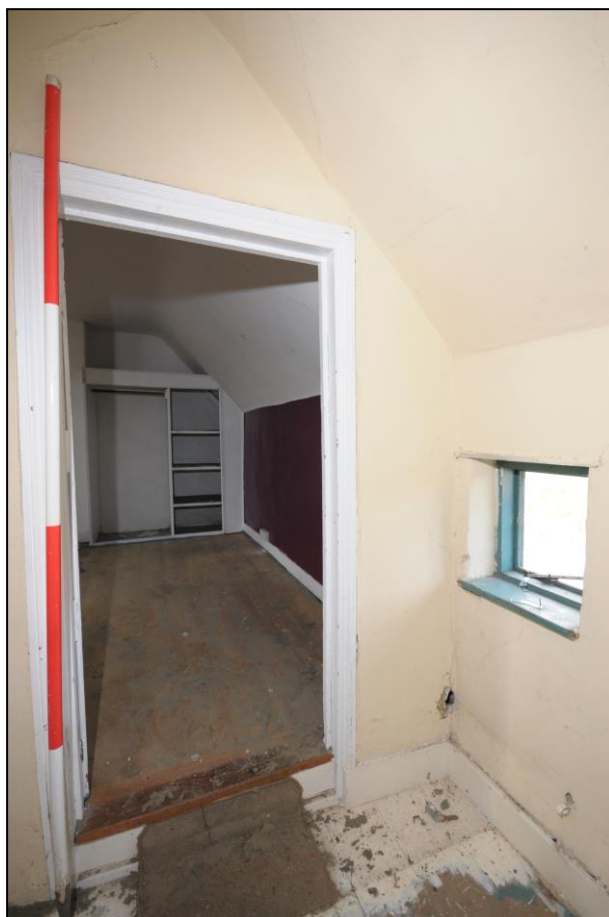
**Image 42:** No. 43, landing

Looking south towards bedroom 1, with small window lighting landing visible at right (Scale 2m)

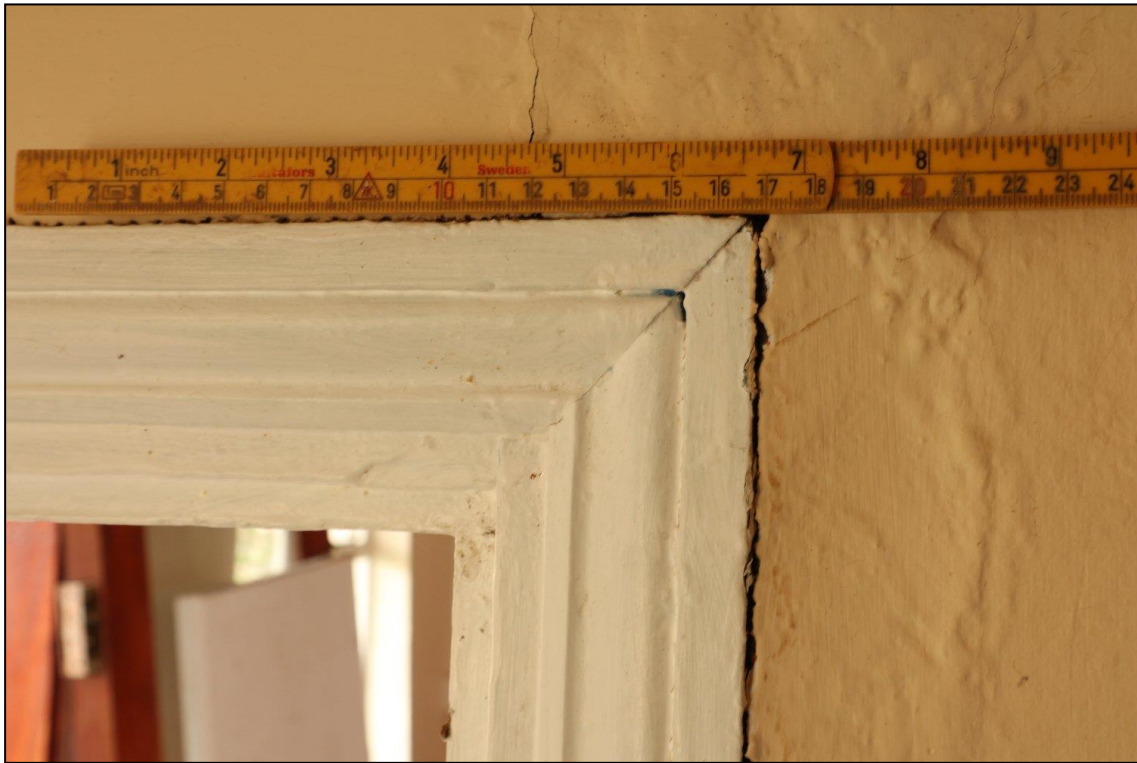
**Image 43:** No. 43, detail of door architrave in entrance lobby

Example of architrave moulding; this one on door to living room in No. 43

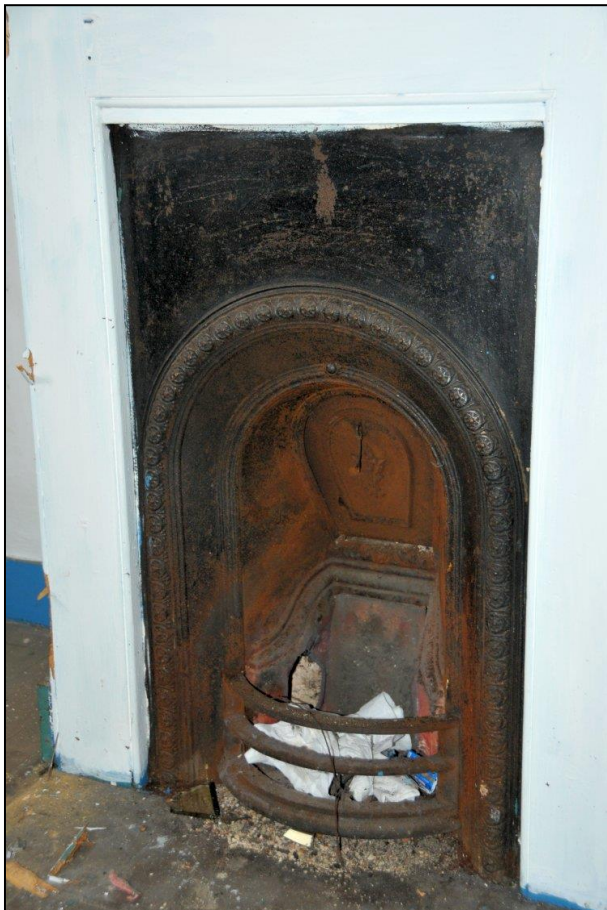
**Image 46:** No. 43, bedroom 1,  
fireplace

- Door off stair landing. Plank and batten door (see description in Section 3.5) and door frame with ogee moulded architrave.
- Window. Two-light timber casement with ovolo and fillet section glazing bars. Timber sill. Cast-metal window stays, probably earlier to mid-20th-century fittings.
- Fireplace (Image 46). Arch plate register grate identical to that in bedroom 1 in no. 41 (see Section 3.6.5). Timber fireplace surround as in no. 41, but with the mantelshelf removed.
