**41-43 CAUSE END ROAD  
WOOTTON  
BEDFORDSHIRE**

**HISTORIC BUILDING RECORDING**

Project: CE3614  
Document: 2020/32  
Version: 1.0

Issue date: 27th May 2020

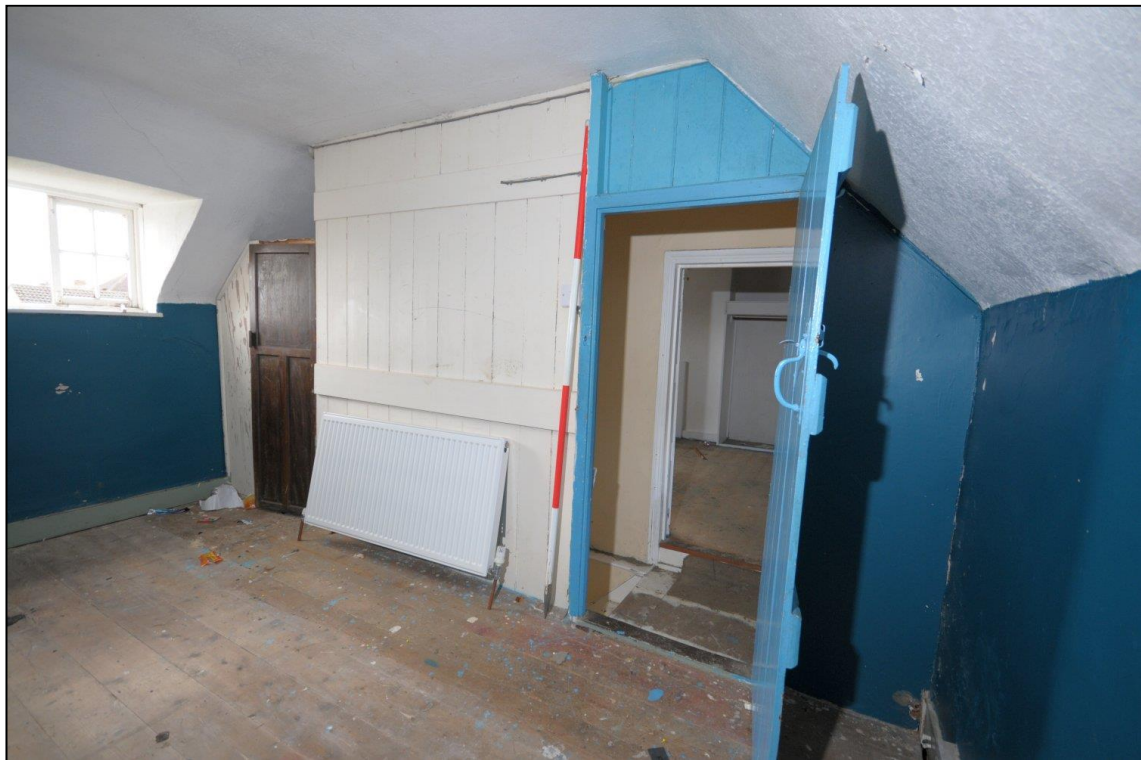
**Image 48:** No. 43, bedroom 2, looking south-east  
Boarded partition enclosing north side of stairs (Scale 2m)

- Door off stair landing. Plank and batten door (see description in Section 3.5) on a plain timber frame.
- Window. Two-light timber casement with ovolo and fillet section glazing bars. Timber sill.
- Timber partition on north side of room, dividing room from stairwell (Images 48 and 49). Partition wall from vertical boards with bead moulding, framed with posts at the door frame and on the north-east corner, and strengthened with two rows of horizontal battens of similar proportions to the vertical boards. A built-in wardrobe at the east end
