**BLOCK B
ROGERS COURT
2 KINGSWAY
BEDFORD**

ARCHAEOLOGICAL WATCHING BRIEF

Project: RC3744
Document: 2021/74
Version: 1.0

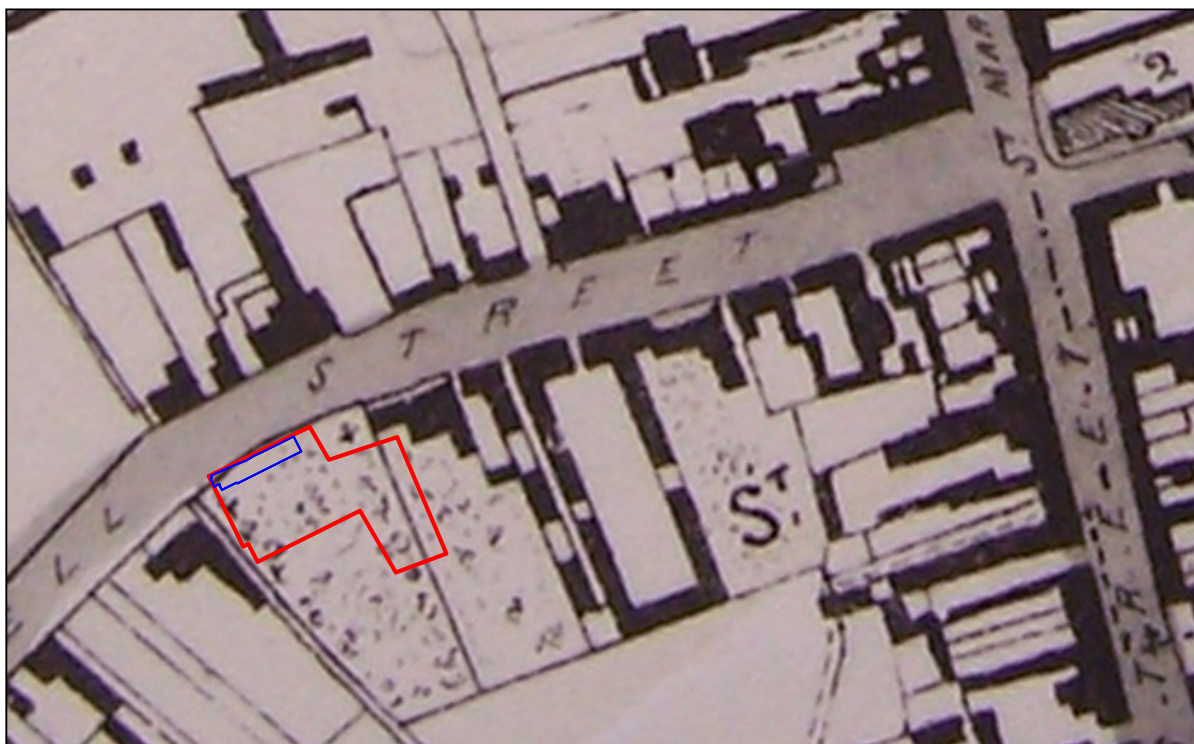
Figure 3: 1836 map

The 1836 Dewhurst & Nichol map of Bedford (Figure 3) shows the PDA as a garden area with buildings on the adjacent plots and the King’s Ditch running along the west side of the plot. By the time of the 1841 Reynold’s map (not illustrated) the King’s Ditch had been culverted in the area adjacent to the PDA. This map shows the PDA occupied by a garden with a central oval lawn.

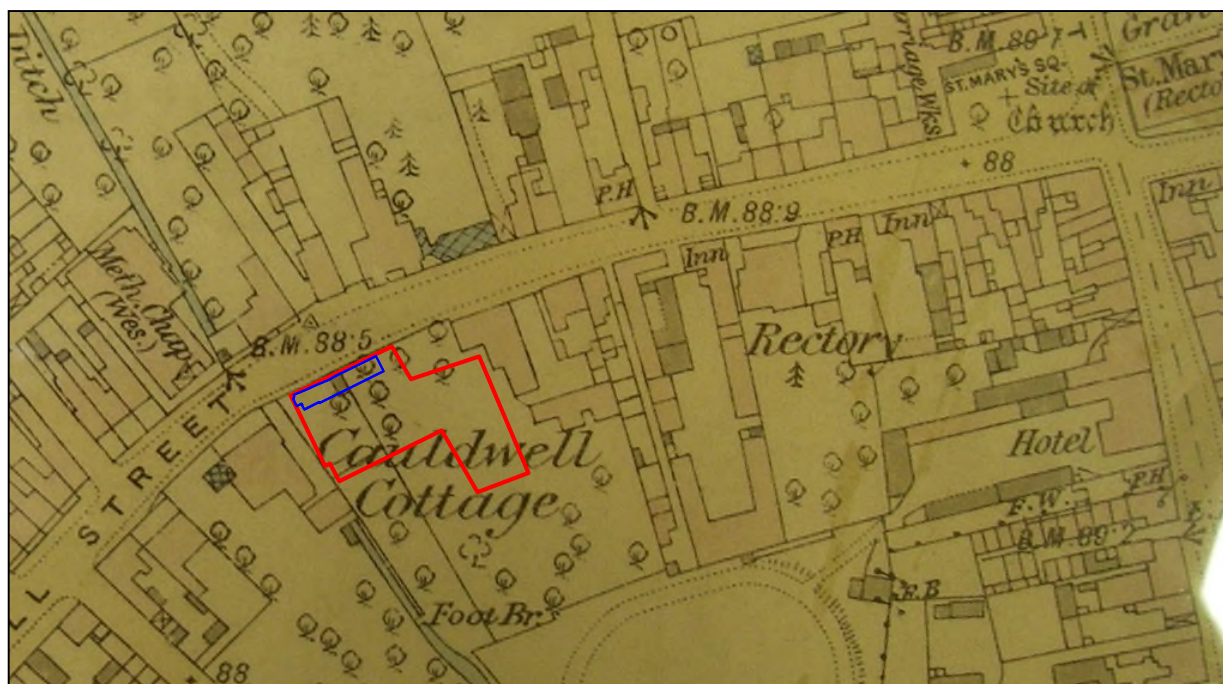
Figure 5: 1884 map

The 1884 first edition OS map (Figure 5) shows the PDA still divided into two plots planted with trees and with a small building on the street frontage of the narrow western plot. The area has a large label ‘Cauldwell Cottage’, although it is not clear which building this refers to. The 1900 OS map (Figure 6) shows an additional small building and another boundary subdividing the western plot within the PDA.

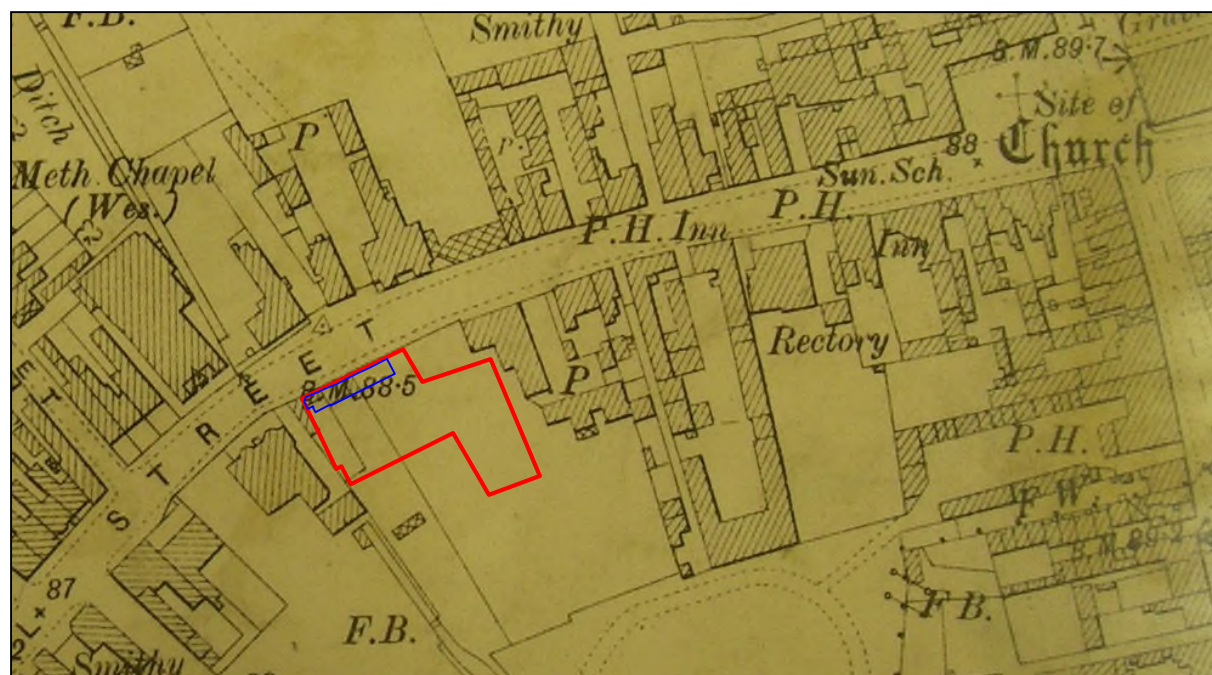
PDA shown in red with trench outlined in blue
(Ordnance Survey 25-inch 1st edition)

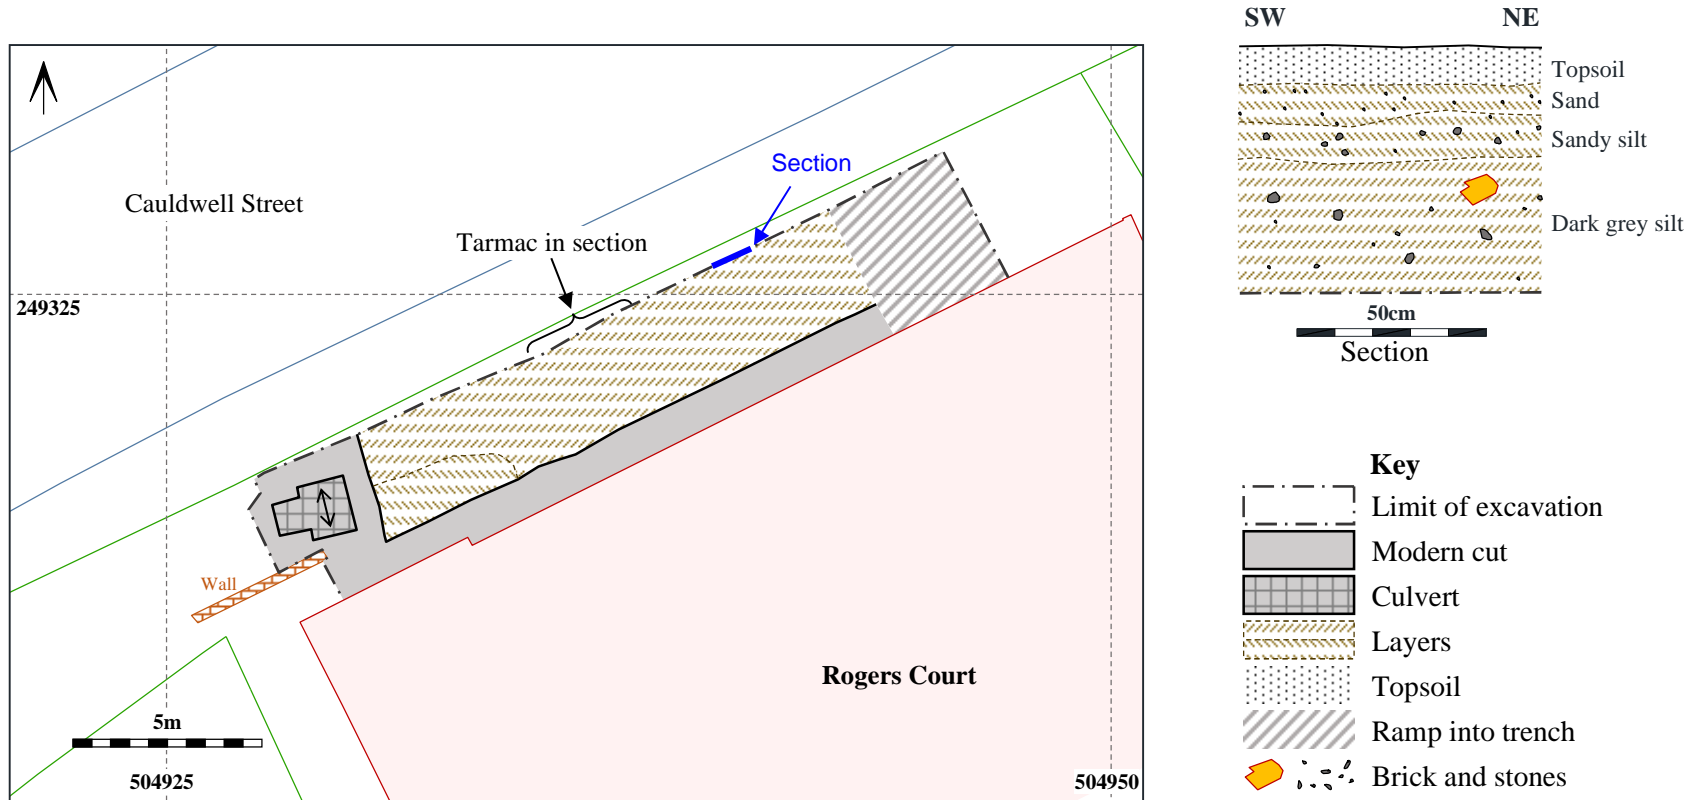
Figure 9: All-features plan and section

The deposits recorded on site were assigned individual context numbers. In the following text and on Figure 9, layers and fills are shown in round brackets and cut features and structures are shown in square brackets. See Figure 9 for plans and sections illustrating the deposits; selected images are included at the back of the report. Information on the individual archaeological contexts for each trench is tabulated in Appendix 1.

Modern make-up layers and surfaces were observed in section in the north side of the trench, immediately below the topsoil. A drawn sample section (Figure 9, Section 1) shows a layer (2) of clean sand (Image 4). The deposits at this depth were quite variable but clearly derived from modern construction activities. A short distance to the left of Section 1 was a tarmac surface buried below the topsoil (Image 3). This tarmac surface appears to correspond to the location of an access road into the PDA which was first shown on the 1924 OS map, where it formed an access to a timber yard (see Figure 7 and Section 1.4.8).

Modern construction features consisted of a cut [4] for the foundations of the present building and a service trench for a drain culvert. It was not possible to distinguish between these two features, so they are indicated with a single line. Investigation by the developers showed that the culvert passes under the building, and so it may be an earlier feature.

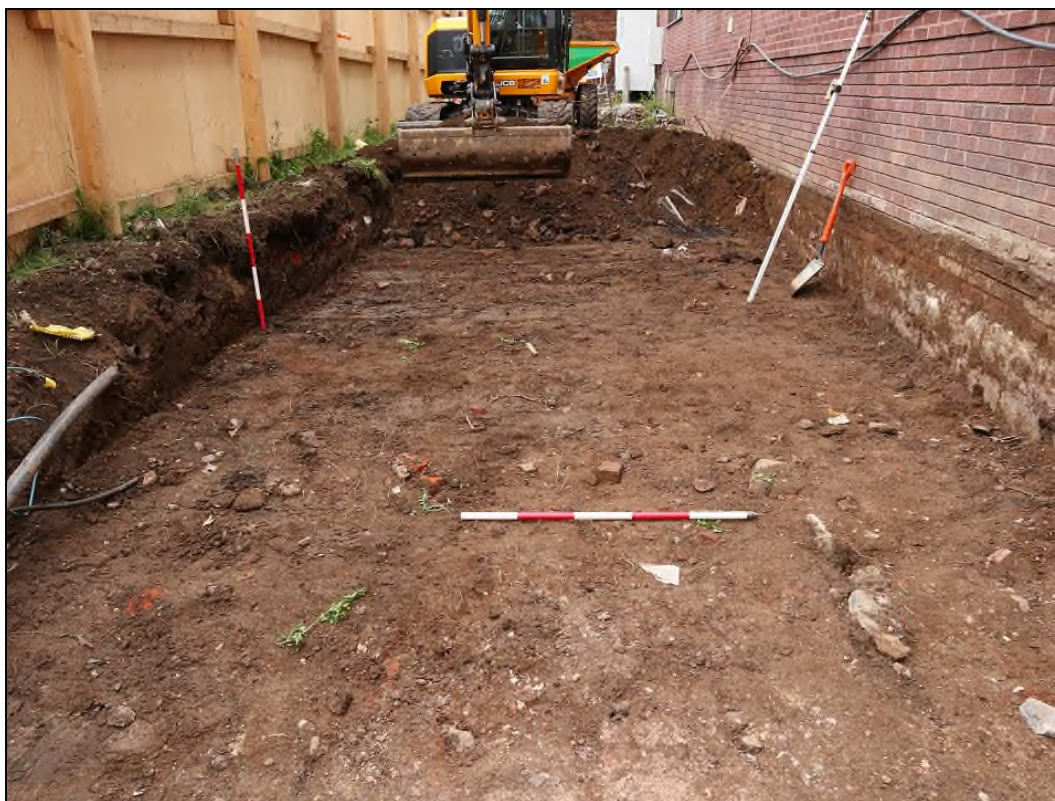
Image 1: Trench, looking east
(Scale 2 x 1m)

Groundworks with the potential to impact on archaeological deposits consisted of a single trench for the construction of a concrete foundation slab. The trench was 20.75m long, up to 4m wide and up to 650mm deep.
