**HIGH DOWN HOUSE
PIRTON
HERTFORDSHIRE**

**ARCHAEOLOGICAL
TRIAL TRENCH EVALUATION**

Project: HDH1615

Document: 2010/37
Version 1.1

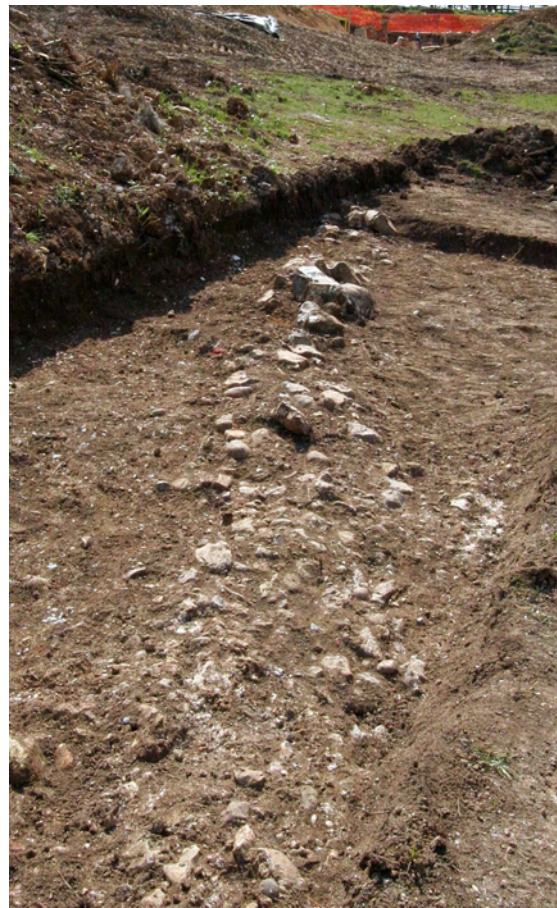
The south-eastern half of Trench 4 contained the remains of a wall (Figure 2). The un-coursed rubble masonry (404) consisted of flint nodules and small stones laid in a probable cut [403], dug into yellow brown silty clay subsoil layer (401). The wall was aligned NE-SW and appeared slightly irregular. The remains survived immediately below the turf and topsoil layer at approximately 0.15m below the surface.

The wall is not shown on the historical maps which date from the early 19th century onwards. The material used to construct the wall contained no dateable material; no tile or brick was visible in its make-up.

Wall [403]/404, looking south-west

The origins and purpose of the flint rubble wall found near to the dovecote are unclear. Its width and irregularity suggest that it is unlikely to be the remains of a building; it, therefore, probably represents a boundary wall. The absence of a boundary in this location on the 19th-century mapping suggests that it pre-dates this period.

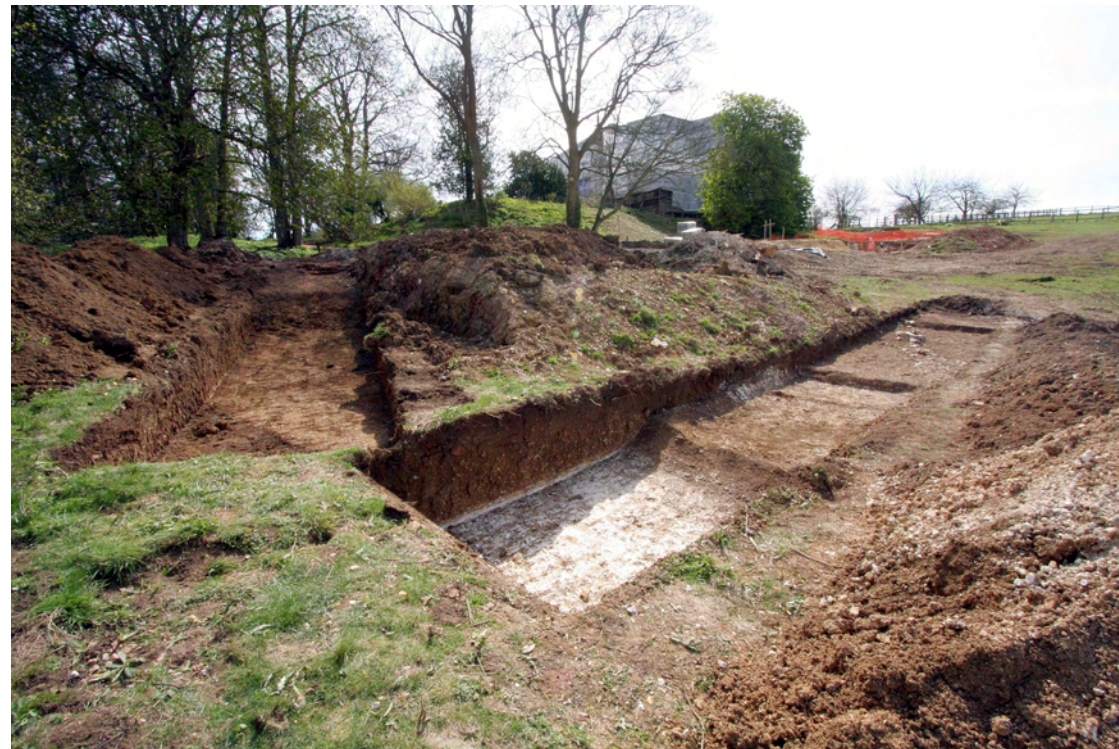
Figure 2: All features plan

Trenches 3 and 4 were positioned to confirm the location and nature of a demolished dovecote that is marked on 19th-century maps (Figure 2).

Trenches 3 and 4, looking south

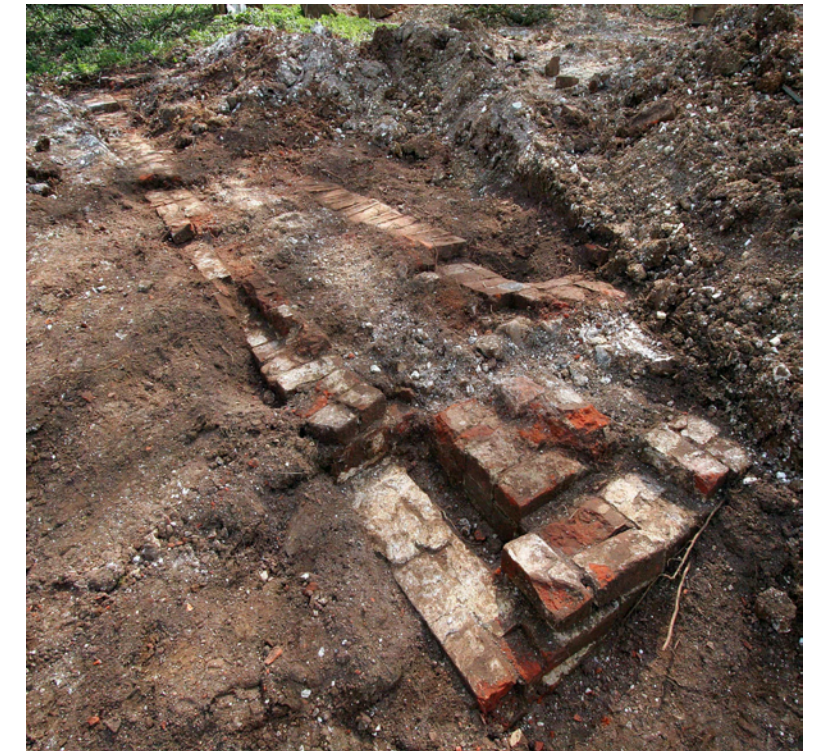
The remains of a building were uncovered in the southern end of Trench 3, matching the dimensions and position of the mapped dovecote. The building had been demolished to ground level and survived beneath a thin covering of soil and plant growth.

It was constructed in plain red bricks, bonded with a white mortar (303). The full extent of the eastern side of the building was exposed within the trench; it was aligned NNW-SSE and was 5.85m long.

A narrow foundation cut [302] was identified around the outside of the masonry to the north-east. Inside the north-east corner of the building was a block of brickwork (304), approximately 0.4m square in plan, constructed with the same type of brick and mortar used in the eastern wall. Inside the building, against the inner face of the walls, was a deposit of chalk rubble (305). The rubble fill was separated from a central hollow containing loose soil (307) by a band of bricks (306) which were laid without mortar. These bricks were a light red or yellowish colour with a shallow frog.

Dovecote remains [302] - 307, looking south

The location of the probable dovecote was confirmed to the north of the House as indicated on historical maps. It was constructed of brick. The dimensions of the bricks, their colour, and the presence of a rudimentary frog all suggest the building dated to the late 17th century (Harley 1974).
