**NISSAN TECHNICAL CENTRE
CRANFIELD
BEDFORDSHIRE**

**ARCHAEOLOGICAL OBSERVATION,
INVESTIGATION, RECORDING, ANALYSIS AND
PUBLICATION**

Project: NTC 1801
Document: 2011/88
Version 1.1

Produced for:
Nissan Technical Centre Europe
Cranfield

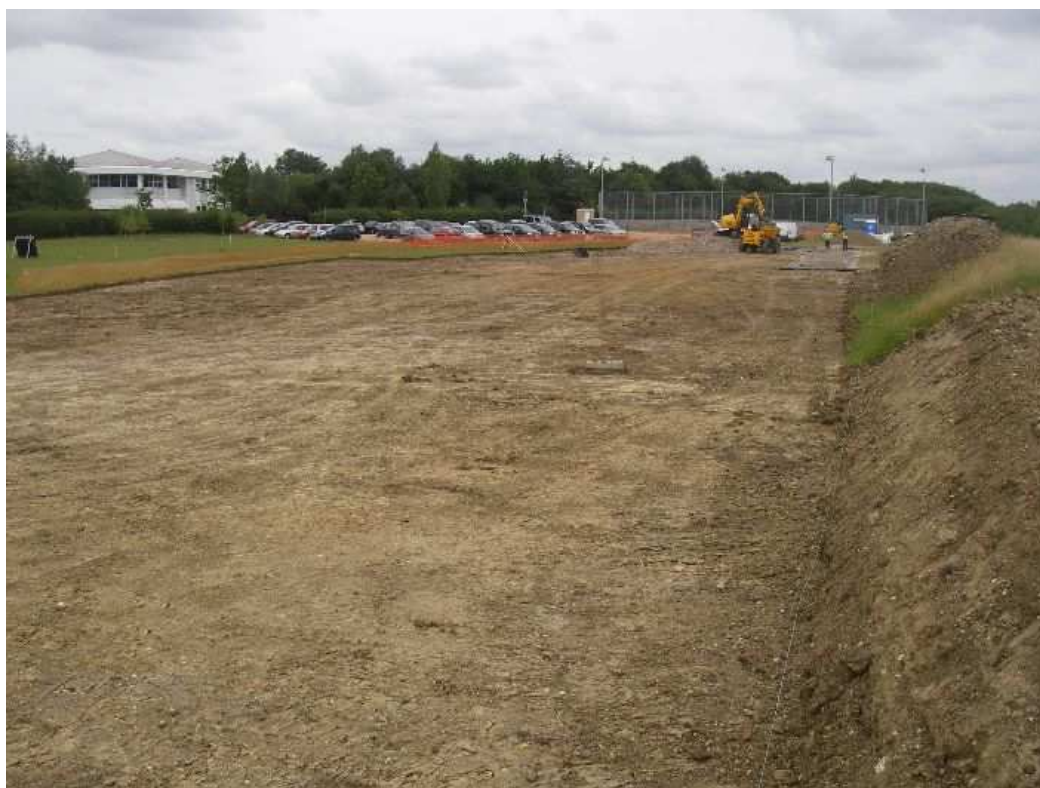
Figure 5: Development area after stripping of topsoil

The first stage of the groundworks involved the removal of 200mm of overburden across the DA (Figures 3 and 5). This consisted of c.150mm of playing field turf (100) together with a further 50mm of the top of the underlying made-up ground (101). The exposed layer, left *in situ*, consisted of dark brown clay with moderate inclusions of pebbles, brick and concrete fragments (101) (Figure 6). It masked any potential archaeological features that may have been revealed in plan.

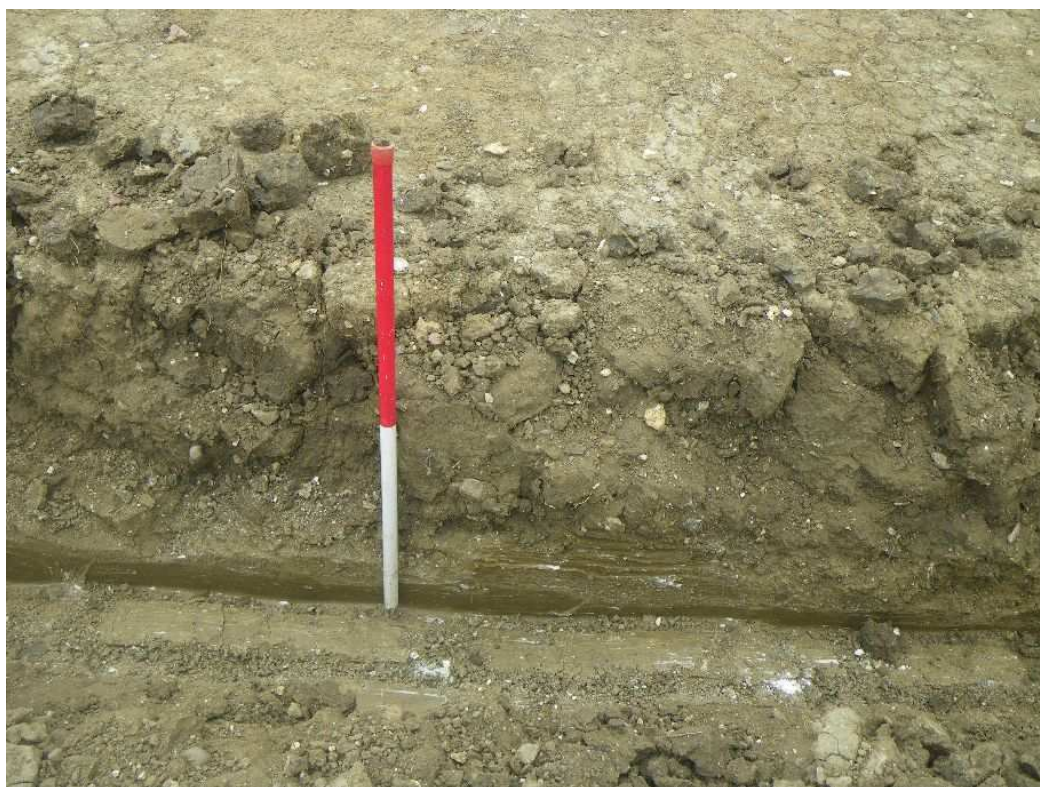
Excavation of the drainage trenches showed the made-up ground (101) to be 0.30–0.50m thick. The layer increased in thickness from 0.30–0.50m from north to south.

Figure 6: Made-up ground (101) above natural clay (1m scale)

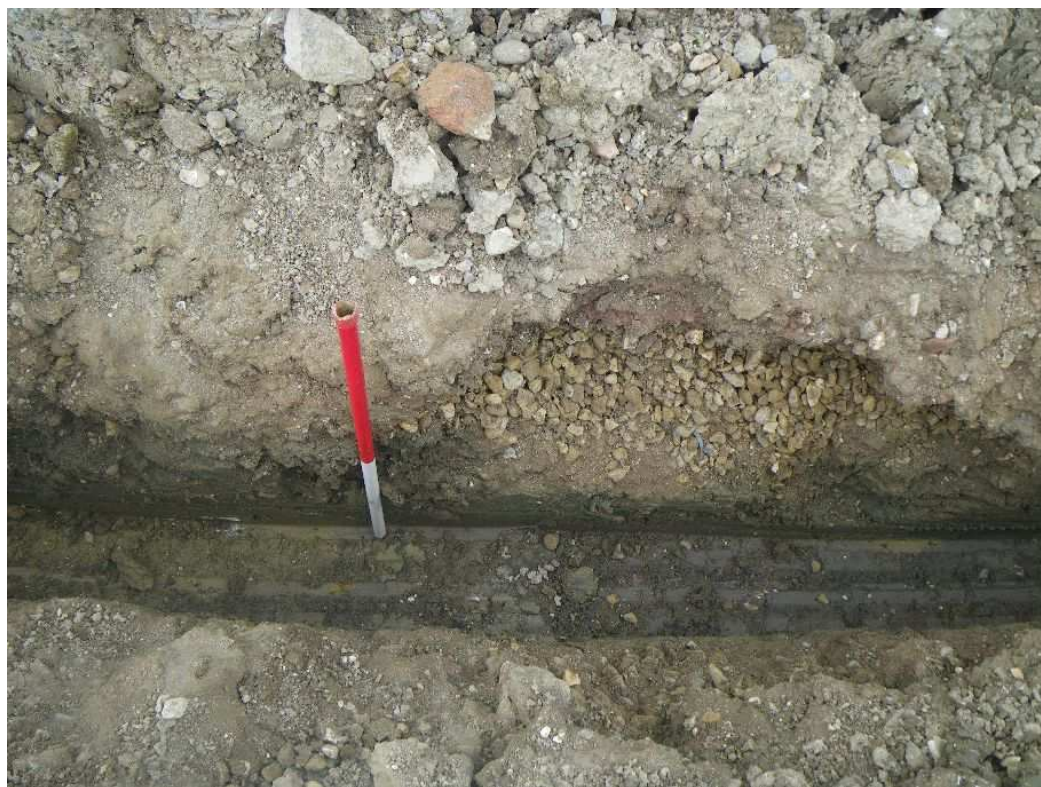
Features [109] and [111] (Figure 8) were located 8m apart and were very similar in size, with near identical fills. It is likely that they represent two segments of a possible enclosure ditch. Feature [105] may represent the corner of a possible ditch, due to its considerable width, or a substantial pit (Figure 7). Feature [107], located c. 3.5m to the NE of feature [105] may either be part of the same feature with an undulating base, or form a separate ditch.

Context	Type	Description	Interpretation
105	Cut	Unclear in plan, steep sides, base not reached. 3.2m wide, >0.5m deep.	Ditch or large pit
106	Fill	Dark brown silty clay with moderate inclusions of pebbles, flint fragments and charcoal flecks and very occasional flecks of burnt clay.	Fill of [105]
107	Cut	Unclear in plan, steep sides, base not reached. 1.0m wide, >0.5m deep.	Ditch? Or part of [105]
108	Fill	Dark brown silty clay with moderate inclusions of pebbles, flint fragments and charcoal flecks and very occasional flecks of burnt clay.	Fill of [107]
109	Cut	Unclear in plan, steep concave sides, base not reached. Located 8m west of [111]. 1.0m wide, >0.4m deep.	Ditch, part of enclosure with [111]?
110	Fill	Mid to dark grey silty clay with occasional charcoal flecks.	Fill of [109]. Natural silting.
111	Cut	Unclear in plan, steep concave sides, base not reached. Located 8m east of [111]. 1.0m wide, >0.4m deep.	Ditch, part of enclosure with [109]?

Figure 7: Ditch [105] in base of trench and N facing section (1m scale)

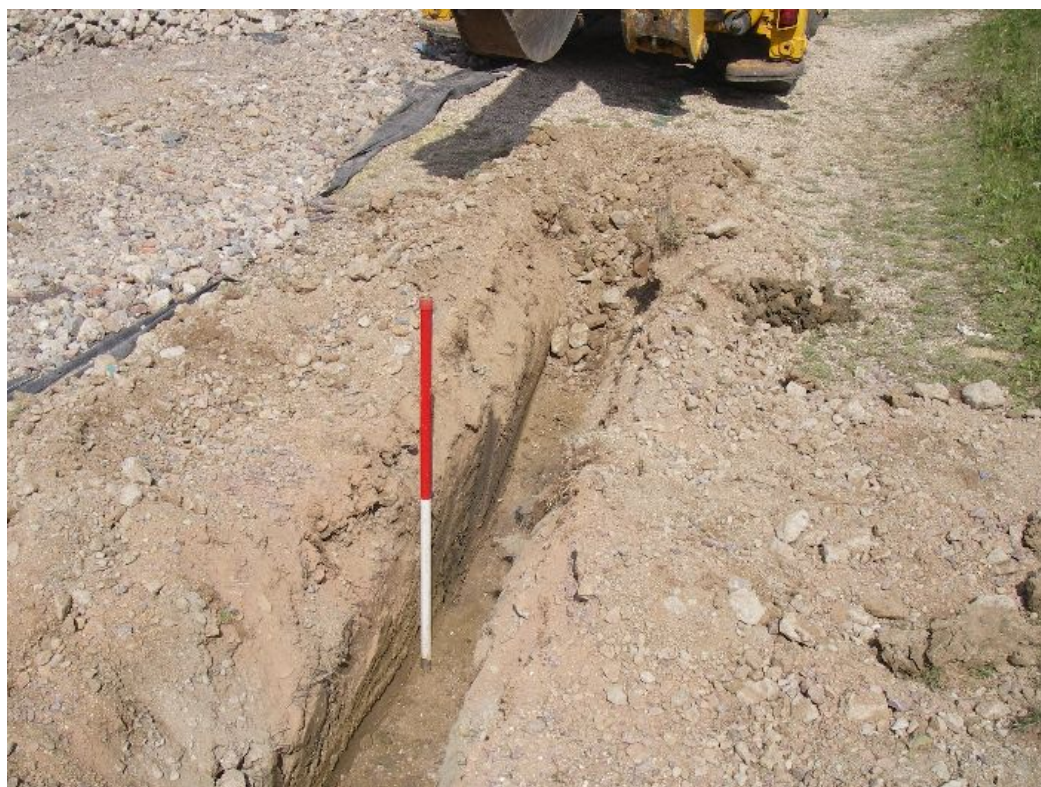
112	Fill	Mid to dark grey silty clay with occasional charcoal flecks.	Fill of [111]

Figure 8: Ditch [111] looking NE (1m scale)
