**FORMER BUS DEPOT
PEACOCK LANE
LEICESTER**

**ARCHAEOLOGICAL WATCHING BRIEF
AND
FIELD EVALUATION**

Project: Y.A6.2011
Document: 2011/114
Version 1.0

7th October 2011

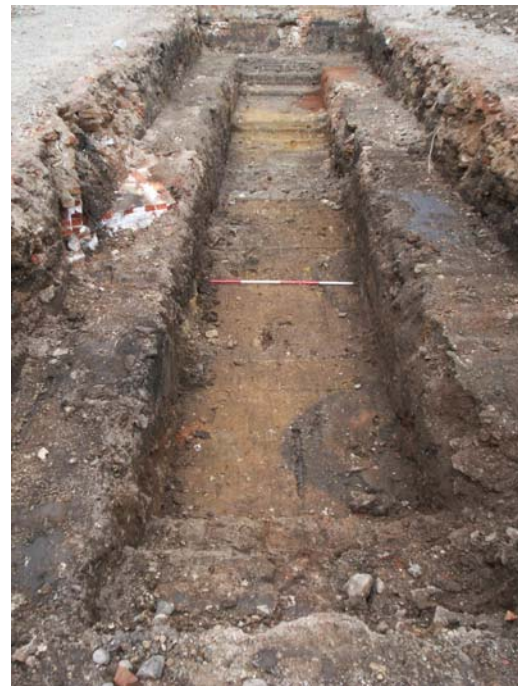
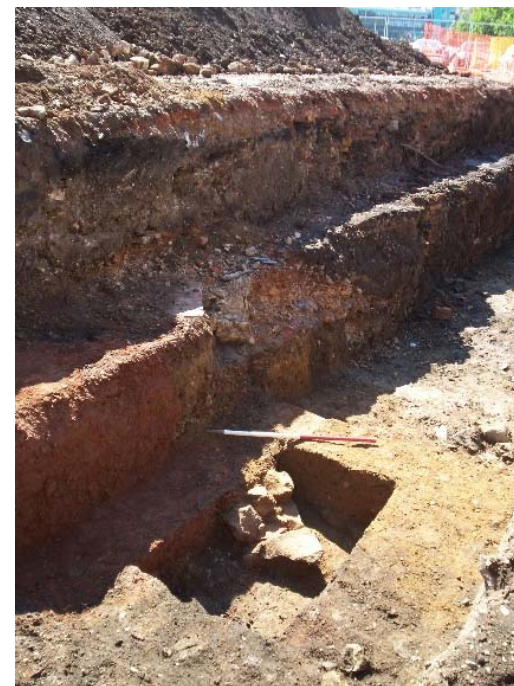
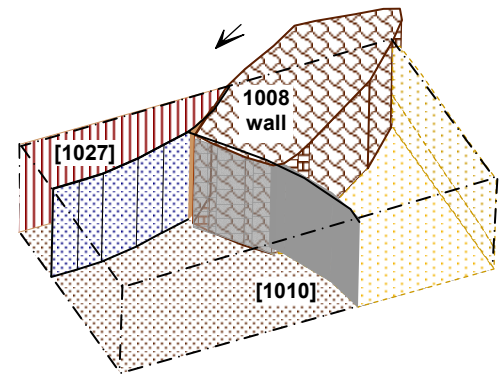
Figure 5: Trench 1 – plan and sections

Trench 1 looking south

Section 1 and wall segment 1008

3d representation of section 2

Trench 1 in the north-western corner of the PDA revealed a series of 19th-century brick foundations, walls and a well, relating to the buildings shown on the 1887 OS map. There were no cellars in this trench.

Wall segment (1008), which consisted of roughly hewn granite blocks and a parallel possible foundation slot [1039], may be part of an earlier building in the northern part of the trench. Only a short stub of (1008) survived and [1039] was not excavated; therefore, its precise date and function are unclear.

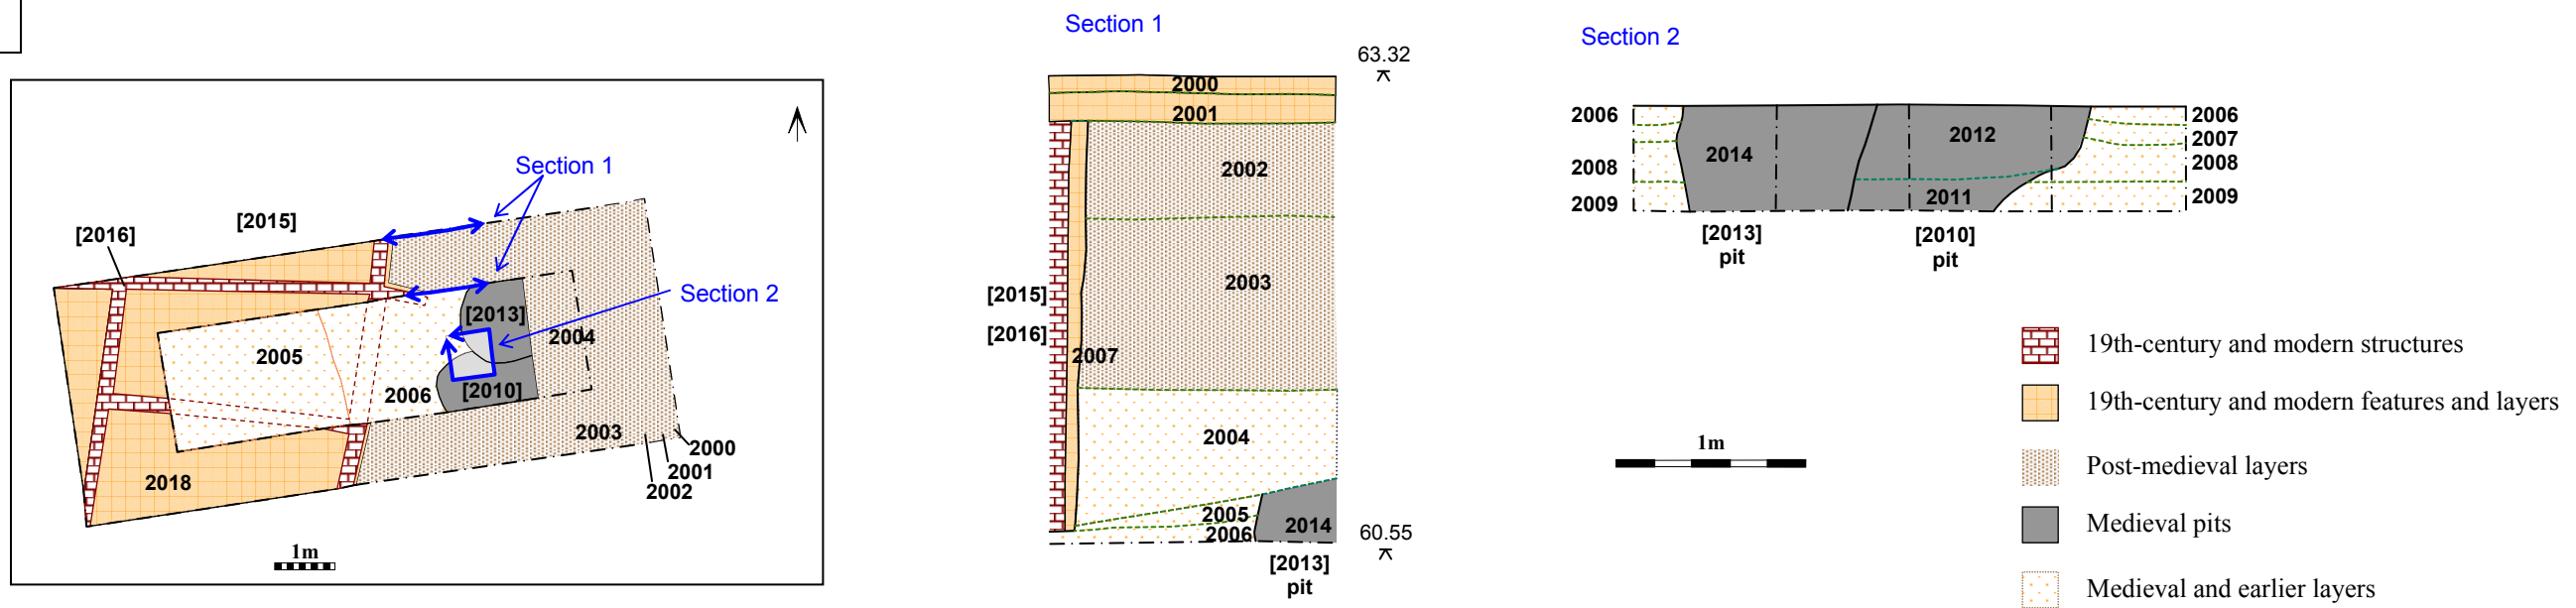
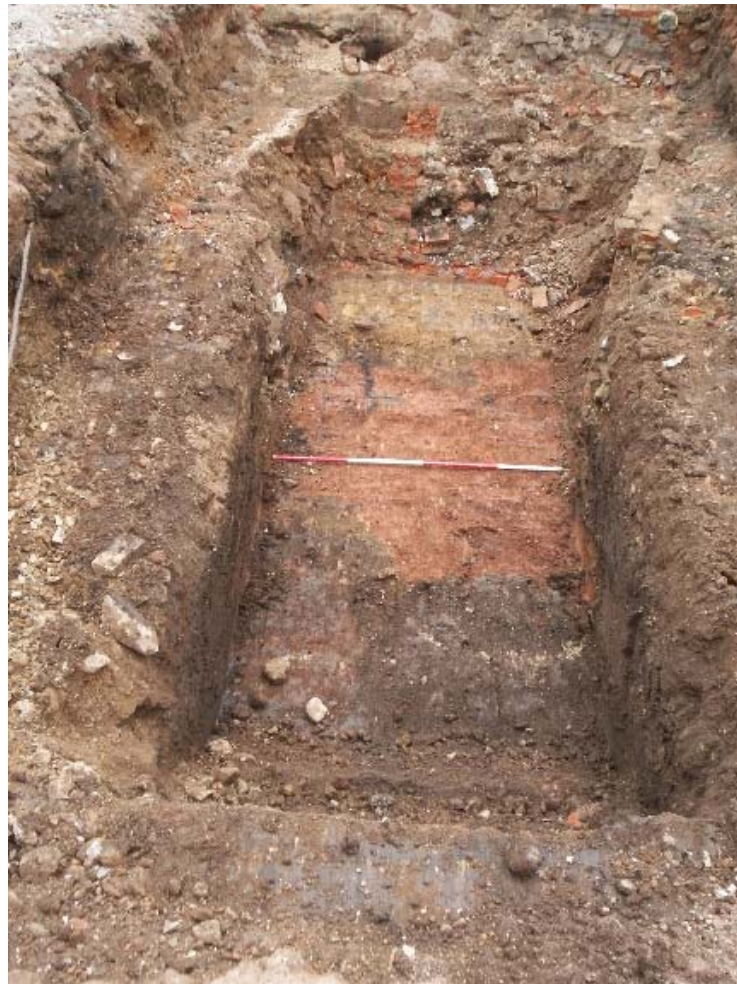
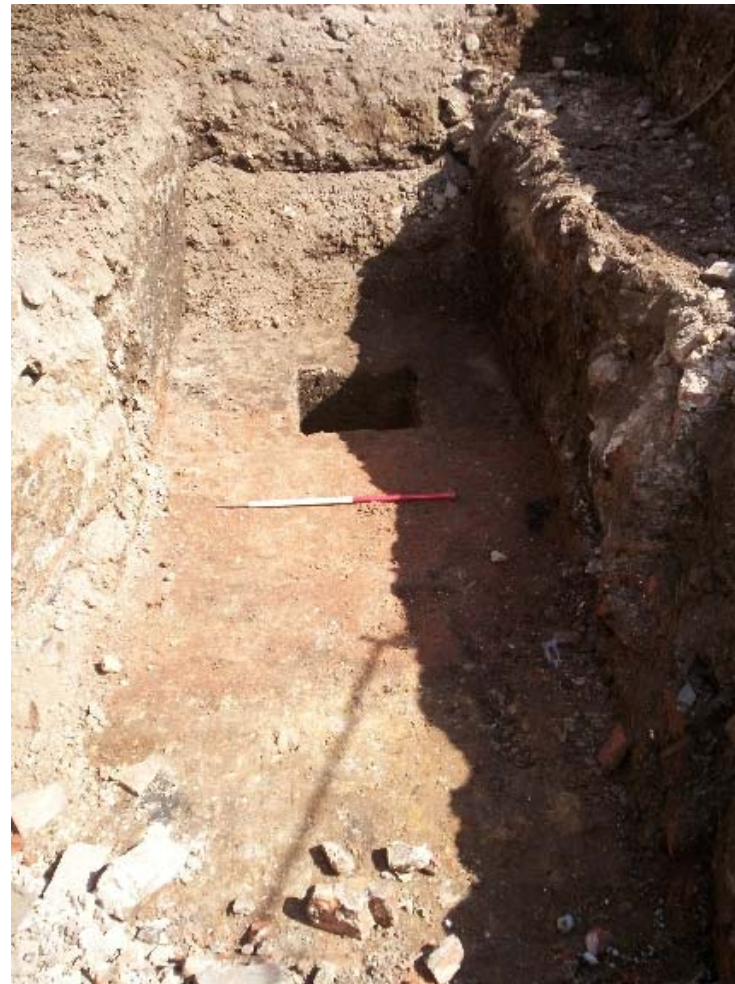
Figure 6: Trench 2 – plan and section

Trench 2 looking west (unexcavated pits [2010] and [2013] in foreground, cellar in background) (2m scale)

Trench 2 looking east (1m scale)

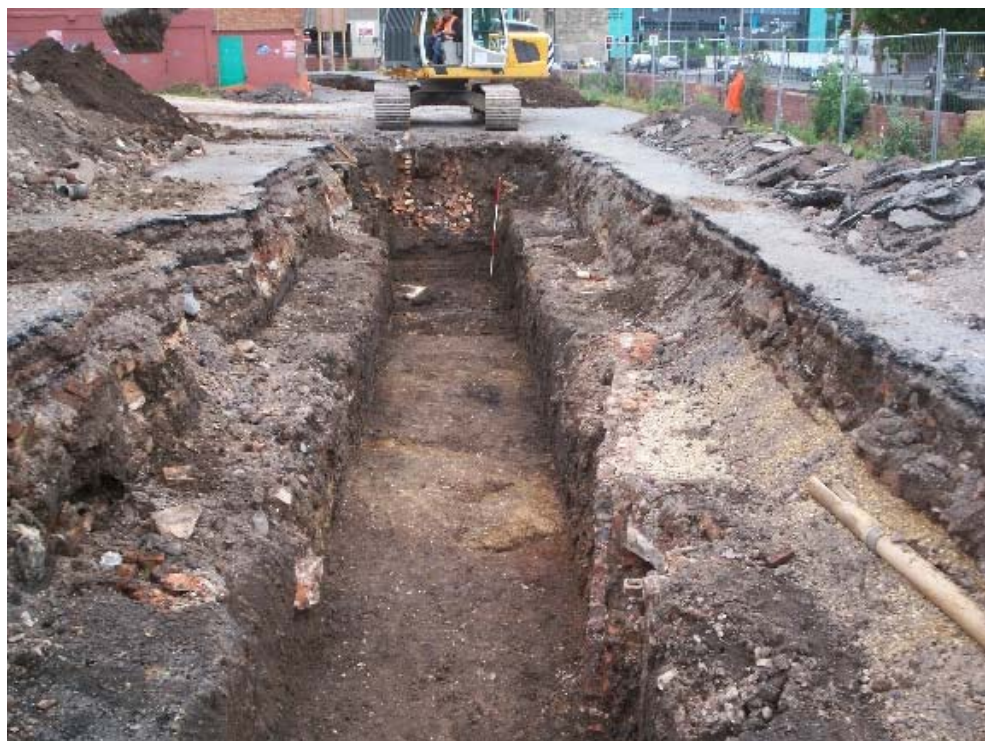
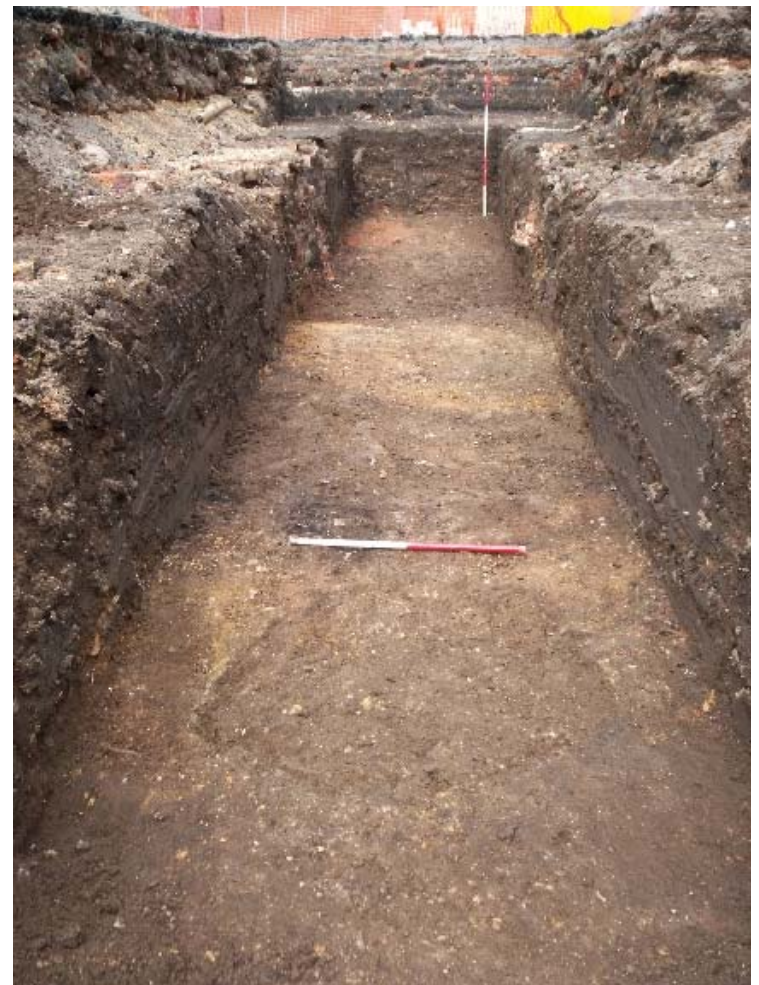
Figure 7: Trench 3 – plan and sections

Trench 3 looking south

Trench 3 looking north (unexcavated pit [3013] in foreground).

The modern structures and post-medieval and medieval “dark earth” layers (3017) and (3003) were removed to a depth of *c.* 2.5m (an average of 60.40m OD). This revealed a series of reddish clay and mid greyish brown layers, with occasional to moderate inclusions of charcoal flecks, small stones, oyster shell and animal bone (3004)–(3016). They were truncated by a circular pit [3013] with a lining of soft humic soil, probably a decayed barrel, and a main reddish brown silty fill.

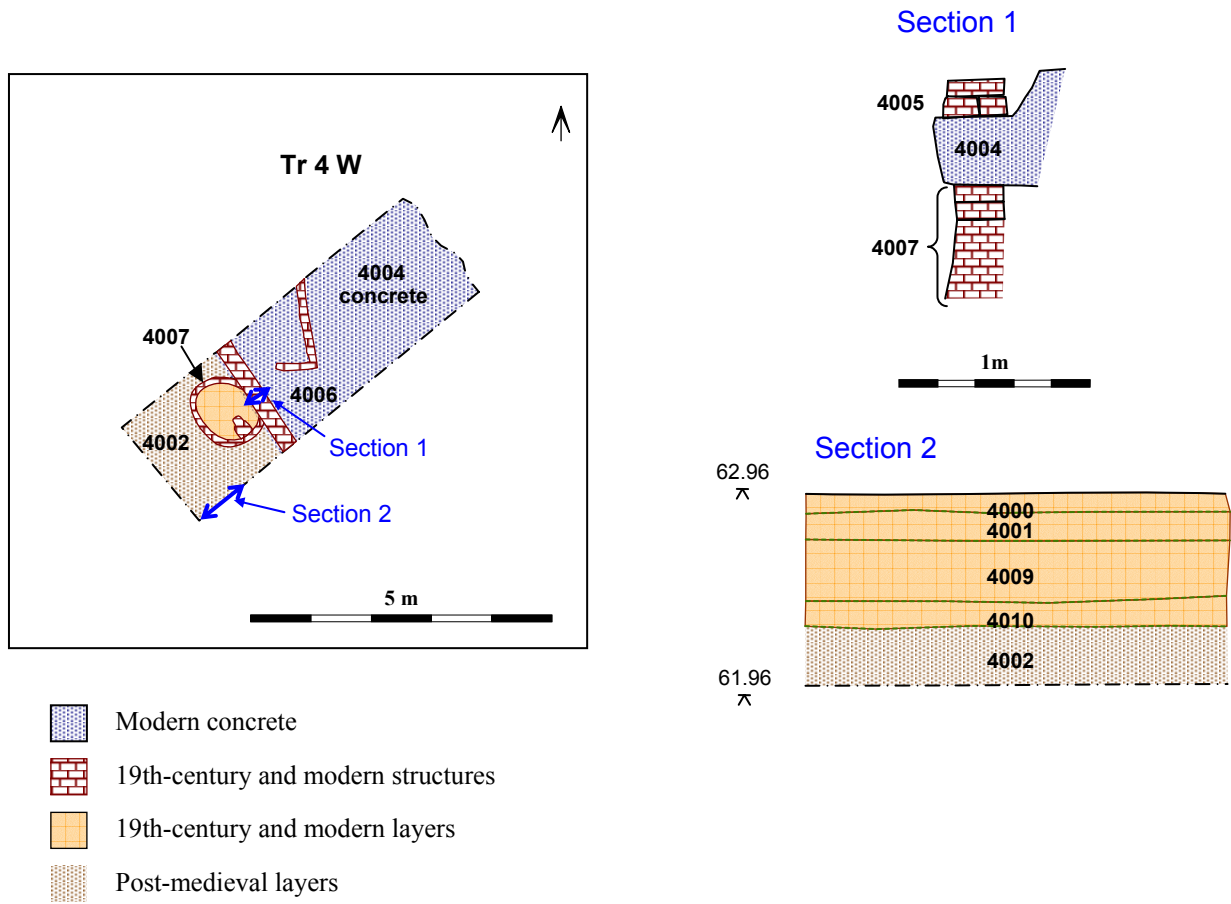
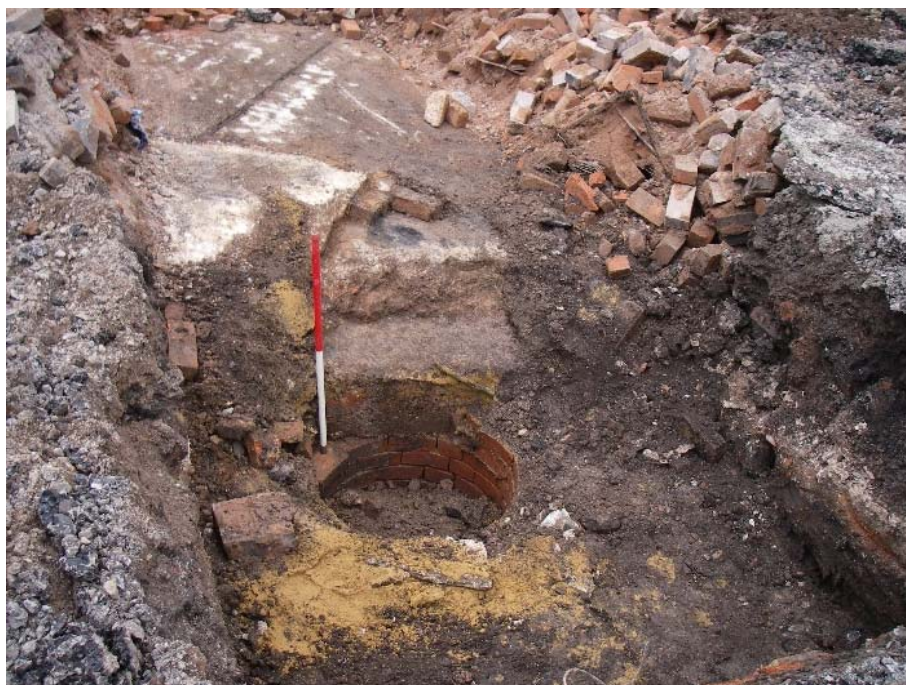
Figure 8: Trench 4 – plan and sections

Trench 4, looking east

The eastern end of Trench 4 was abandoned after the discovery of broken-up blue asbestos tiles above a solid concrete slab at a depth of 0.5m below ground level (Figure 18). Investigation of the western end of the trench revealed the same concrete slab below brick and concrete demolition rubble. The western edge of the slab was defined by the remains of a low brick wall just visible above ground. Its lower edge lay across the corner of a probably early 20th-

The concrete slab most likely represents the foundation for a 20th century building that stood on the site and was demolished. As it was found to be 0.6m thick the western end of the trench, too, was abandoned and backfilled.

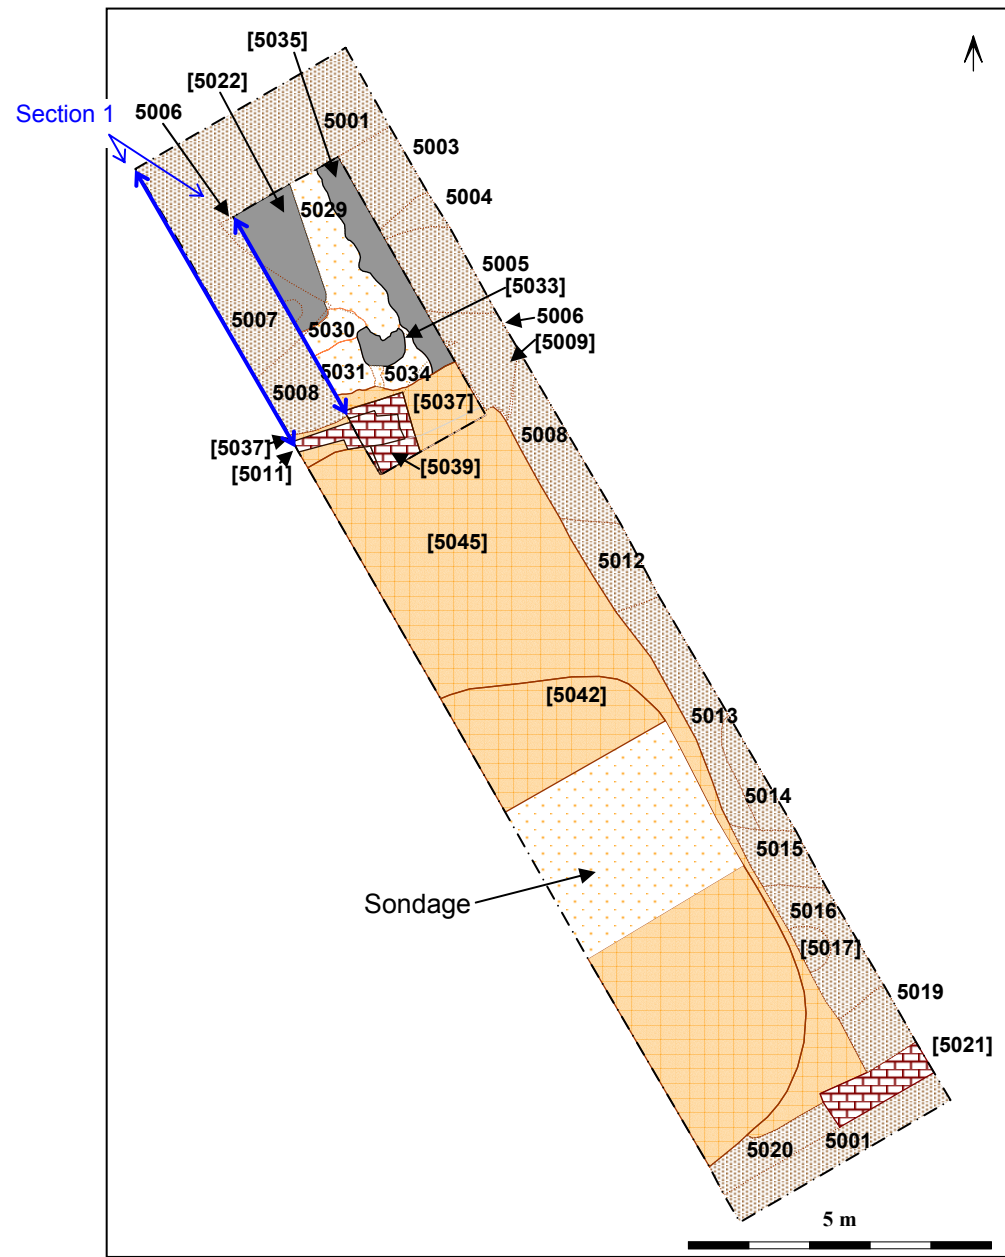
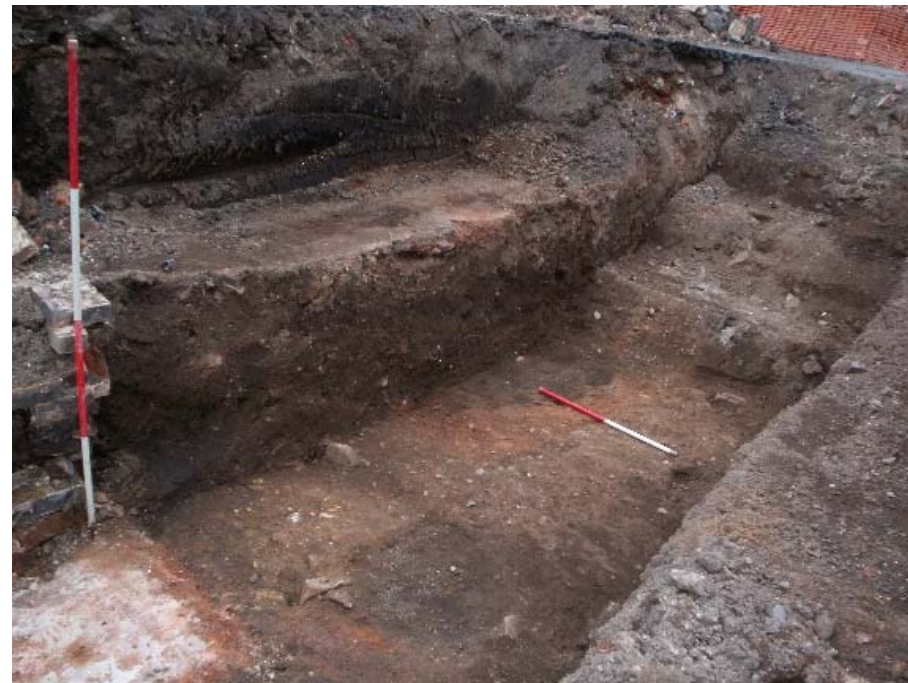
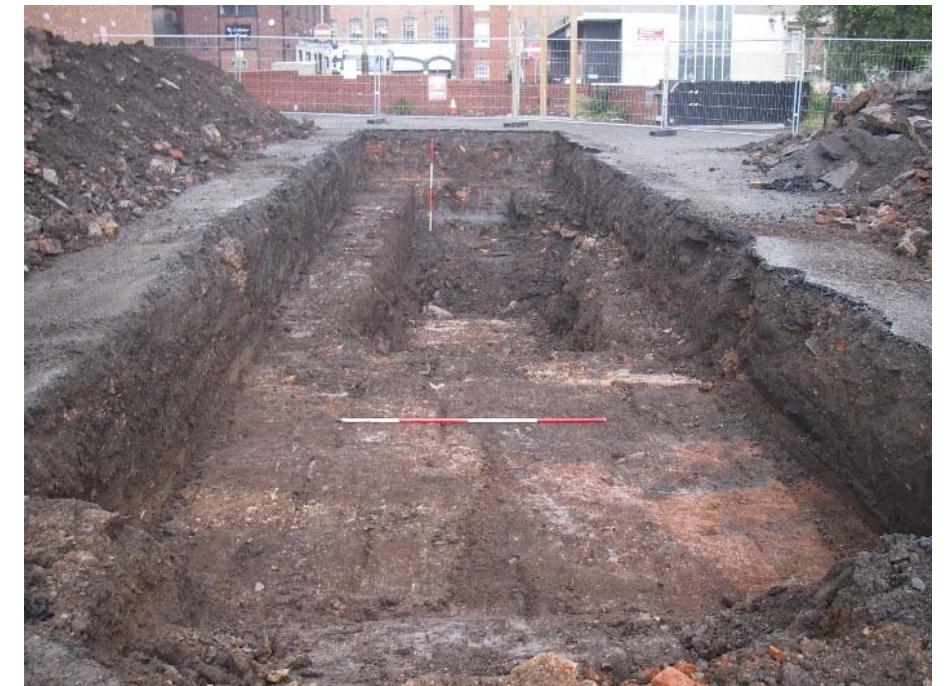
Figure 9: Trench 5 – plan and sections

Trench 5, northern end and Section 1 (looking NW). Roman and medieval layers in base of trench.

Trench 5, looking south, modern demolition cut in far end of trench, post-medieval layers in near end (2m scales)

Trench 5 was located in the southernmost part of the PDA adjacent to a modern building to the east of the site. It was situated across the boundary of former 19th-century buildings, outhouses and an area of open space to their rear. The majority of the trench was found to be truncated by 19th-century cellars and their demolition in the early-mid 20th century.

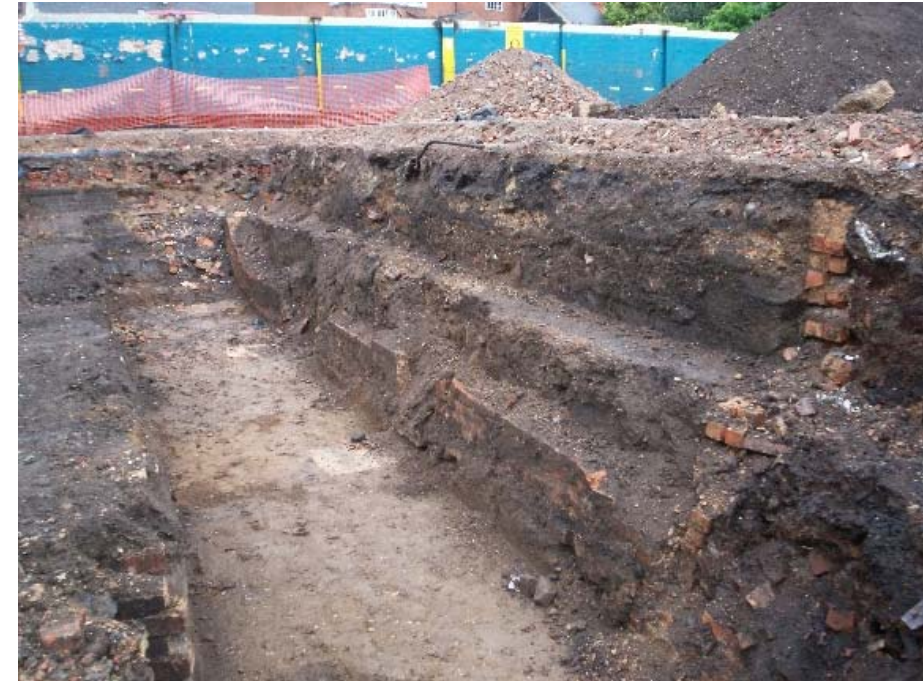
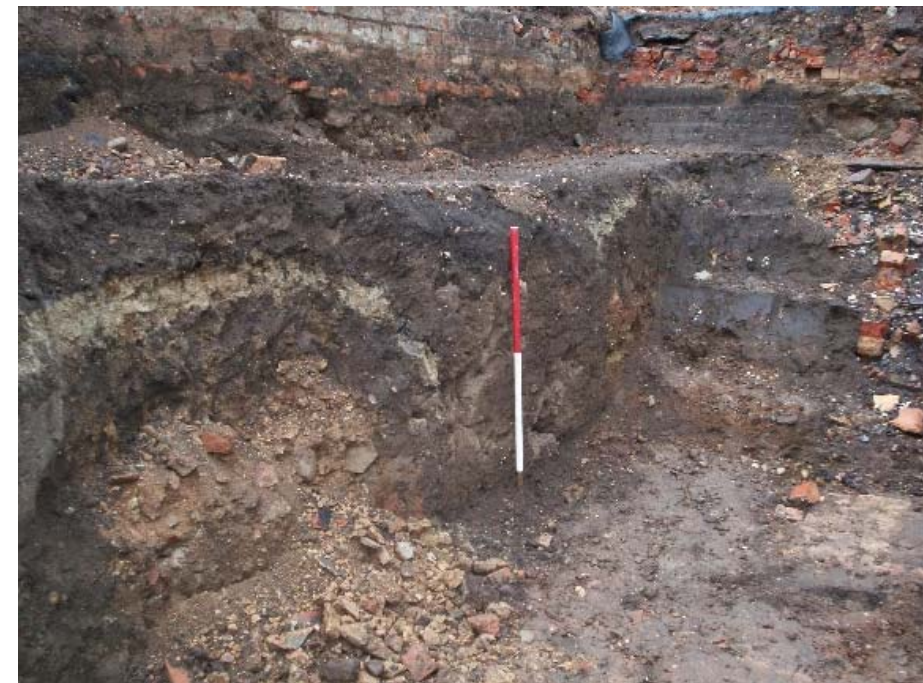
Figure 10: Trench 6 – plan and section

Trench 6, looking east

Trench 6, south-facing section (eastern part of Section 1), showing clay layer 6021 and pit [6036]. (1m scale)

A further brick wall (6007), with foundations up to 2.5m deep extended along the full length of the trench along the edge of the inner step, with a parallel brick division (6006) 1m to its north, which survived in the eastern part of the trench. This arrangement of walls is more reminiscent of the inspection pits of the bus depot than a 19th-century cellar. It is possible that they represent part of an early phase of the bus depot that was subsequently backfilled and built over. Most of this inspection pit was removed by machine in the remainder of the trench but a series of brick pads, (6009), (6011) and (6014), most likely relating to the same structure, were still present in the base of the trench at a depth of *c.* 2.5m.

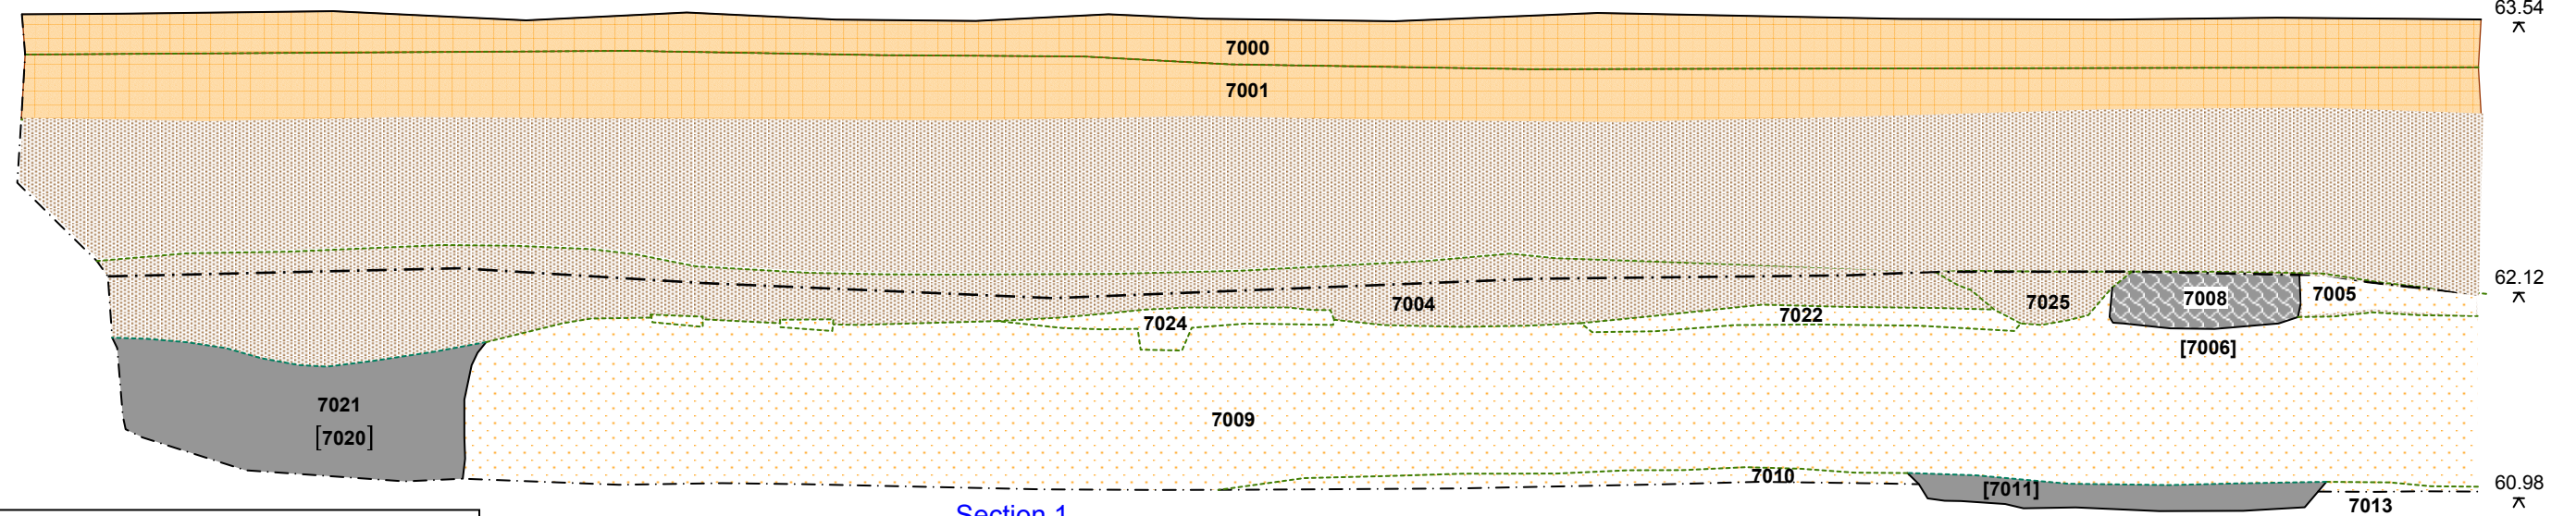
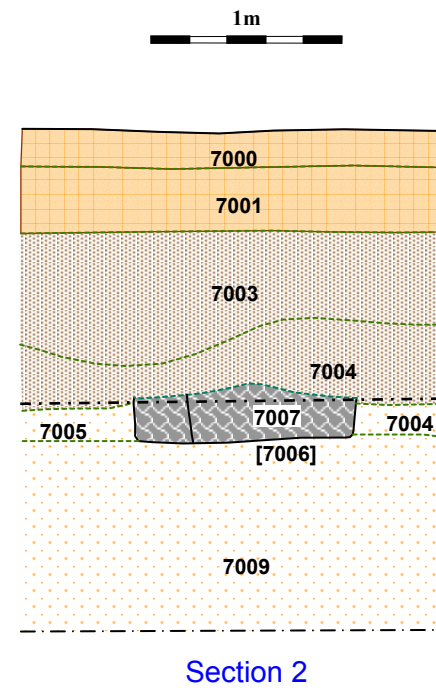
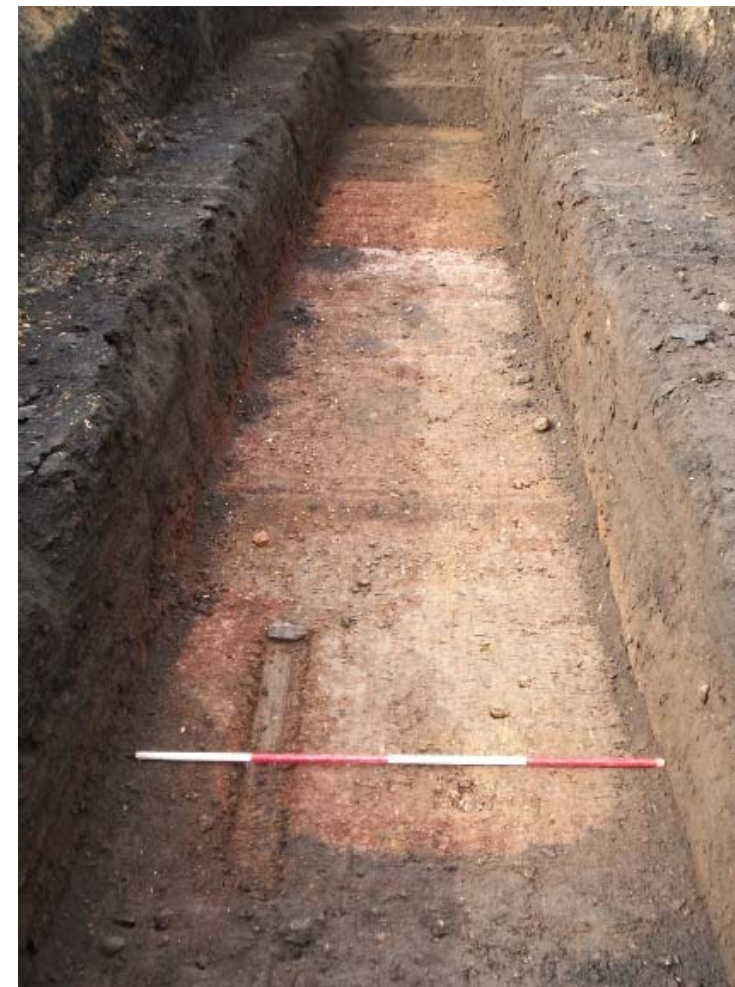
Figure 11: Trench 7 – plan and sections

Trench 7, looking north. Ditch [7011] in northern end of trench. Pits [7020] and [7013] in foreground (2m scale)

Trench 7 lay in an area of open ground in the eastern part of the PDA. Removal of the post-medieval built-up dark soil (7002) revealed a wall footing [7006] at a depth of 1.3m below ground level in the northern part of the trench (Figure 19). The footing was on an E-W alignment and continued beyond the limit of excavation at both ends. It was very shallow with a maximum depth of 0.25m and was 1m wide. It was filled with loose small and medium-sized limestone cobbles in a yellow sandy mortar matrix (7007). The western part of

A wide and shallow ditch [7011] truncated (7010), and another layer (7013), in the northern part of the trench. It was on an E-W alignment and continued beyond the limit of excavation at both ends. It was 2m wide and a maximum of 0.15m deep. Fill (7012) of the ditch contained Roman pottery and ceramic building material and a small quantity of animal bone and oyster shell. Its position within the trench was very similar to that of later wall foundation [7006]. It may be possible that this is a boundary that survived for a considerable period of time.

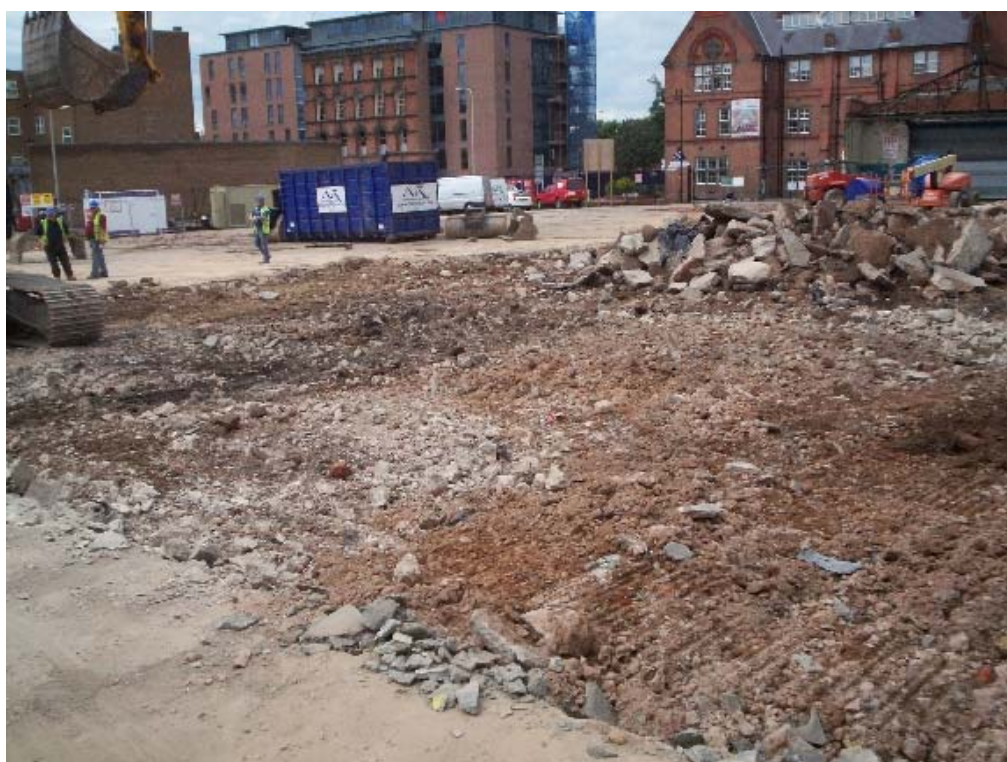
Figure 13: Rubble layers exposed after removal of concrete slab

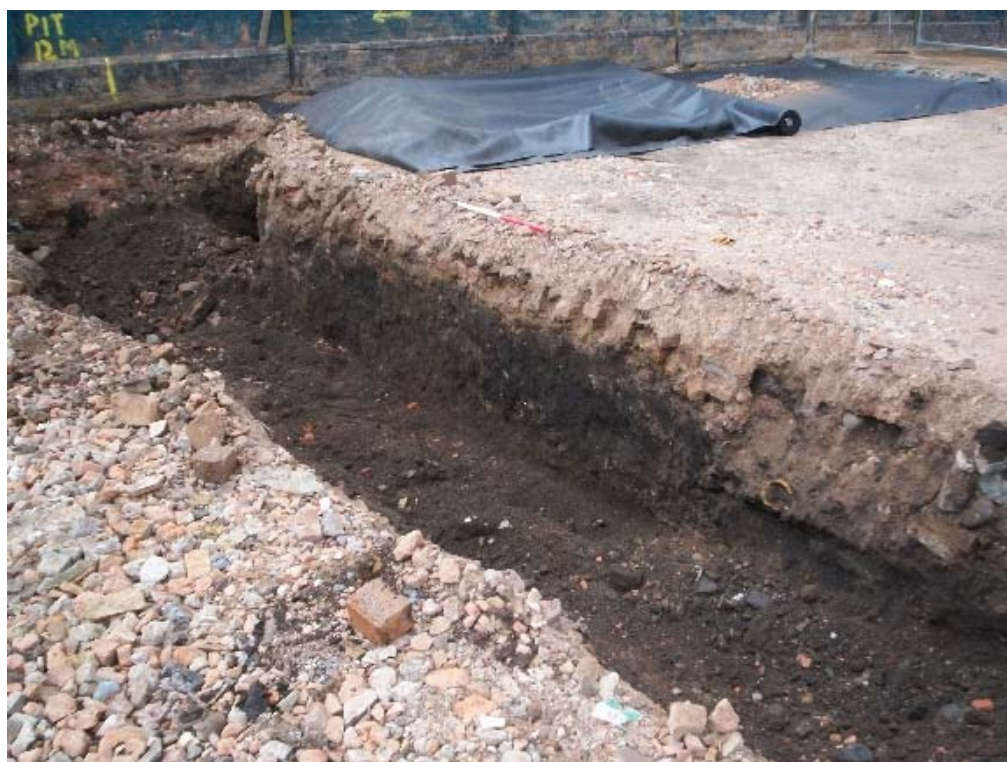
Figure 14: Post-medieval “dark earth” exposed in side of inspection pit

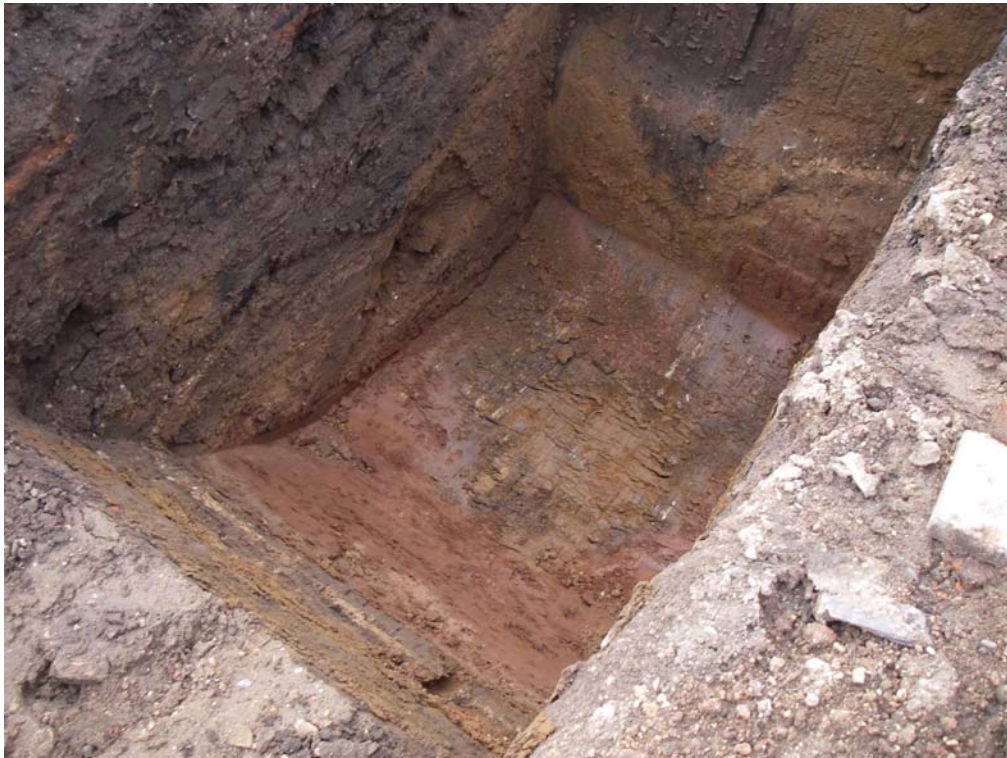
Figure 15: Trench 1, sondage in southern end of trench, potential Roman pit [1047], looking SE

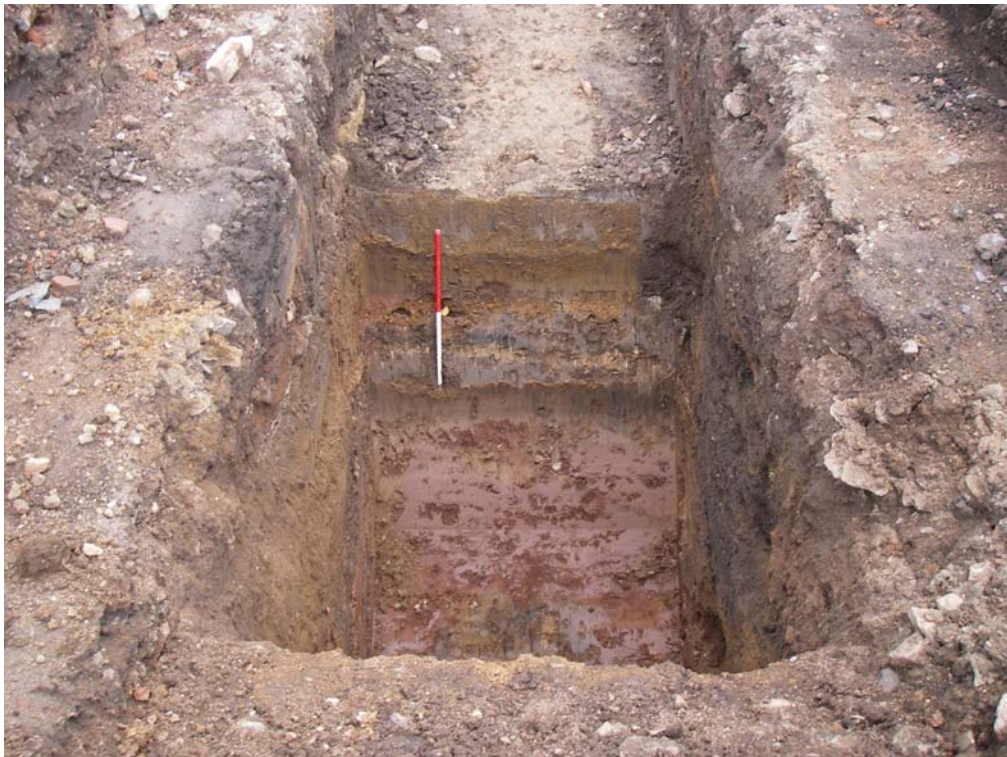
Figure 16: Trench 1, sondage in southern end of trench, looking north at depth of layers (1m scale)

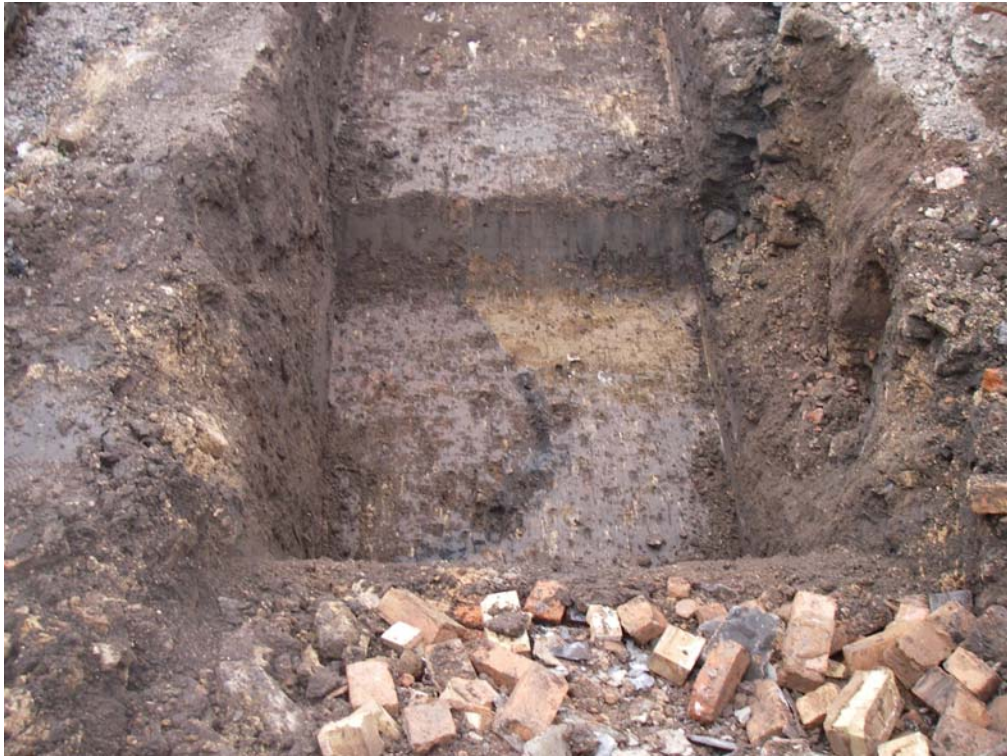
Figure 17: Trench 3, southern end of trench, showing potential Roman pit [3023], looking north

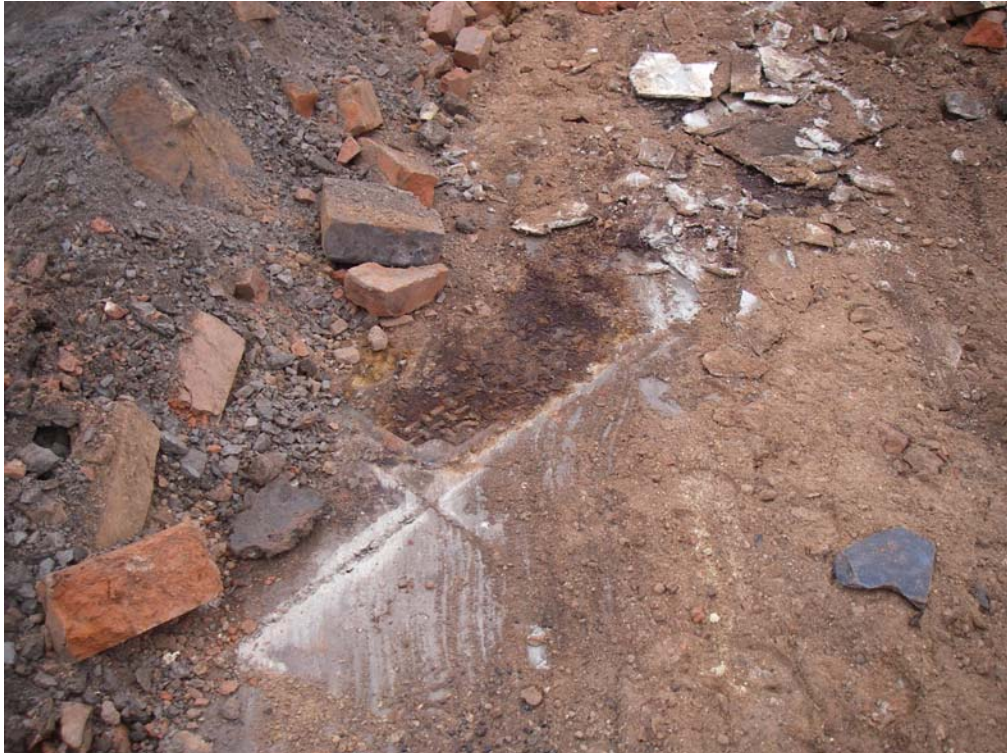
Figure 18: Trench 4, asbestos plates above concrete slab

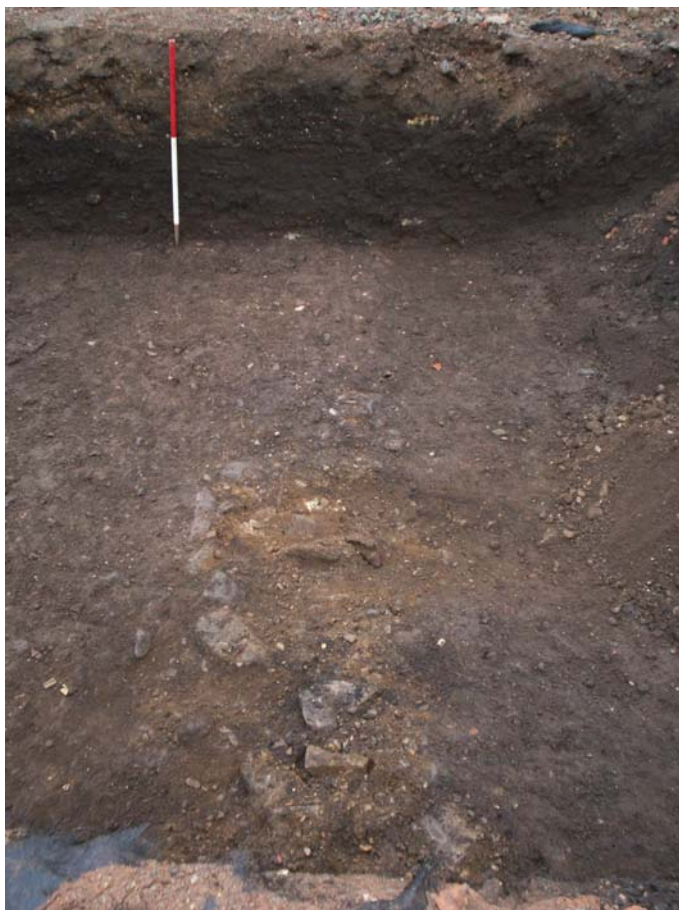
the wall foundation contained a more mixed backfill which contained a fragment of post-medieval pottery.

Figure 19: Trench 7, wall foundation [7006], looking west (1m scale)

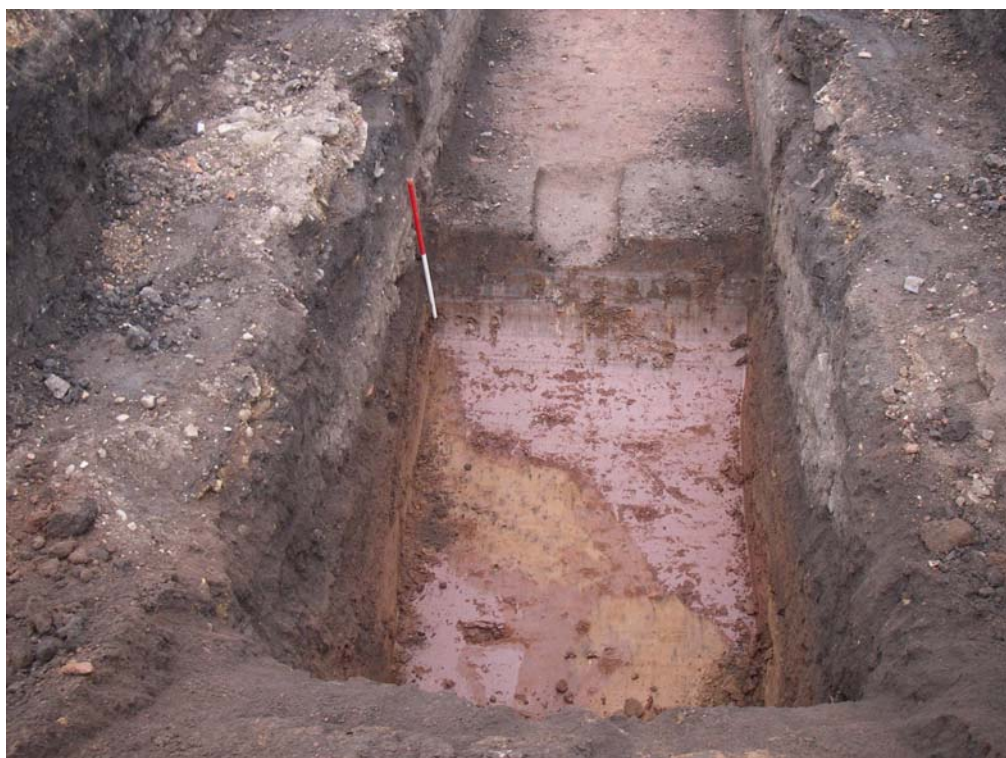
Figure 20: Trench 7, sondage in northern end of trench, looking south (1m scale)

After recording the possible wall foundation, the deposits in Trench 7 were reduced to a depth of 2.4m (an average of 60.95m OD). A thick layer of medieval dark earth (7009) was present throughout the trench below the layers discussed above.

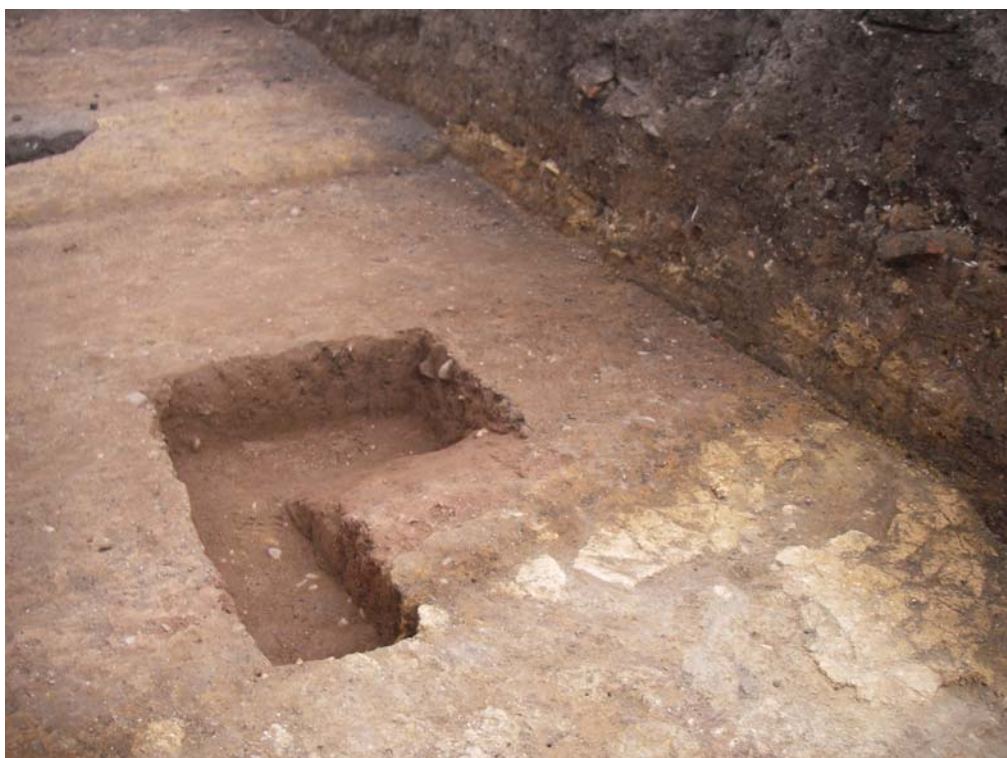
In the centre of the trench the deposit overlay a deposit of mid orange brown sandy gravel (8038) adjacent two several slabs of yellowish, soft, broken limestone (8039) (Figure 21). These may be the remains of a surface — whether internal or external is unclear.

Figure 21: Trench 8, possible Roman floor surface (8039)

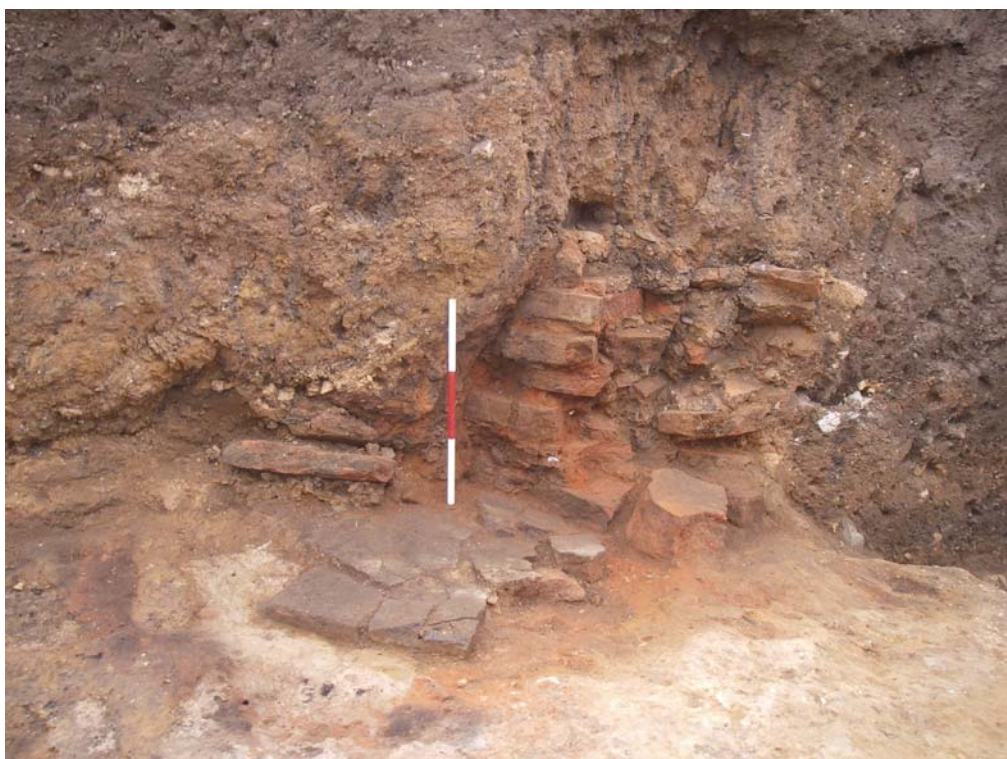
A stack of irregular flat Roman bricks (8030) was visible in the southern section of the trench (Figure 12, Section 5; Figure 22). It was unclear whether they represented a structure surviving *in situ* or an assemblage of displaced building material. The bricks were adjacent to a small gully [8026] on a NNW-SSE alignment. The gully was originally 0.9m wide, 0.2m deep with a near vertical western edge, suggestive of a beam slot or wall foundation trench. It was most likely extensively robbed out by [8046], a wide cut visible in section above [8026].

Figure 22: Trench 8, stack of ceramic building material (8030) in section
