**FORMER BUS DEPOT
PEACOCK LANE
LEICESTER**

**ARCHAEOLOGICAL WATCHING BRIEF
AND
FIELD EVALUATION**

Project: Y.A6.2011
Document: 2011/114
Version 1.0

7th October 2011

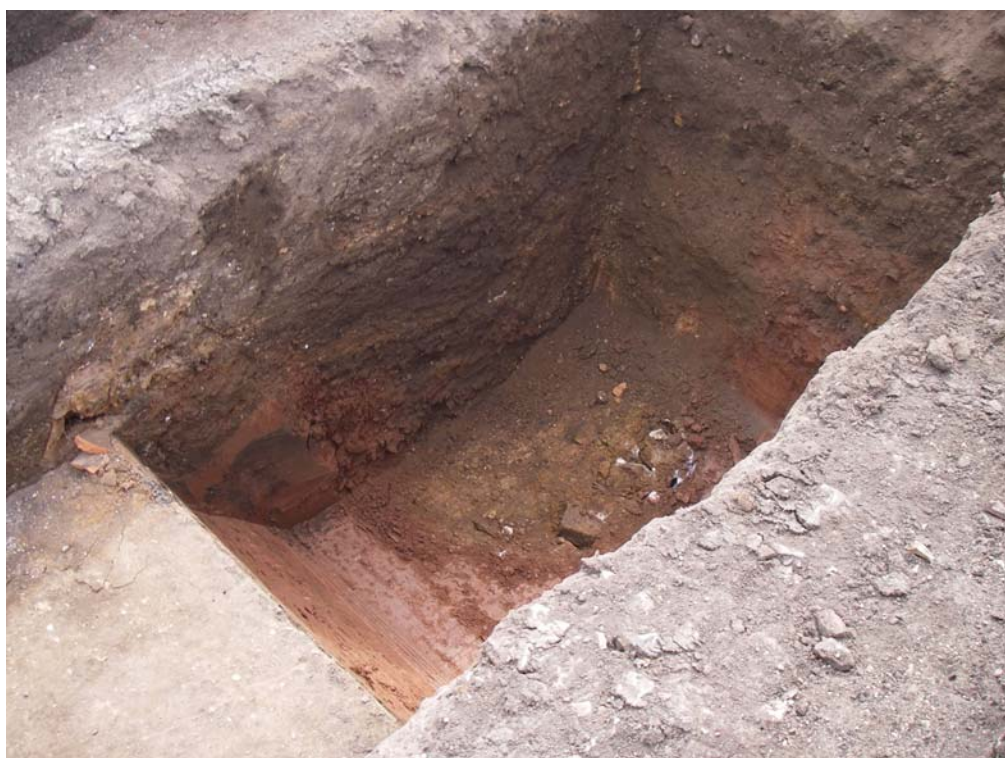
Figure 23: Trench 8, sondage in western end of trench, showing full depth of pit [8013] with ?Roman building rubble in base

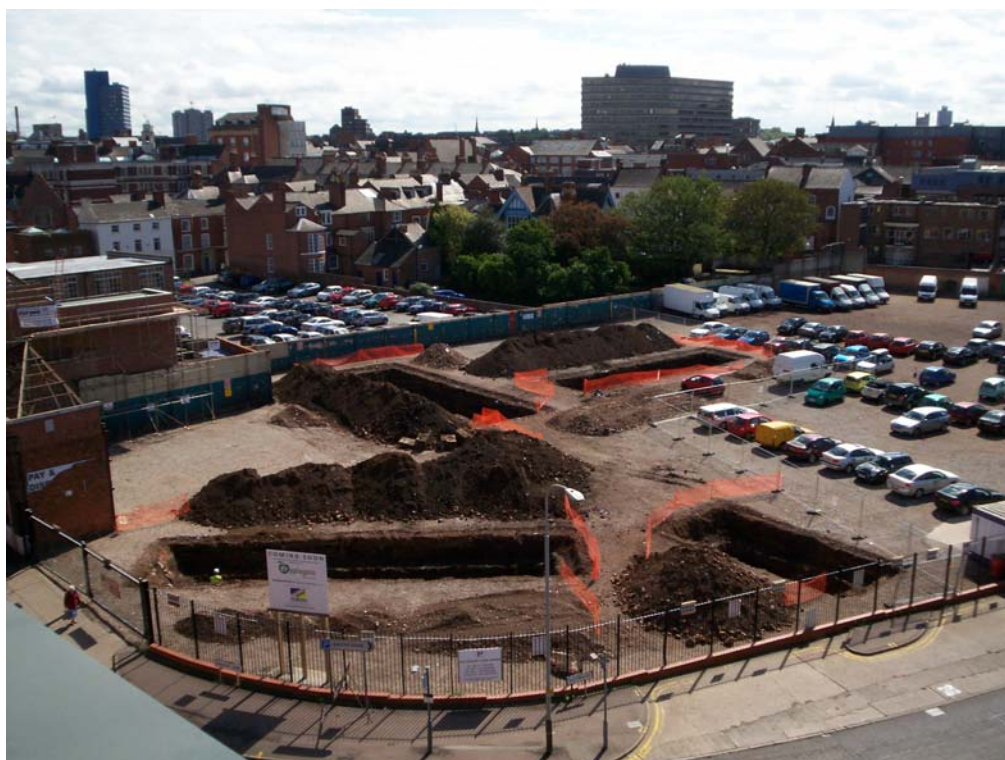
Figure 24: Evaluation trenches in northern part of site
