**LAND ADJACENT TO DRAKEWELL ROAD
BOW BRICKHILL
MILTON KEYNES**

ARCHAEOLOGICAL FIELD EVALUATION

Project: DR1800
Document: 2011/101
Version 1.1

13th October 2011

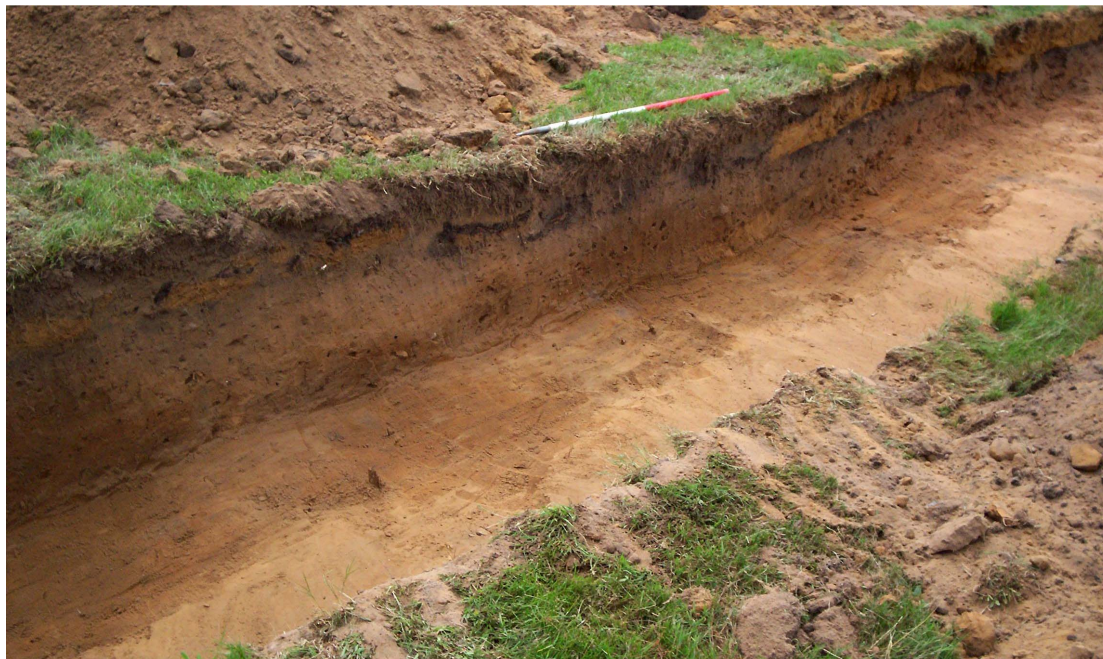
Image 1: Southern section of Trench 1, showing yellow colluvium (101) and buried turf (102) to the margins of image. The depression in the centre of the section is created by the movement of soil down the dry valley. Scale 1m in 0.5m divisions.

A dark grey brown pasture soil (100) developed over this material. It was generally less than 0.1m thick though increasing to 0.31m in the central part of the trench, within the dry valley (Figure 2: Section 1; Figure 3: Image 1). Whilst small fragments of modern brick were noted in the colluvium and buried subsoil, no artefacts were recovered to indicate activity in the medieval or earlier periods.

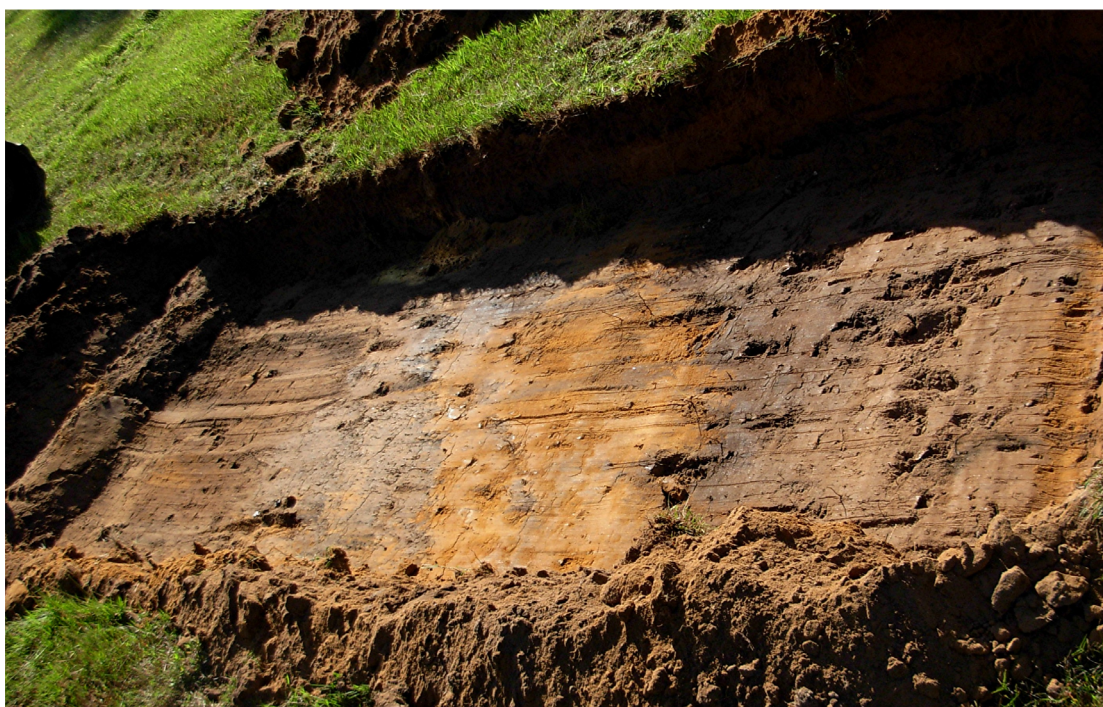
Image 2: Trench 1 during machining revealing thicker linear bands of yellow colluvium (101). Darker bands to either of this are the buried turf and topsoil (102). The trench is 1.6m wide.

The turf had a shallow undulating profile in section and was sealed below a yellow silty sand colluvium (101). The colluvium had been lost to erosion in the centre of the trench. Small fragments of modern brick were present in this deposit. Towards the base of the colluvium, a series of parallel bands aligned roughly NNW-SSE were defined, where it filled the undulations in the buried turf (Figure 3: Image 2; Figure 4: Image 3). These followed the slope of the ground down to the NNW and would appear to be the results of down-slope soil movement, rather than the preserved remnants of ridge and furrow cultivation.

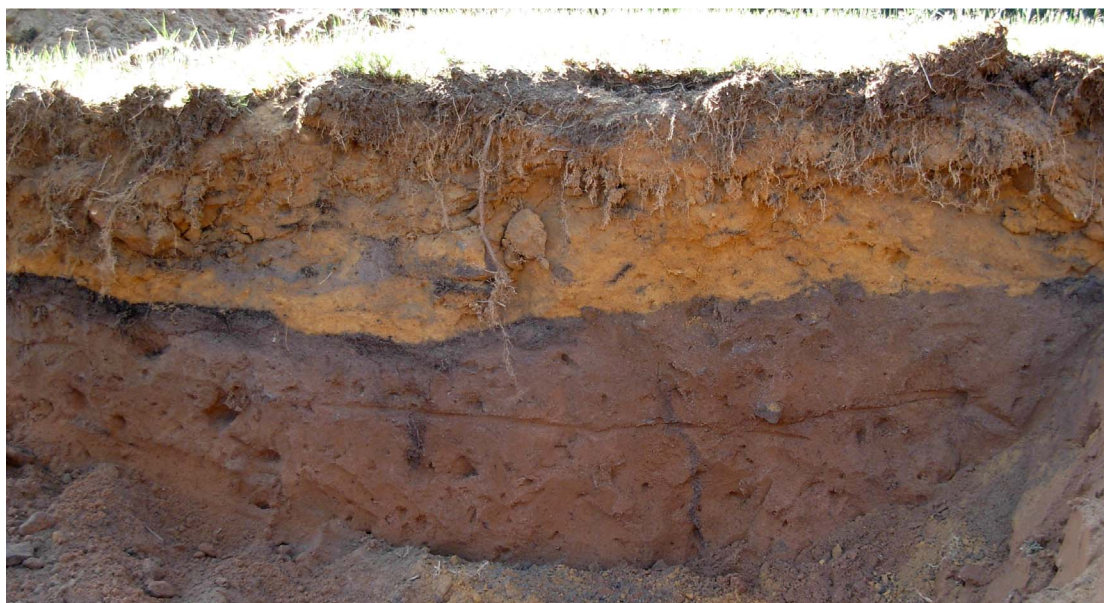
Image 3: Detail of deposition sequence in Trench 1 revealing undulating nature of buried turf – the thin black band between the yellow sand (101) above and the reddish grey subsoil (103) below.

Straddling the top of a dry valley (Figure 2), two contrasting geological strata were revealed, with (105), in the centre of the trench, being associated with the dry valley. The trench revealed an old soil profile, which was best preserved at the limits of the trench, away from the disturbance associated with soil movement down the valley (Figure 3: Image 1; Figure 4: Image 3). The old soil profile comprised a thin band of dark turf and soil (102), above red grey sandy silt subsoil (103) (Figure 4: Image 3).

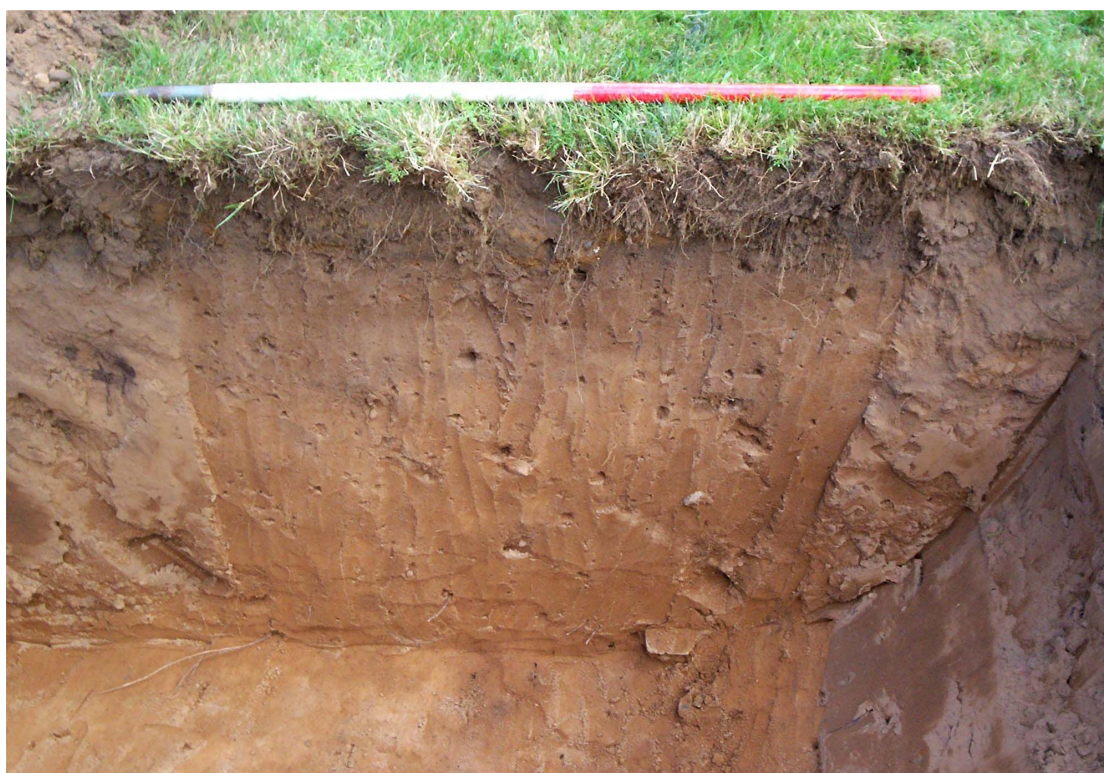
Image 4: Northern section of Trench 2, showing deposition sequence within the dry valley, comprising topsoil (200) above an extensive lighter coloured subsoil (201). Scale 1m in 0.5m divisions.

Situated on the upper, northern slope of another dry valley (Figure 2), the trench revealed a much thicker soil profile (Figure 2: Section 2; Figure 4: Image 4) *c.* 0.75–1.0m thick. This consisted of dark topsoil, above mid red grey silt subsoil. These deposits were more mixed than in Trench 1, probably due to the down-slope movement of material. Small fragments of modern brick were present in these deposits, although no artefacts were recovered to indicate activity in the medieval or earlier periods.

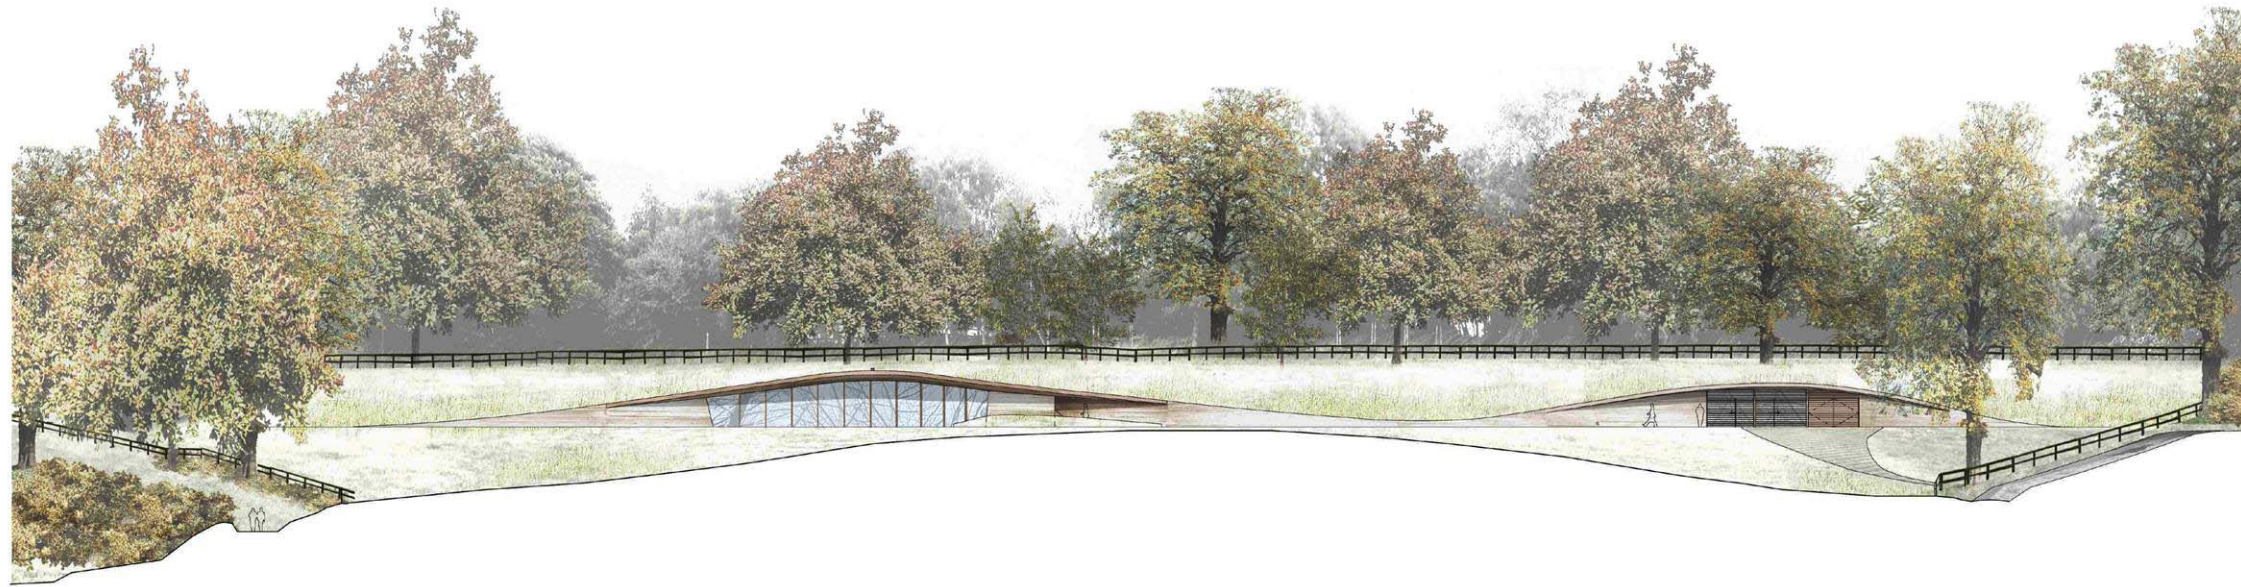
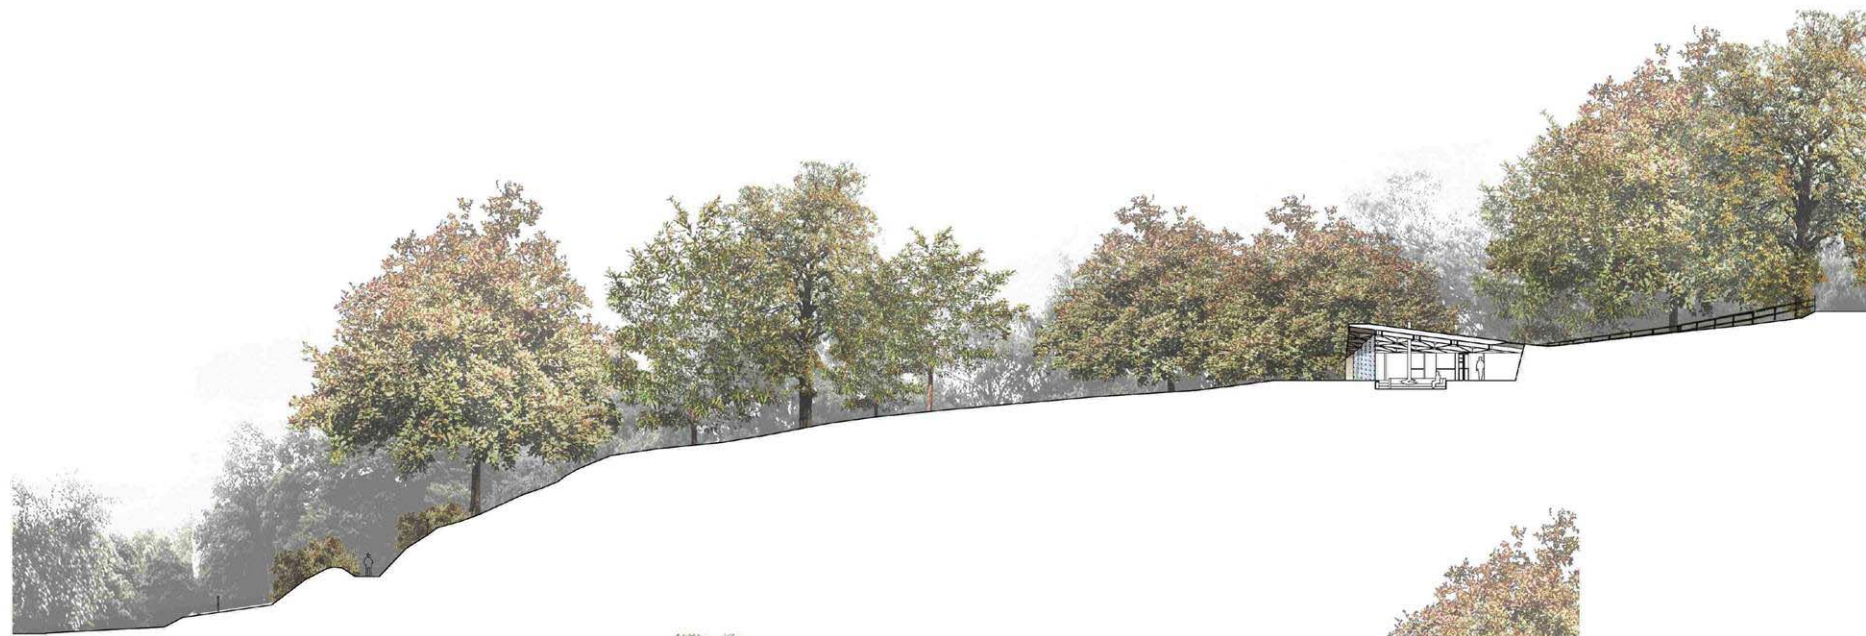
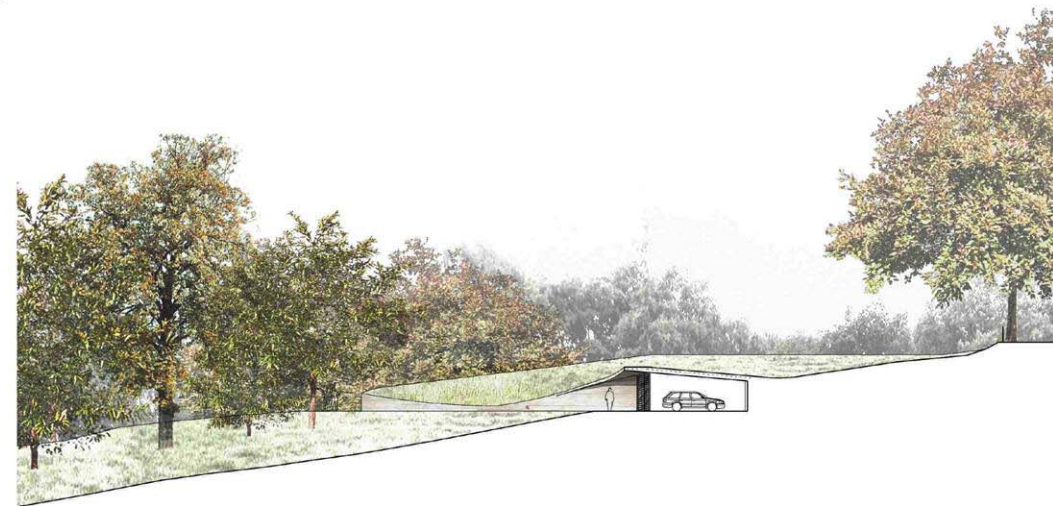
Figure 5: Proposed development – elevation and sections
Copyright of Burd Haward Architects - reproduced with permission

Front Elevation AA

Section BB

Section CC

The proposed development has been deliberately designed to minimise its visual impact on the area, particularly the church. Both buildings will be sunk into the ground, utilising the contours of the two dry valleys (Figure 5). The proposed design will see the roofs covered by soil and turf, so that the buildings will blend into the landscape if seen from the north-east or east. The associated driveway, set down-slope, will use a stabilising matrix, which will allow grass to grow through. This will again minimise visual impact on the area. From the church, the rising ground will mask movements to and from the site.

As the design of the dwelling envisages a sunken building with grass covering to the roof structure, the visual impact will be minimal. The roof forms have been designed so as to be an extension of the existing topography. The eastern part of the land parcel, where the buildings are situated is in deep shadow in the morning, cast from the adjacent mature deciduous trees, whilst as the sun rises it will minimise any shadow which could emphasise the location of the dwelling in particular. Even after leaf fall the dense crowns of the trees will hinder views across the site; the lower winter sun will cast dappled shadows across the site. The dense crowns of the trees will also restrict views from the tower into this area.

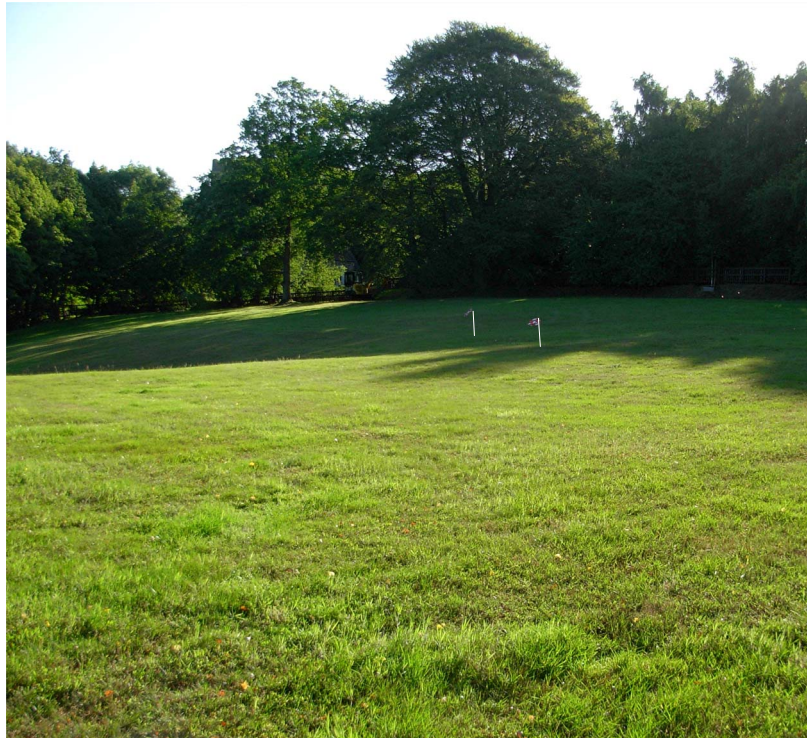
Image 1: View of Trench 1 (dwelling) looking north-east towards the church. (White canes mark the ends of the trench.)

There is no publicly accessible path which would give viewpoints that superimpose the proposed development onto the backdrop of the church. Generally the site is screened from the church by mature deciduous trees (Figure 2 and Figure 6: Images 1 and 2), with only two noticeable gaps in this screen. In the vicinity of the lower church gate in the area where the hollow-way is at its shallowest, it is possible to view the site (Figure 7: Image 3). The site can also be glimpsed, through a second gap further south, which from the raised path to the south of the church provides limited views of the site (Figure 7: Image 4). The porch step of the church is *c.* 1m below the level of the path and provides a very restricted view towards the site (Figure 8: Image 5). These gaps through the trees would provide views towards the rear of the buried dwelling; the garage being masked by rising ground between the two dry valleys (Figure 2 and Figure 8: Image 6). Landscaping associated with the proposed development includes limited tree planting which would close these gaps.

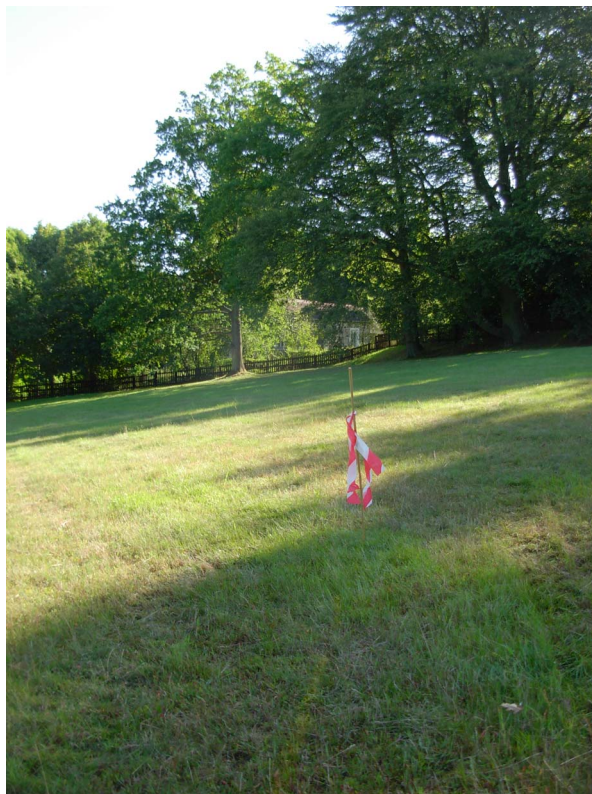
Image 2: View of north end of Trench 1 looking north-east towards the church, which is just visible through the trees.

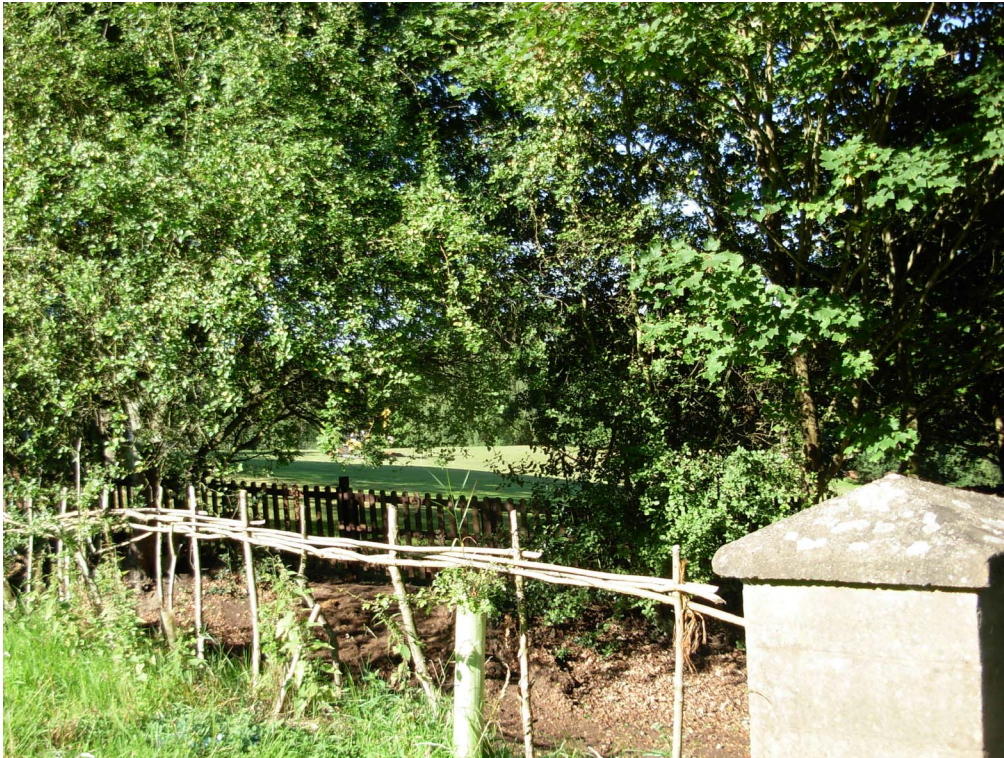
Image 3: View of site from churchyard near lower gate, looking to the south-west. The yellow mechanical excavator is just visible opening Trench 1.

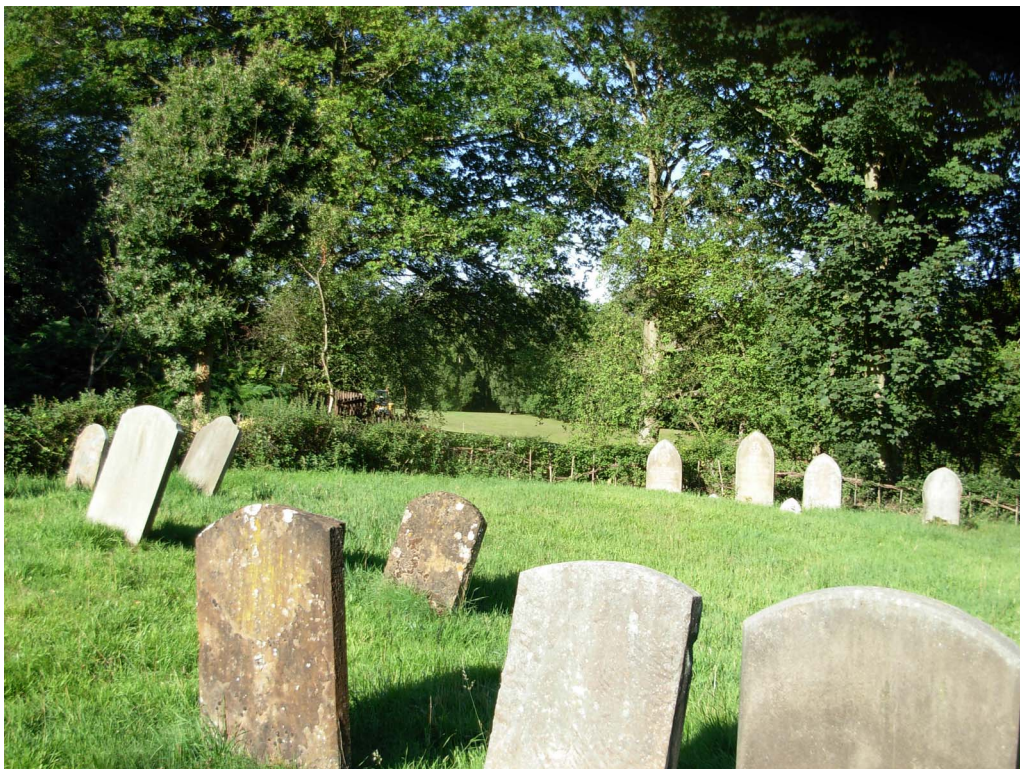
Image 4: View of site from raised pathway to the south of the porch doorway.

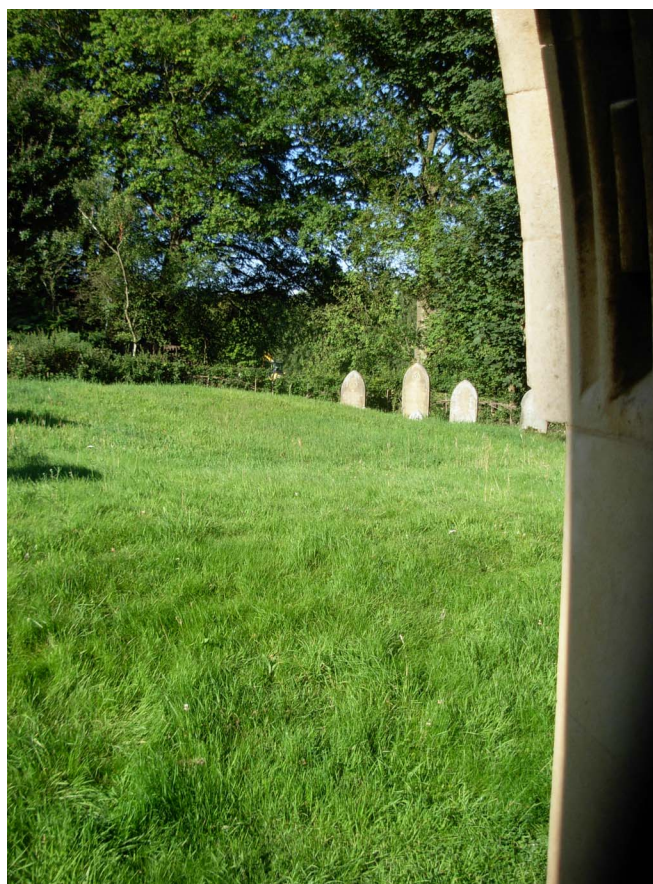
Image 5: View from doorway of church porch looking south-west, towards the site.

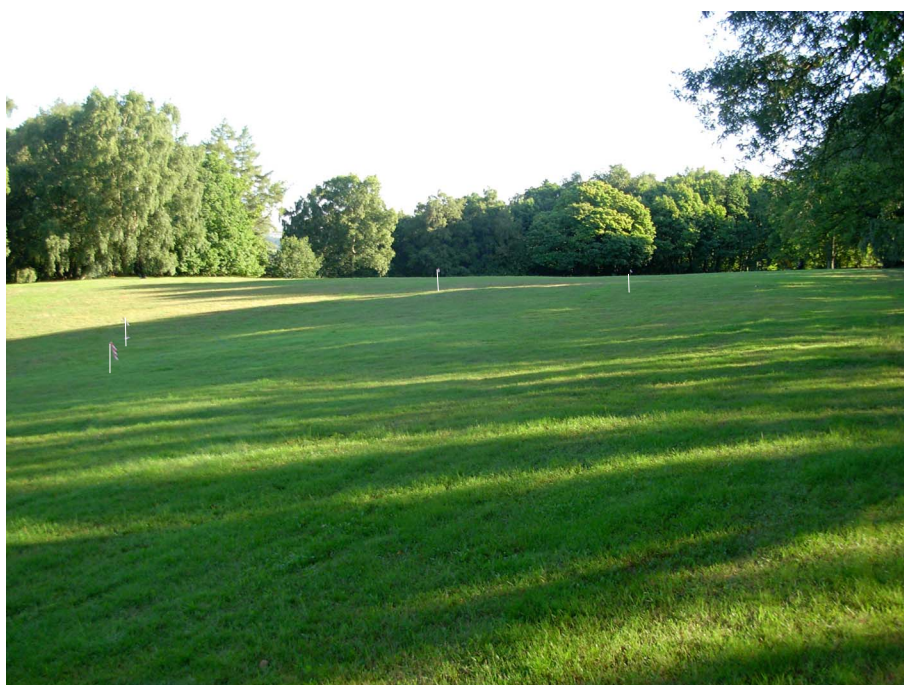
Image 6: View of garage site below crest of ridge with dwelling site beyond and church to top right of the image. (White canes mark the ends of the trenches.)
