The Grange, Blunham, Bedfordshire Summary of Archaeological Works to date

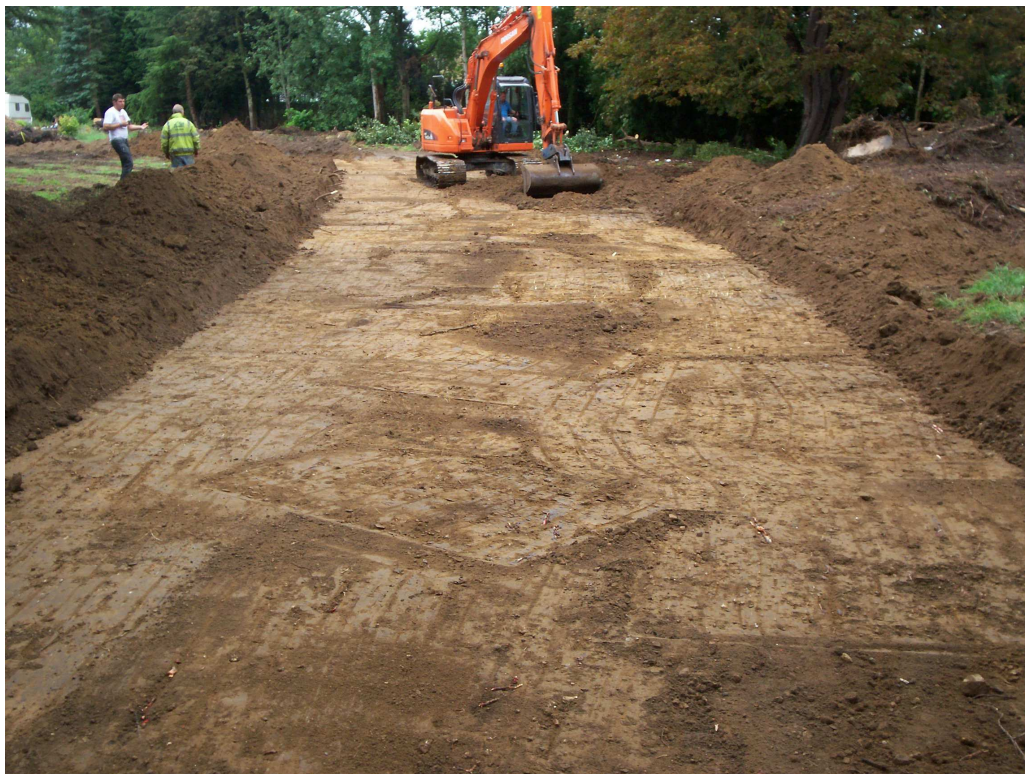
Image 1: Stripping of the driveway down to formation level, revealing the interface between ploughsoil and underlying subsoil.

Monitoring of the stripping of the turning area and driveway, which extends from the house, in a south easterly direction revealed a cultivation soil, with the ground reduction stopping at the interface of the ploughsoil and underlying subsoil (Figure 2: image 1). However, an associated service trench extended *c.* 0.8m below the present ground level, exposing the undisturbed geological strata, which consisted of light grey yellow sandy gravel to gravely sand (Figure 2: image 2). No archaeological deposits or artefacts were revealed in this area.

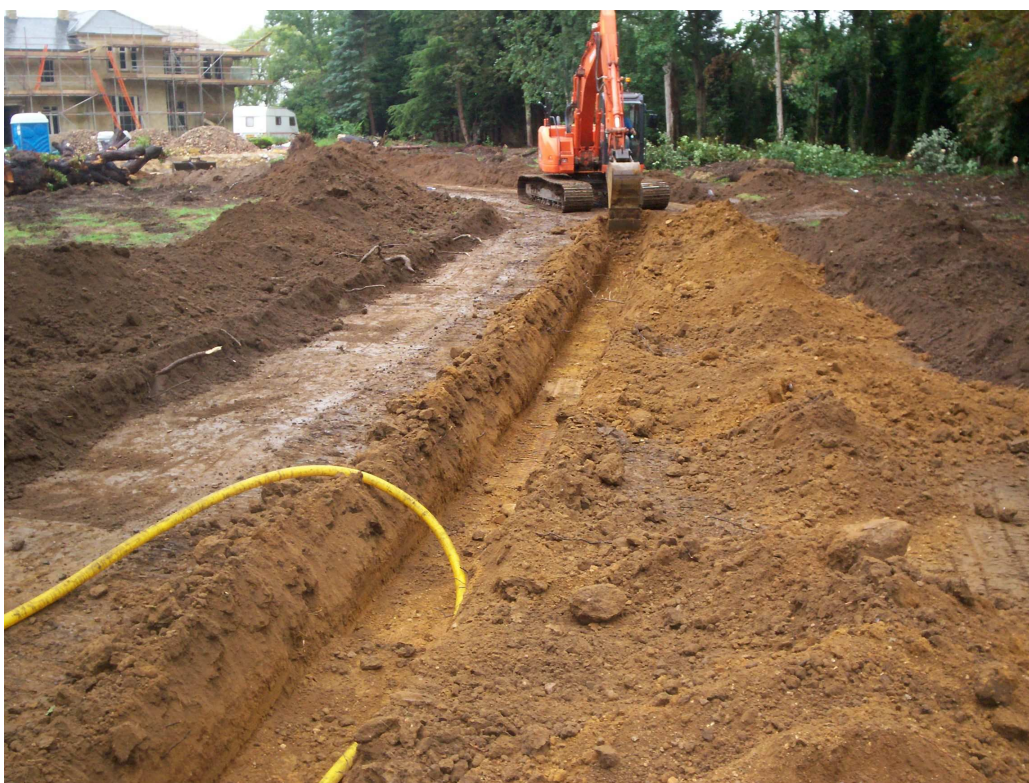
Image 2: Cutting drainage trench along driveway, exposing the undisturbed geological strata.

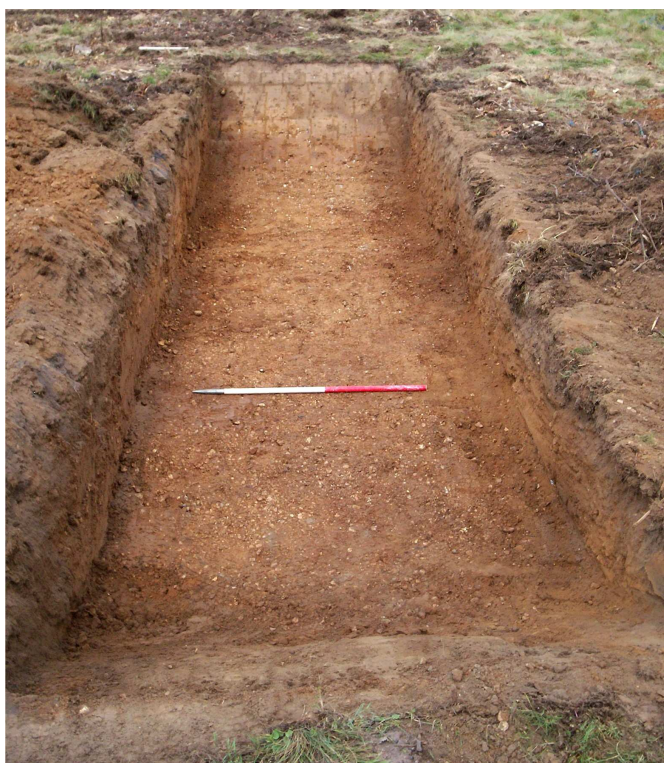
Image 3: Trench 3, showing the slight variations in the geological strata. No archaeological features were present. Scale 1 metre in 0.5m divisions.

It was only possible to open two of the trenches (Tr 2 and Tr 3 on Figure 1), with Trench 1 being inaccessible at present. These trenches revealed a darker sandy gravel geological strata (Figure 3: image 3). These are river terrace gravels, with the variations due to the nature of deposition.

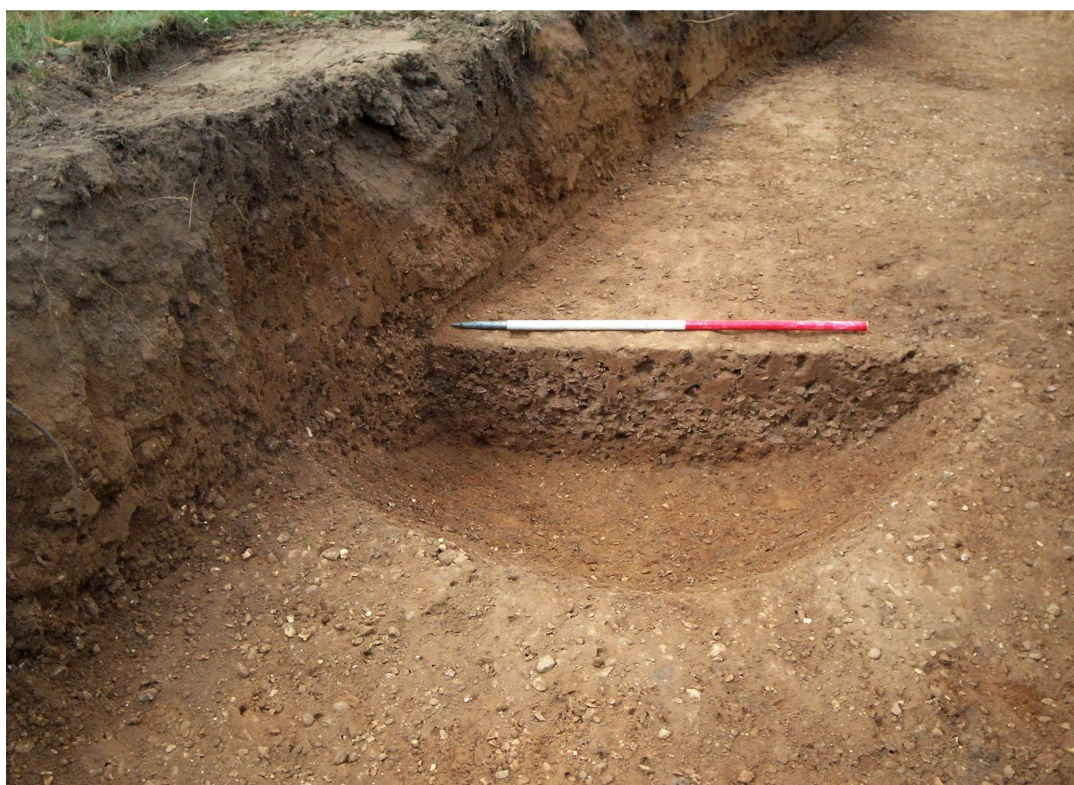
Image 4: Trench 2, showing terminal of undated ditch [203] excavated. The intermediate stony fill, suggests the presence of an associated bank to the left. Scale 1 metre in 0.5m divisions.

The trenches revealed a cultivation soil, between 0.6-0.8m thick. A single archaeological feature was exposed on the western side of Trench 2. The linear ditch was aligned NW-SE, at least 6.5m long, with a well-defined terminal in the SE (Figure 3: image 4). Two sections were excavated across the ditch, one at the terminus and a second further to the NW, at the request of the CBCA following the site visit. In section the ditch has a concave profile *c.* 1.5m wide and increasing in depth from 0.4m deep near the terminal to 0.7m further to the NW (Figure 4: image 5). A series of fills were exposed, with the intermediate fill indicating the presence of an associated bank to the west. The upper fill was probably derived from natural silting of an adjacent ploughsoil. As no finds were recovered from the feature during hand excavation a sample was taken for dry sieving. The 20 litres sample has been processed with no finds being recovered.

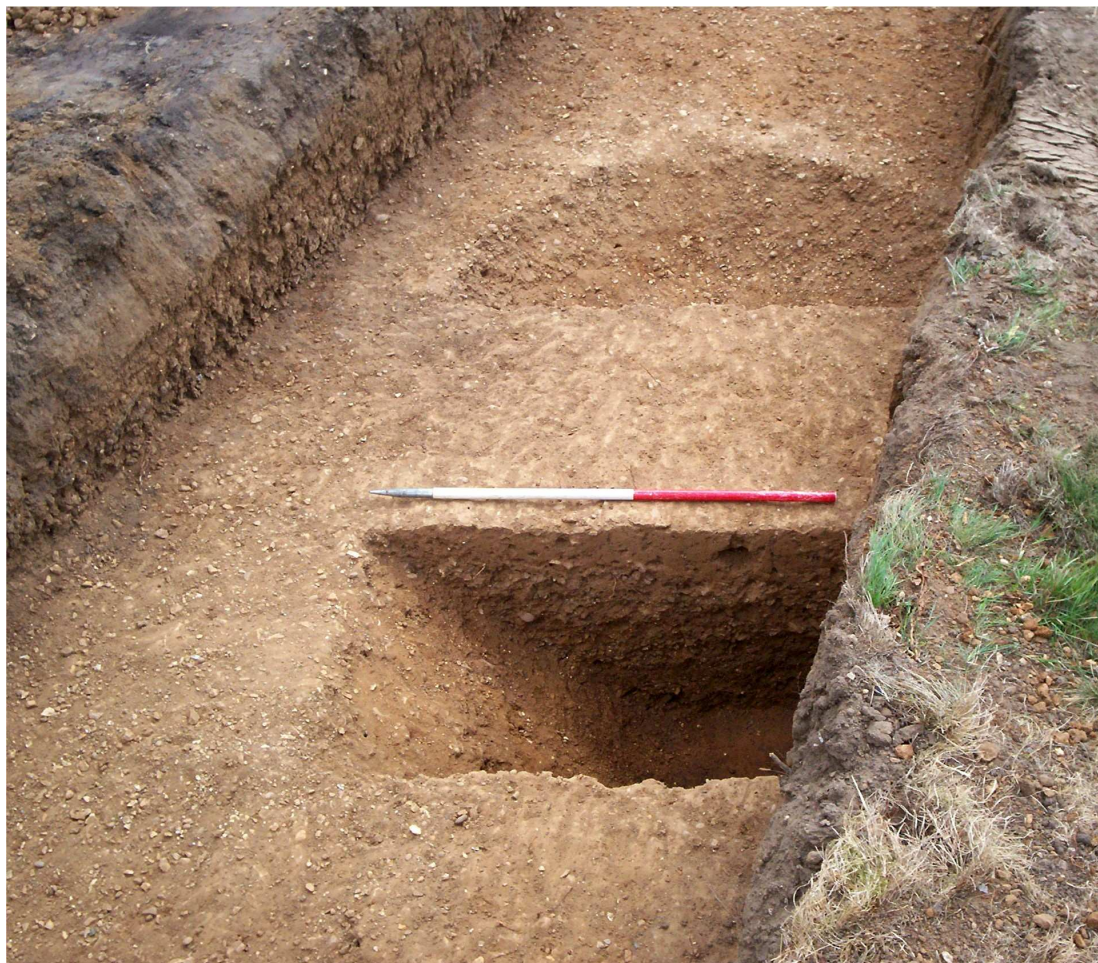
Image 5: The additional segment excavated through the ditch in Trench 2 revealed a deeper profile, filled with a similar sequence of deposits as the terminal segment. Scale 1 metre in 0.5m divisions.
