ST DOMINIC'S RC PRIMARY SCHOOL HARPENDEN HERTFORDSHIRE

ARCHAEOLOGICAL WORKS COMPRISING STRIP,
MAP AND RECORD INVESTIGATION AND
ARCHAEOLOGICAL MONITORING
AND RECORDING

Project: SD1842 Document: 2011/109

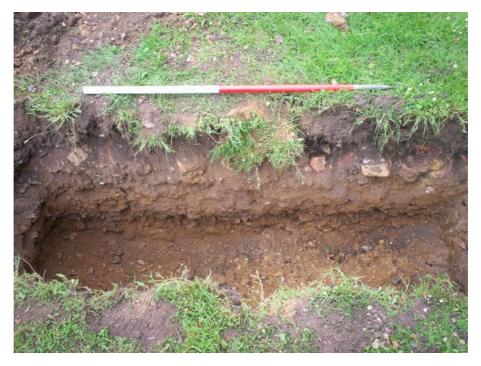
Figure 3: Photos showing typical deposits revealed during the groundworks

Topsoil of generally 0.18–0.28m thickness directly overlay natural geological deposits within the majority of the excavations. A thicker topsoil of up to 0.48m, formed through landscaping of the school grounds, was visible within the soakaway.

Within the northernmost footing trenches a layer of modern building rubble of c. 0.1m thick was sandwiched between the topsoil and underlying geology (Fig. 3).

Topsoil, modern rubble and natural geology visible within one of the footing trenches.

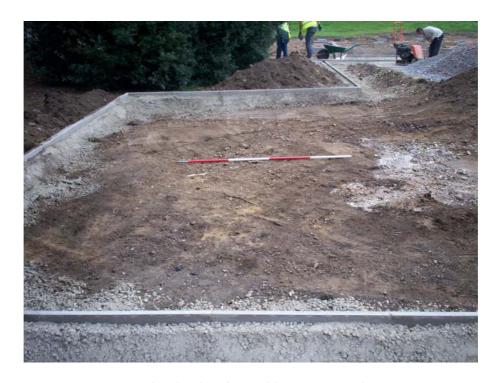
The groundworks only revealed deposits associated with landscaping of the school grounds and geological deposits. The underlying geology was mostly revealed within the deeper excavations associated with footings and services. The groundworks did not fully penetrate the overburden within the area of the car park specified for strip, map and record. The deposits revealed are summarised below.

Ground reduction for parking area. Scale 2m
