**THE BELL HOTEL, CHEQUER STREET  
ST ALBANS, HERTFORDSHIRE**

**ARCHAEOLOGICAL ASSESSMENT AND HISTORIC  
BUILDING IMPACT SURVEY**

Project: BH 1318

Document: 2007/127  
Version 1.1

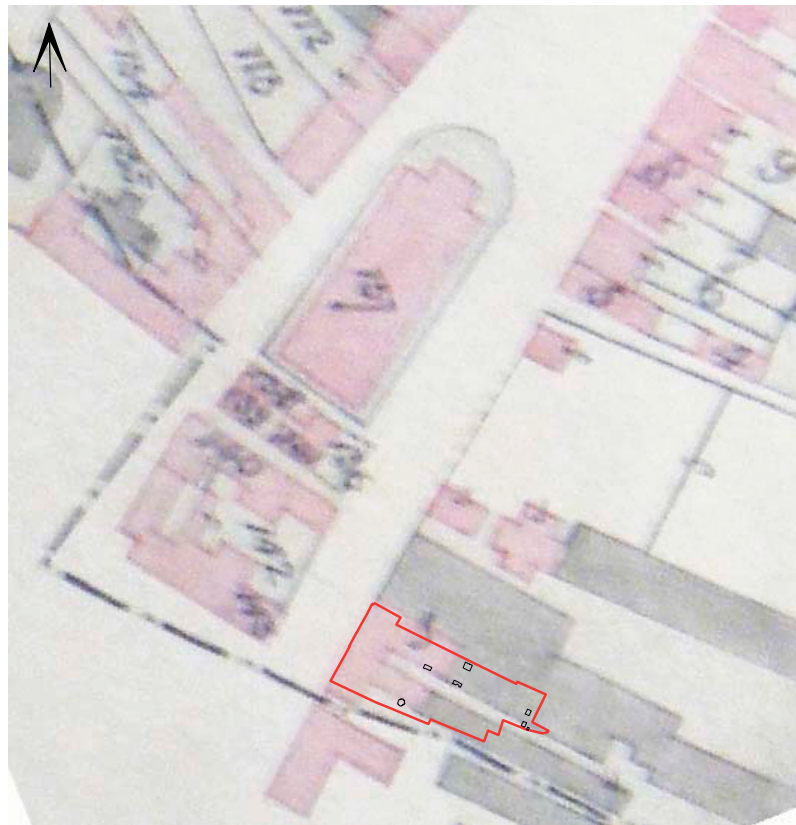
**Figure 2:** Building plan area overlain onto 1840 tithe map.  
Scale and position approximate

The location of the Bell Hotel is on the boundary of St Albans and St Peter's parishes. The Hotel and associated land are listed as number 1 in the tithe apportionment. This colour-toned map shows the more established structural elements of the Hotel in pink forming a trilithon shape heading back from Chequer Street. It also shows the building integrated with what are thought to be more temporary structures that are shown in black. The temporary buildings reach away from Chequer Street for a considerable distance and are considered to be stables and yard buildings.

The apportionment of the tithe lists number 1, Brewery Cottages, Bell Inn, Gardens and Pightle as belonging to Thomas Kinder and occupied by him and others.

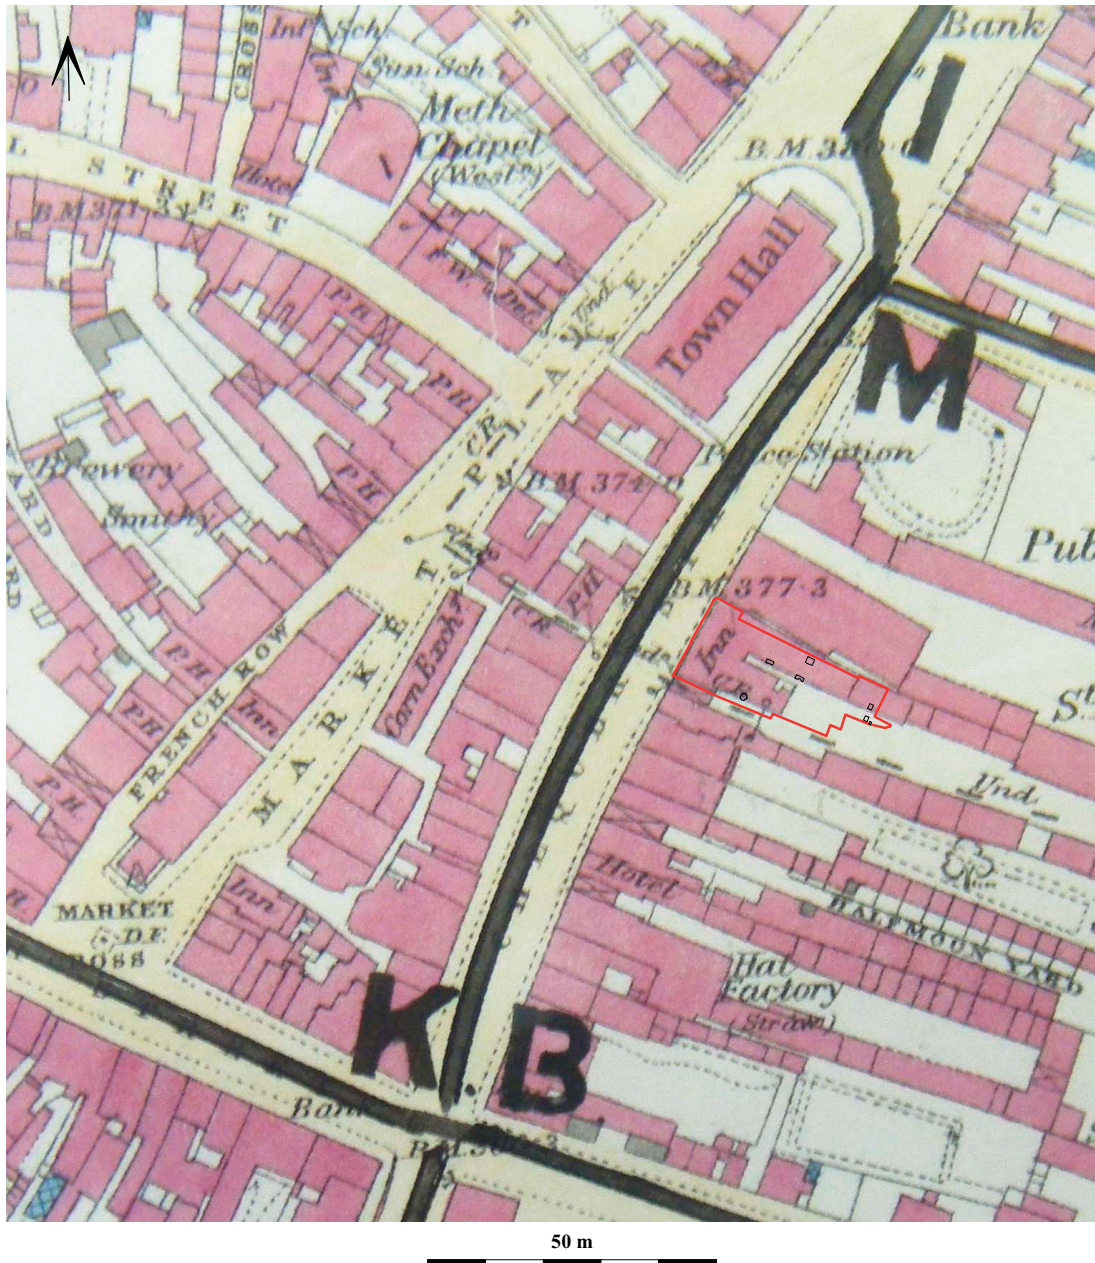
Figure 4: Building plan overlain onto 1880 1<sup>st</sup> ed OS map.

Chequer Street, known as Hollywell Hill until 1794, is now clearly marked and encompasses the area adjacent to the market place between St Peters Street and Holywell Hill. The Bell Hotel is marked 'Inn' and a thin range of buildings now extend eastward away from Chequer Street along the edge of an equally narrow yard. The general building shape has not changed although there is no longer a visible discrimination between additional and original parts of the building. The yard area extends to a line level with the edge of Westbourne Terrace

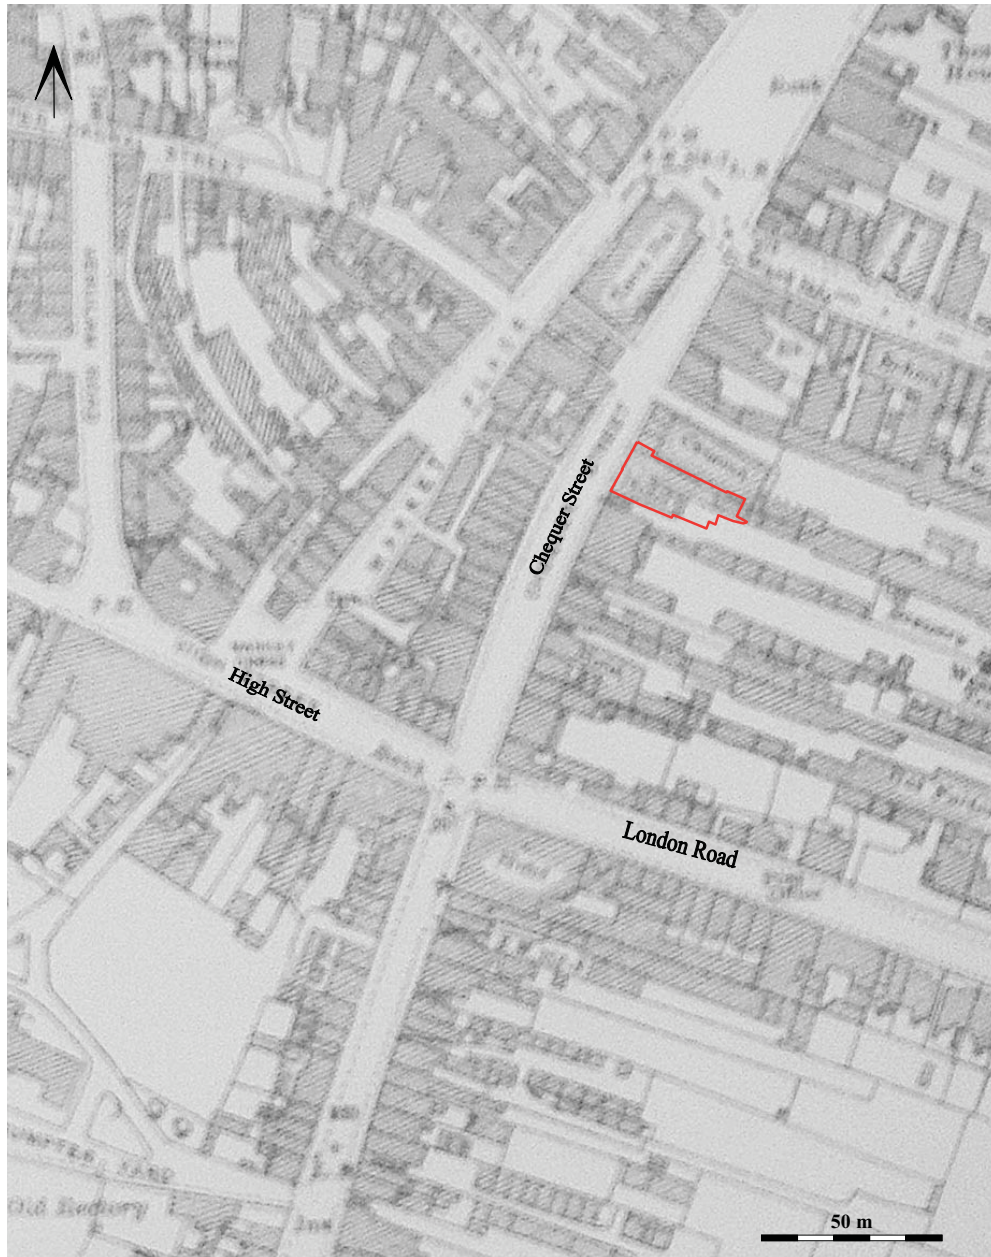
**Figure 5:** Building plan overlain onto 1924 3<sup>rd</sup> ed. OS map

The premises show little change from the previous map. More familiar names and landmarks are beginning to appear within the area. The building to the north is now labelled 'Cinema',

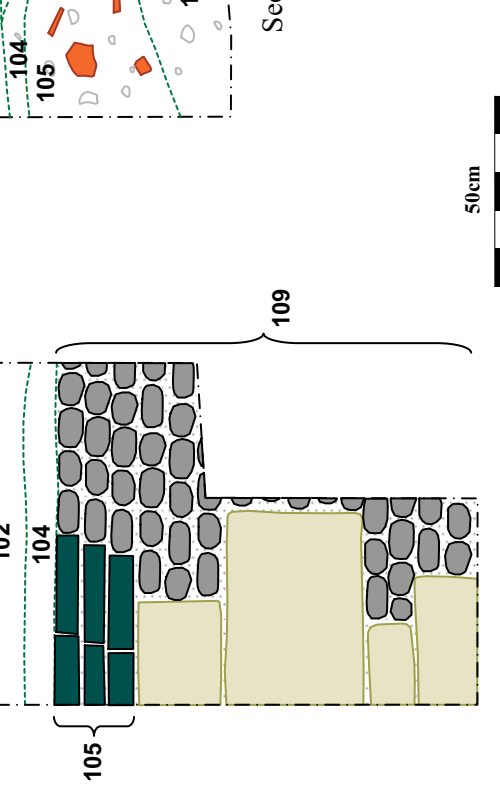
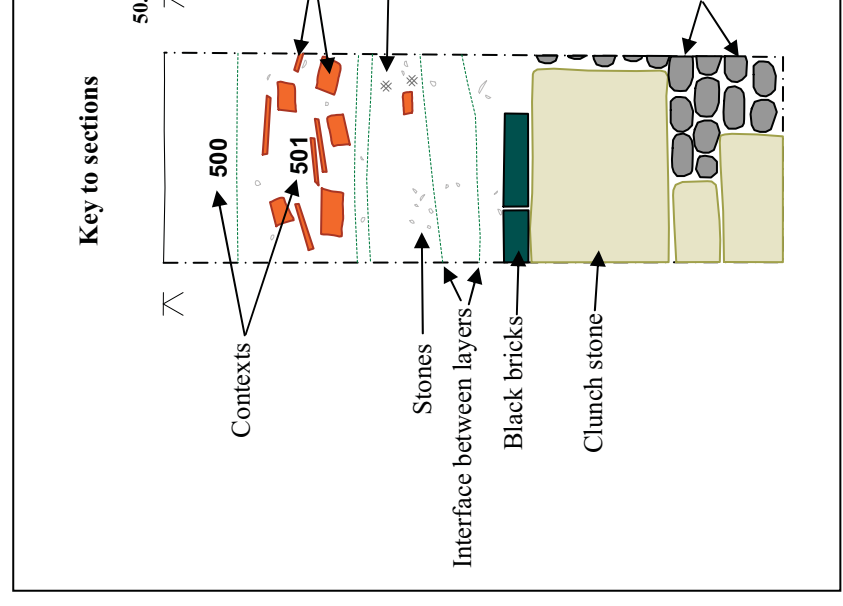
Figure 7: Te

Section 1

Located on the western side of Pit 1, and visible from a depth of 0.4m below current ground surface, were two phases of wall (108) and (109). Wall (108) appeared to be a patch of later repair to wall (109) and comprised dark grey/black bricks visible for three courses and covering an area measuring 0.45m x 0.2m. (Fig. 8). The build up of more recent deposits around the wall suggest that it was within the fabric of the brick-built extension that was present on the site as late as the early 1980s.

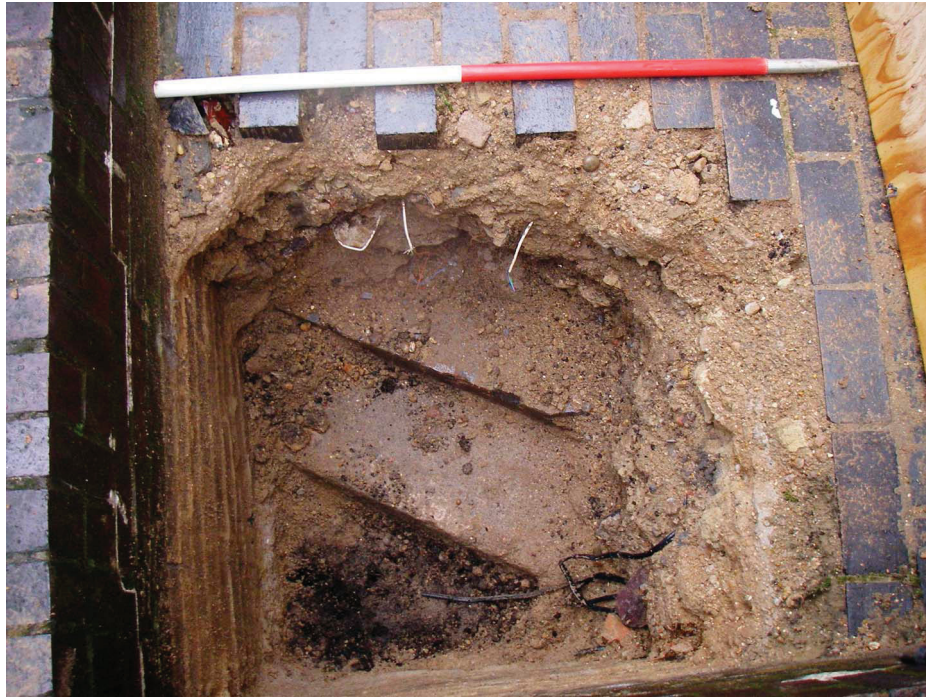
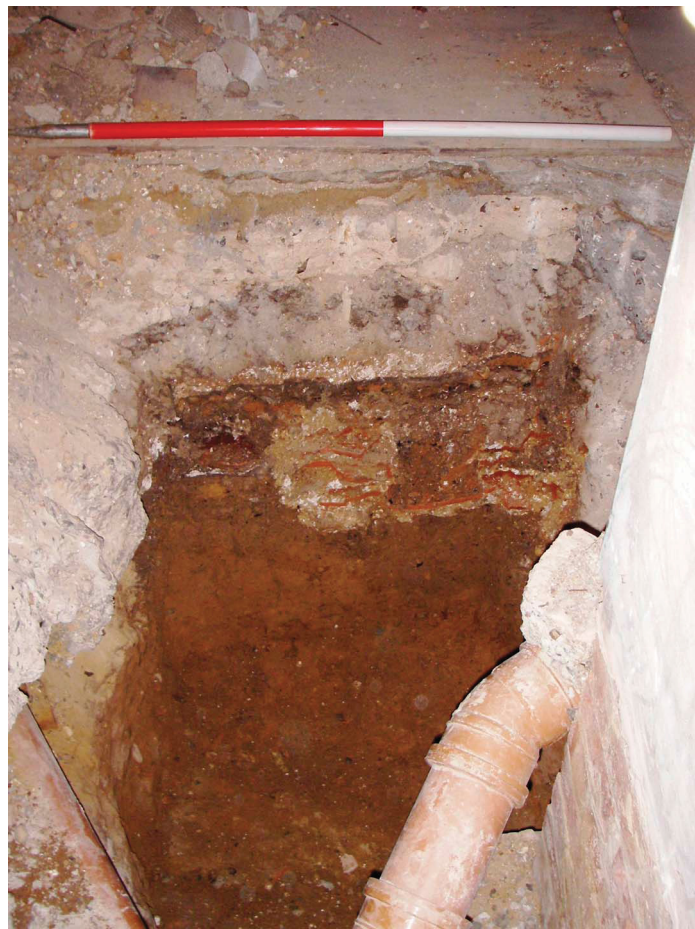
**Figure 9:** Pits 2 and 3; Photographs. (Scale 1m)

Pit 2

Pit 3

Test Pits 3, 4, 5 and 6 were located around pillars and foundations within the existing conservatory extension. No artefactual evidence dating earlier than the modern period was found.

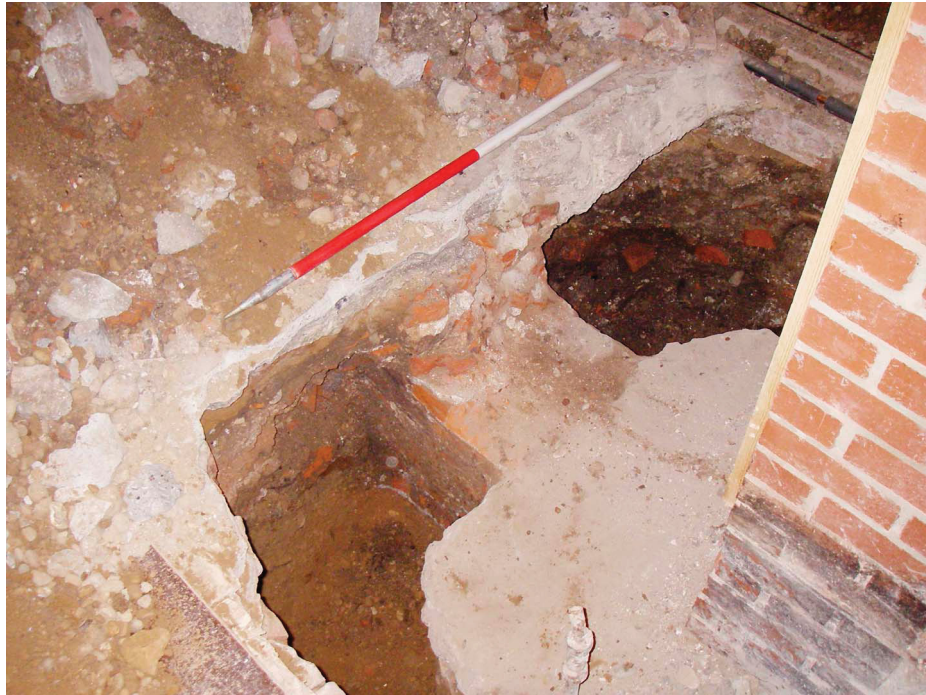
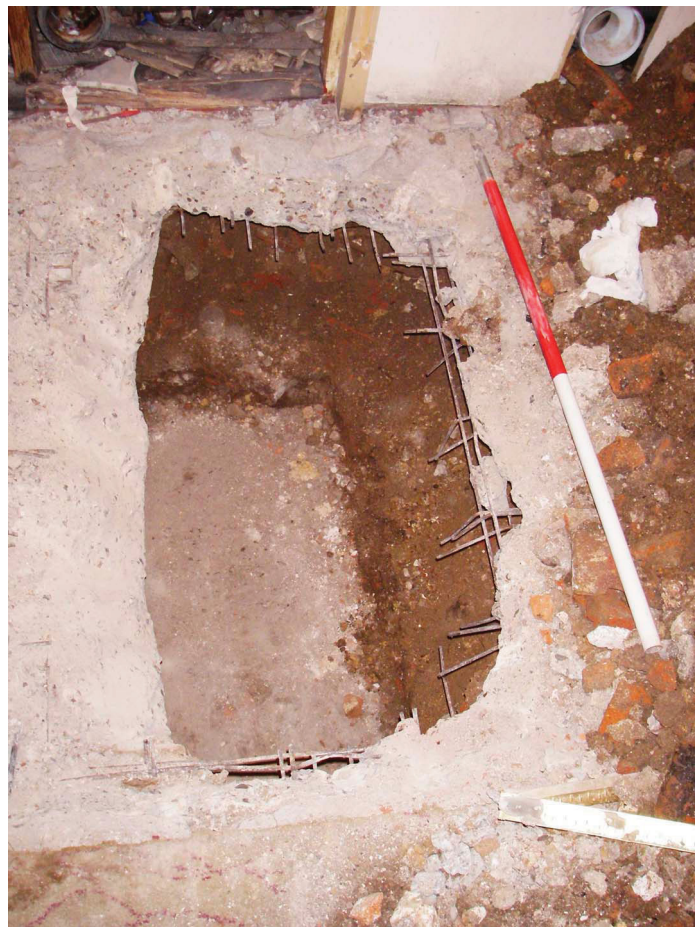
**Figure 10:** Pits 4 and 6; Photographs. (Scale 1m)

Pit 4

Pit 6

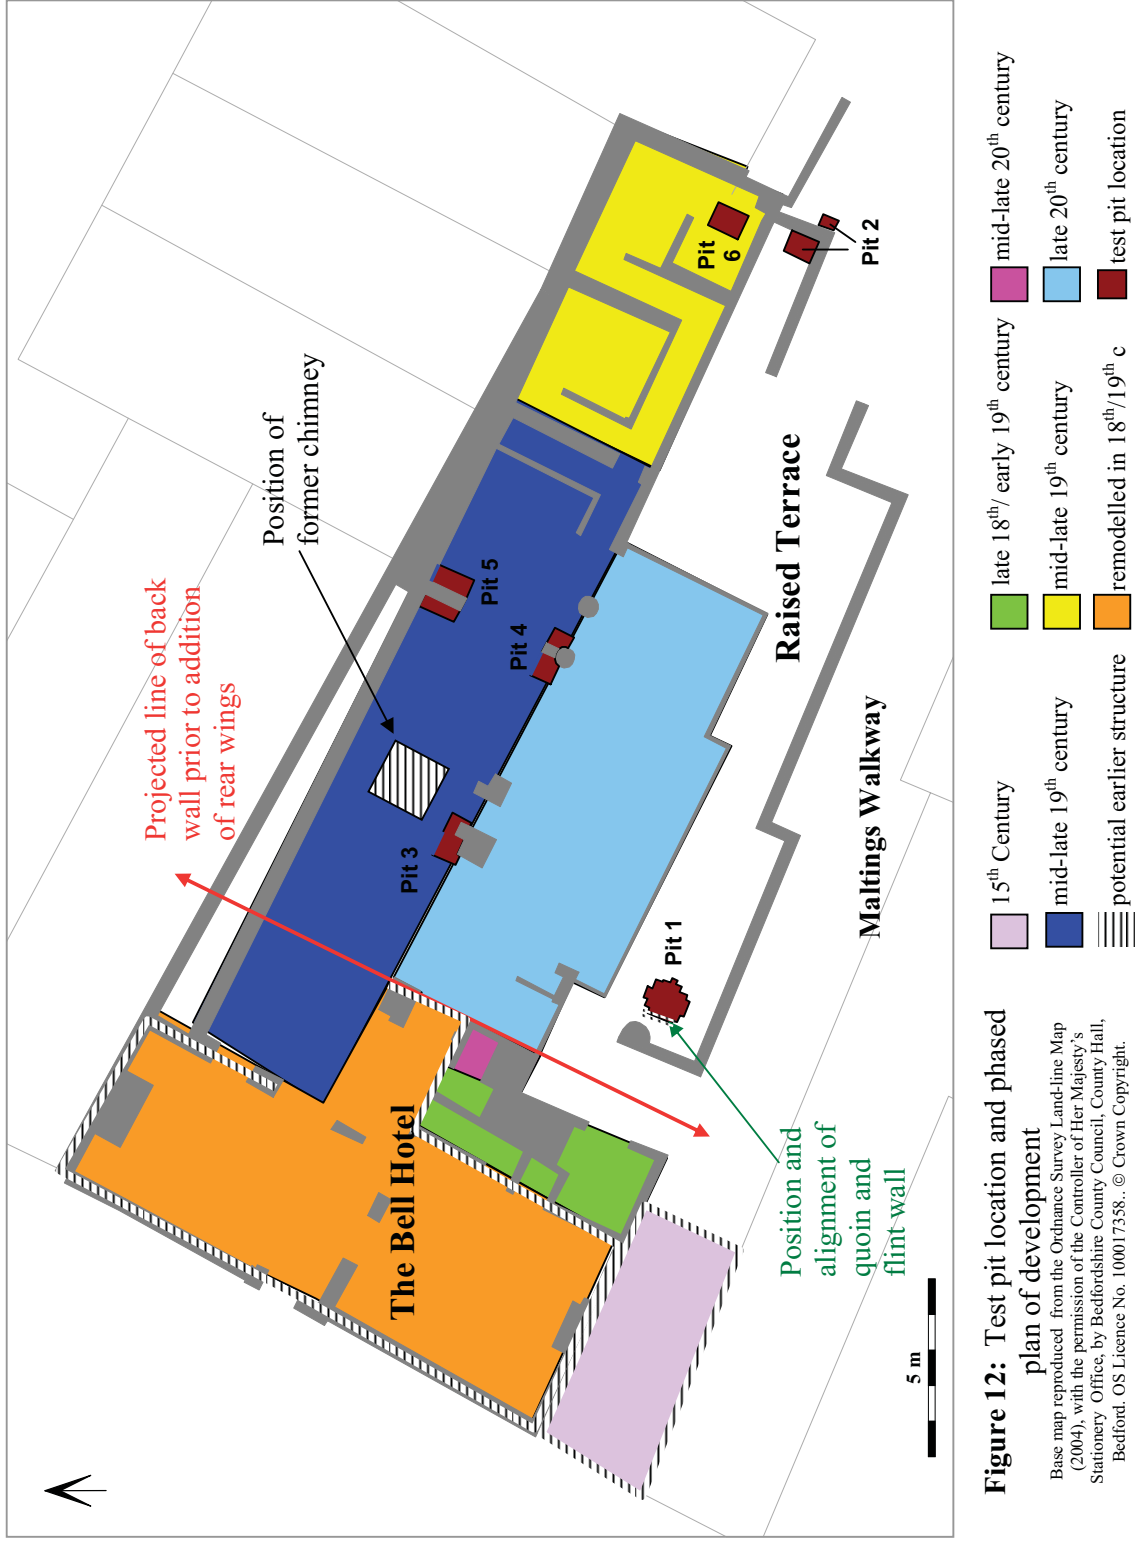
**Figure 12: Test pit location and phased plan of development**

The north wing was an addition to The Bell Hotel in the mid-late nineteenth century (possibly c. 1865). It replaced an earlier structure which probably dated to the 18th century (only the chimney breast remains from this phase – see Fig. 12). The north wing was built in two parts comprising a two-storey and a single-storey building. It was re-modelled throughout the 20th century and when the conservatory was added almost the entire ground floor external south elevation of the two-storey part of the north wing was removed. The attached single-storey building has also undergone some changes to its fabric.
