**THE ROYAL OAK
33 HIGH STREET
ROXTON
BEDFORDSHIRE**

**ARCHAEOLOGICAL OBSERVATION, INVESTIGATION
RECORDING, ANALYSIS AND PUBLICATION**

Project: RO1956
Museum accession no. BEDFM: 2012.25
OASIS ref: albionar1-122196

Document: 2012/61
Version 1.0

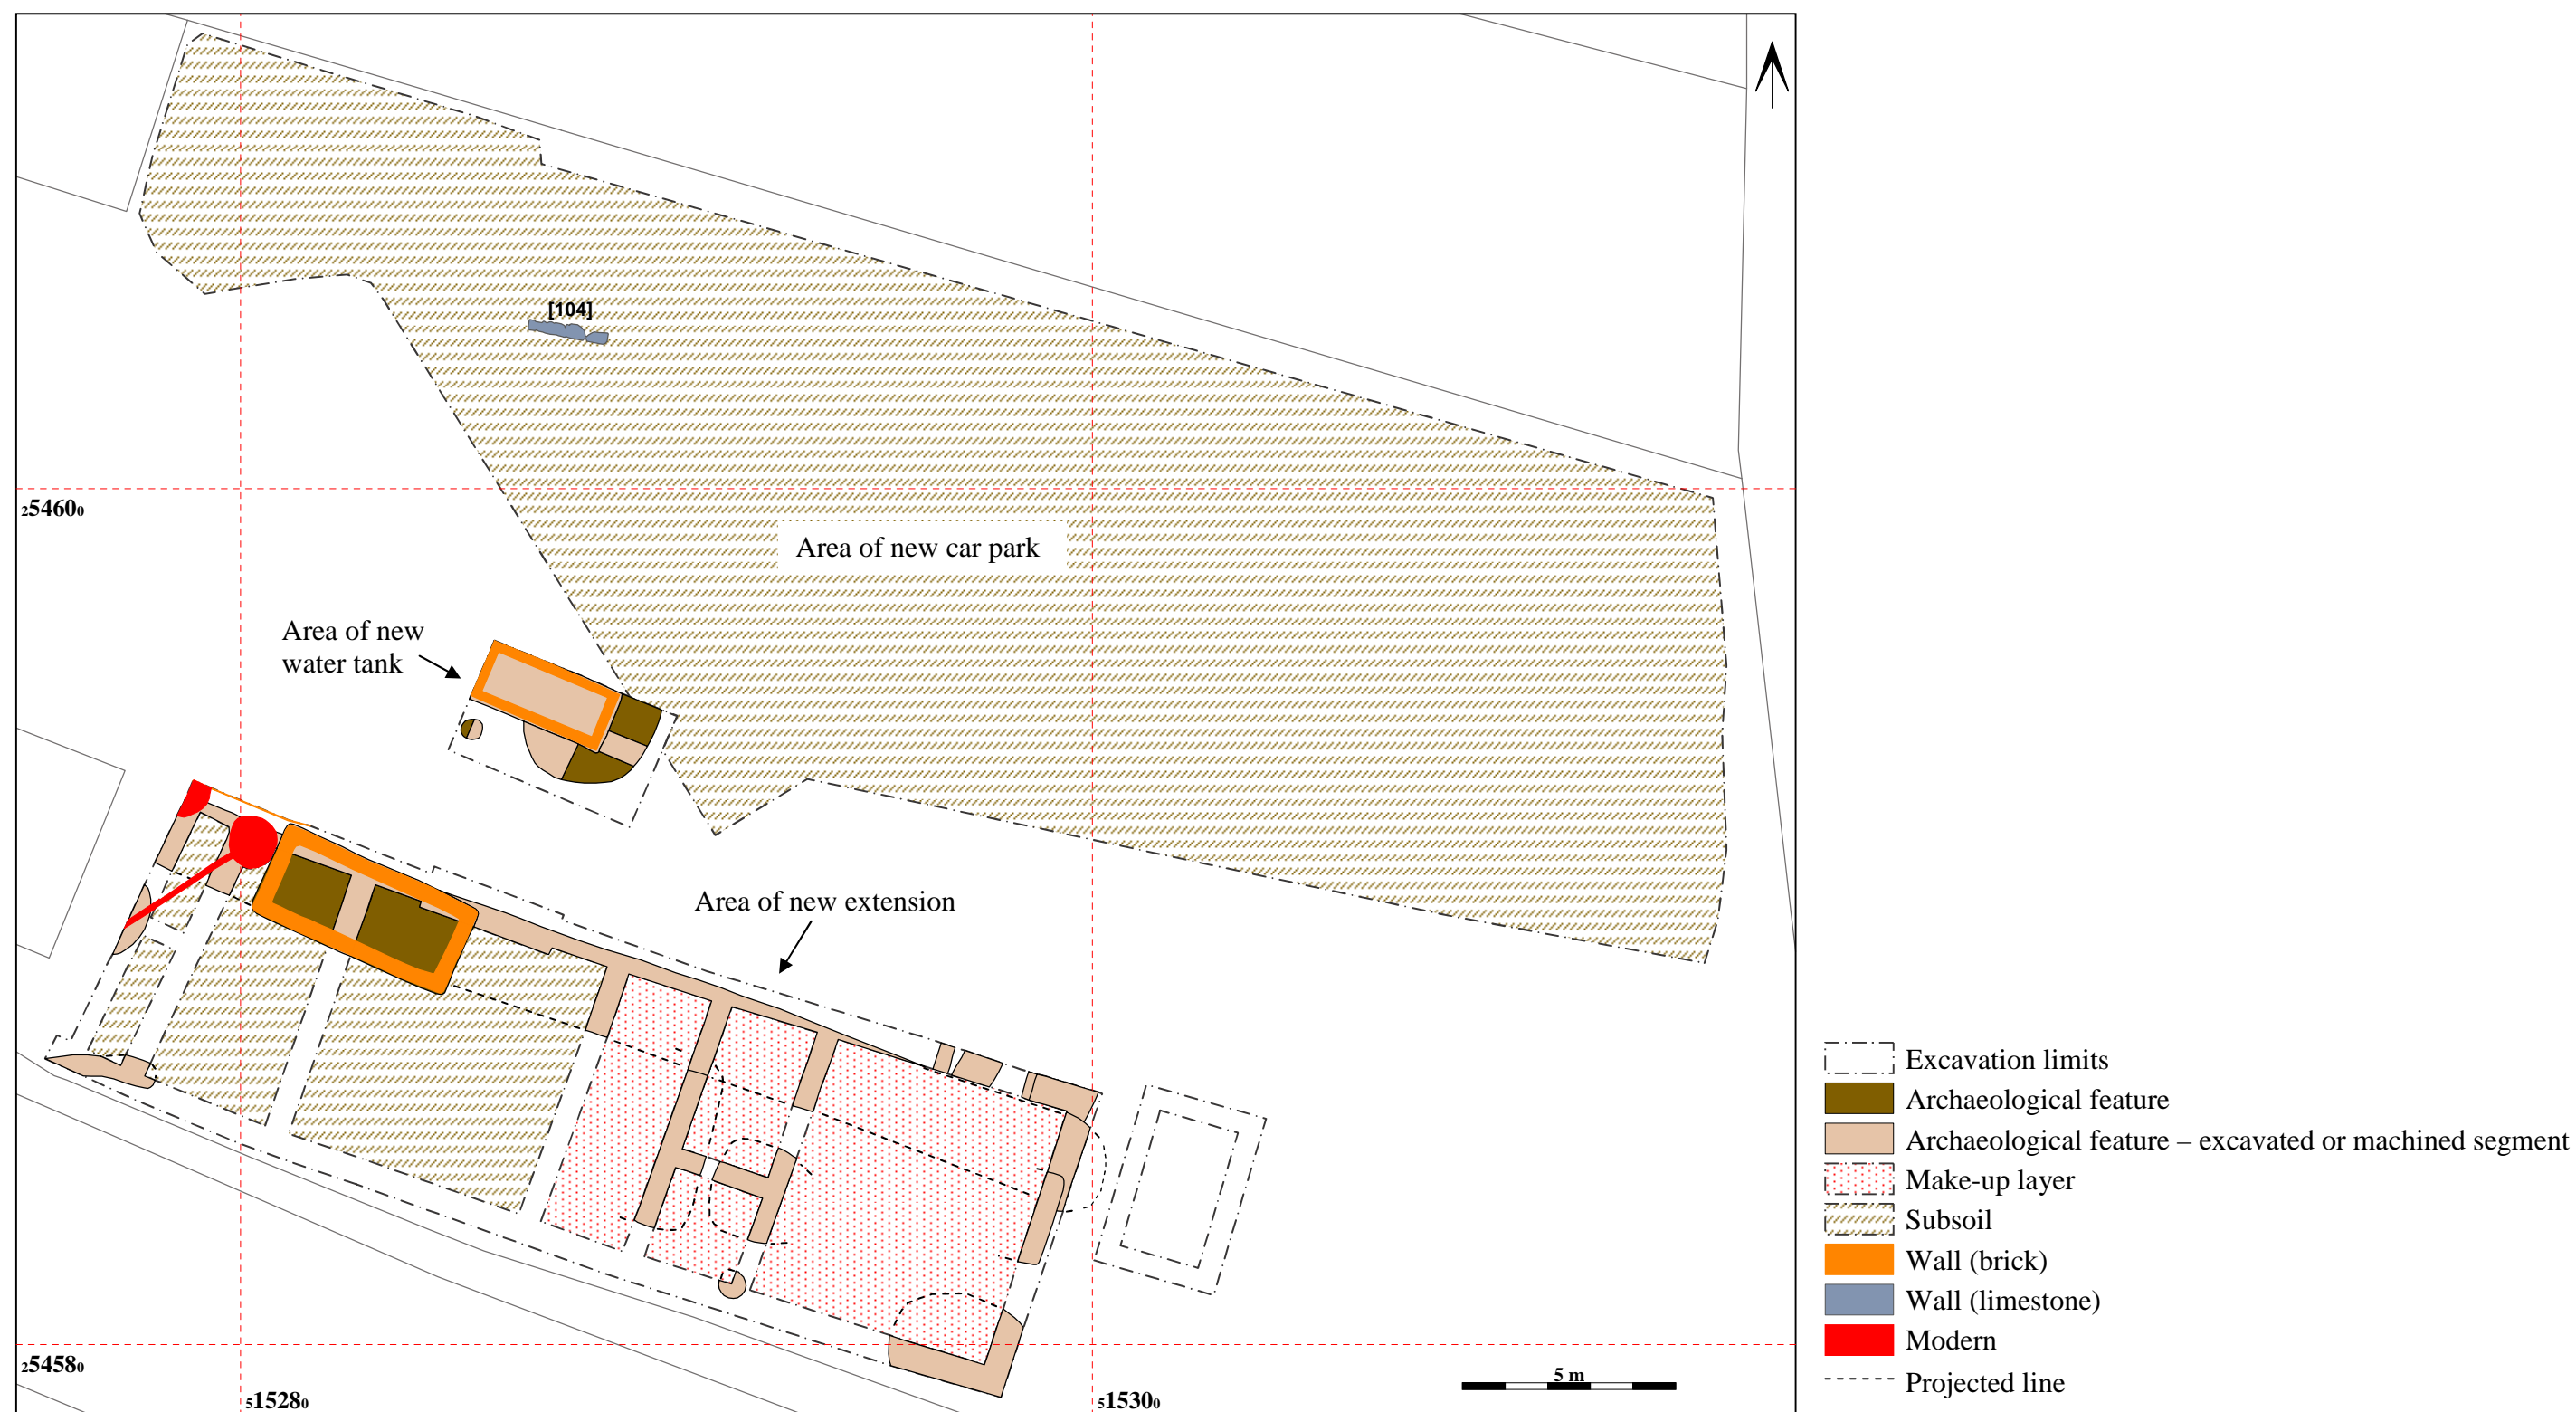
Figure 2: Location of all features

In the area of the new car park a 1.8m-long wall of roughly hewn sandstone blocks, bonded with mortar, was discovered (Figure 2). It was E–W aligned, 0.34m wide with only one course of stones surviving. An imprint of a brick on the upper-most mortared surface indicates that the structure is likely to have been a foundation for a brick wall; a number of outbuildings and walled areas are shown within this general area to the rear of the previous Royal Oak building on the 1884 OS map.

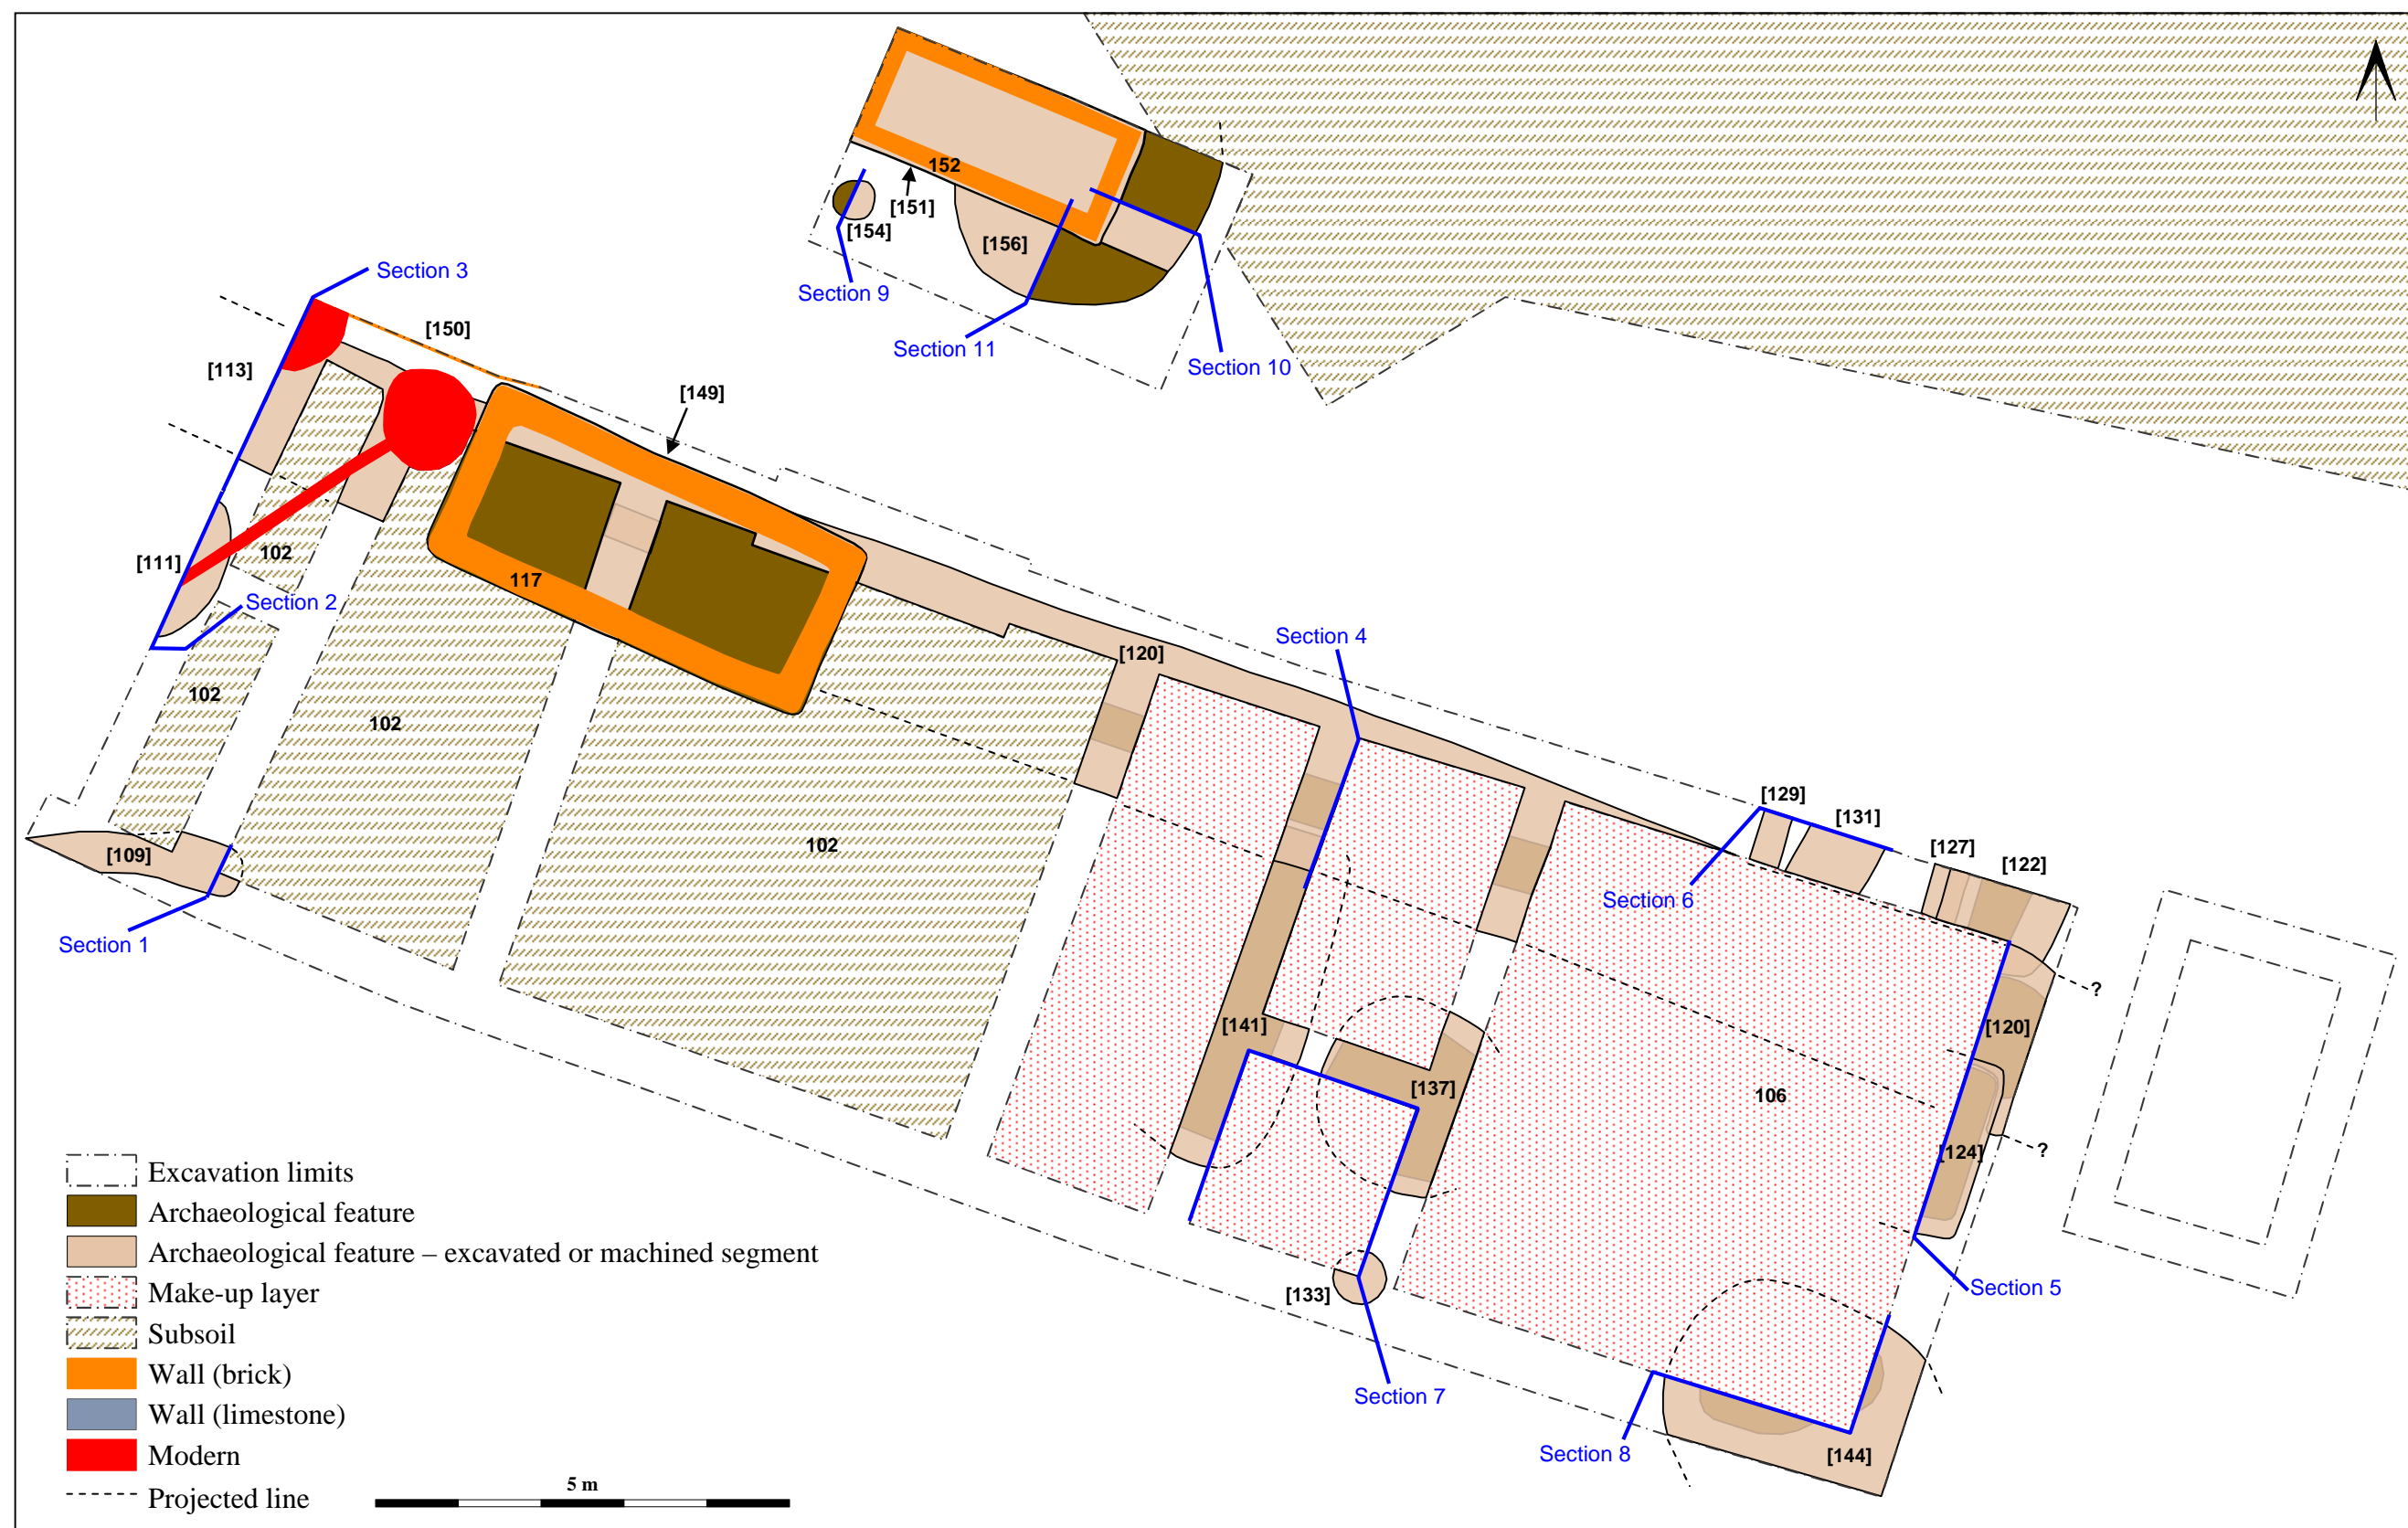
Figure 3: Detail of features revealed within the excavations for the new extension and water tank

further large pit [144] (with similar fills to pit [137]) was located nearby, although it contained no artefacts (Figures 3 and 4).

Several ditches were revealed beneath the subsoil in the area of the new extension (Figures 3 and 4). The largest, ditch [113/120] (see also Figure 6), was distinctly V-shaped in profile and parallel with the ESE–WNW aligned School Lane to the south. It was 1.7m wide, 0.93m deep and at least 22.5m in length. Its three fills contained few artefacts, including small fragments of coal and clinker suggesting that the ditch is likely to date to no earlier than the post-medieval period. Two substantial perpendicular ditches [122] and [141] appeared to join the ENE–WSW aligned boundary [113/120]; a large post-medieval brick fragment was recovered from the upper-most fill of ditch [141].

The remnants of two brick structures were revealed during the excavation of foundation trenches for the extension to the existing building (Figures 3 and 6). Only the south face of an ESE–WNW aligned brick wall (150) was partially visible within the edge of one of the foundation trenches; its location indicates that it is likely to be the remains of the northern exterior wall to the earlier Royal Oak building that was previously located in this vicinity. The brick walls (117) of a probable cellar (149) were located immediately to the south of wall (150); the rectangular cellar measured 4.9m x 2m across and survived to a depth of *c.* 0.95m. The backfill (118) within the cellar contained CBM, building rubble and other modern material (not retained) which included a 19th-century glass bottle embossed with the Jarvis Brewery label.

The brick walls of a probable water tank were revealed during excavation for a new water tank to the north of the new building extension (Figures 3, 5 and 6); it measured 3.5m x 1.5m and 1.35m in depth. The brick walls (152) were bonded with dark yellow mortar and set on a 0.1m-thick concrete raft (161). The inside faces of the walls were covered by greyish-white plaster; some of the pipes leading into the tank were still in place. The feature had been backfilled with deposits of mid brown-grey sandy silt, which contained a number of modern finds (not retained), prior to this area being covered with concrete hardstanding.

Two further pits cutting the subsoil were revealed during the excavation of the foundation trenches for the new extension (Figures 3 and 4). Sub-circular pit [111] was at least 1.75m in diameter and 0.65m deep with a fill of light yellow-brown sand that contained no artefacts. Pit [124] was more rectangular in plan, measuring 2.2m long, at least 0.4m wide and 0.52m deep; a fragment of clay pipe within its main fill (126) of mid brown-grey clay silt indicates that it dates to no earlier than the post-medieval period.

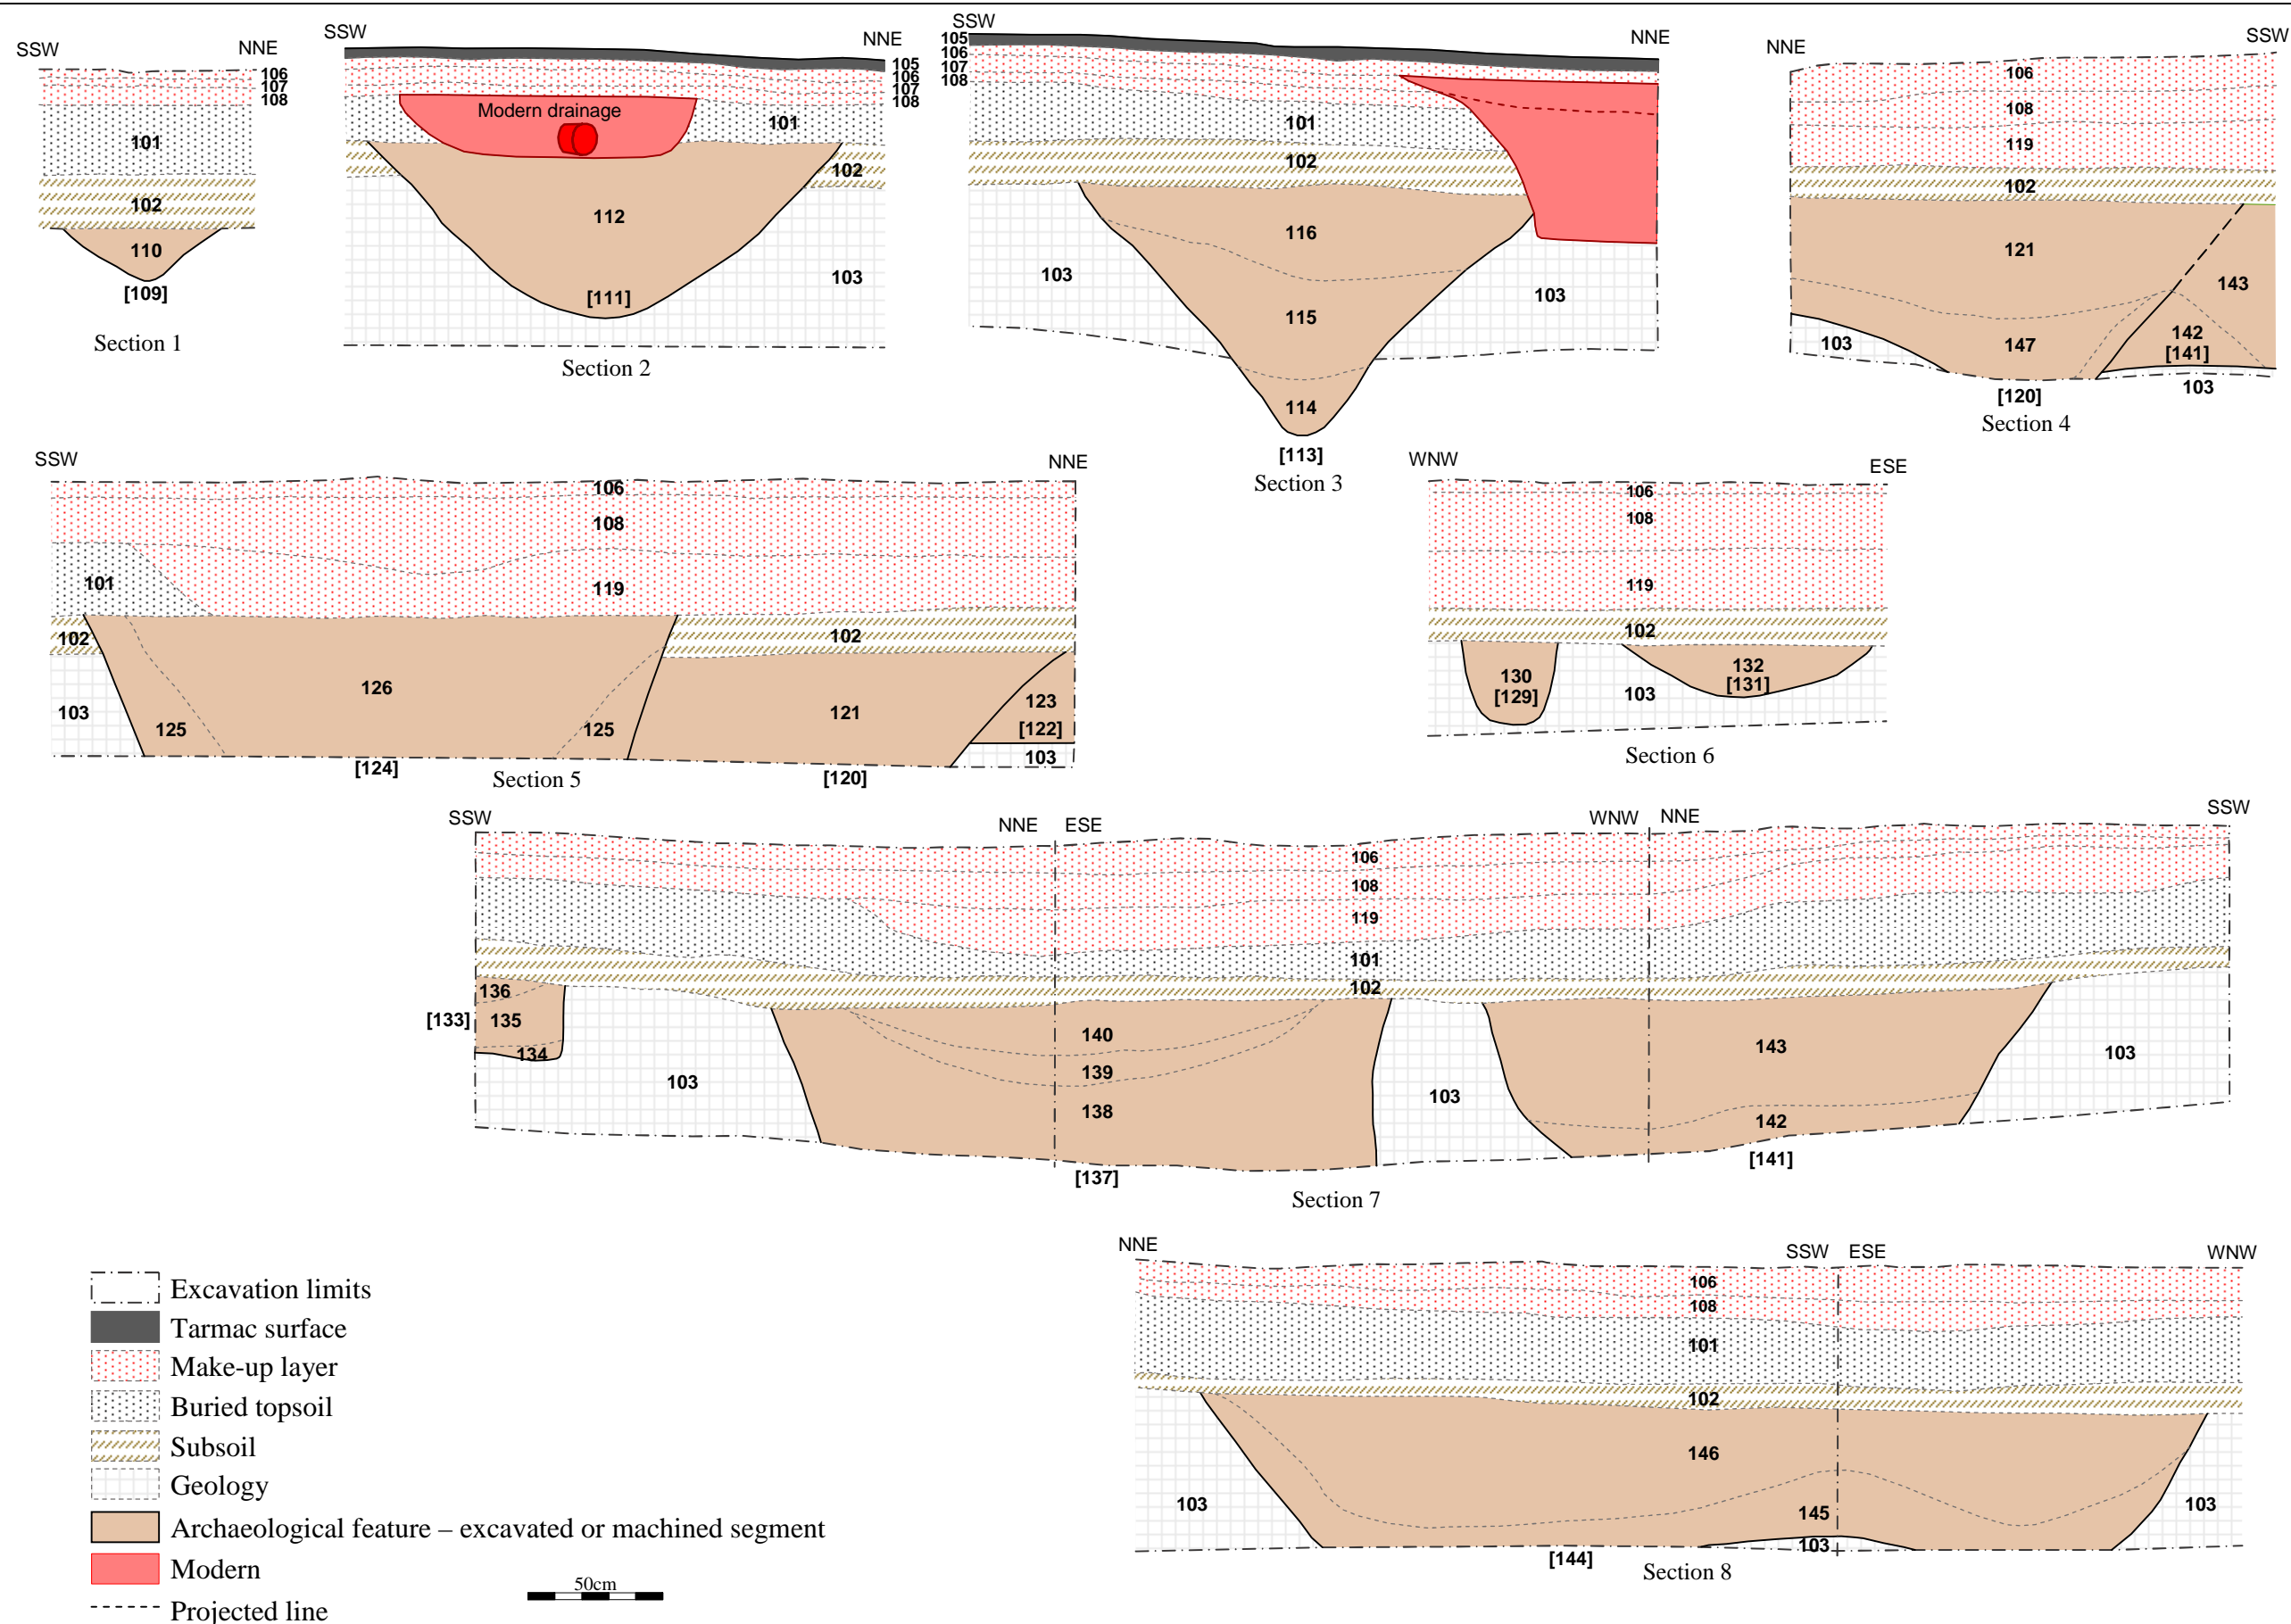
Figure 4: Selected sections of archaeological features excavated within the area of the new extension

The only feature containing evidence to suggest that it might be earlier in date was a large oval-shaped pit [137] identified towards the eastern end of the area of the new extension (Figures 3 and 4). One of its three fills contained a small sherd of 13th–14th-century pottery, though its abraded nature and proximity of the pit to other features containing similar fills dating to the post-medieval period suggest that it cannot be used to date the pit with any certainty. A

Three smaller ditches [127], [129] and [131] were also located in the vicinity of ditch [122] and approximately perpendicular to the large boundary [113/120]; ditch [127] may have been a precursor to ditch [122], being largely truncated by the later ditch. A small, slightly curving ditch [109] was visible within the foundation trenches at the other end of the new building footprint. All four smaller ditches had similar fills, largely comprised of grey-brown sandy silt that contained no artefacts.

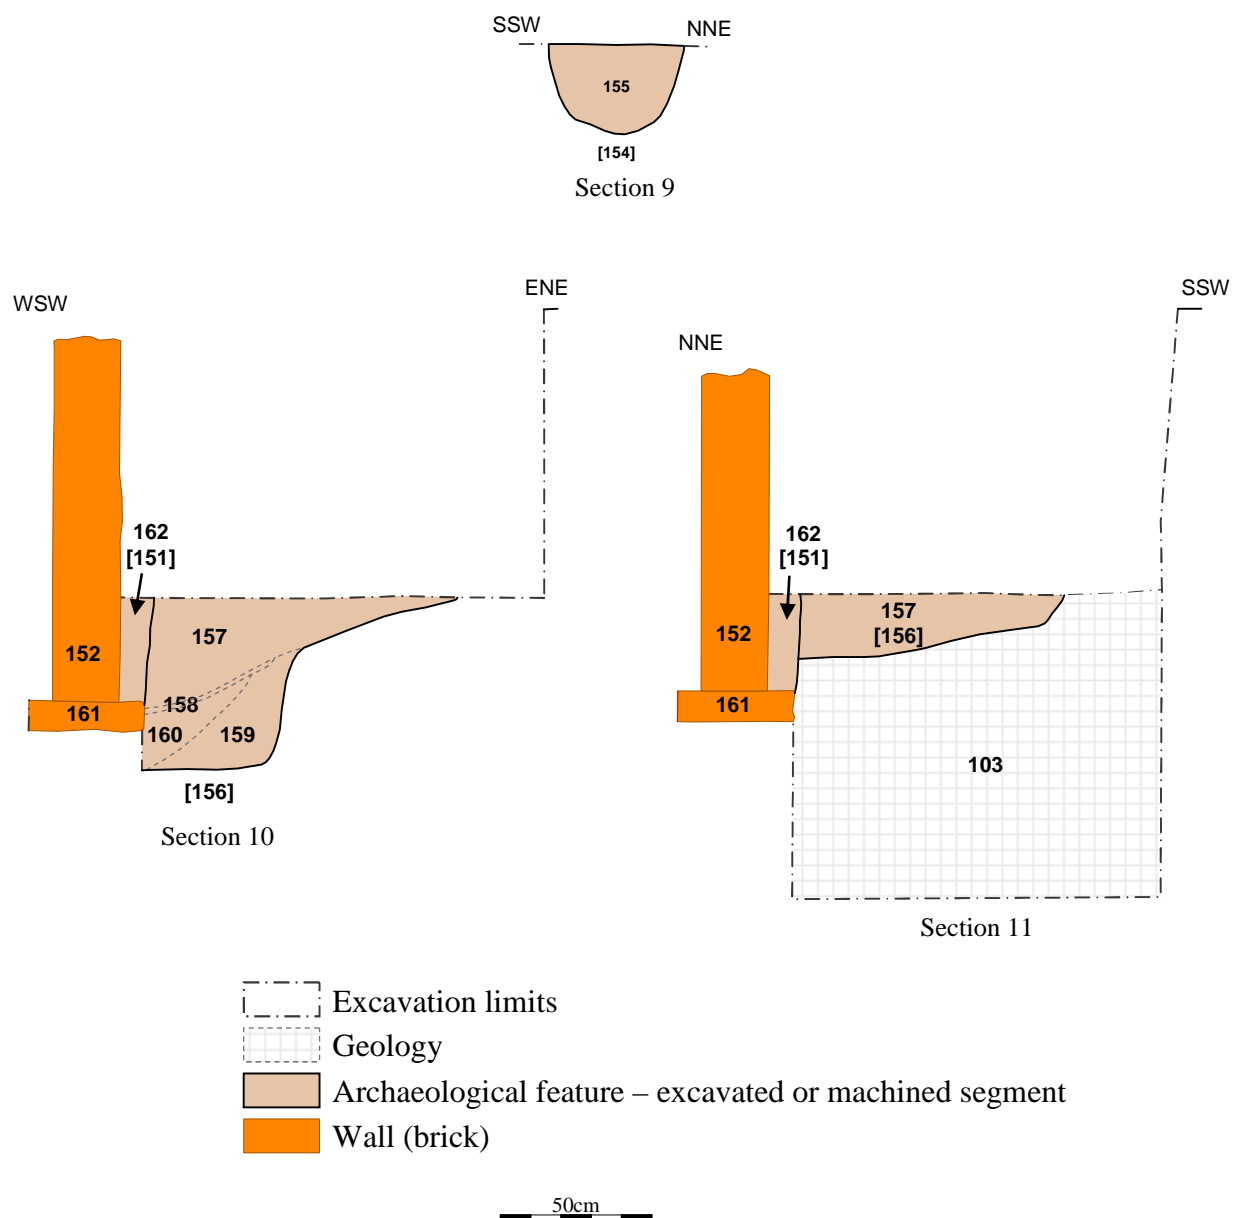
Figure 5: Selected sections of archaeological features excavated within the area of the new water tank

The only other features sealed by the subsoil were two circular postholes. Posthole [154] was revealed in the location of the new water tank (Figures 3 and 5); its single fill of mid brown-grey clayey silt contained a very small sherd of post-medieval pottery and a fragment of clay pipe. The second posthole was located in the vicinity of the large pits [137] and [144]; it contained three fills consisting of yellow-grey and grey-orange silty sands and sandy silts.

The water tank had truncated a large pit [156], which may also once have been used for storage; the lowest (159) and (160) of its four fills appeared to have been formed in waterlogged conditions, with deposit (160) consisting of dark grey to black silty clay. These deposits were overlain by a thin layer of decayed wood (158), which may represent a collapsed lining of the upper parts of the feature. This layer in turn was sealed by deposits of mid orange-brown silty sand and gravel (157), deriving from the collapsed sides; modern pottery, roof tile and vessel glass were recovered from the uppermost deposit.

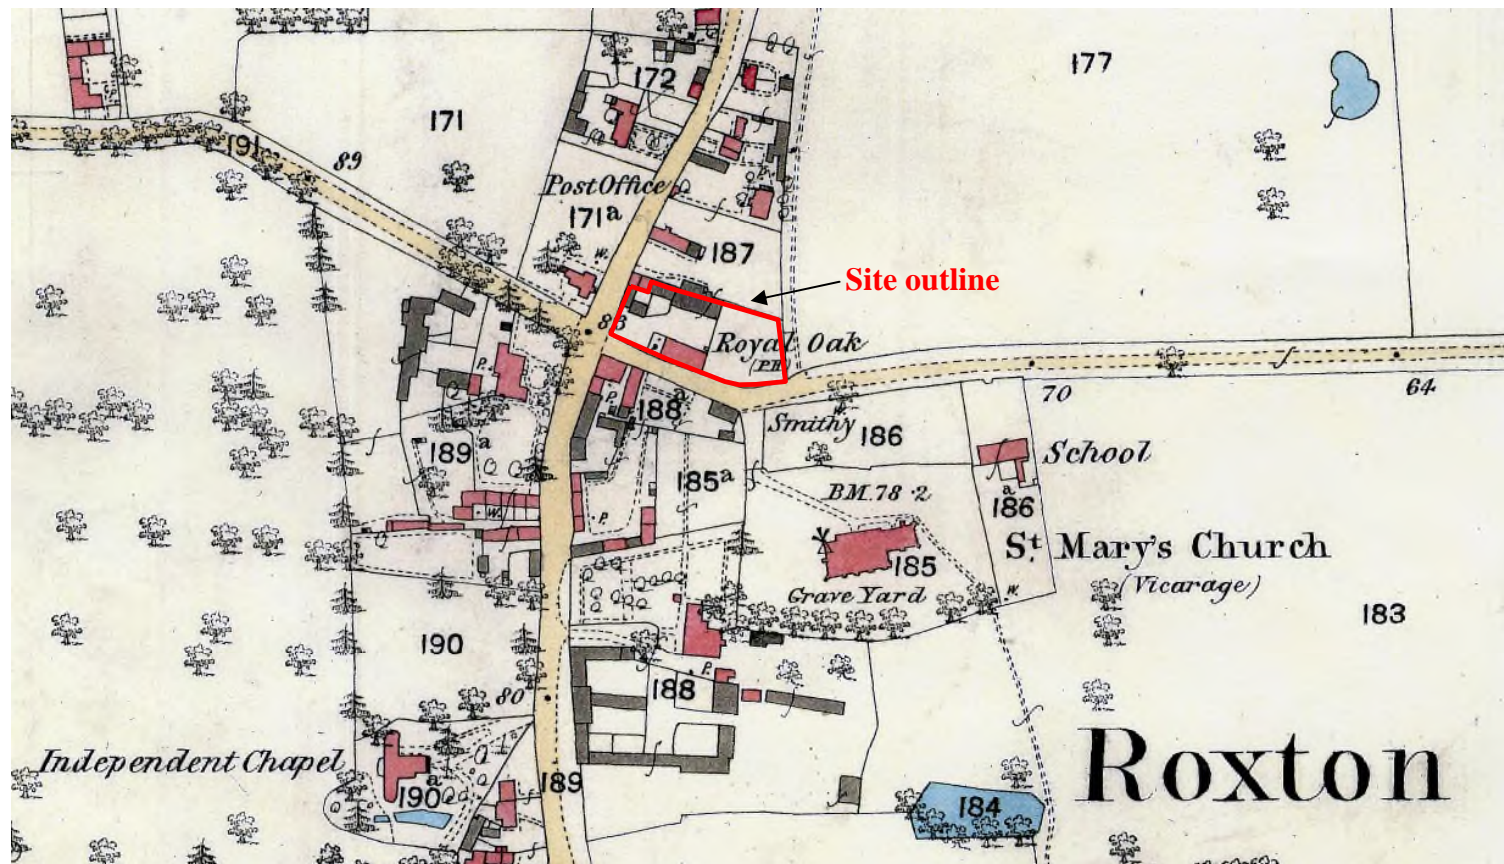
Extract of the 1884 1st edition OS map

The existing Royal Oak PH was constructed during the early 20th century and is shown on the 3rd edition OS map of 1926; it replaced a previous Royal Oak building marked on the earlier OS maps a little to the south-east of the existing building (Figure 6). This earlier building also appears to be shown on the

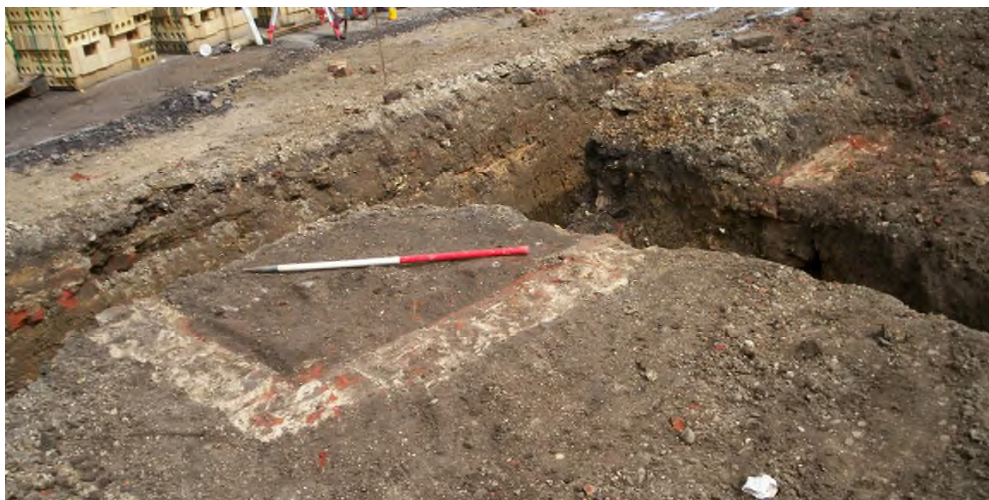
View of brick structure [149]
(facing NE)

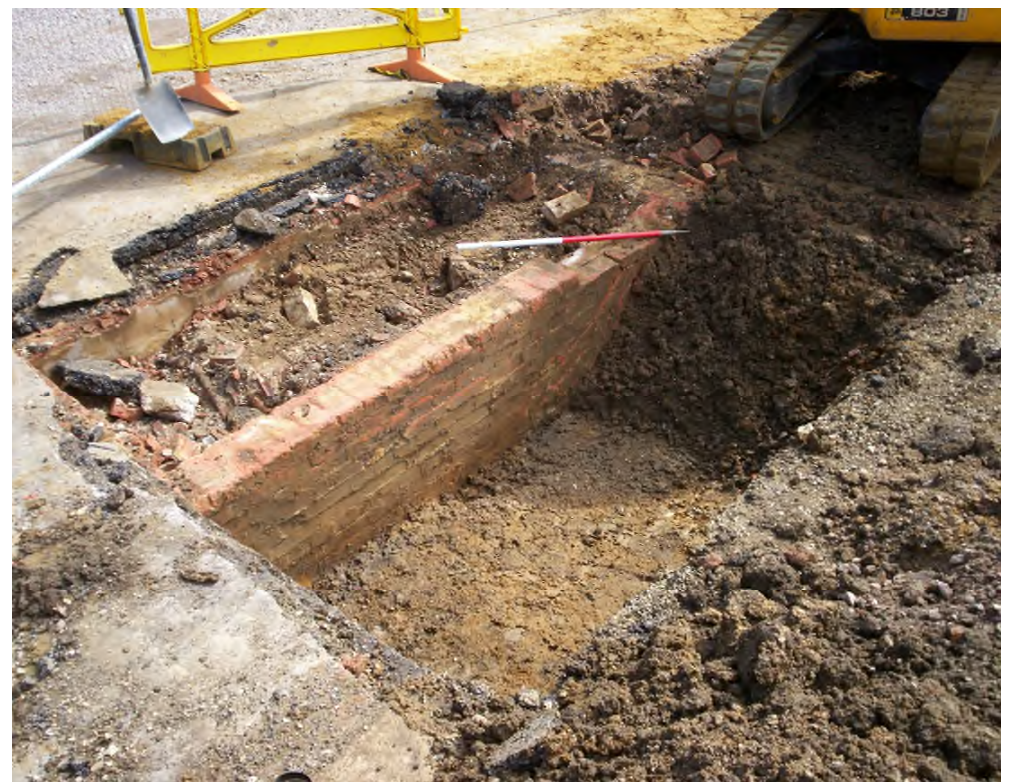
View of brick structure [151] and partially exposed pit [156]
(facing NE)

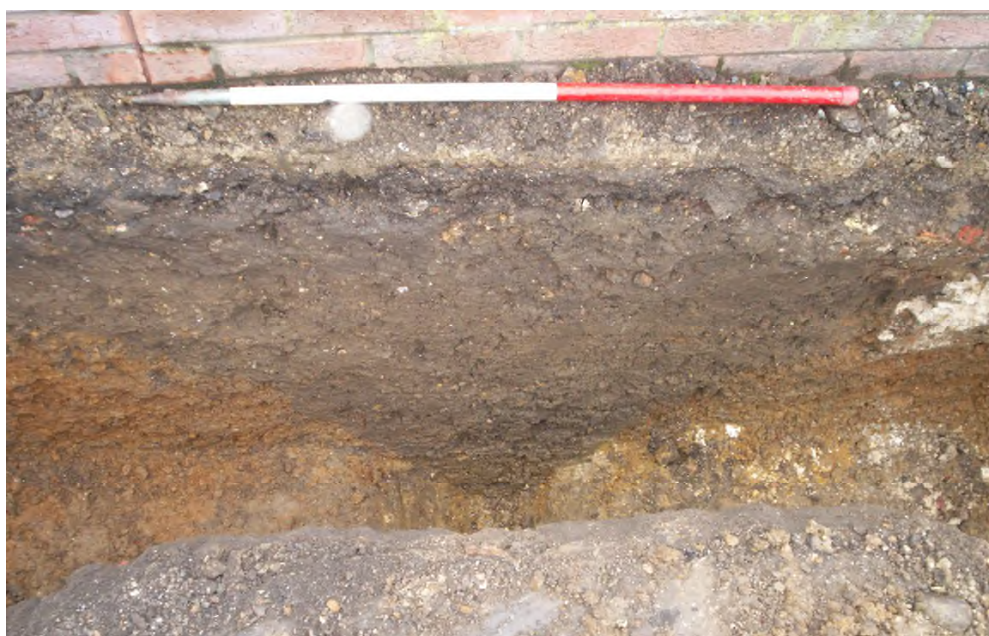
View of ditch [113/120]
(facing NW)

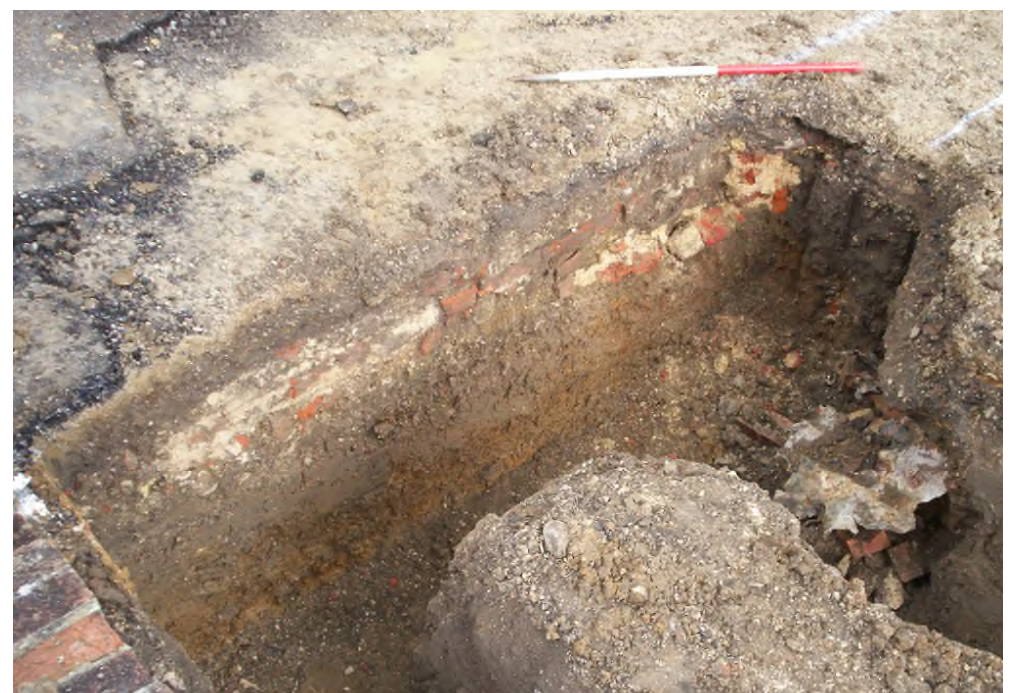
View of brick wall [150]
(facing NE)
