**4 MOOR END LANE,
EATON BRAY, DUNSTABLE,
BEDFORDSHIRE**

**ARCHAEOLOGICAL OBSERVATION,
INVESTIGATION, RECORDING, ANALYSIS
AND PUBLICATION**

Project: MEL1926
Luton Museum Accession no. 2012.15
Document: 2012/142
Version 1.1

28th March 2013

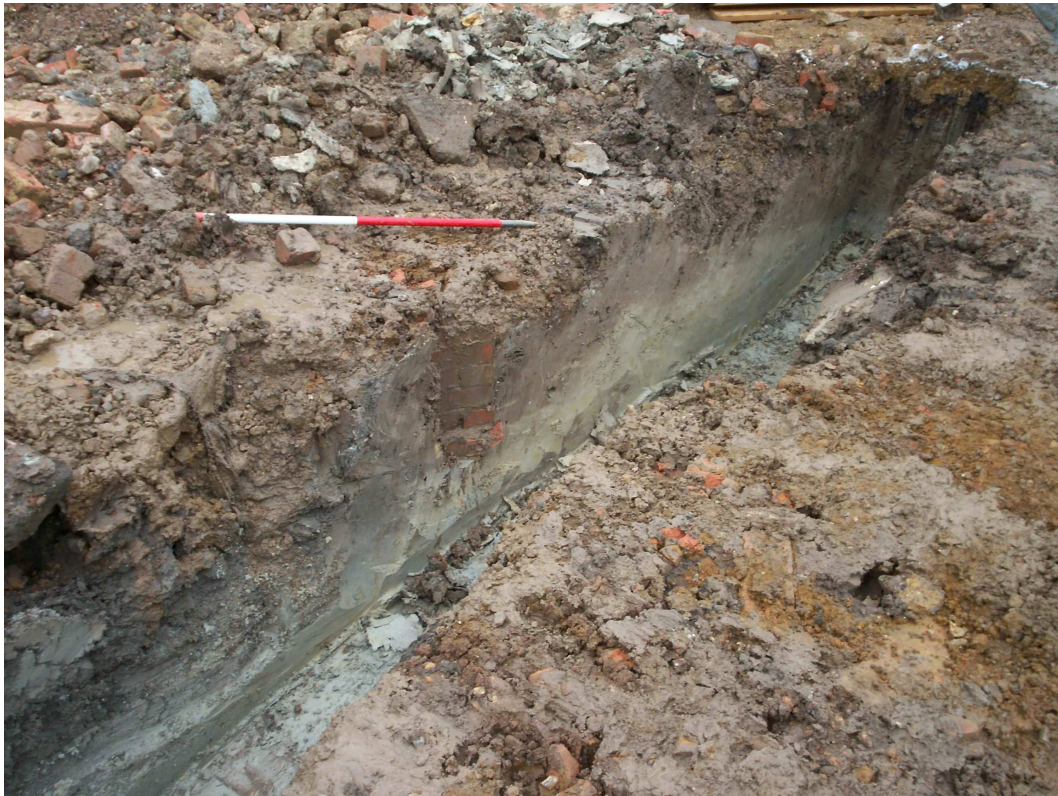
Figure 3: Selected photographs of sections 1 and 2

Also observed within the house foundation trenches of Plot 2 were other large modern disturbances [10] and [21] (Figures 2, 3 and 4) and the remains of some brick foundations [12] in the northern trench. The latter, as well as the earlier disturbances [10] and [15], are possibly associated with a former late 19th-century structure on site (Figure 2 and 3).

Section 1 with features [10], [15], [19] and wall remains [12]

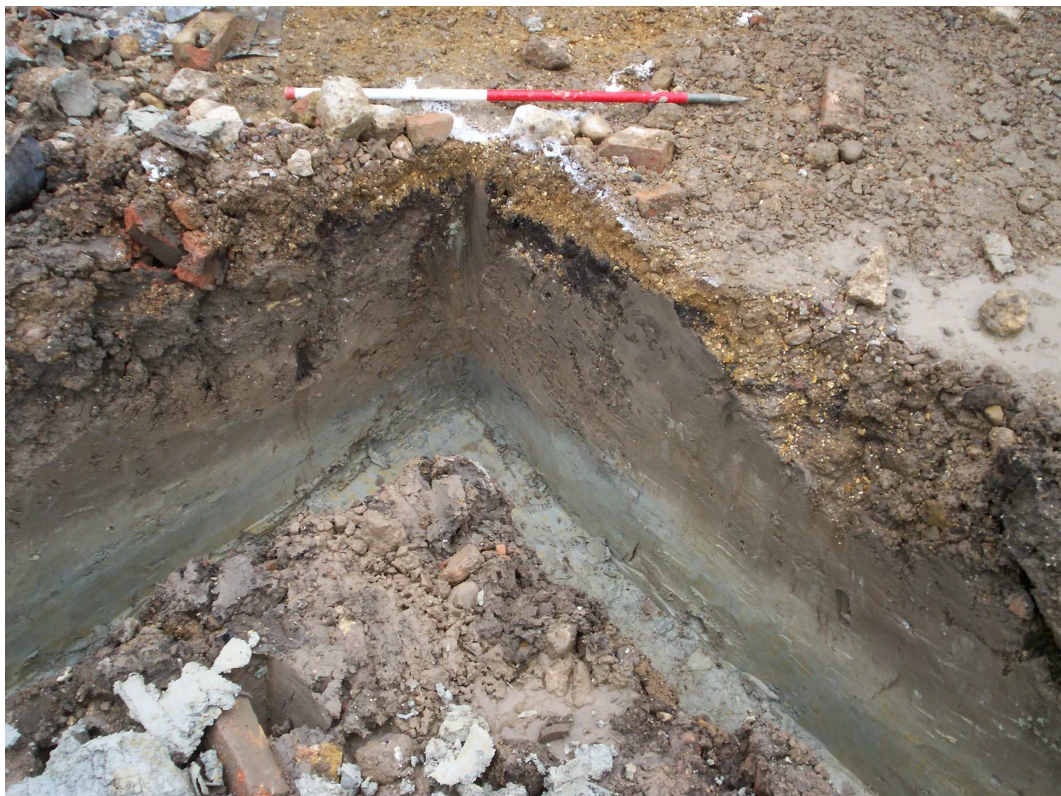
Disturbance [21] is later than [10] and could again be associated either with the 19th- or 20th-century buildings

Section 2 showing feature [10] and [21]

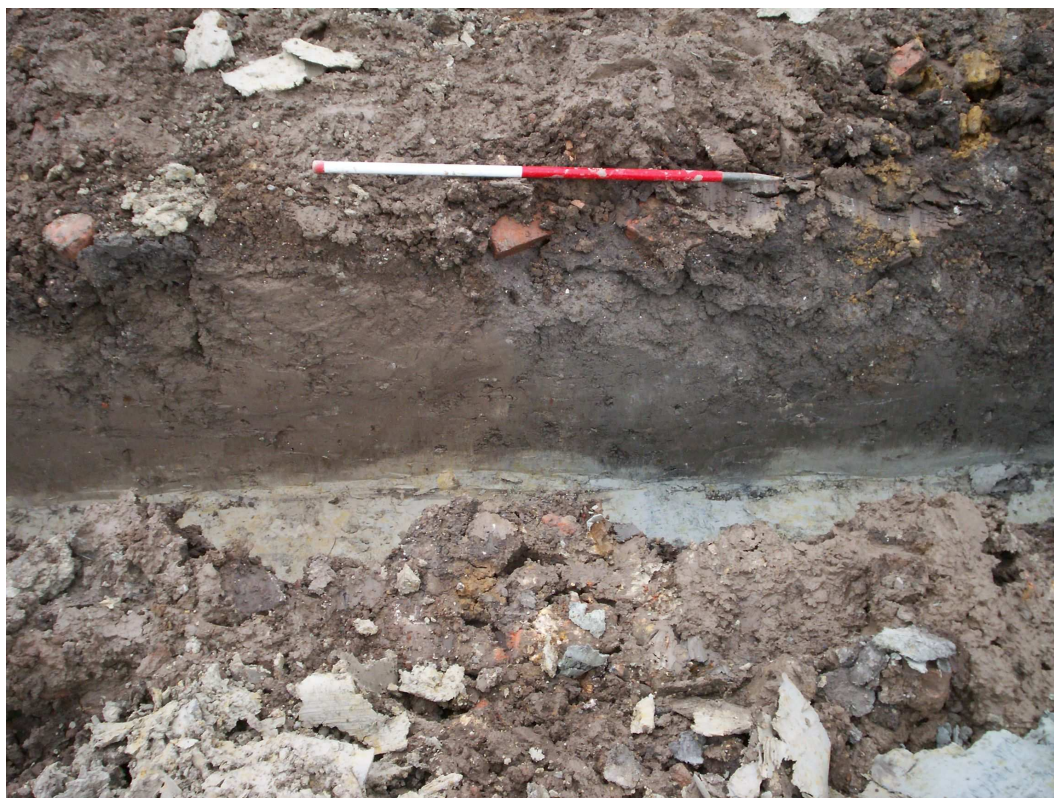
Figure 4: Selected photographs of sections 3 and 4

Section 3 showing feature [10] and [15]

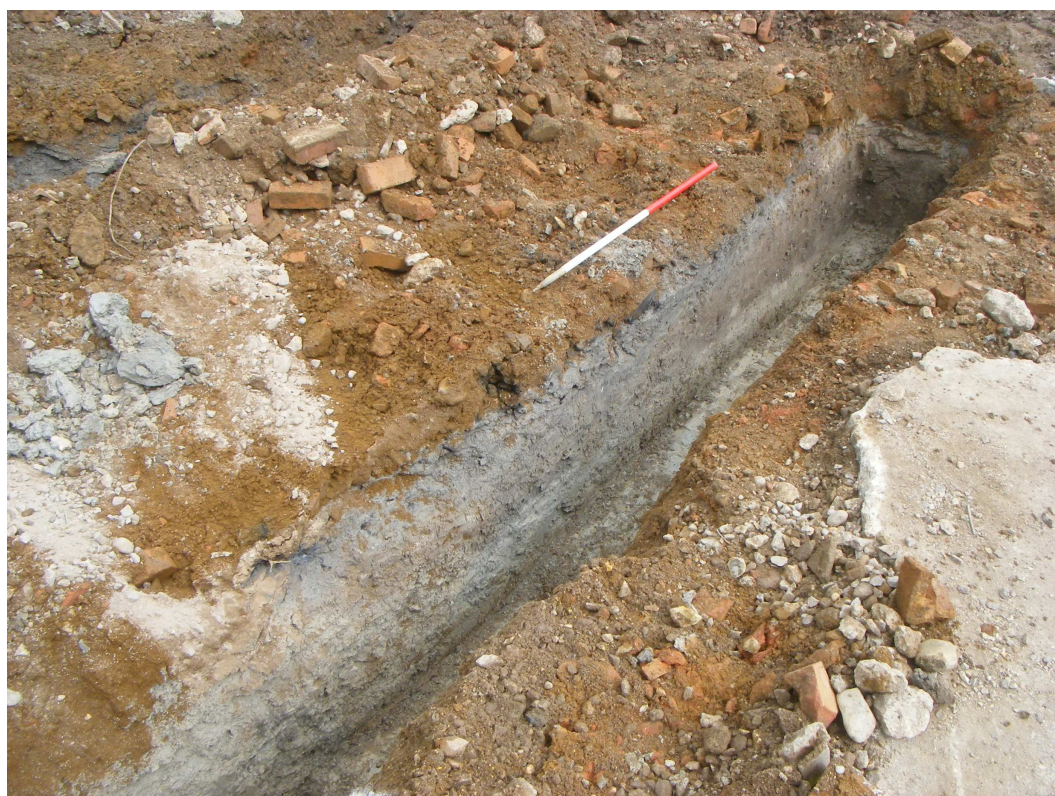
In the foundation trenches for Plot 2 a possible ditch [5] was recorded on an east-west alignment in the area of the garage. The lack of finds and the fact it was cutting modern disturbance [3] suggests it is modern in origin (Figures 2 and 4). The disturbance [3] is thought to be the same feature as [15], which was observed in the foundation trench for the house and in service trenches to the north of Plot 2. The northern extension of disturbance [15] was observed in ST I and II leading away from Plot 2 (Figure 2).

Section 4 showing ditch [5] and feature [3]

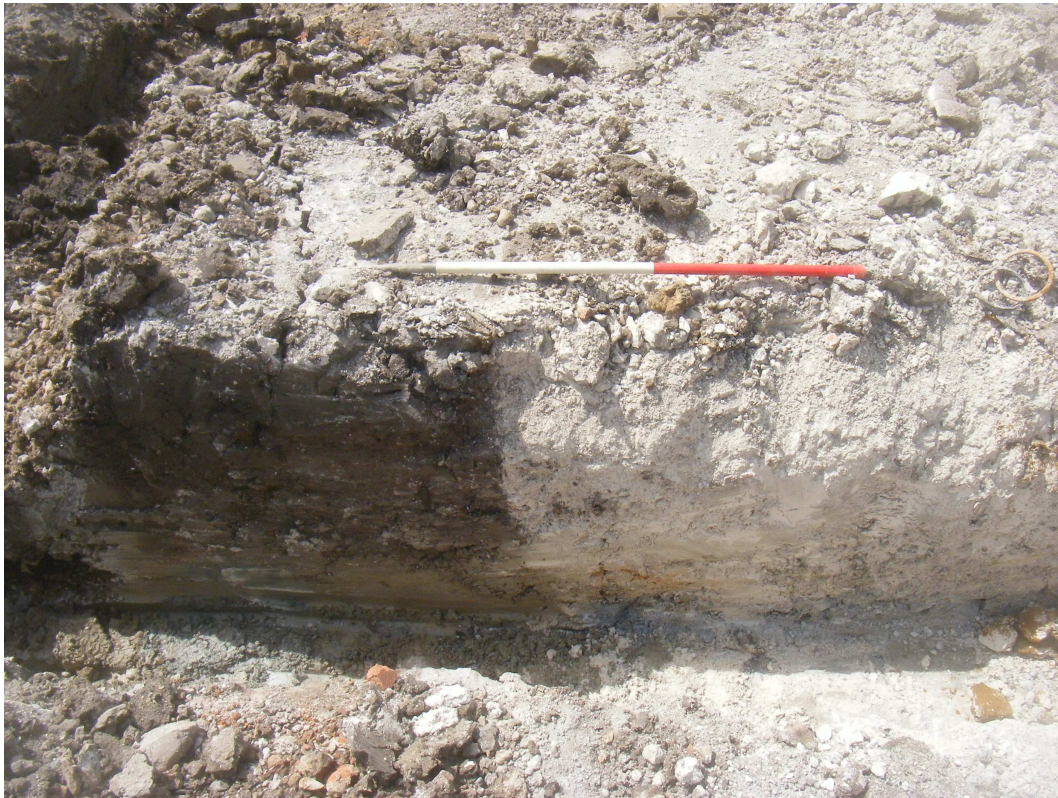
Figure 5: Selected photographs of 20th-century disturbance under Plot 1

A large modern disturbance was encountered in the area underneath the demolished building, where the foundations for Plot 1 were excavated (Figures 2, 5 and 6). The disturbance extended beyond Plot 1 and its eastern extent was encountered in ST IV. The disturbance reached 0.1–0.2m beyond the level where the geological levels were typically encountered and was backfilled with a white chalky deposit. Embedded in this, along the outline of the demolished building, were substantial concrete foundations and brick.

Whereas the backfill deposits from most of the features could derive from surrounding soil and may represent a re-deposition and reworking of the soil, the backfill of the intrusion observed at Plot 1 is alien to the site and must be considered as deliberate backfill or dump of chalky material as a contemporary event to the construction of the foundations of the demolished building.

20th-century disturbance in foundation trench Plot 1

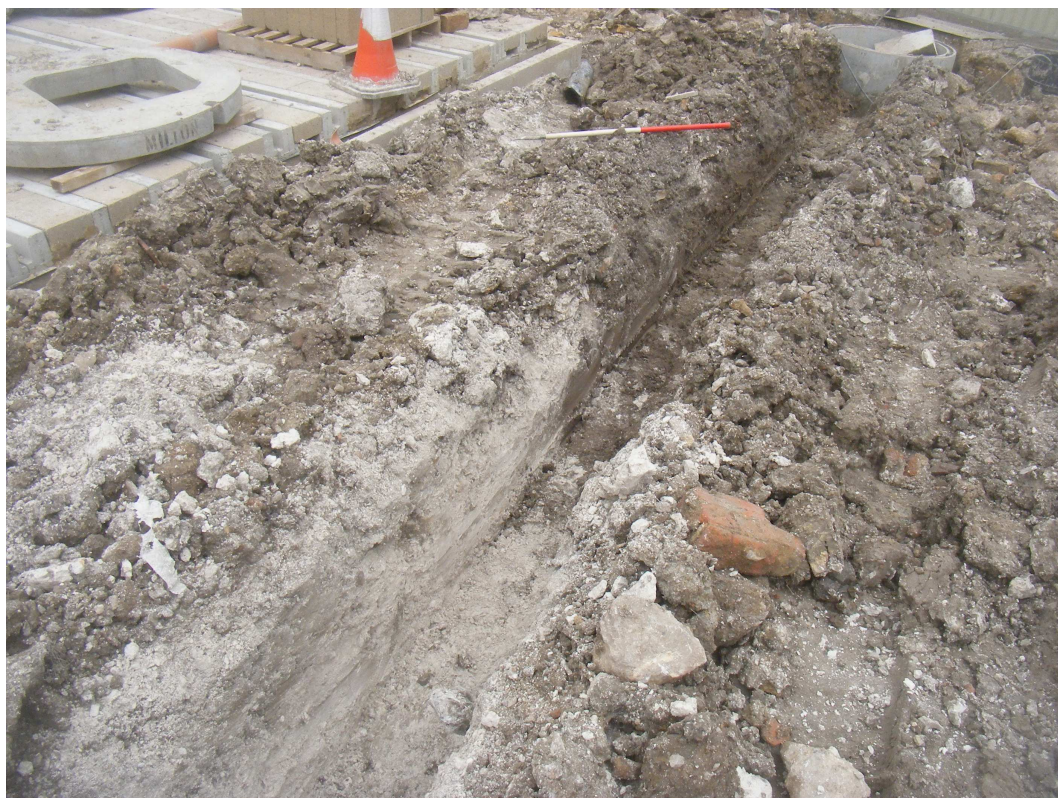
20th-century disturbance in Service Trench IV

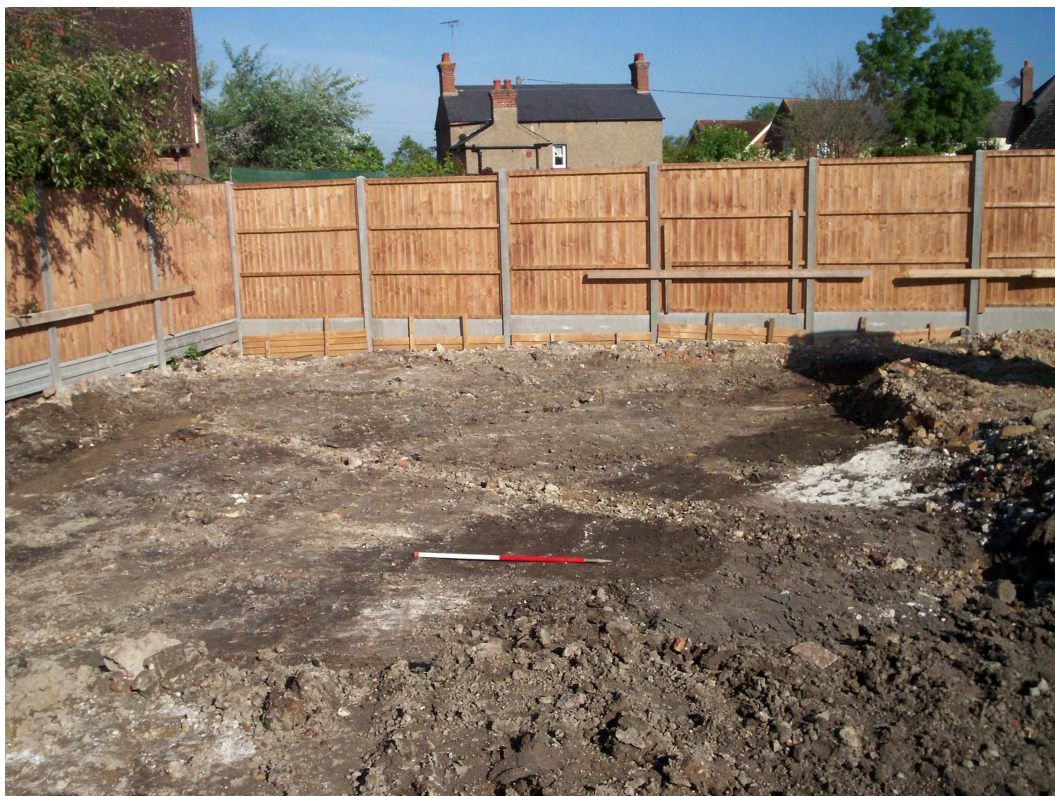
Figure 6: 20th-century disturbance in west corner of development area
