**BEDFORD COLLEGE ENERGY CENTRE
COOLING SYSTEM
BEDFORD**

**ARCHAEOLOGICAL OBSERVATION,
INVESTIGATION, RECORDING, ANALYSIS AND
PUBLICATION**

Project: BC 1856

Document: 2012/148
Version 1.0
Issue date: 30th January 2013

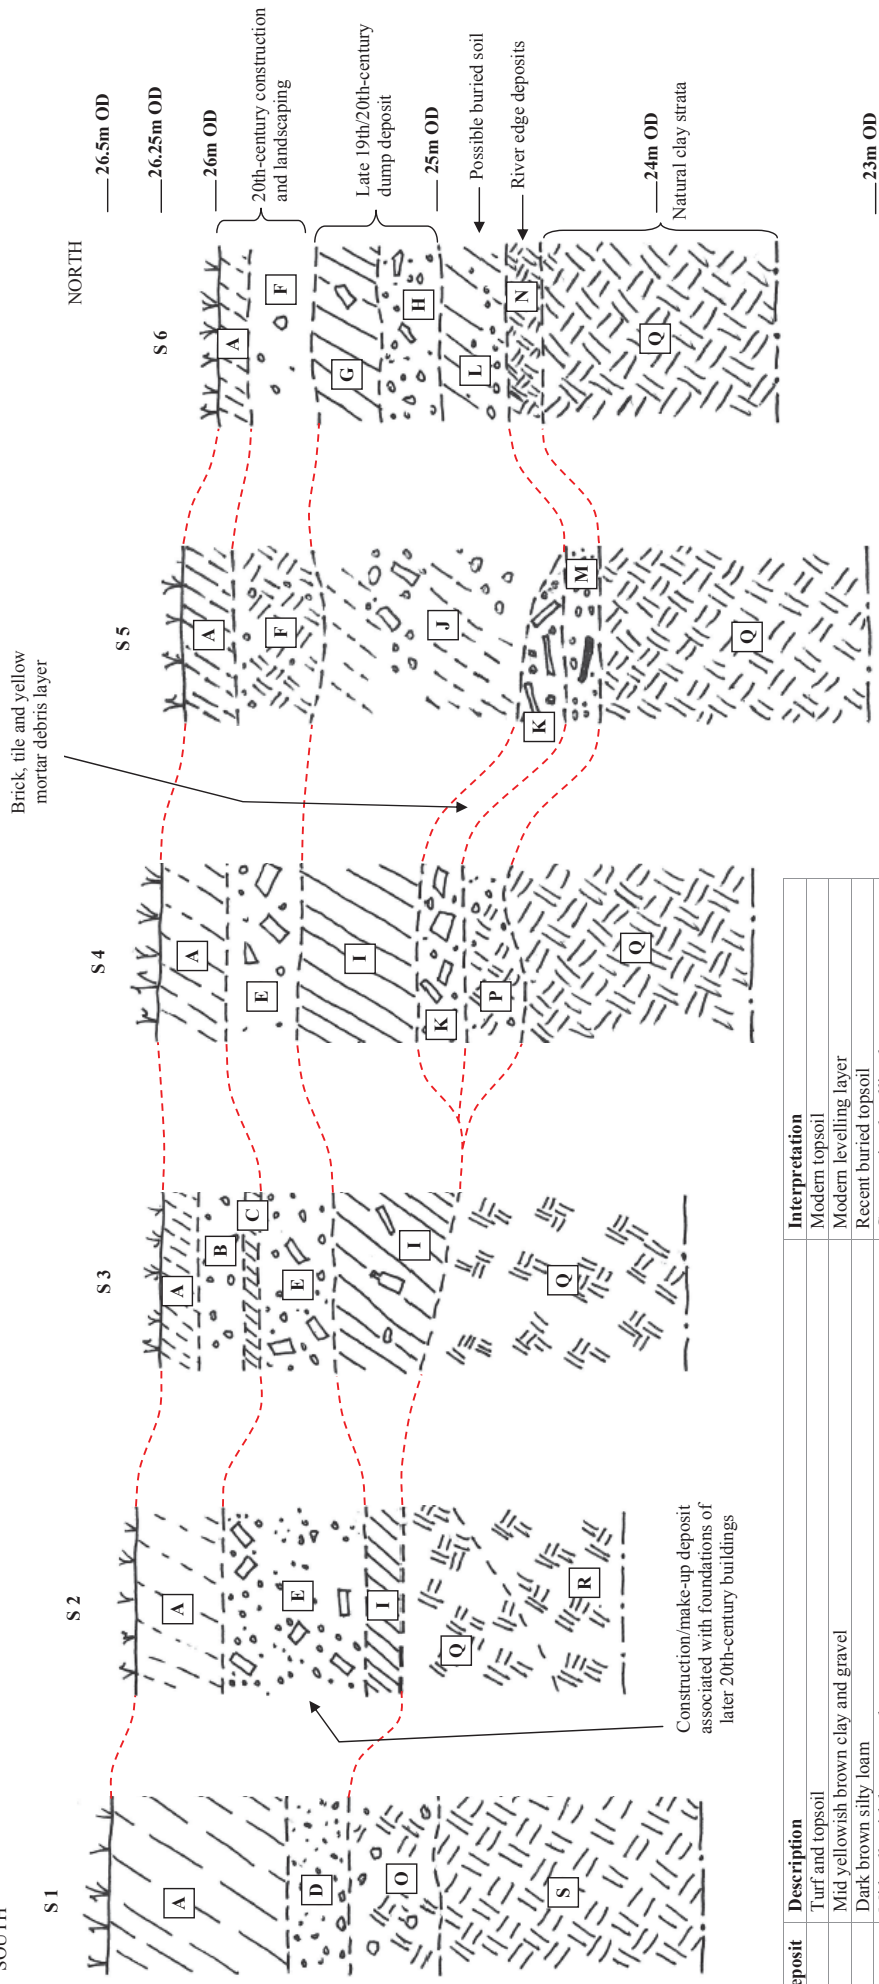
Figure 3: Schematic section through deposits in St Mary's Gardens
(See Figure 2 for the location of each component section)

Deposit	Description	Interpretation
A	Turf and topsoil	Modern topsoil
B	Mid yellowish brown clay and gravel	Modern levelling layer
C	Dark brown silty loam	Recent buried topsoil
D	Mid yellowish brown sand	Construction-levelling layer
E	Mid yellowish brown sand/gravel with occasional fragments of brick and concrete	Construction make-up deposit associated with C20th foundations
F	Mid orange brown sandy clay	Modern levelling layer
G	Dark grey silty loam with modern brick/tile fragments and modern refuse	Modern dump deposit
H	Mid yellow brown silty gravel with brick, tile and glass	Modern dump deposit
I	Dark grey/black silty soil with late C19th/20th debris (bottle glass, enamel plate, fragment of enamel advertising sign, stoneware and leather boot)	Late C19th/early C20th refuse/dump deposit
J	Mixed silt and stony layers containing C19/20th debris	Late C19th/early C20th refuse/dump deposit
K	Layer with frequent fragments of brick, tile and lumps of yellow mortar	Demolition debris

L	Dark grey/black silty loam with small stones	Buried soil
M	Mid orange brown sandy gravel with occasional fragments of wood (branches or roots)	River edge deposit
N	Dark greenish grey clay	River edge deposit
O	Mixed dark grey clay/silt with moderate stone concentration	Possible river edge deposit
P	Dark grey clay with occasional stones	Possible river edge deposit
Q	Mid yellow brown clay	Holocene river alluvium
R	Mid to dark grey clay	Holocene river alluvium
S	Dark grey silty clay	Possible channel deposit

The results are shown in plan (Figure 2), section (Figure 3) with the deposits summarised in Table 1. In the following text sections are referred to as S1, S2 etc and are shown in Figure 3 and are located in plan on Figure 2. Deposits are labelled (A), (B) etc. and are shown in section in Figure 3 and summarised in Table 1.

The section through the deposits in St Mary's Gardens provided good evidence of the general sequence of deposits on the river bank. Prior to any landscaping activity in this area the river channel appears to have been wider, with ground rising gradually from the river's edge at *c.* 24.3m OD to something over 25m OD at the edge of what is now the college grounds.

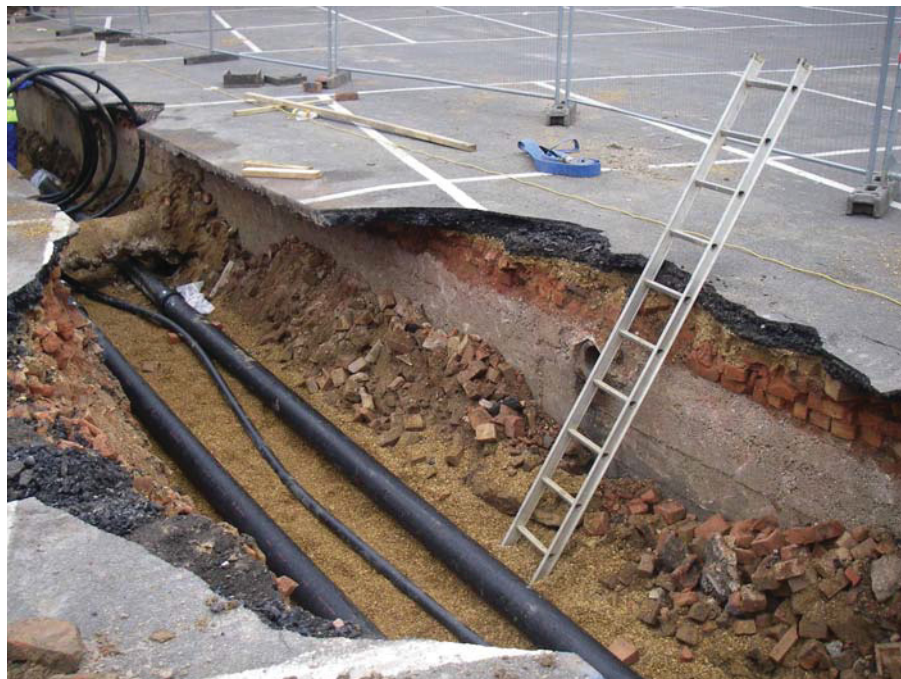
Image 2: Trench in car park showing King's Ditch culvert
A concrete culvert enclosing the King's Ditch is visible in the east side of the trench

In the initial section of the trench through the western part of the college car park the observations were limited. Here, the trench lay alongside the modern concrete culvert for the King's Ditch and the observed deposits consisted of a deep layer of brick rubble over natural clay.

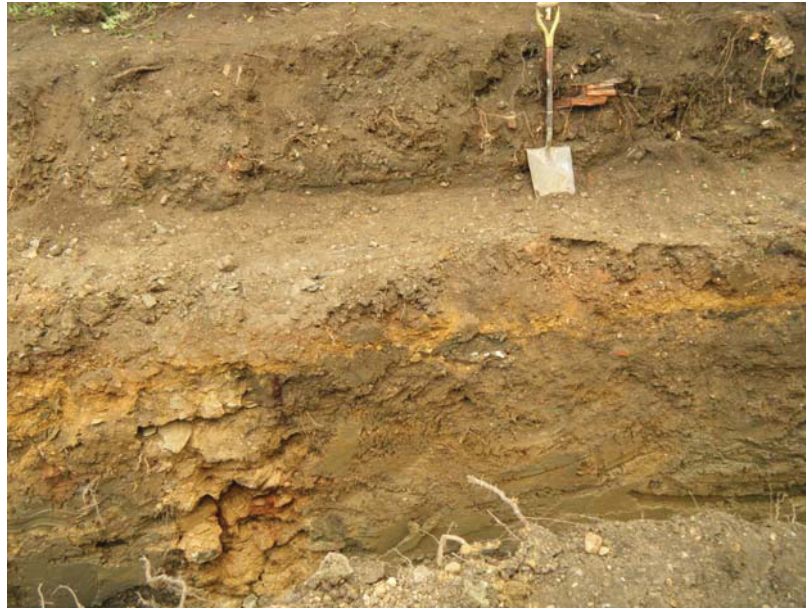
Image 3: Limestone foundation at southern edge of St Mary's Gardens

The foundation is cut into the underlying subsoil (O) and geology (R) and is sealed beneath topsoil (A) and a yellow brown construction/levelling layer (D). Dark silty clay (S) visible to the left of the foundation may represent the fill of a former channel

Deep foundations were found at the south end of the trench (Figure 2, Image 3). These consisted of two blocks of masonry aligned NNW-SSE and ENE-WSW which probably represent the north-west corner of a building or structure. The base of the foundation extended to the bottom of the trench at a depth of *c.* 2.8m below the current ground surface. The truncated upper part of the masonry was sealed by a recent construction/levelling layer (D). A few bricks were incorporated into the foundation which mainly consisted of limestone rubble which was set on a thin layer of concrete or mortar at the base.

A dark silty clay deposit (S) towards the south end of the trench in St Mary's Gardens, next to a deep limestone foundation may represent silting within a back channel of the river (Image 3). This channel is shown on historical maps from the 16th century to the mid 19th century.

The deep limestone foundations found at the south end of the trench correspond to the position of a building shown on the 1836 Dewhurst and Nichols map of Bedford. The map shows the King's Ditch immediately west of the building and the back channel of the river on the north side of the building. This probably accounts for the extremely deep foundations as the building appears to have been built on the edge of these two watercourses. The Dawson panorama of 1833 shows a number of buildings in this approximate location, but there are no buildings on the 1841 Reynolds map which could correspond to the foundations.

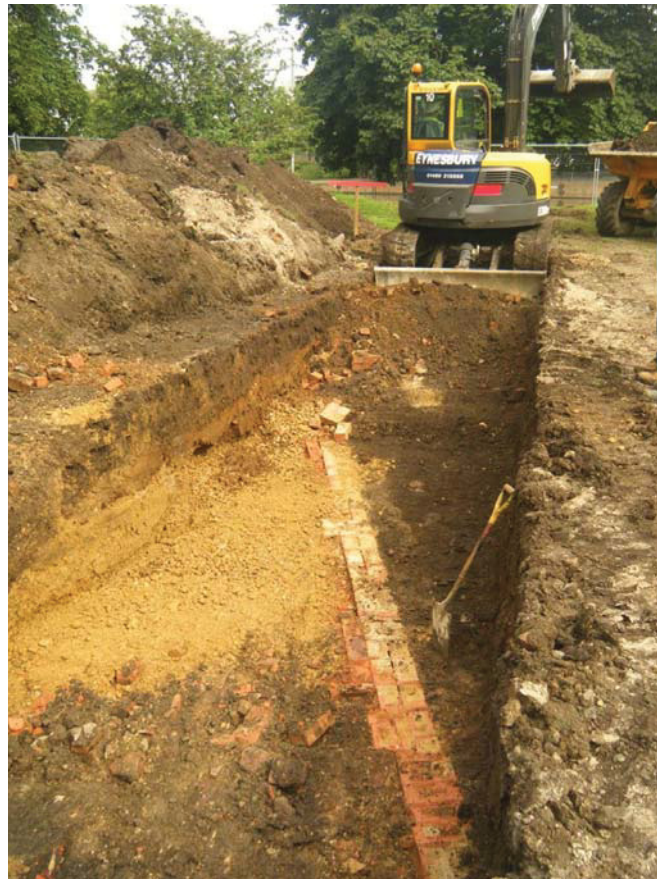
Image 4: Brick foundations in St Mary's Gardens

Shows foundation in mid part of the trench where it crosses St Mary's Gardens (location S3 Figure 2, looking north). The yellow construction deposit (E) is visible on left hand/interior side of the wall and the wall cuts through a dark dump deposit (I) which contained late 19th/20th-century refuse.

In the middle of the trench across St Mary's Gardens there were a series of foundations aligned approximately NE-SW and NW-SE, which appear to have been the external and internal cross-walls of a building aligned NW-SE (Figure 2

and Image 4). The foundations survived just below present topsoil and levelling layers. They were comparatively shallow, consisting of Fletton common bricks made by the London Brick Company, and were set on narrow, concrete strip footings. They were cut into a dark silty soil containing late 19th- and 20th-century refuse (I). A layer of yellow gravel with fragments of brick and concrete (E) represented the remains of an internal floor construction layer.

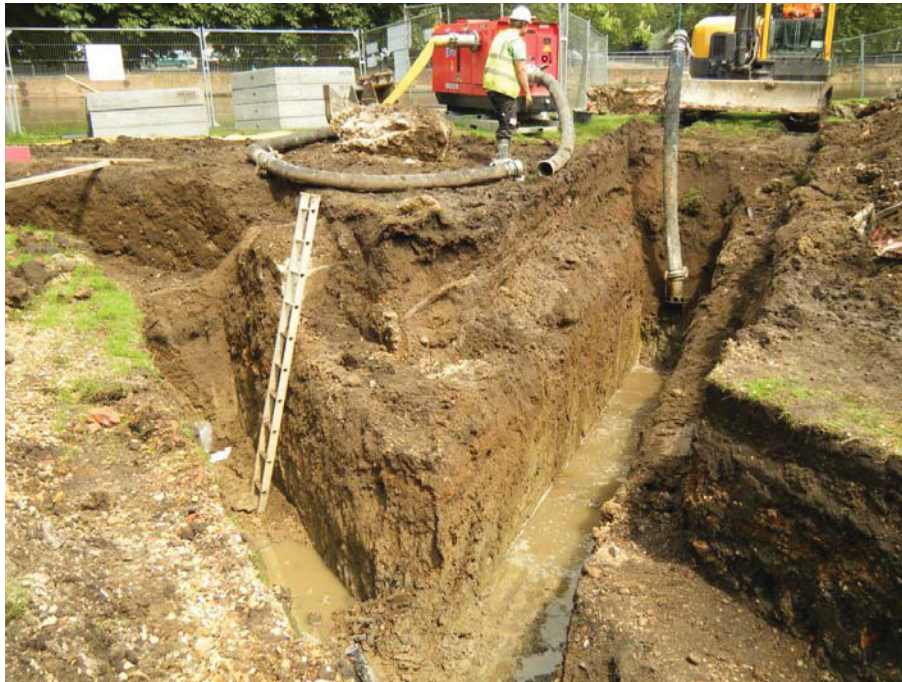
Image 5: Trench in St Mary's Gardens

Image shows area where intake and output trenches diverge (near S4 Figure 2) looking towards the north-east with the trees along the river bank in the background.

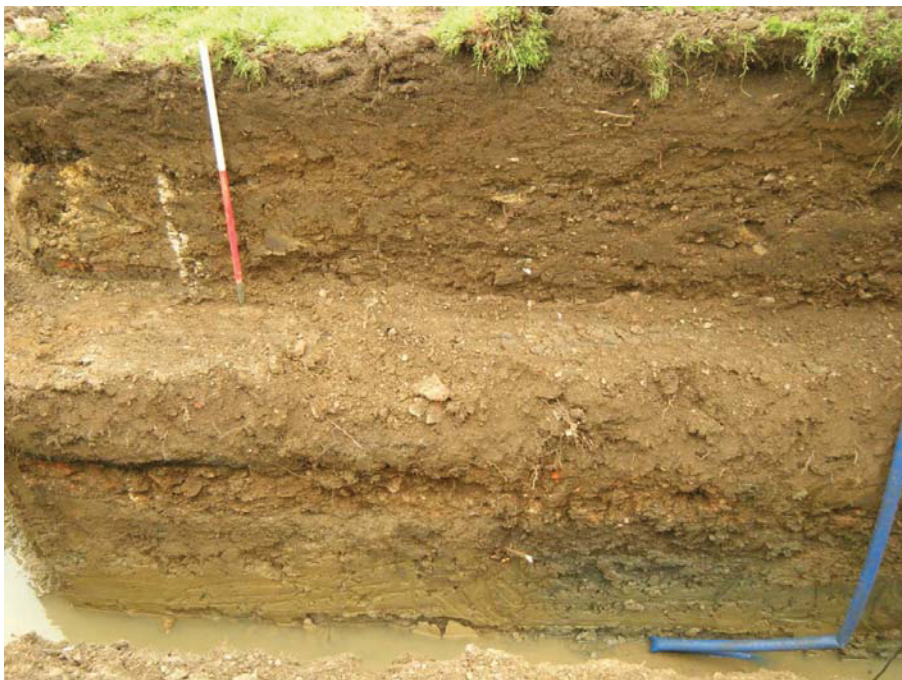
Image 6: Trench in St Mary's Gardens showing Section S4

Image shows rubble from modern construction at top left (E) and dump deposit (I) sealing a narrow band of brick, tile and mortar debris (K) situated below the step in the side of the trench

A distinct layer containing tile, brick and mortar fragments (K) was found in the northern part of the trench, beneath the layers containing domestic refuse (Image 6). The layer was at least 20m wide east to west, being seen in the southern part of the inlet trench and extending eastwards along the outlet trench as far as section S5 where it ran out. It was up to 0.2m thick and comprised a mixed deposit of mainly tile and mortar with some brick. The mortar debris consisted of soft yellow mortar and the tiles were fragments of plain peg tiles. This demolition debris may have been used to form an area of hard standing or could just have been a dump deposit.
