**CAR PARK EXTENSION
NISSAN TECHNICAL CENTRE
CRANFIELD
BEDFORDSHIRE**

**ARCHAEOLOGICAL OBSERVATION,
INVESTIGATION, RECORDING, ANALYSIS AND
PUBLICATION**

Project: NTC 1946
Document: 2012/127
Version 1.0

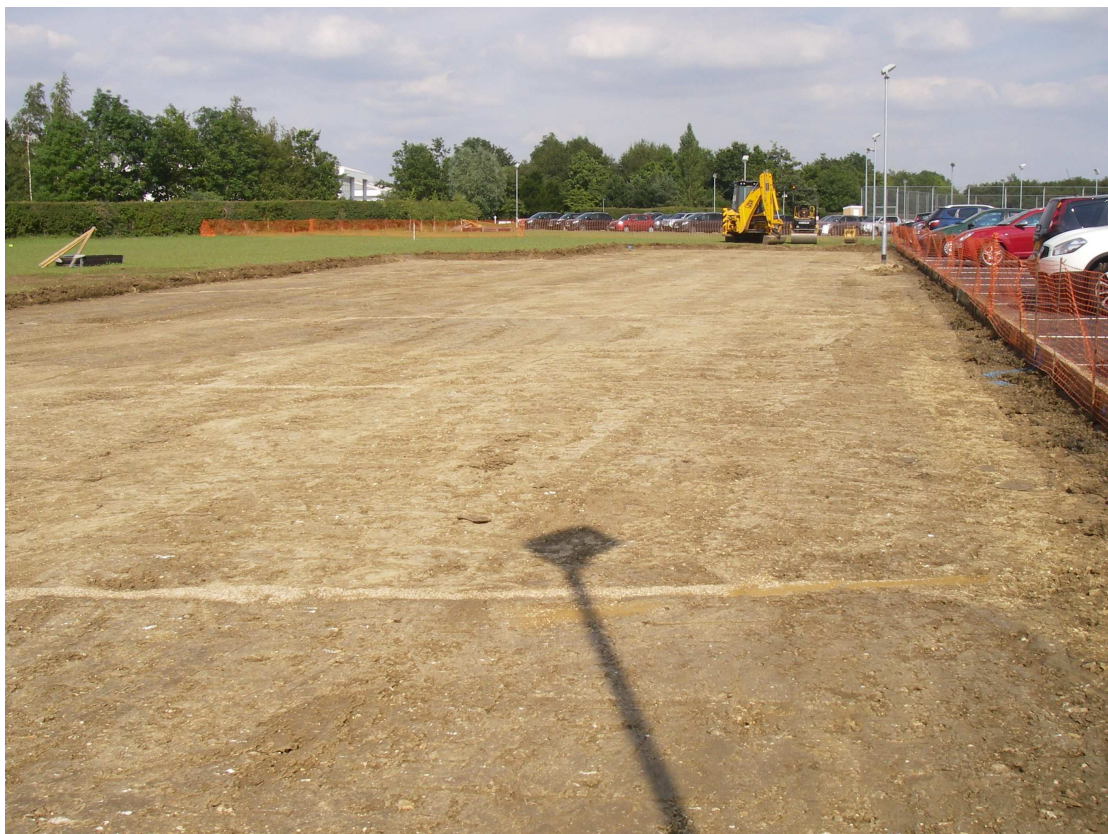
The first stage of the groundworks involved the removal of 200mm of overburden across the DA (Figures 5 and 6). This consisted of *c.*150mm of playing field turf or topsoil together with a further 50mm of the top of the underlying made-up ground. The exposed layer of made-up ground, left *in situ*, consisted of mid brown clay with moderate inclusions of pebbles, brick and concrete fragments. It masked any potential archaeological features that might have survived beneath it.

The thickness of the layer and its modern inclusions suggest that it was probably formed during the construction of Cranfield Airfield.

Figure 5: Car park extension after stripping of topsoil (looking west)

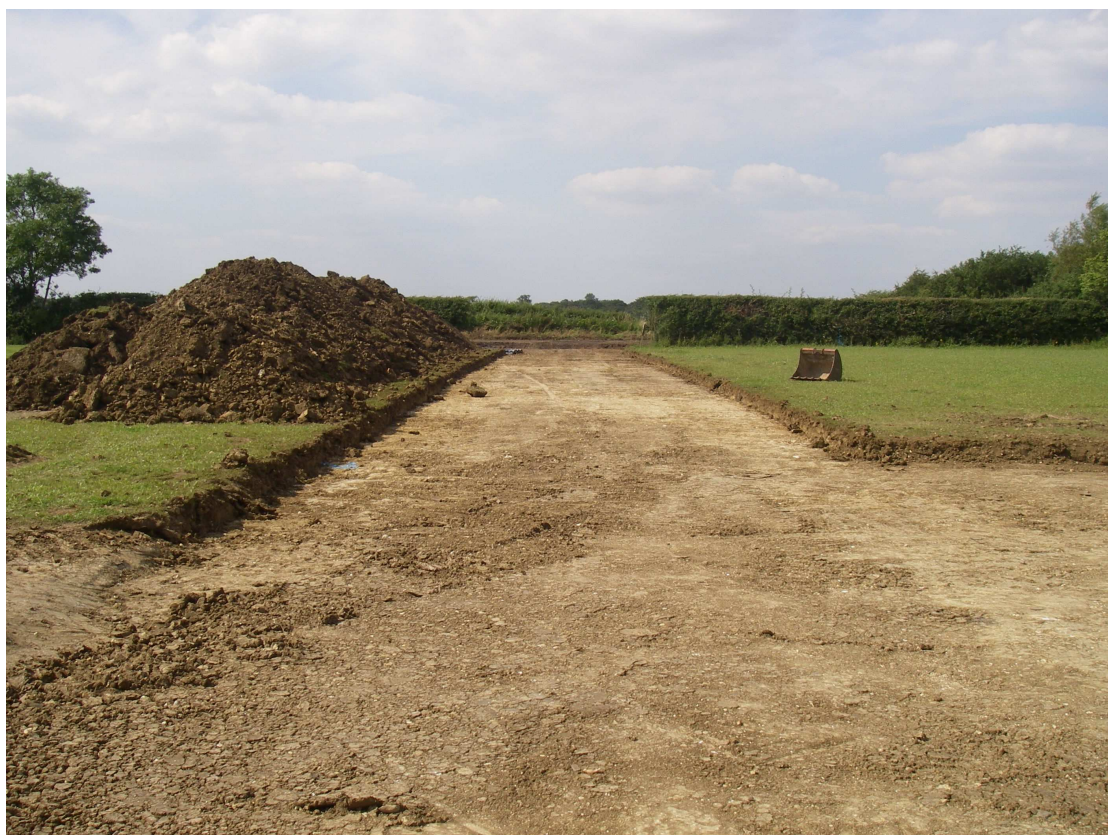
Figure 6: New access road after stripping of topsoil (looking north)

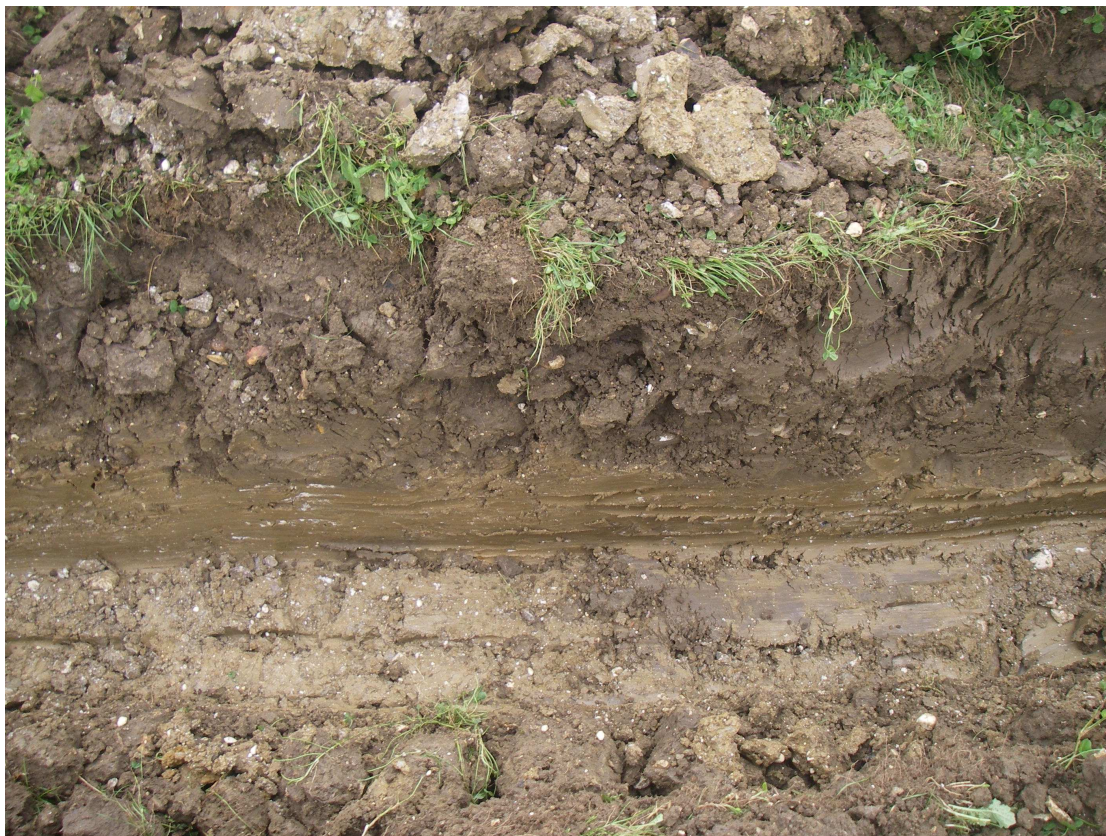
Excavation of the drainage trenches showed the made-up ground to be 0.30–0.50m thick. It increased in thickness from north to south.

Geological deposits were revealed within the base of the service trenches at a depth of 0.30–0.50m below ground level. They consisted of light to mid orange brown clay with frequent small and medium-sized chalk fragments and flecks. No archaeological features or artefacts were revealed in any of the trenches.

Figure 7: Soil profile. Topsoil and Cranfield Airfield layer (0.50m thick) above glacial Till
