**PEGSDON GRANGE TENNIS COURT
PEGSDON
BEDFORDSHIRE**

**ARCHAEOLOGICAL OBSERVATION,
INVESTIGATION, RECORDING, ANALYSIS AND
PUBLICATION**

Albion
archaeology

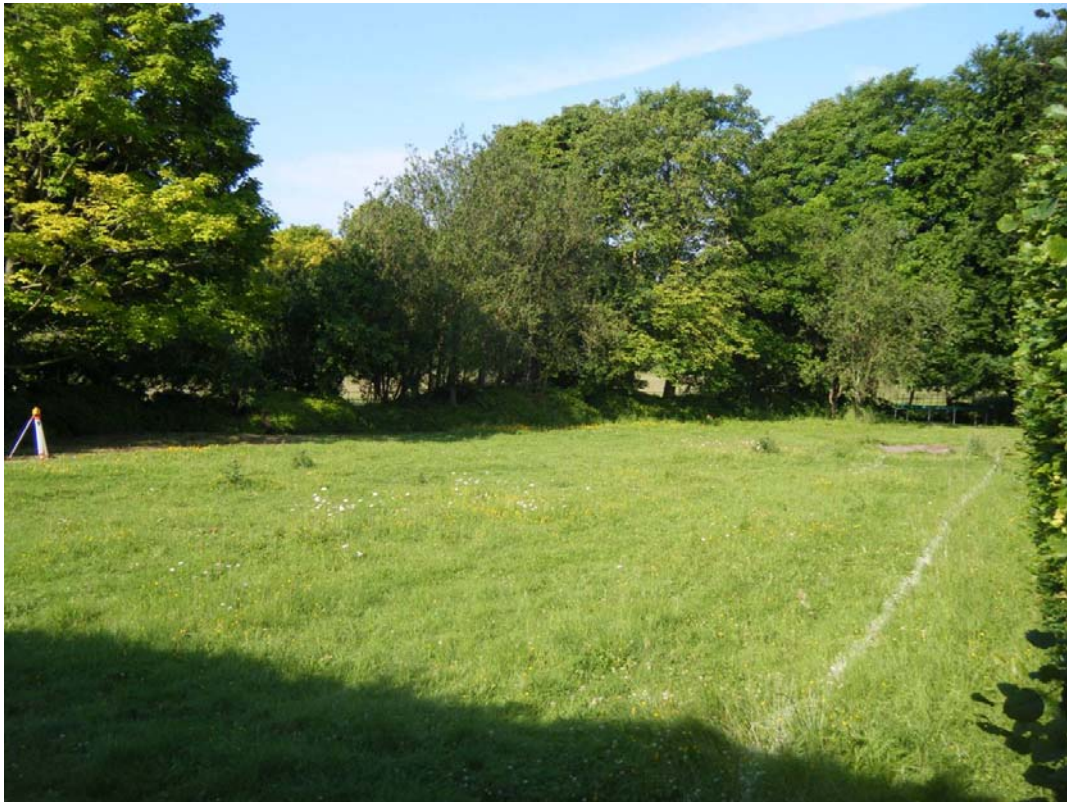
Plate 1: Area before machining, looking west

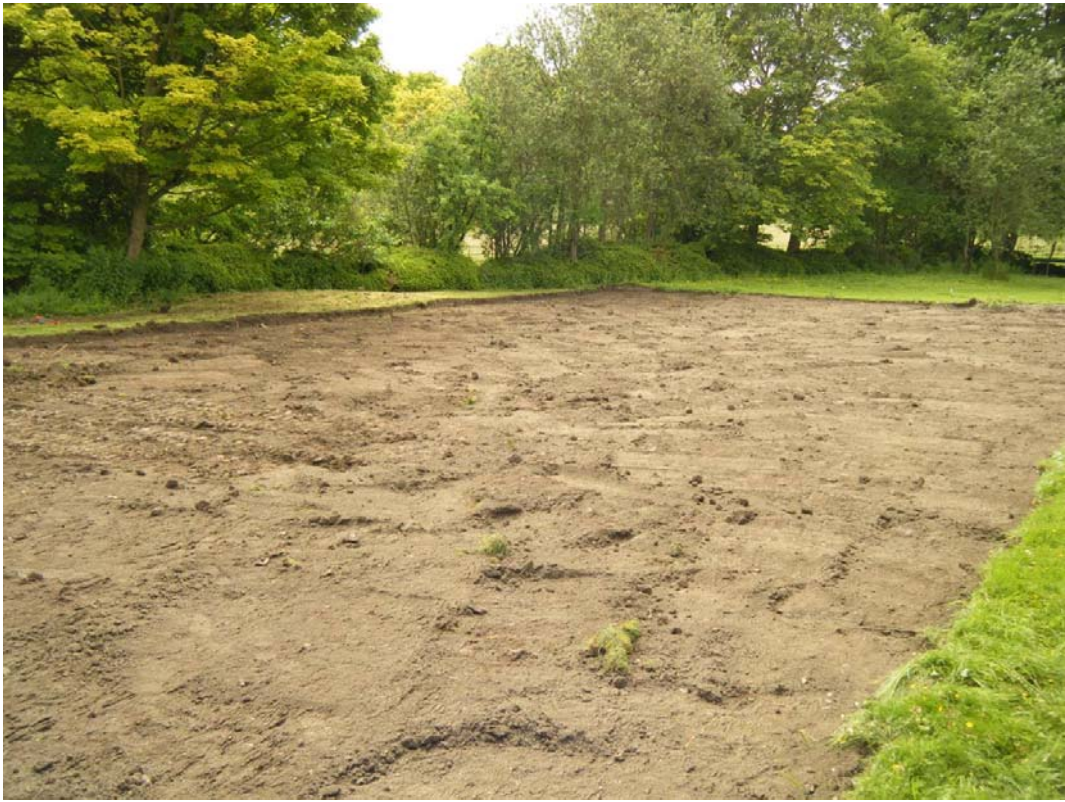
The material removed from the site of the tennis court consisted of a single undifferentiated layer of topsoil. It comprised a dark grey silty loam with

occasional small to medium sized stones. No subsoil deposits were exposed, although some lighter patches of soil may have marked the interface with the underlying deposits.

Plate 2: Area after machining, looking west

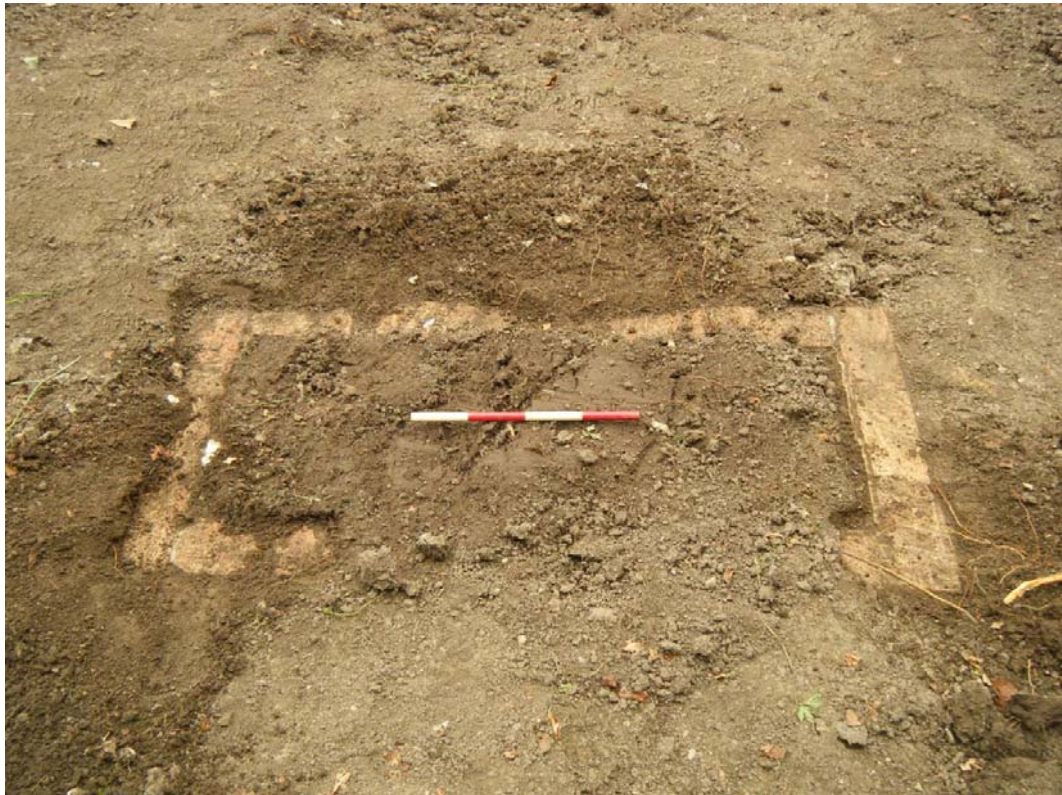
In the north-west corner of the excavation the top of a brick chamber was exposed (see Plates 3 and 4). It consisted of a rectangular cut, lined with a single layer of bricks. The chamber had external dimensions of 1.4m by 0.7m. The bricks were 9 inches long by 4 inches wide (height unknown) in a light pinkish or yellow colour without frogs in the exposed upper surfaces. The interior surface of the chamber was lined with a thin layer of cement render. The interior was filled with soil indistinguishable from the overlying topsoil layer.

Plate 3: Brick-lined chamber in north-west corner of site

A disused brick-lined chamber was identified in the north-west corner of the area. The type of brick used in its construction indicates a later 19th or earlier 20th century date. The relatively small size of the chamber suggests that it could have been an inspection pit for a drain; however no cut for a drain was visible.

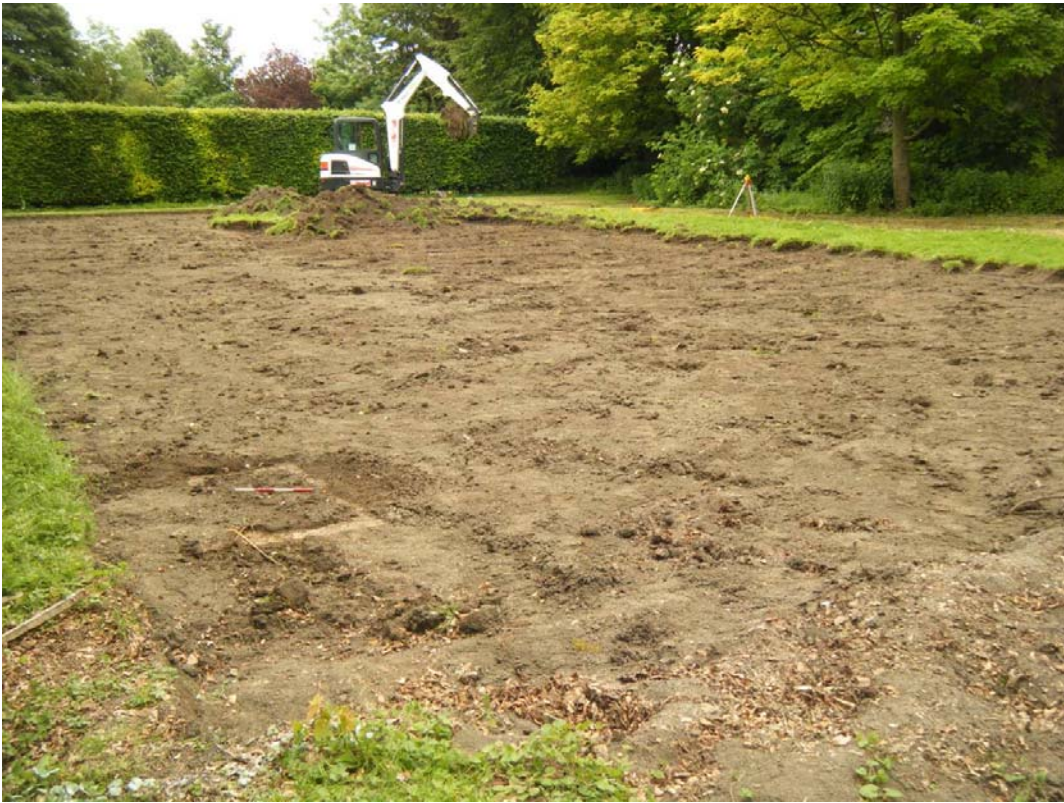
Plate 4: Area after machining, looking south-east
