**20-22 SILVER STREET
BEDFORD**

**ARCHAEOLOGICAL OBSERVATION,
INVESTIGATION, RECORDING, ANALYSIS
AND PUBLICATION**

Project: SB1993
Bedford Museum accession no. BEDFM: 2012.38
OASIS ref: albionar1-129602

Document: 2012/117
Version 1.1

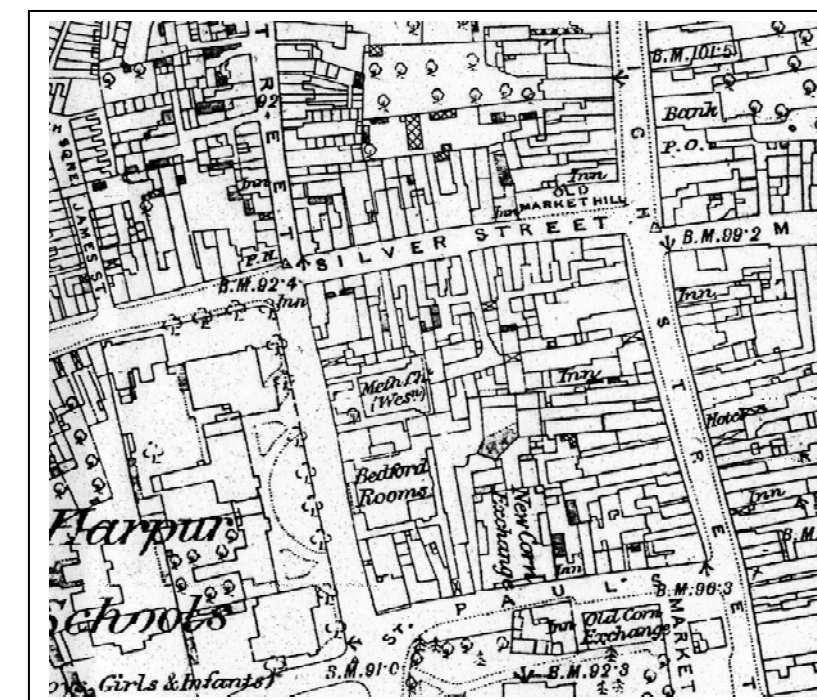
Map 4: Detail of 1st edition Ordnance Survey map of 1881

The Mercer map of 1876-78 and the first edition Ordnance Survey Map of 1882 show that, by latter part of the 19th century, the area within the block had been extensively developed with little open ground remaining (Figure 2: Maps 3 and 4). Due to the density of activity, the blocked in buildings of the Mercer map of 1876-78 are easier to discern, with the series of buildings occupying the rear of the site. These buildings extend south of the present boundary, into the area which is now parking/access road.

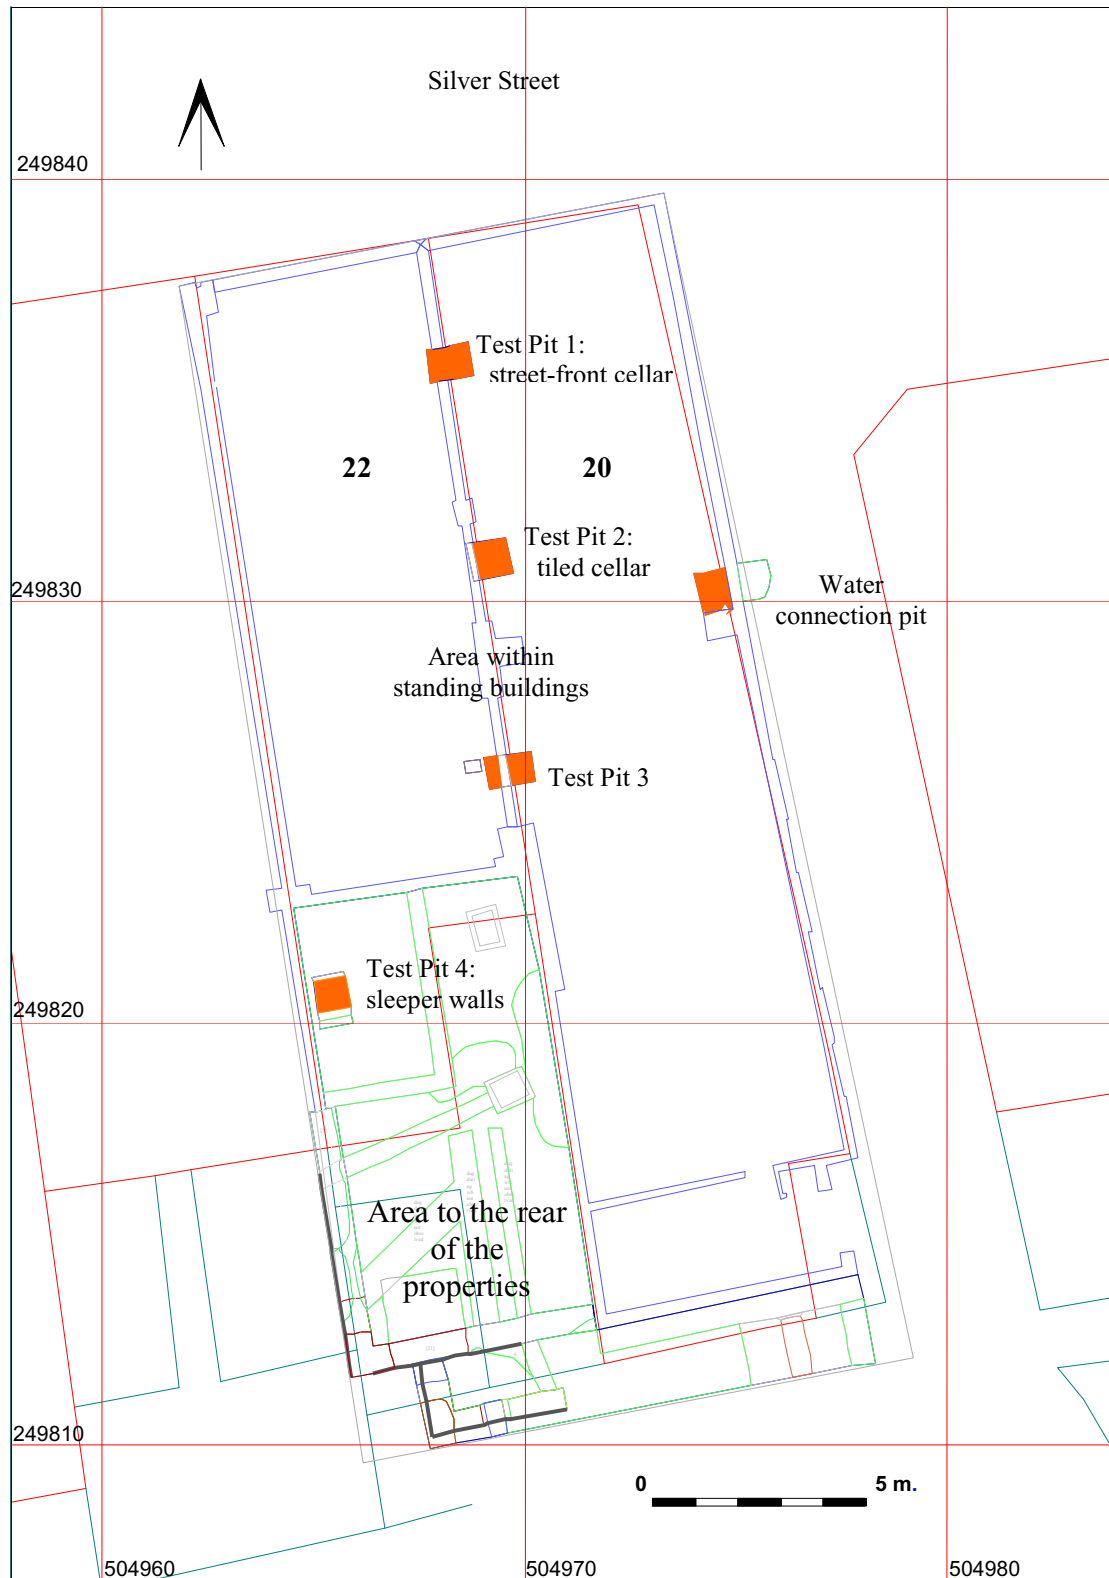
Figure 3: Area within the standing buildings — All-features plan

The initial monitoring works were undertaken within the standing buildings, with four test pits (Test Pits 1-4 on Figure 3) being opened to assess the footings of partition and external walls. Other works consisted of a water connection pit adjacent to the eastern external wall and drainpipe trenches that connected to an existing junction point within the building; this did not penetrate below deposits associated with the modern flooring.

The middle test pit (Test Pit 2 on Figure 3) was excavated to a depth of 0.8m through concrete and into a back cellar that had been in-filled with brick rubble. In contrast to the northernmost cellar, this cellar had vertical walls that had been faced with glazed white and black tiles (Figure 4: image 2).

The southernmost test pit (Test Pit 3 on Figure 3) was only excavated to a depth of 0.3m because reinforced concrete was encountered.

A further test pit was located internally, adjacent to the western wall of 22 Silver Street within a lean-to building at the rear of the former shop. The test pit (Figure 3 - Test Pit 4) was excavated to a depth of 0.8m. Within it was a layer of concrete supporting sleeper walls aligned E-W, *c.* 0.16m wide and 0.8m apart, which had probably been used to support a suspended timber floor.

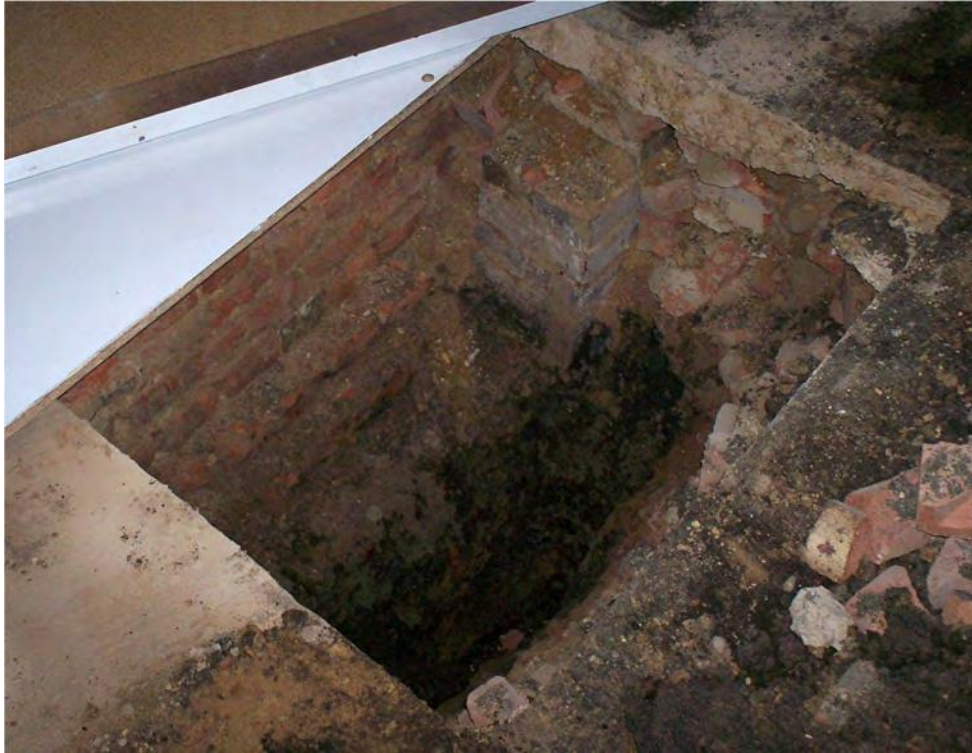
Image 1: Stepped footings of brick partition wall. The black deposit below the rubble is coal dust, suggesting that a coal cellar occupied the area towards the street frontage.

The northernmost test pit (Test Pit 1) was excavated to a depth of 1.4m through concrete and into the backfilled front cellar of 20 Silver Street. This area had stepped footing (Figure 4: image 1). Underneath a layer of backfilled brick rubble was a thick deposit of coal dust. Adjacent to the partition wall were two brick pillars that appear to have been a later addition. It is likely that the front cellar had been used to store coal.

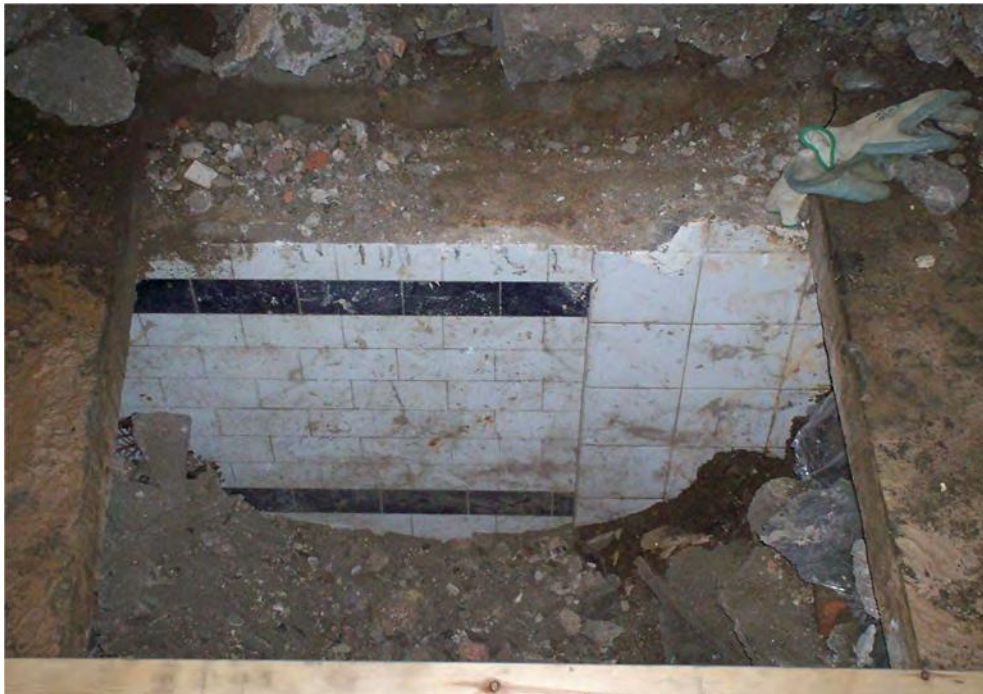
Image 2: Evidence for a second cellar revealed toward rear of building. The change in tiles may suggest a subdivision of this area.

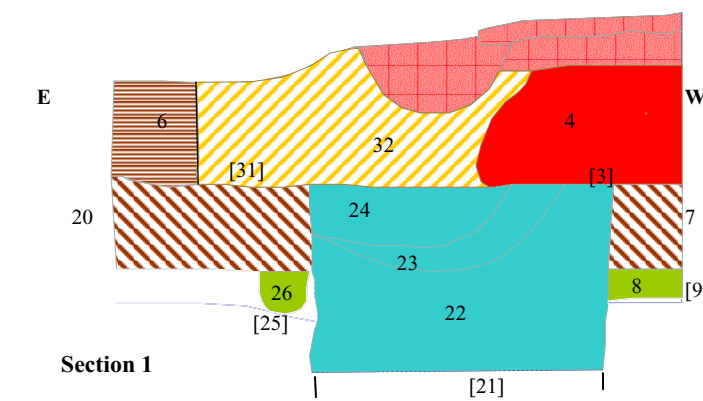
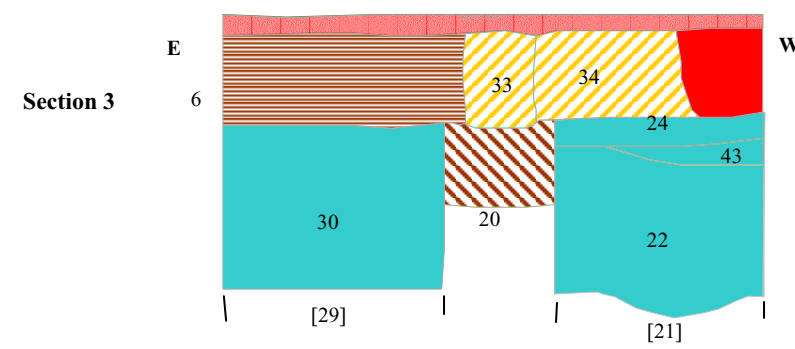
Figure 5: Area to the rear of the properties — All-features plan and selected section

The all-features plan of this area (Figure 5) with associated sections has been colour-coded for clarity. Where possible the features will be discussed stratigraphically from earliest to latest, integrating finds information, while more detailed finds information is provided in Appendix 1. The investigation area extended marginally westwards, beyond the footing for the former property boundary wall [3], which was removed during the construction works.

Only the northern part of the feature was exposed, as it had been severely truncated by later activity, which hindered determination of form and profile (Figure 5: sections 1 and 2 and Figure 6: image 3). However, the feature was at least 0.32m deep, with a flat base, though the sides were lost to later activity. The mid brown sandy silt contained no finds.

Only the northern part of this feature was revealed. It had a semi-circular form in plan, 0.3m across and 0.26m deep with vertical sides and concave base (Figure 5: section 1 and Figure 7: image 5). The sole fill consisted of dark brown clayey silt, with occasional small stones, though no packing stones or post-pipe were observed.

The dark grey brown sandy silt was 0.34–0.5m thick, with a horizontal, well-defined lower boundary (Figure 5 – brown hatched deposit on sections 1, 2 and 3 and Figure 7: images 5 and 6). This is interpreted as a cultivation soil. Its location and depth suggest it was a hand-dug soil, rather than traces of an arable ploughed field — the latter is typically only *c.* 0.3m thick. The presence of ceramic building material (CBM) was noted in (20) in the east whilst (7) towards the western margin of the site had fewer inclusions. No finds were recovered from this deposit. The presence of CBM would suggest that this soil was still cultivated in the post-medieval period.

Confined to the western margin of the area, beneath the property boundary wall [3], a cluster of three pits were identified (Figure 5 and section 2 - solid brown features). Pits [14] and [18] were intercutting in the west, while [27] was further to the east. Only parts of each feature were exposed, though the revealed elements suggest that [14] and [27] were smaller deeper pits, while [18] would appear to have been much larger, with a shallower profile.

Pit [18] was larger than the others, extending 3.4m N-S, by at least 0.5m wide and up to 0.33m deep, with steep sides and a generally flat base (Figure 5: section 2). The mixed fill of dark brown grey clayey silt contained small-medium sized stones. CBM fragments were observed in section but were not retrieved; this material would indicate a post-medieval date. This pit marginally truncated earlier pit [14].

A 0.5m thick layer of dark grey brown sandy silt sealed all the features discussed previously (Figure 5: sections 1-3 — horizontal brown hatching). The deposit was observed across the whole stripped area. It was very similar in color and texture to the old cultivation soil (7/20), but contained many more inclusions including pottery, CBM fragments, stones and charcoal. The pottery ranged in date from the post-medieval to modern periods (Appendix 1). It seems likely that it had been a cultivation deposit, probably removed from the part of the site closer to the street frontage on Silver Street during construction works, and spread in the backs of the properties, possibly as a garden soil.

A series of remains identified in the SW corner of the area are thought to represent the NE corner of a shallow brick-lined feature [31] (Figure 5 and section 1 — yellow hatched feature). This would appear to be a sunken square or rectangular structure, at least 2m by 2m wide and 0.55m deep with vertical sides and flat base. The northern edge was defined by a 0.45m thick, E-W aligned brick wall (32), whilst the eastern extent was defined by fragments of soft friable mortar (33) up to 0.4m thick. The latter may be remnants of a mortar raft for a wall, damaged by subsequent robbing and by a modern service. It cut through garden soil (1/6) and was buried under modern make-up layer (Figure 5: section 1). This may be associated with the kiln as the finds are of a similar date to the kiln.

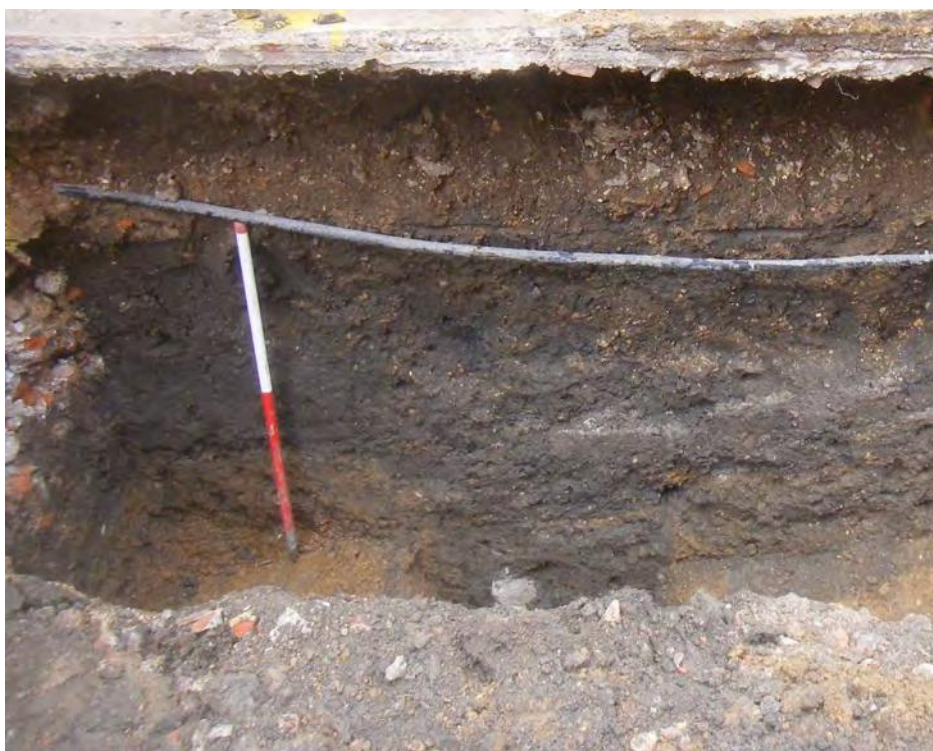
Image 3: Southern part of western section, showing a series of features. The deepest is robber trench [11] with earlier pit [9] to left and later pit [14] to right (compare with section 2). The continuation of boundary wall [3] can be seen at the extreme left of the image. Scale 1m in 50cm divisions.

Aligned E-W, robber trench [11] extended from the western limit of investigation, measuring 0.7m wide and at least 0.78m deep, with a very steep southern edge, which became vertical, lower down the profile. Only the vertical lower portion of the northern side survived, due to later truncation. The trench truncated the buried cultivation soil (20) (Figure 5: section 2 and Figure 6: images 3 and 4). Two fills were defined. The upper deposit consisted of dark grey brown sandy silt up to 0.48m thick. The lower fill was slightly lighter in colour: a mid grey clay silt with medium and large slabs of limestone up to 0.32m across. These are considered to be discarded remnants of the robbed masonry wall. Small quantities of animal bone and oyster shell were recovered from the feature (Table 1).

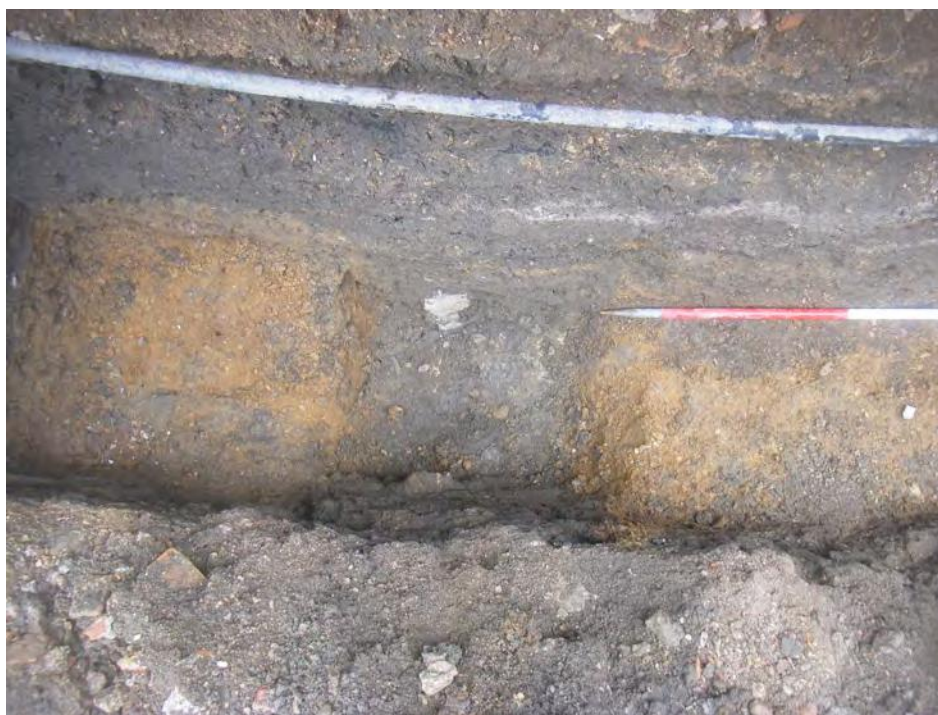
Image 4: Vertical view of robber trench [11], with undisturbed geological strata to either side. Large stones can be seen in the exposed fill (12). The scale is on the fill of pit [14]. Scale 1m in 50cm divisions.

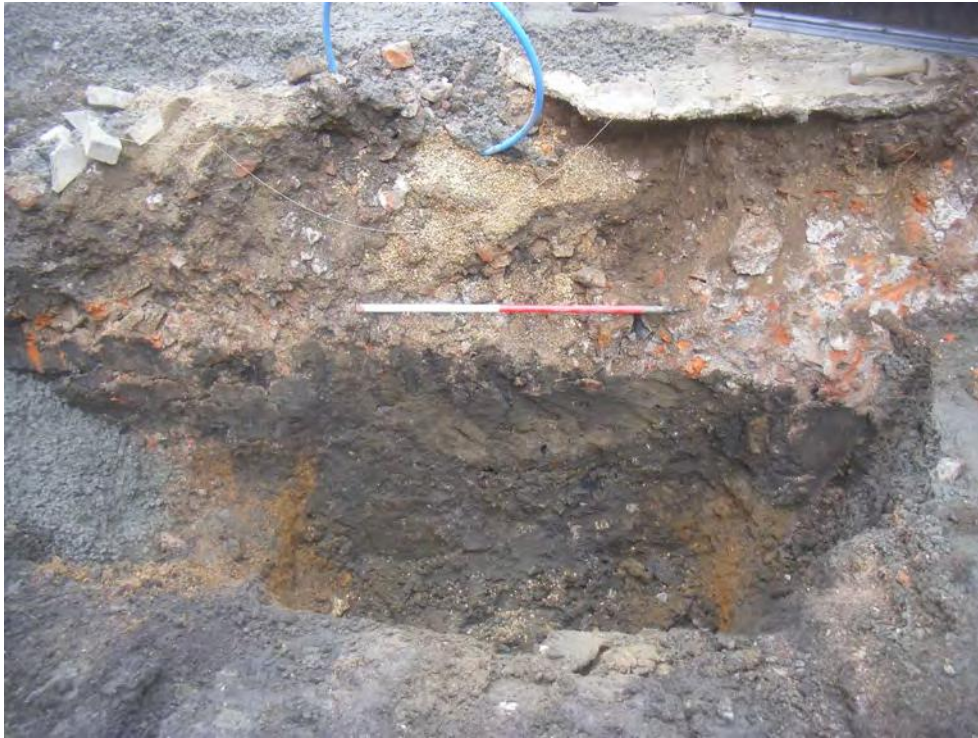
Image 5: Southern face of E-W footing trench showing large robber trench [21] continuing below level of machining. Posthole [25] can be seen immediately to the left. The remains of boundary wall footing [3] are visible in the upper part of the image. Scale 1m in 50cm divisions.

Robber trench [21] was aligned N-S extending from the southern limit of investigation. It was traced for 4.1m to a squared limit in the north, defined against cultivation soil (7/20). In section, the cut was 1.8m wide and at least 1.2m deep with vertical edges, continuing below the limit of investigation (Figure 5: sections 1 and 3, Figure 7: images 5 and 6). The main fill of the feature (22) consisted of dark brown grey clayey silt, at least 1.1m thick; no large stones were visible in this deposit. There was no evidence of weathering or collapse of the sandy gravel edges within the fill, indicating that this material was probably backfilled shortly after the feature had been excavated. A small fragment of post-medieval roof tile (106g) was recovered from this deposit. The other three deposits (23), (43) and (24) were confined to the upper eastern edge of the feature (Figure 5: sections 2 and 3). While (22) and (23) were 0.2–0.4m thick and light yellow brown to mid brown grey in colour, intermediate deposit (43) was a distinctive mixed ashy deposit of dark grey to black, up to 0.14m thick. These deposits are considered to be the results of dumps of material into a hollow left by settling of (22), rather than a later pit. The lowest asymmetrical fill (23) contained a considerable amount of oyster shells.

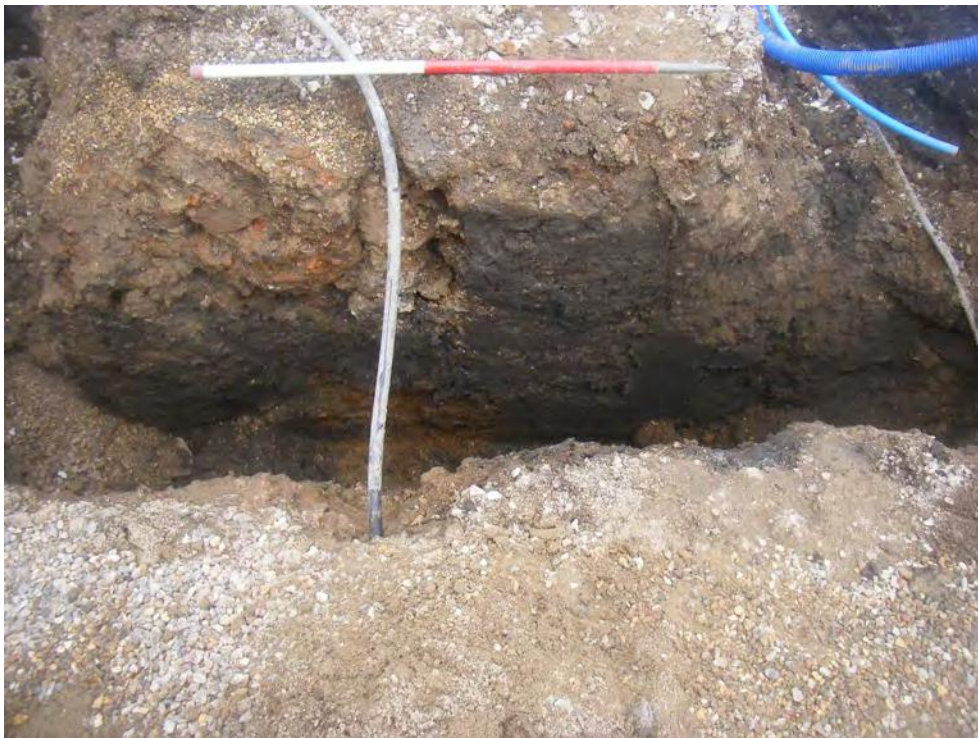
Image 6: Elements of robber trenches [21] and [29] separated by a patch of undisturbed geological strata, above which is cultivation soil (20) – compare with section 3. Scale 1m in 50cm divisions.

A short distance to the east, a third robber trench [29] was identified (Figure 5 section 3, Figure 7: image 6). It was a substantial feature, at least 1.3m E-W by 0.95m deep, with near vertical edges. As only a short segment was

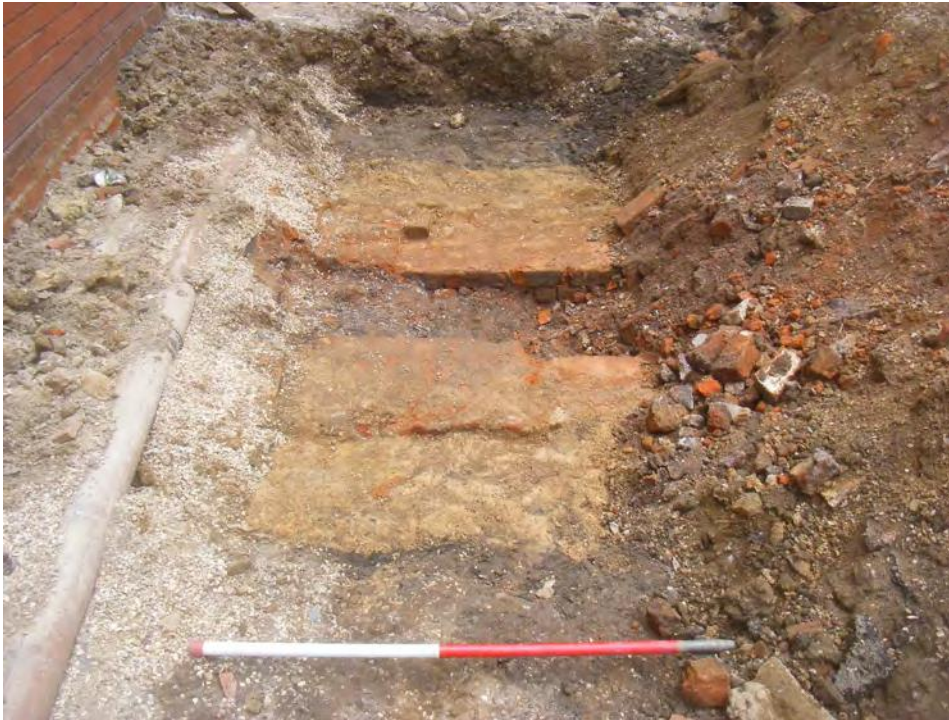
Image 7: Looking across floor of clay tobacco pipe kiln. The face of the flue indicates that the floor was formed of at least two courses of bricks. Adjacent to modern service pipe are traces of a wall, which crosses the flue and appears to define the northern wall of the kiln. Scale 1m in 50cm divisions.

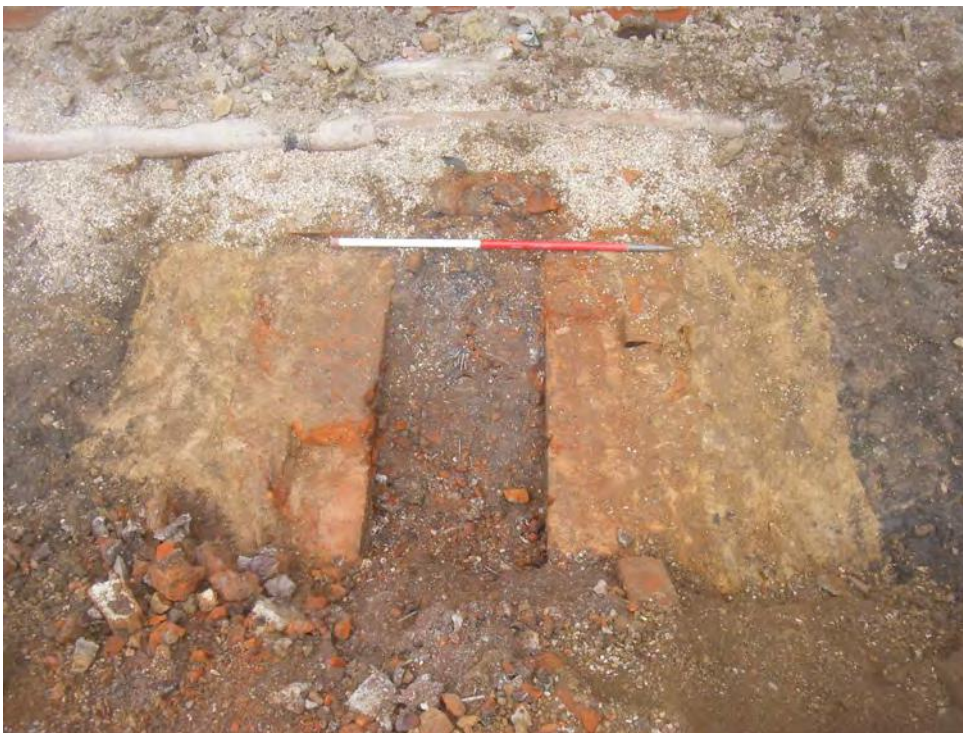
Image 8: Floor of kiln with central flue. Brick structure at end of flue appears to be the back wall of the kiln, indicating that the stoke pit is in the vicinity of the viewer. Scale 1m in 50cm divisions.

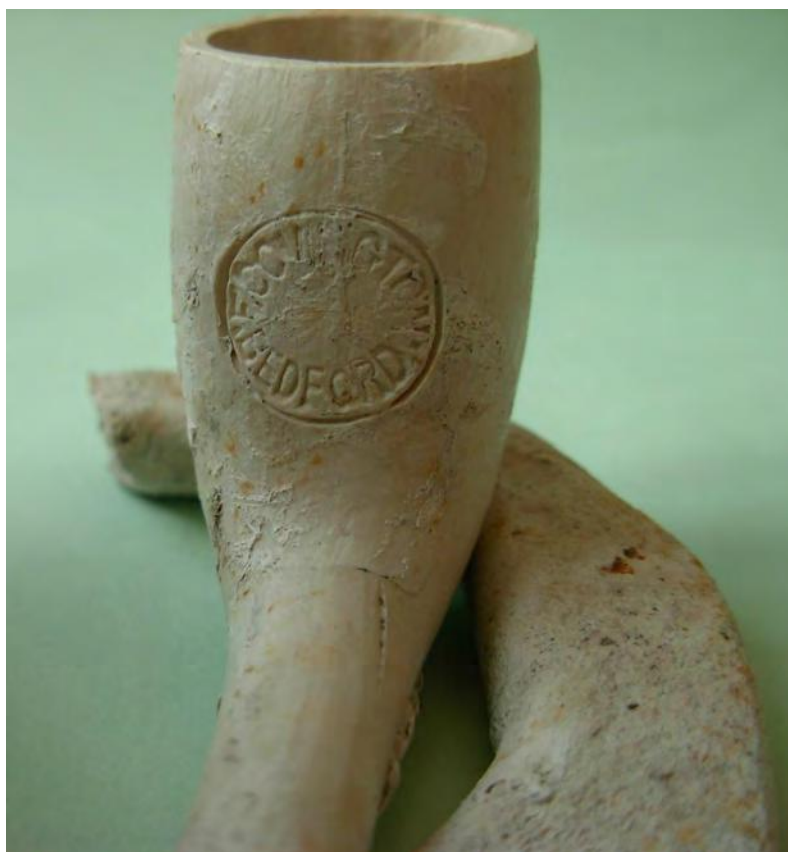
Image 9: Bowl stamp of pipe-maker, F Covington of Bedford

The assemblage comprises fourteen stem fragments (the longest measuring 170mm) and seven complete or partial pipe bowls. The majority survive in good condition, with little abrasion, and all are burnished. Three bowls have partially blackened internal surfaces, indicating use; three are unused, suggesting they were deposited soon after manufacture. Examination of bowl and spur forms suggests a 19th-century date for the assemblage (*cf.* Oswald 1975, 37-41). Locally, forms correspond with mid-late 19th-century types O and R, recovered from earlier excavations in Bedford (Baker and Hassall 1979, 242).

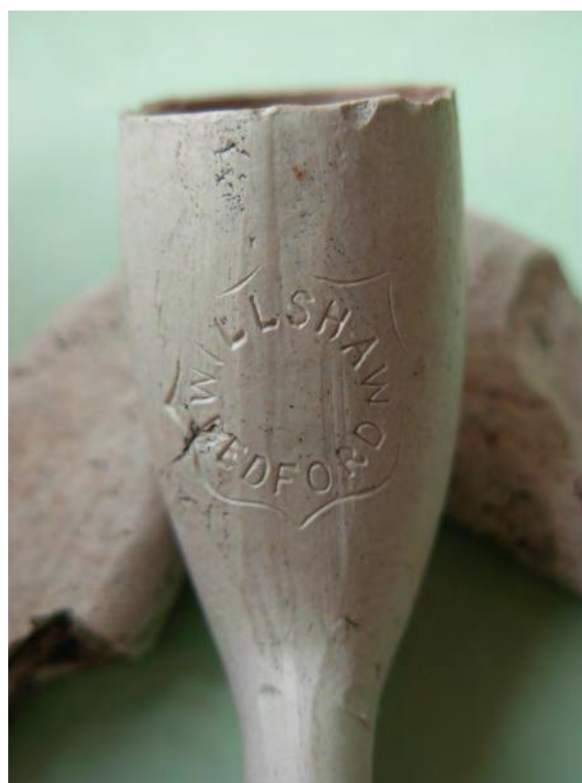
Image 10: Bowl stamp of pipe-maker, Willshaw of Bedford

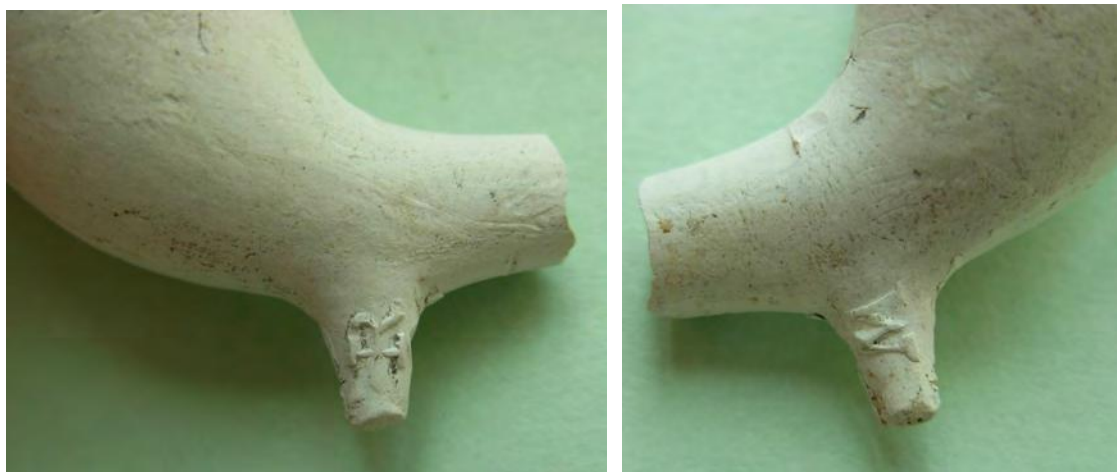
Image 11: Spur stamped with initials RW (Richard Willshaw) on a plain bowl

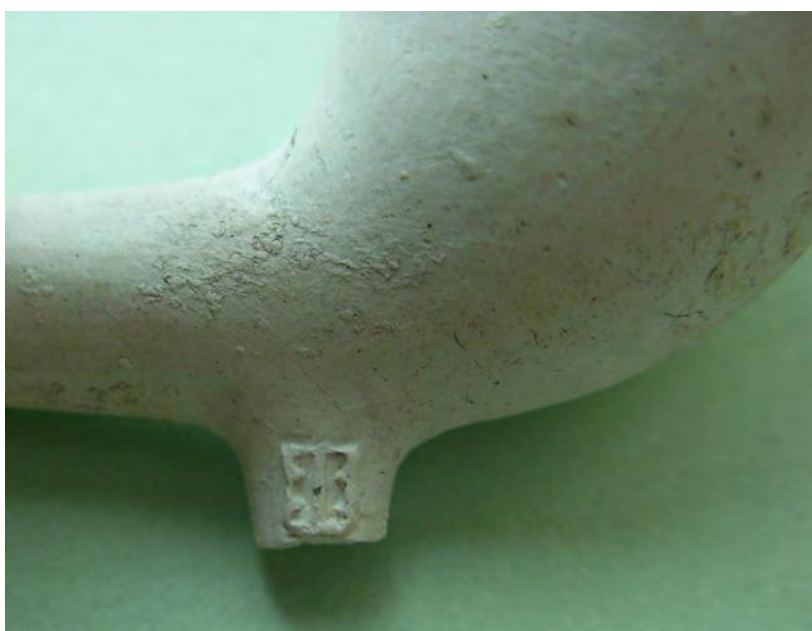
Image 12: Spur stamp from unidentified pipe-maker

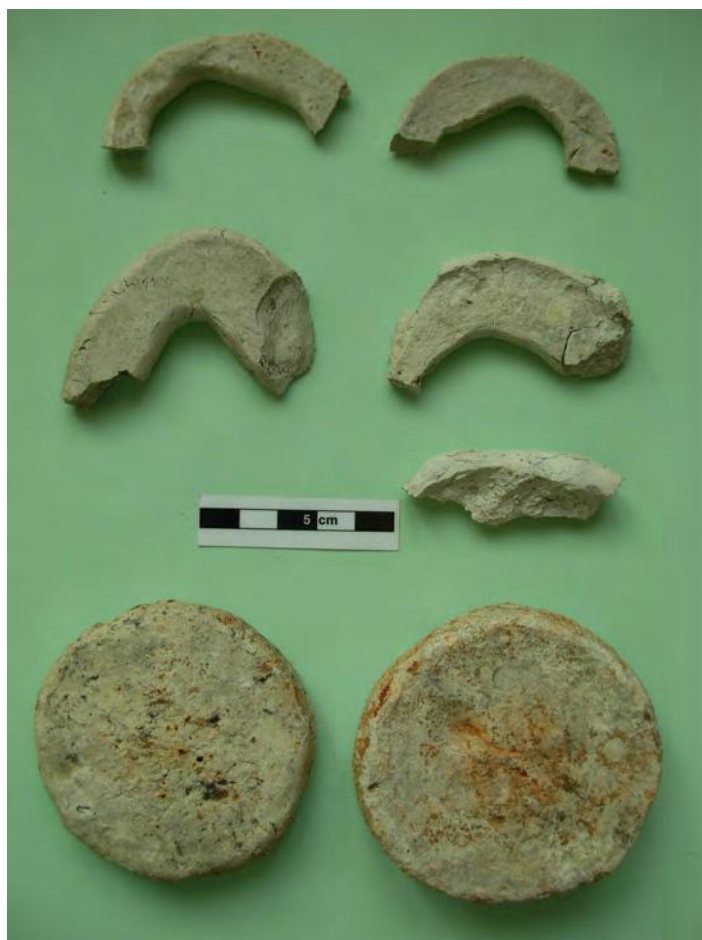
Image 13: Selection of pieces of kiln furniture – ‘ring wads’ and ‘buns’ recovered from the clay tobacco pipe kiln. All the pieces are made from pipe clay. Scale 5cm in 1cm divisions.

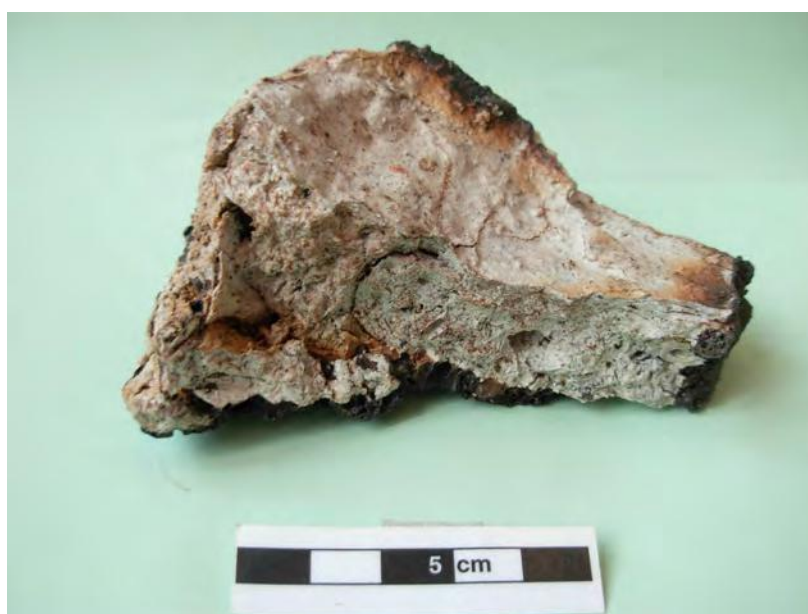
Image 14: Fragment of possible ‘muffle’ or ‘sagger’ made from pipe clay and incorporating clay pipe stem fragments. Scale 5cm in 1cm divisions.

The deposit also contained a vitrified base fragment of a possible sagger or small muffle of indeterminate form (214g), measuring 25–50mm in thickness, and incorporating broken fragments of clay pipe stem. The sagger / muffle would have contained pipes to protect them from direct heat during firing. Three pieces of highly vitrified clay / brick (178g), with glassy surfaces,
