**THE GATE HOUSE
THE COMP
EATON BRAY, DUNSTABLE
BEDFORDSHIRE**

**ARCHAEOLOGICAL OBSERVATION,
INVESTIGATION, RECORDING
ANALYSIS AND PUBLICATION**

Project: GH1998
Luton Museum Accession no. 2012.30
Document: 2012/113
Version 1.0

3rd August 2012

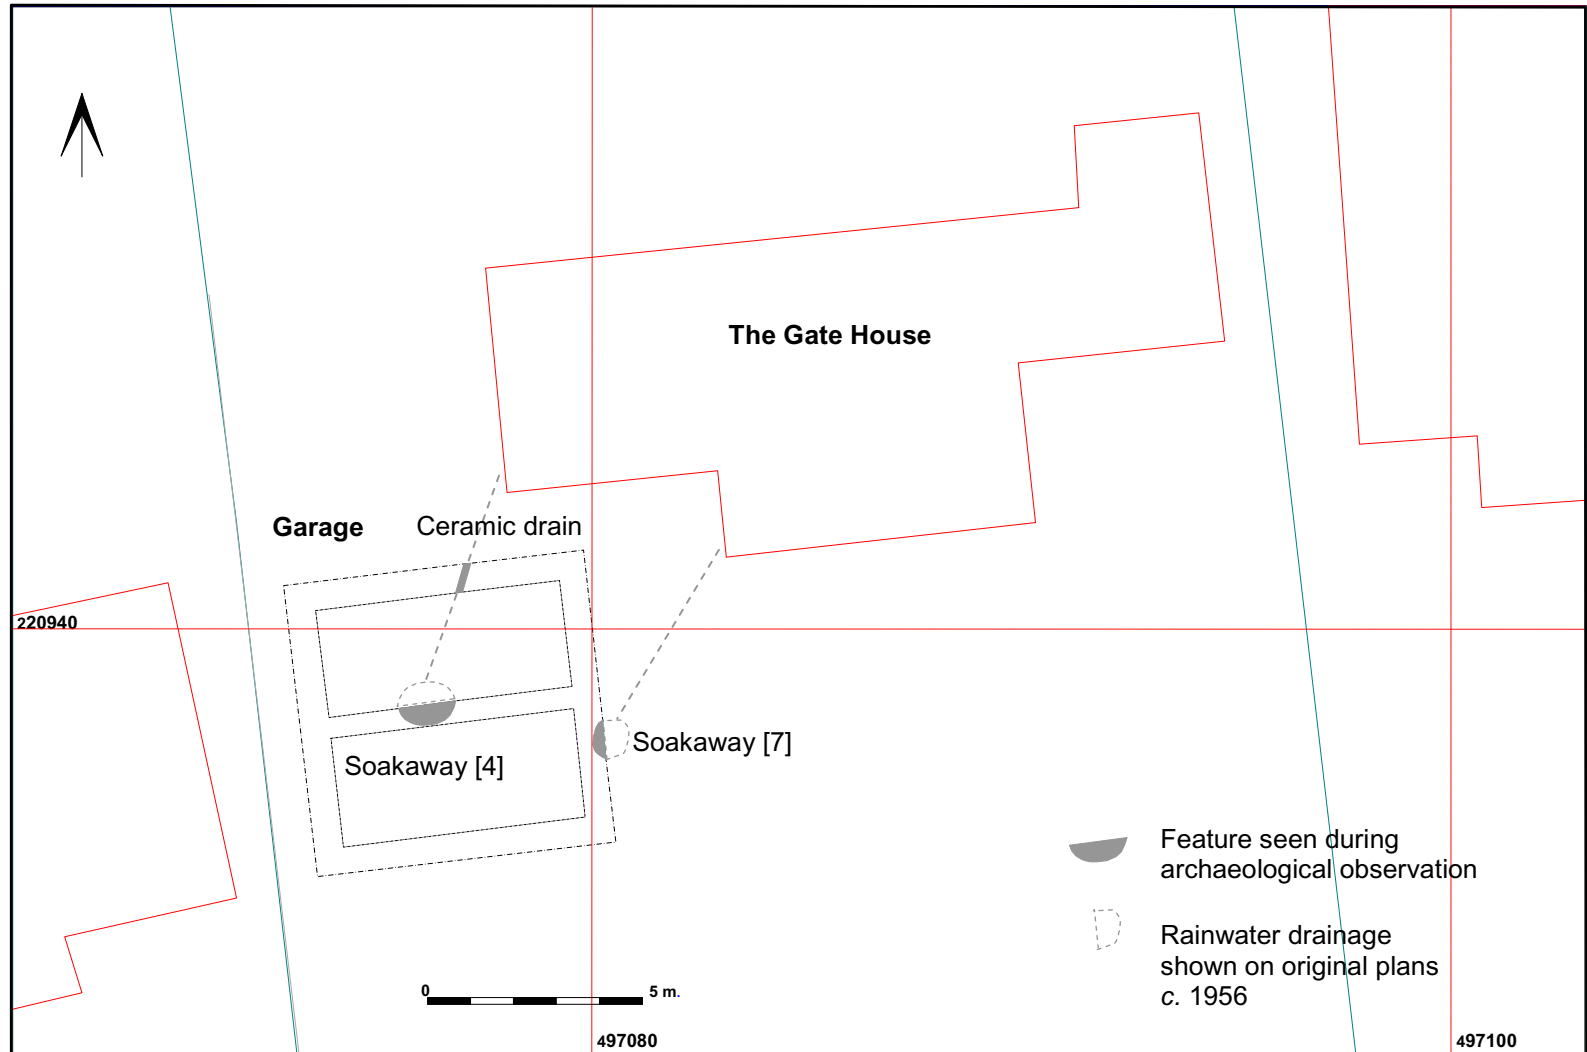
Figure 2: All features plan

Two modern soakaways [4], [7] and an associated ceramic drain were revealed (Figure 2, Figure 3: image 2 and Figure 4: image 3). The soakaways were sub-circular in plan, at least 1.35m across and 0.85m deep, with vertical sides, extending into the geological substrate. They contained brick rubble and had been capped with redeposited topsoil.

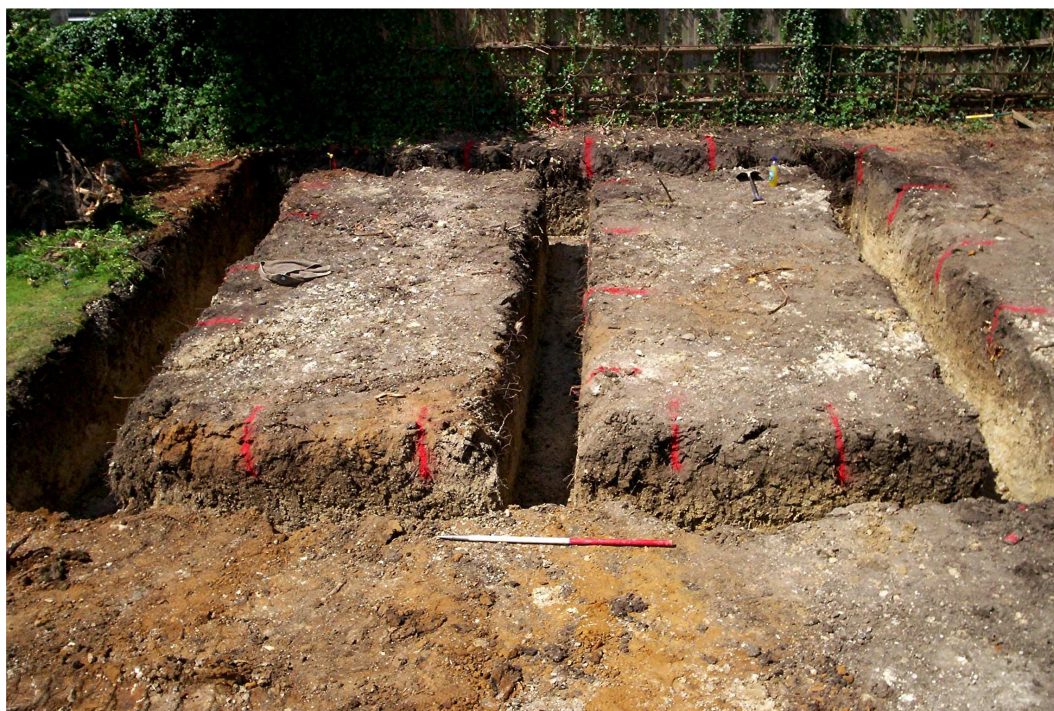
The footing trenches for the garage were opened on 25th July 2012. The trenches were 0.65m wide and generally 1.1m deep (Figure 2 and Figure 3: image 1) and were excavated by a mechanical excavator fitted with a toothless bucket.

Image 1: General view of excavated garage footings, looking west. Scale 1m in 50cm divisions.

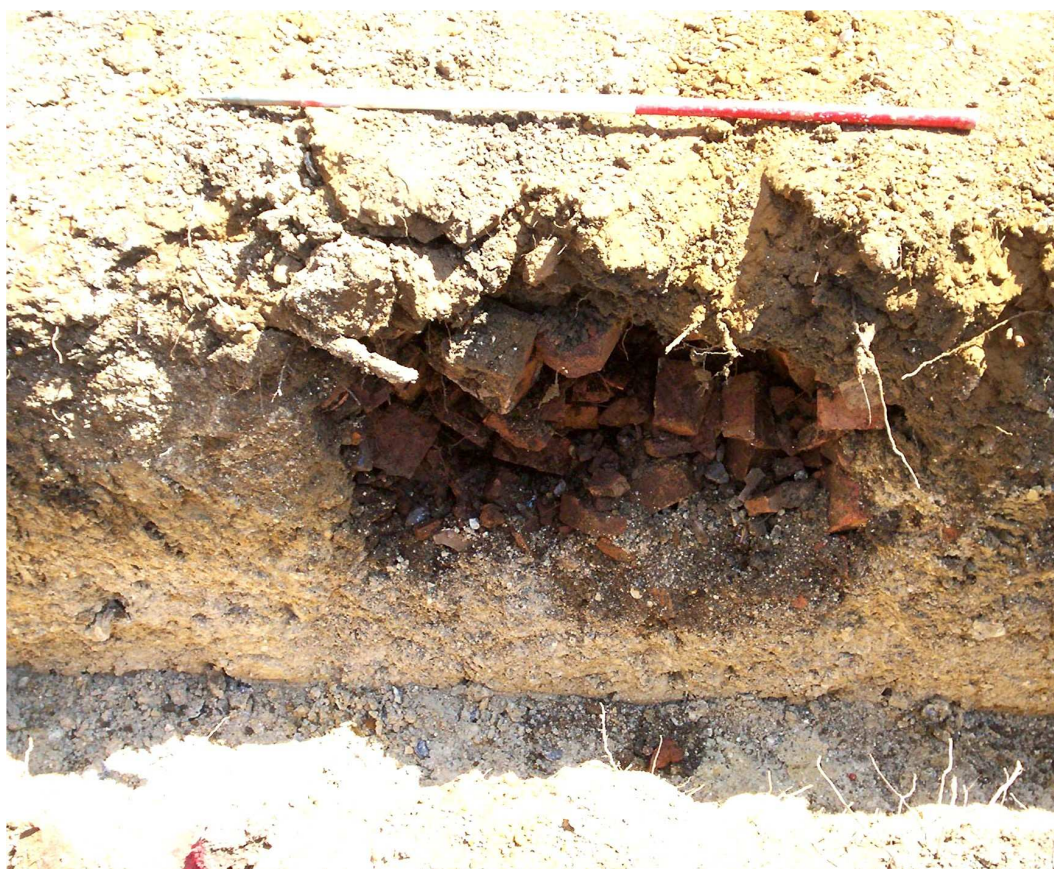
Image 2: Section through brick-filled soakaway [7]. Scale 1m in 50cm divisions.

The two brick-filled soakaways and ceramic drain correspond to elements of the rainwater drainage system shown on the 1956 architect's drawing of the house.

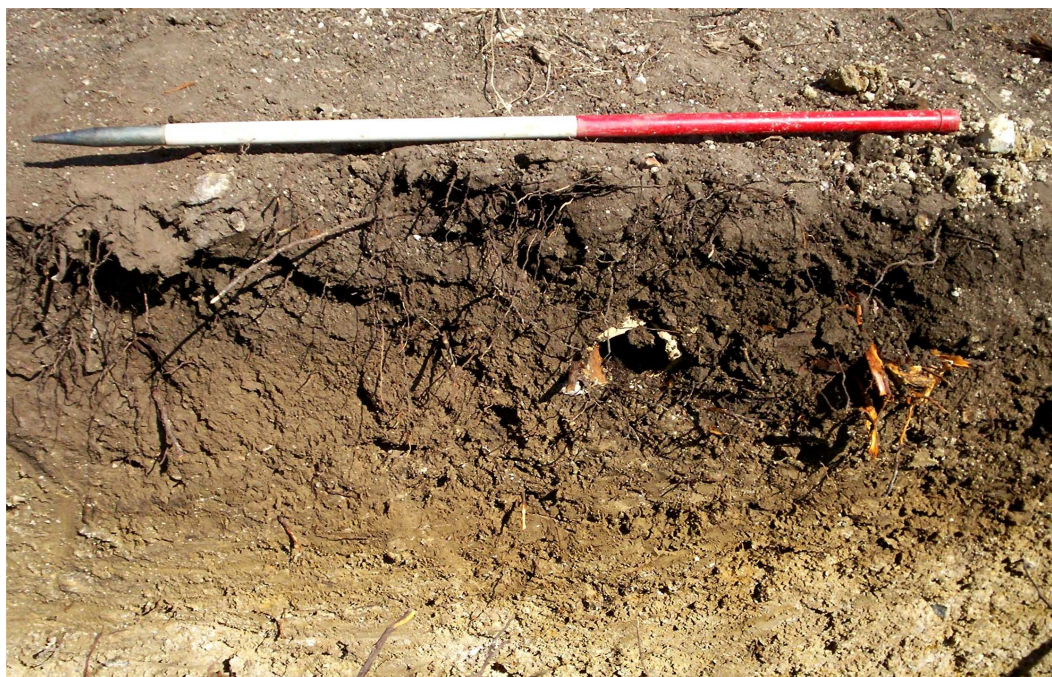
Figure 4: Selected image 3

The trenches revealed dark brown topsoil up to 0.15m thick. This was above mid-dark grey brown clay silt subsoil up to 0.45m thick. This would appear to be an old soil profile. There was no evidence of ploughing associated with arable cultivation. However, this soil may have been associated with the former orchard. No finds were recovered from these deposits.

Below the overburden was undisturbed geological strata composed of light yellow white clayey chalk.

Image 3: Typical soil profiles, with ceramic drain associated with rainwater drainage system. Scale 1m in 50cm divisions.
