**BASMEAD MANOR
STAPLOE
BEDFORDSHIRE**

**ARCHAEOLOGICAL TRIAL TRENCH
EVALUATION**

Project: BM1876

Document: 2013/06
Version 1.0
18th January 2013

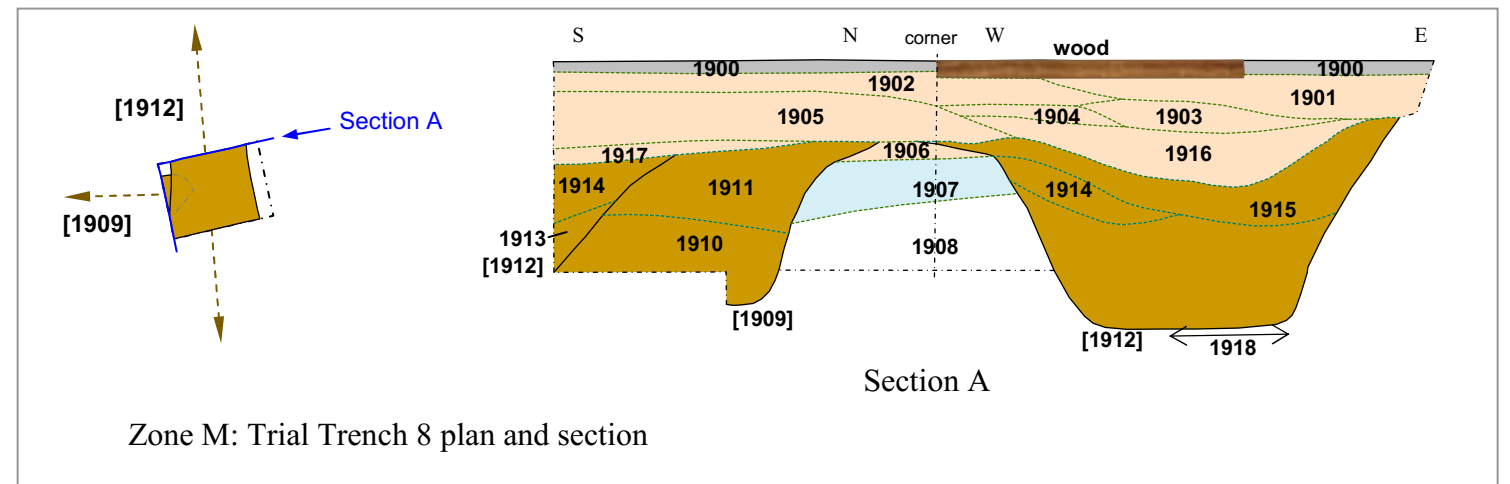
Figure 3: Details of Areas D-F and M

Section D. Trial Trench 7

Zones D-F: detail plan showing results of monitoring and trial excavation

3.4.1 Trench 5 (Figure 3: section C)

3.4.2 Trench 6 (Figure 3: section B)

3.4.3 Trench 7 (Figure 3: section D)

3.4.4 Trench 8 (Figure 3: section A)

In the south-east quadrant of the moated area monitoring and trial excavation produced a consistent picture of the archaeological deposits (Figure 3) — a cobbled surface sealing clean boulder clay. This surface was covered with a thin dark silty layer, probably an organic farmyard deposit which was in turn buried by a layer of imported clay used to raise and level the area. The depth of the levelling deposit varies across the area; it is greatest in the west and the middle, thinning towards the east arm of the moat. Fragments of yellow gault brick noted in the make-up layer suggest a 19th-century date for this deposit. Remnants of a cobbled surface survived at ground level, above the make-up layer. The levelling of the farmyard appears to have been contemporary with the rebuilding and construction of a range of buildings along the south edge of the area (the Long Barn) during the later 19th century.

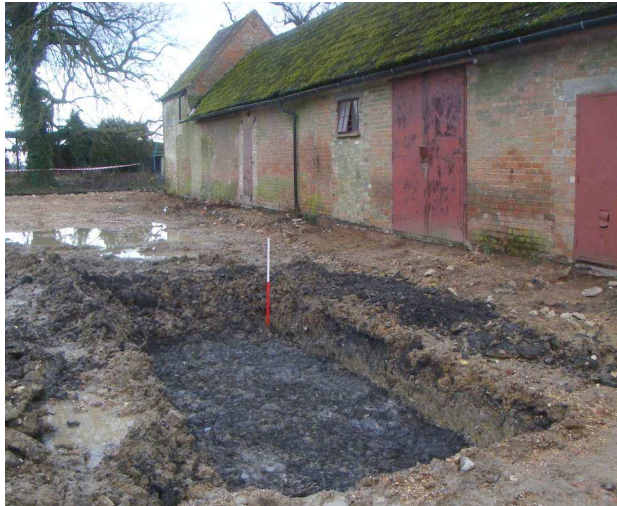
A: Trench 7 looking SE

Earlier cobbled yard surface (1805) in the base of the trench below clay levelling layer. The modern ground level corresponds to the floor level of the 19th-century buildings in the background.

Cobbled surface (1805) was equivalent to that seen in Trenches 5 and 6 but was better preserved. As in Trench 6, it was overlain by a layer of organic material (1804) up to 0.08m thick, which related to its latest period of use. Part of the surface was lifted at the eastern end of the trench; this showed that it lay directly on undisturbed boulder clay (1806).

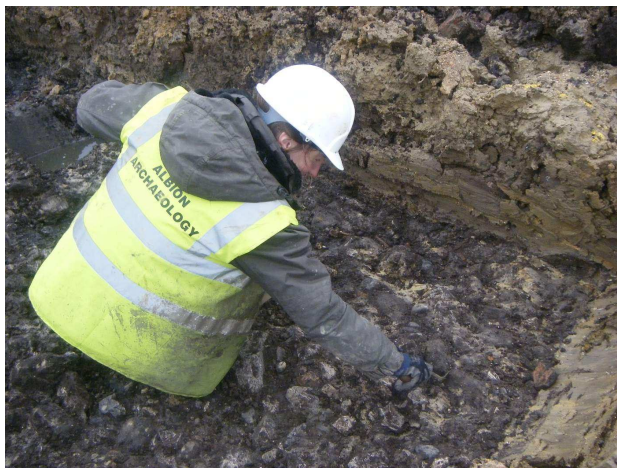
B: Trench 6

Cleaning cobbled surface (1705) with clay levelling layers above the cobbled surface visible in section.

A cobbled surface (1705), corresponding to the one in Trench 5, was present. The cobbles measured 5–15cm and were better preserved at this point. The level of the surface dropped towards the south end of the trench. It was overlain by a brownish black organic deposit (1704), up to 0.04m thick, probably comprising a farmyard trample deposit. The cobbles were left *in situ*.

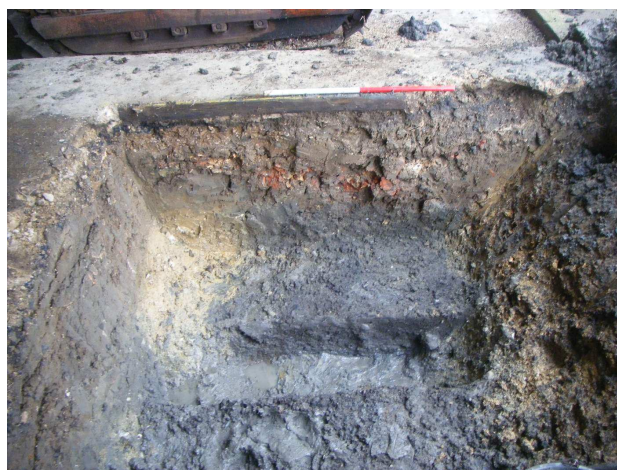
C: Trench 8 looking north

Section through ditch [1912] with rubble and make-up layers above.

Two ditches were present within this trench. The larger more visible of the two [1912] was 2.1m wide and 1.1m deep, with steep sides and a flat base. On a broadly north-south alignment the ditch lies perpendicular to the moat and may have originally joined the moat which is situated approximately 12m to the north. A thin layer of wood (1918) was found in the base of the ditch. A smaller east-west aligned ditch [1909], 1.5m wide and 0.7m deep, was partially visible in the west side of the trench. This appeared to join the larger ditch and was probably broadly contemporary.
