**WHITEHOUSE FARM  
TILSWORTH ROAD, STANBRIDGE  
BEDFORDSHIRE**

**ARCHAEOLOGICAL FIELD  
EVALUATION**

Project: WHF1950  
Museum accession no: LUTNM 2012.22

Document: 2012/111

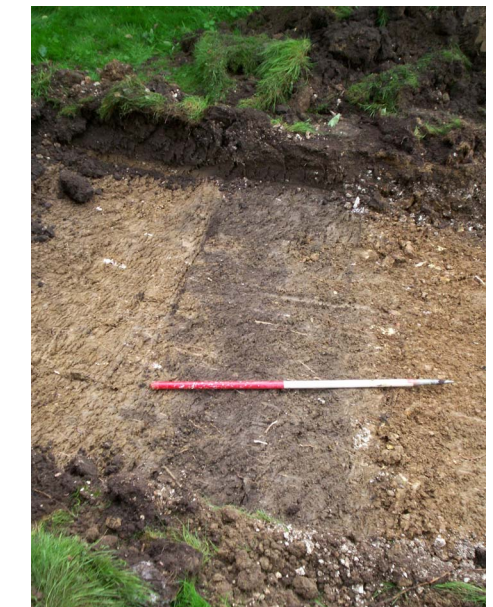
A shallow ENE-WSW aligned ditch [805] was revealed in Trench 8 on the same alignment as the existing garden hedge. Ditch fill (806) contained a complete clay tobacco pipe bowl with a flat heel and milled rim, datable to *c.*1640–1660. Just to the south of the ditch was a shallow, gravel- and clay-filled footing trench [808], which probably helped support an overlying chalk pathway (see below).

Trench 8: Field boundary [808]

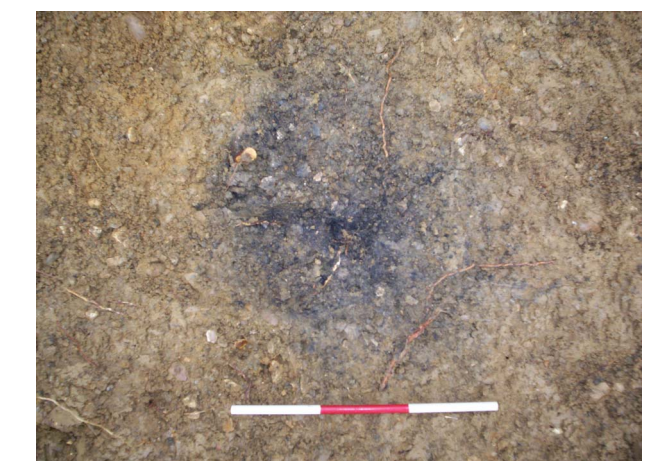
An isolated, un-urned cremation burial [803] was located towards the northern end of Trench 8 (Figure 2, Section 2 and photograph). No human bone was visible during excavation, but a very small quantity (2g) of burnt bone — including several tooth crowns — was recovered from a sieved soil sample. A visual appraisal of the assemblage identified the best preserved fragments as a partially complete first maxillary incisor crown and two deciduous molar crowns from a child of around 3 years at death<sup>4</sup>. The cremation was completely excavated so all human remains from the feature have been recovered and removed from site.

Trench 8: Cremation [803]

One exception is the small un-urned cremation burial that was revealed in Trench 8. The fact that this contained human remains raises the significance and likelihood of any further potential assets of a similar nature from low to moderate and the impact of the potential development on those deposits is therefore classed as moderate to high.

Any such potential impact could be mitigated by means of a suitable programme of archaeological works.

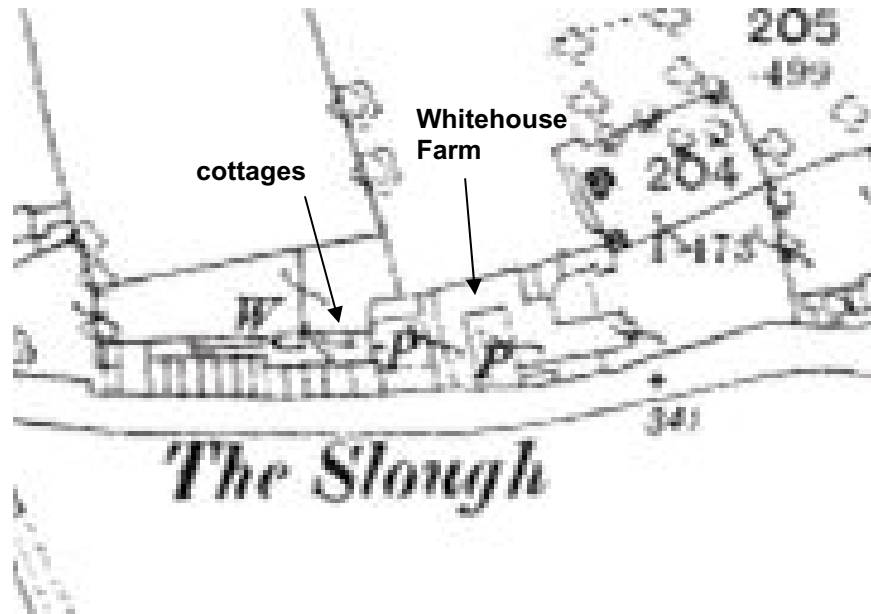
Figure 3: 1882 25-inch first edition OS map

The 17th-century tobacco pipe bowl could indicate that the boundary is part of the pre-enclosure and late medieval layout of fields in this area. The ditch is shown on the 1881 OS map (Figure 3) and the boundary is still in existence today.
