**HOLME MILLS HERITAGE PROJECT
HOLME
BIGGLESWADE
BEDFORDSHIRE**

ARCHAEOLOGICAL DESK-BASED ASSESSMENT

Project: HM1622
Document: 2010/15
Version 1.0

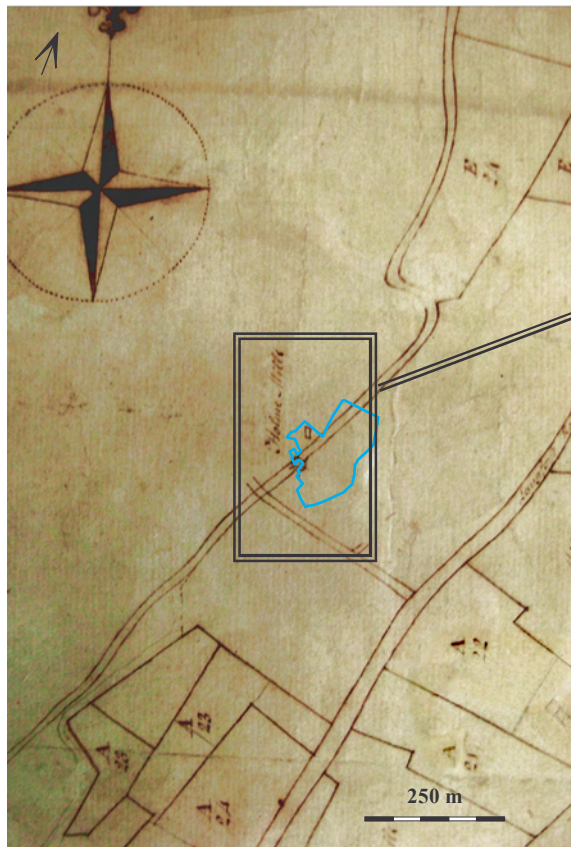
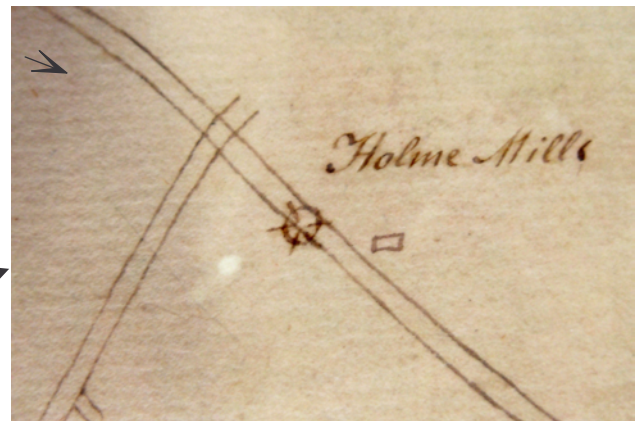
Figure 4: Detail of mill from the map of Holme for Sarah, Duchess of Marlborough. Dating to the 1730s or 1740s. Scale and position of Development Area are approximate.

Map of Holme for Sarah, Duchess of Marlborough – HA 527 (Figure 4)

Although undated, this depicts the area in the 1730s or early 1740s. This is the earliest depiction of a mill at the site, showing a waterwheel labelled as ‘Holme Mills’ (Figure 4). This is a schematic map, although it does contain useful information. A rectangular building is shown on the west bank of the river, which, although away from the waterwheel, would appear to be associated, as few buildings are shown in any detail. The map also shows the original course of the River Ivel, with a crossing point to the south of the mill.

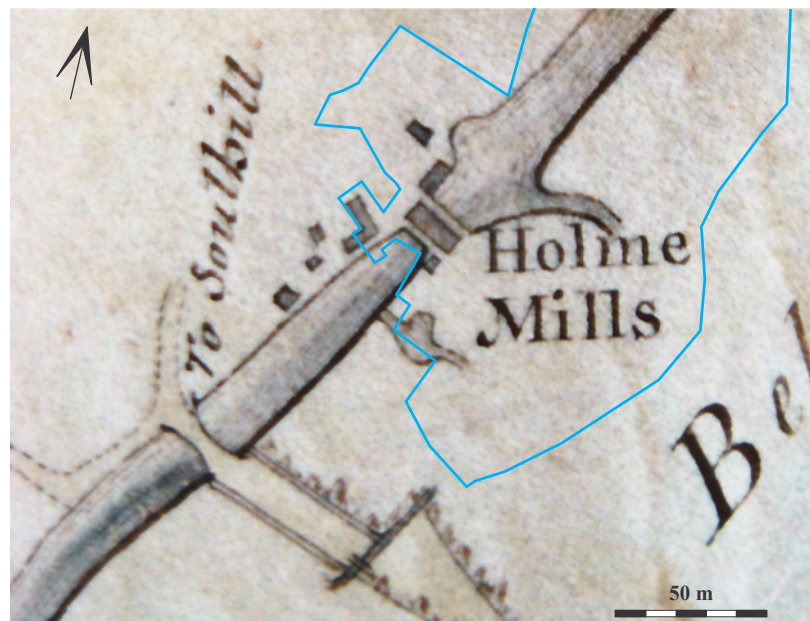
Figure 5: A Plan and Survey of Holme Estate 1781. Scale and position of Development Area are approximate.

1781 Plan and Survey of Holme Estate – HF 400/1 (Figure 5)

The mill and associated buildings near the River Ivel are shown in considerable detail for the first time, although the grey tone indicates that they are not part of the estate of the Right Honourable Earl Spencer. Only parts of the area are depicted, with the eastern leat ending abruptly, as it extends into an area labelled ‘Land belonging to Dean and Chapter of Westminster’.

The map indicates that a leat extended eastwards from the main channel of the River Ivel. The mill building straddles the main channel a short distance south of the junction of the leat and main channel. Only part of the eastern mill island is shown, with a small square structure located a short distance south of the mill, against the bank of the river.

A series of buildings are shown adjacent to the west bank. Immediately to the north of the mill against the channel is a rectangular building aligned roughly north-south, with a regular ‘indent’ into the river bank, at the northern limit. The location may suggest that this is a landing place for boats to load/unload. A perpendicular, rectangular building is located to the north-west. A series of buildings are located to the south of the mill; the main one is an inverted L-shape in plan with three smaller buildings to the south. The main building roughly corresponds to the location of the present Miller’s House.

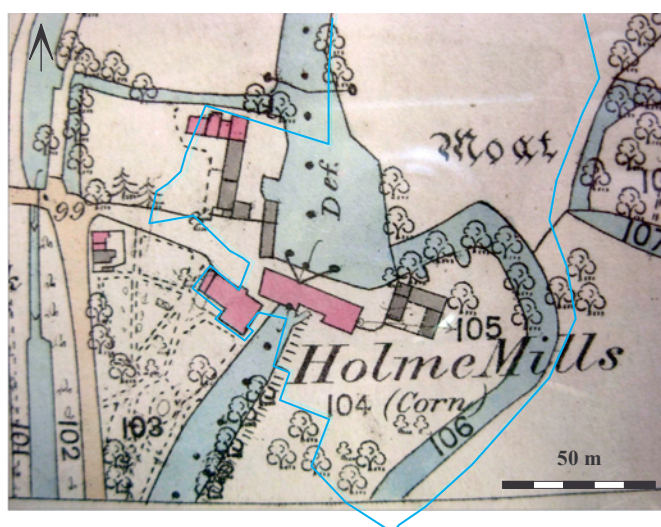
Figure 7: 1884 Ordnance Survey 25-inch map, first edition. Scale and position of Development Area are approximate.

1884 Ordnance Survey 25-inch map, first edition (Figure 7)

The map indicates a complex series of leats and channels associated with the corn mill, which is clearly defined straddling the main channel. Most of the channels correspond to those shown on earlier maps. The mill is significantly longer than the current building at almost 39m (c.130’), with a central segment of narrower width. This is likely to correspond to the buildings shown on an 1890 picture of the mill (Howes 2009, 92) (see Section 2.2.5). Immediately south of the mill, a narrow channel diverges from the main channel, heading north-eastwards towards the middle of the central segment of the building, before stopping — probably entering an enclosed leat. A short distance to the south-west is the Miller’s House with associated paths and garden in the triangular area to the south, defined by the converging watercourses of the main channel and the Ivel Navigation. Cottages are located to the west, adjacent to Broom Road; three main buildings and a smaller outbuilding to the south are shown within a defined area. Two main blocks of ancillary buildings are associated with the mill, comprising an inverted L-shaped range with outliers in the area north-west of the mill. A second range of buildings to the east of the mill defines a central enclosed yard.

The northern ancillary buildings are located adjacent to the angle between the main channel and the east-west arm of an L-shaped leat, which extends to the Ivel Navigation. This leat does not appear on the earlier maps. An irregular series of four square to rectangular structures, which range from 7.4m square (24’ 6”) to 9.25m (31’) long and 3.7–7.4m wide (12’–24’ 6”) define the northern extent. This approximates to the site of the rectangular building shown on the 1781 map. Two larger structures define the main component to the east, with the larger example measuring approximately 15m (50’) long and 5.6m (18’ 6”) wide. Two smaller structures cluster around the southern extent of this range. The western side of the main channel is lined by two rectangular buildings, which are slightly smaller than the large structures immediately to the west. These two structures correspond to the building present in 1781. The ‘indent’ north of these buildings was still present, measuring c.8m north-south by 6m. This would seem to be too small to be a loading dock. The main channel is very wide immediately downstream of the mill, at the junction with the eastern by-pass leat. Whilst this may have been to ensure the swift movement of water away from the mill, it may have also provided access to water transport.

Situated immediately south of the junction of the main channel and the by-pass leat was a series of four buildings. These defined three sides of a yard, with a wall defining the southern side and a narrow passageway in the south-west, leading towards the mill. Two regular ‘indents’ are shown in the

southern edge of the by-pass leat in the vicinity of the buildings. These 'indents' are slightly smaller than the one described previously.

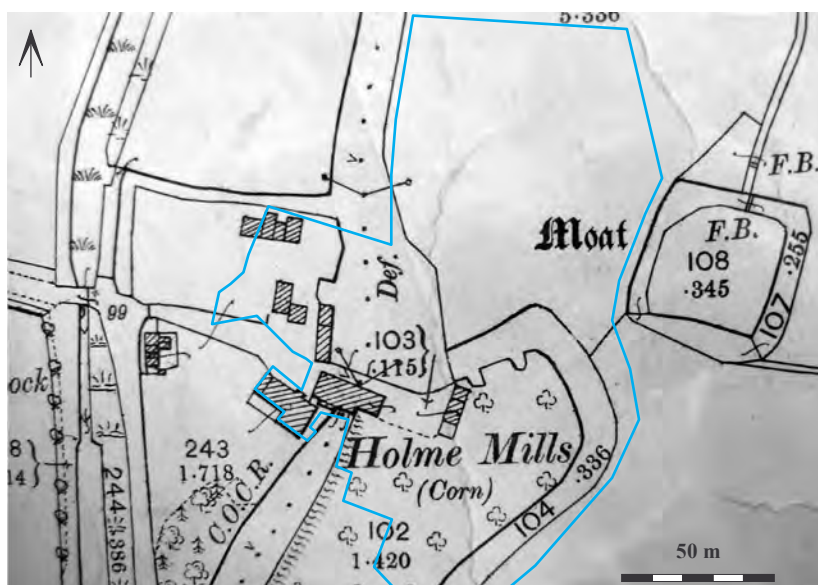
Figure 8: 1901 Ordnance Survey 25-inch map, second edition.
Scale and position of Development Area are approximate.

1901 Ordnance Survey 25-inch map, second edition (Figure 8)

This map shows no change to the watercourses associated with the mill, although the Ivel Navigation north of the Holme Mills lock is shown as marshy ground. There has been a significant change to the mill building and ancillary structures, some of which may be associated with the fire of 1899 (BLARS X758/1/3). At this time, William Jordan, who had been a tenant since 1894, became owner of the mills.

The mill building has undergone significant change, being shortened, but having a similar form to the earlier mill, with a narrower segment in the east (similar to the earlier central segment). This is likely to be the rebuilt yellow brick mill following the 1899 fire. A small addition has been added to the south elevation of the mill, on the west bank of the main channel, which corresponds to the stairwell. There is no sign of the narrow channel, which diverged from the main channel on the 1884 map. The significance of this is uncertain.

The northern ancillary buildings now form isolated groups as the largest element of the eastern range of buildings has been demolished, as has at least one of the smaller structures at the southern extent of this range. The two buildings on the western bank of the main channel are unchanged, although a boundary which connected them to the main cluster of buildings to the west has gone, indicating a change of access into this area.

Most of the ancillary buildings to the east of the mill have gone, with only a single range of three buildings and possible open structure to the south. The location and north-east to south-west alignment of this range of buildings suggests that these correspond to the western range of buildings depicted on the previous map, with partition of the southern building. The two 'indents' in the by-pass leat are still present.

The Miller's House is unchanged, though no detail is shown of the garden area to the south, apart from the trees towards the southern tip of the island. It is not clear if the garden had gone, or if the survey simply omitted such detail.

The cottages adjacent to the Broom Road have undergone change, with the northern building being extended, whilst the southern buildings have been replaced by smaller structures.

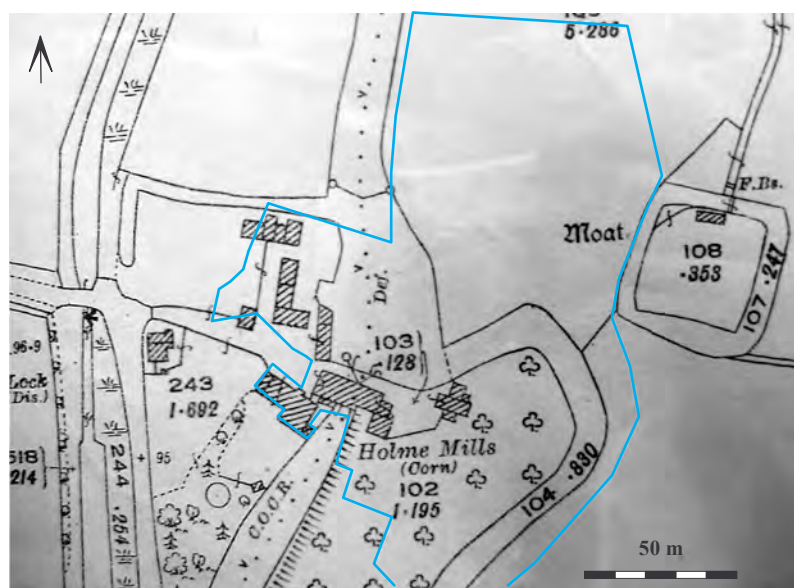
Figure 9: 1926 Ordnance Survey 25-inch map, third edition.
Scale and position of Development Area are approximate.

1926 Ordnance Survey 25-inch map, third edition (Figure 9)

Minor changes have occurred to the watercourses associated with the mill. The L-shaped leat, defining the northern and north-eastern limits of the mill site is now shorter, stopping north of the roadway. The two 'indents' in the southern bank of the eastern by-pass leat have gone. The lock on the Ivel Navigation is shown as 'disused'.

The mill building has been extended to the east, with a new range of two buildings of different size forming a perpendicular range, extending to the south. These are likely to correspond to buildings shown on a 1910 picture of the mill (Howes 2009, 15) (see Section 2.2.5). A wider yard has been created in the area to the east, extending to the ancillary buildings.

The northern ancillary buildings have undergone change, whilst the northern component of four buildings is unchanged. A new building has been added to the south, linked by a roughly north-south boundary to the northern buildings. A short distance to the east a new L-shaped range of buildings has been created, utilising the larger of the early buildings as its core and adding to the north and south. The buildings on the western bank of the main channel are still present, although the northern building may have been altered.

The eastern ancillary buildings have also undergone change. It would appear that the central building in the range has been enlarged.

A minor extension to the Miller's House is apparent, extending from the south-east corner, towards the main channel. The garden also appears to have undergone change with the wooded area extending northwards and the addition of a circular pond.

Two cottages are now present adjacent to Broom Road, set within a larger land parcel. Whilst it is possible that the northern cottage has undergone alteration rather than being rebuilt, the southern example is definitely new, being much larger than the buildings shown previously.

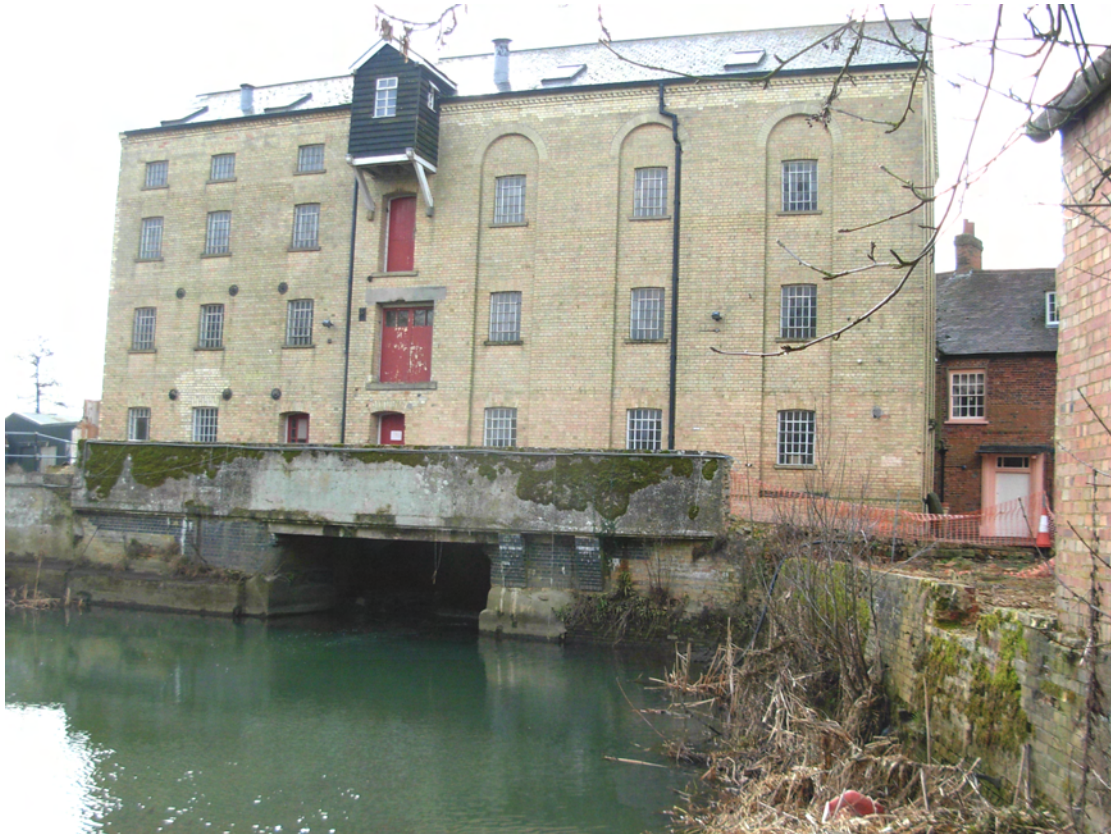
Figure 10: Northern elevation of the mill (with red brick Miller's House beyond and ancillary buildings at right-hand margin of the image).

On the western side of the main channel the horizontal timber lap building can be seen. The red brick footings of this are visible today in a recently cleared area of site adjacent to a 20th-century building (Figure 10).

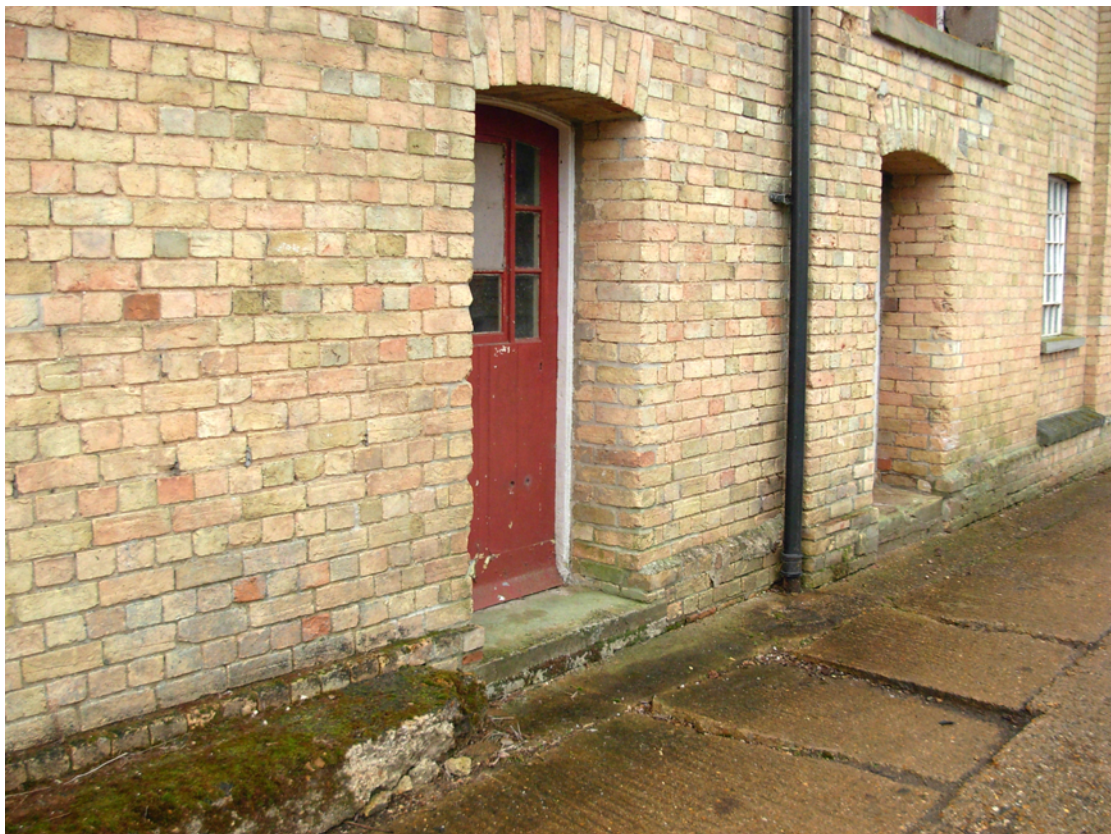
Figure 11: Detail of ground floor of northern elevation of mill, with off-set lower brick courses.

The combination of the photographs and the first and second edition Ordnance Survey maps suggests that the current yellow Arlesey brick mill was built on the footings of the earlier mill; the maps indicating very similar dimensions. It is not clear if this explains the off-set lower brick courses visible in the current mill walls (Figure 11).
