**15 SILVER STREET
BEDFORD**

**ARCHAEOLOGICAL OBSERVATION,
INVESTIGATION, RECORDING
ANALYSIS AND PUBLICATION**

Project: SB2018
Accession no.: BEDFM:2012.56
OASIS ref.: albionar1-135048

Document: 2013/20
Version 1.0

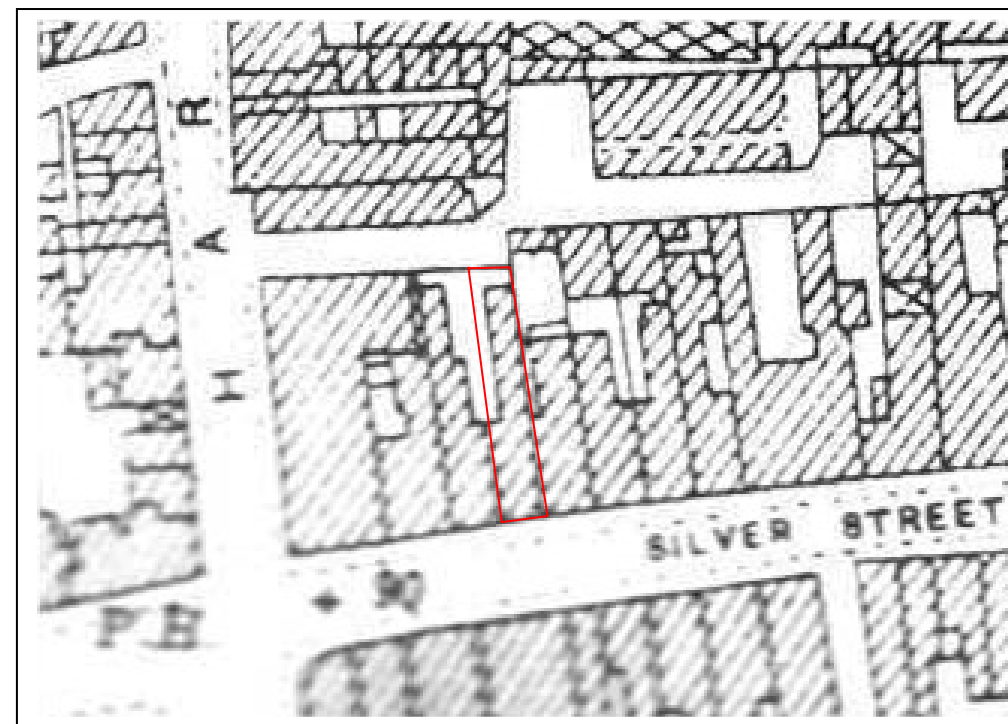
Map 3: Detail from third edition Ordnance Survey map of 1924

The 1924 3rd edition Ordnance Survey map shows the building to occupy the full width of the plot at the street frontage, though tapering to the rear, with a narrower building occupying the eastern side of the plot (Figure 2: Map 3). The western side of the plot was open, extending to Hawes Court.

It is not possible to determine the structural function of the pier. The pier base was similar in appearance/composition to the other modern foundations found in the trenches. It is not clear, however, what it was supporting. The N-S aligned foundation [12] appears to correspond to the western side of the long narrow building which is shown to the rear of the property on the 1924 Ordnance Survey map (Figure 2: Map 3).

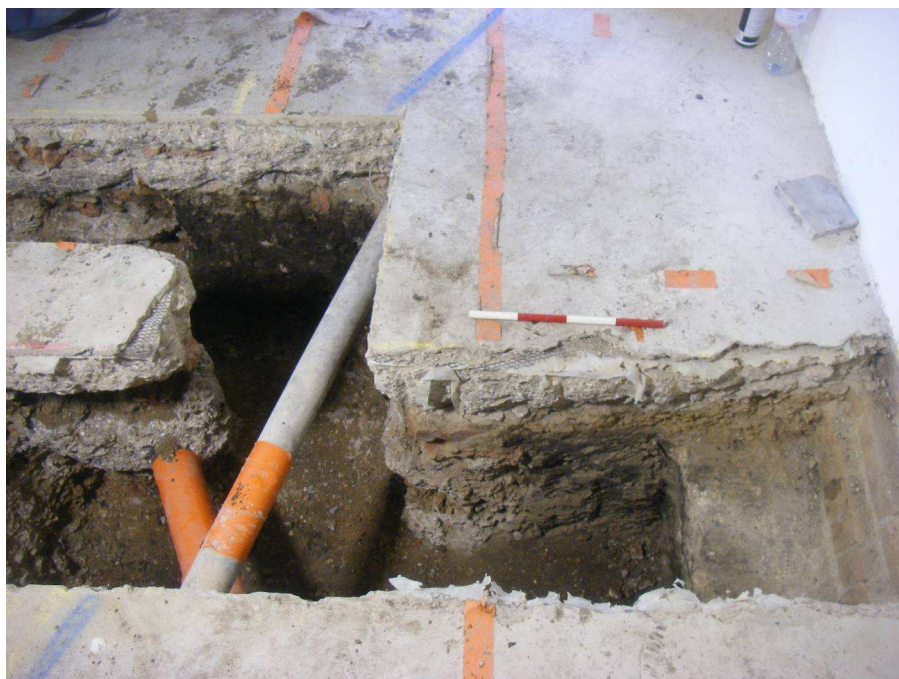
Image 1: Eastern end of Trench 1 looking north (scale 40cm)

The image shows concrete pier [9] in the centre, wall foundation [8] at right-hand side and dark soil layer (5) between.

The internal floor slab consisted of concrete (1) laid over a make-up layer (2) (Figure 3: Section 2 a/b, Figure 4: Images 1 and 2). The composition of the floor which included a vapour control layer and expanded metal mesh shows that the floor has been replaced in the modern period, i.e. in the last few decades.

The foundations of the east and west sides of the current building were observed at either end of the trench. The foundations at the east side of the building [8] consisted of a stepped brick plinth on top of a concrete strip foundation extending down to the undisturbed gravel (Figure 4: Image 1). The wall at the west side of the building was built over a relatively shallow concrete strip footing [18].

Evidence of earlier structures consisted of a N-S aligned concrete foundation [12] in the middle of the trench and a square or rectangular concrete pier [9] with remains of brickwork at the top (Figure 3: Section 2b, Figure 4: Images 1 and 2). The full western extent of the pier was not apparent due to disturbance associated with service trenches in this area.

A deep layer of soft, dark brown or black silty soil was found across the whole trench, (5) and (11), (Figure 3: Section 2a/b, Figure 4: Images 1 and 2). It was up to 0.6m thick and was cut by all of the modern intrusions for services and foundations. The layer contained a moderate concentration of small stones, occasional fragments of charcoal and a few fragments of animal bone. A single sherd of transfer-printed earthenware was recovered from approximately half-way down the profile. The base of the layer was lay 1m below the modern ground surface on undisturbed gravel (31). The thickness and nature of the deposit would indicate a cultivation soil, probably hang-dug garden plots.

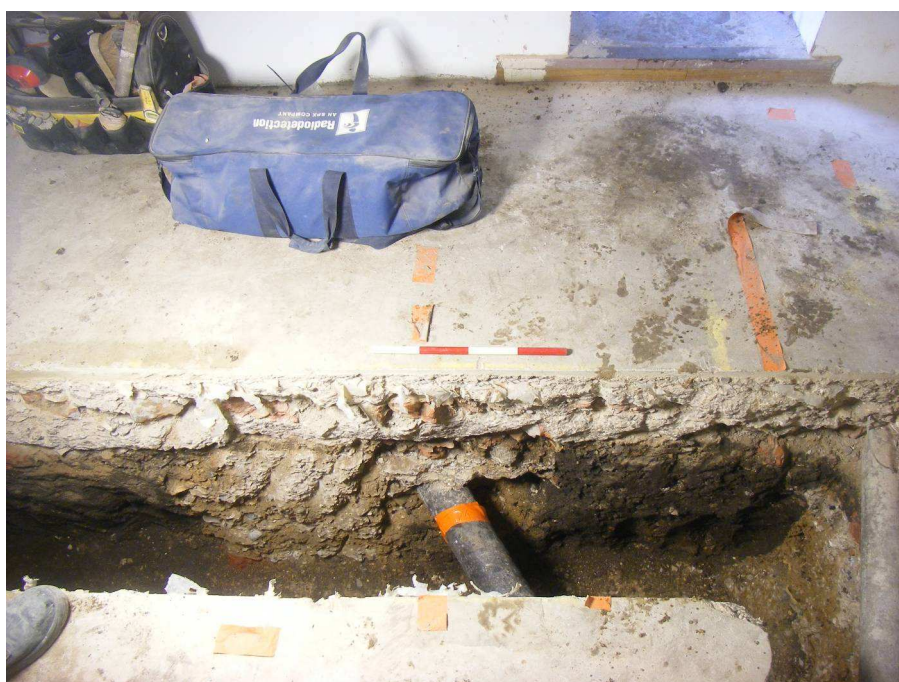
Image 2: Central part of Trench 1 looking north (scale 40cm)

The image shows sewer trench [14] in the centre, the concrete foundation of a former wall [12] immediately to the left and dark soil (11) to either side.

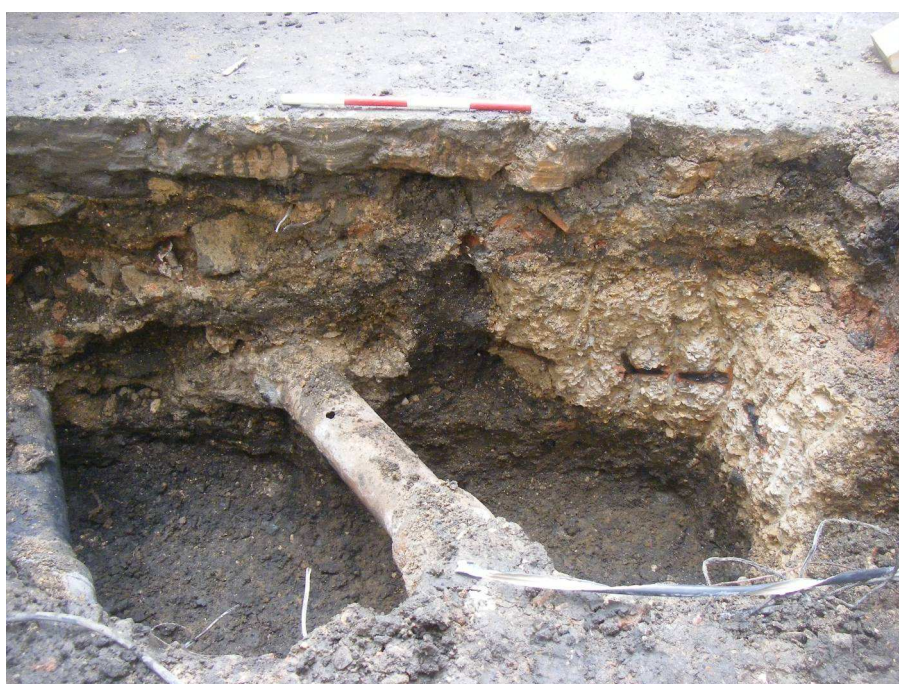
Image 4: Eastern end of Trench 2 looking north (scale 40cm)

The image shows concrete foundation [26] at the right and service trenches [22] and [24] in the left hand half, all cutting the dark soil layer (30) which is visible in the base of the trench.

The existing concrete yard surface (20) was laid over a mixed layer of soil and brick rubble (21) (Figure 3: Section 1 and Figure 5: Image 4).

Foundation [26], a concrete strip footing in the NE corner of the trench (Figure 5: Image 4), was aligned with the north wall of a small extension at the rear of the property, which contained a lobby and toilet. Foundation [28] was a large N-S aligned concrete footing which formed a continuation of the western side of the property. It was at least 0.8m wide and 0.8m deep (Figure 3: Section 1). The size of this foundation contrasts with the smaller foundation [18] seen in Trench 1, which formed part of the same wall-line.

The trench contained a layer of very dark soil up to 0.7m thick (Figure 3: Section 1, Figure 5: Images 3 and 4). It lay directly above the undisturbed geological strata in the base of the trench and was cut by the foundations and service trenches (Figure 5: Image 4). A few fragments of animal bone were observed and a small amount of pottery dating from the Saxo-Norman and early medieval periods was recovered. The deposit contained no other occupation debris.
