**LAND AT GREYFRIARS
BEDFORD**

**ARCHAEOLOGICAL TRIAL TRENCH
EVALUATION**

Project: GF2074

Document: 2013/02
Version 1.0
10th January 2013

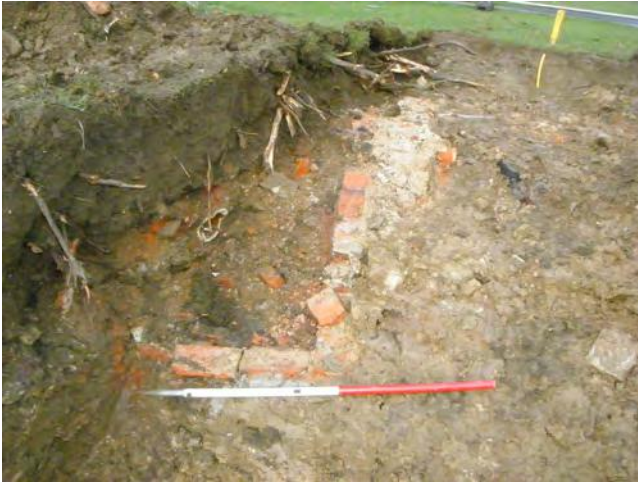
At the northern end of the trench the remains of cellars [105, 106] or deeper brick foundation remained partially intact.

Trench 1: Remains of Victorian foundations [105]

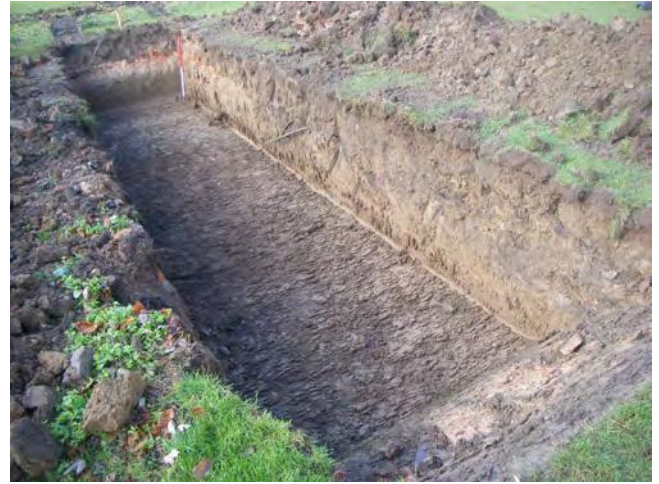
Topsoil (400) comprising dark grey brown clay silt was present to a depth of 0.35m. This overlay layers containing a large amount of brick rubble (401) measuring up to 0.5m thick. These represent the remains of the 19th-century foundations and their demolition. A clay layer (402) is probably made up ground raising the level prior to the construction of the 19th-century buildings.

A buried subsoil (403), similar to that observed in Trench 2, comprised a grey brown silty clay, up to 0.35m thick. This overlay brown grey clay geological deposits (404), with reddish silty inclusions, at a depth of *c.* 1.1m.

Trench 4: view from the east end of trench

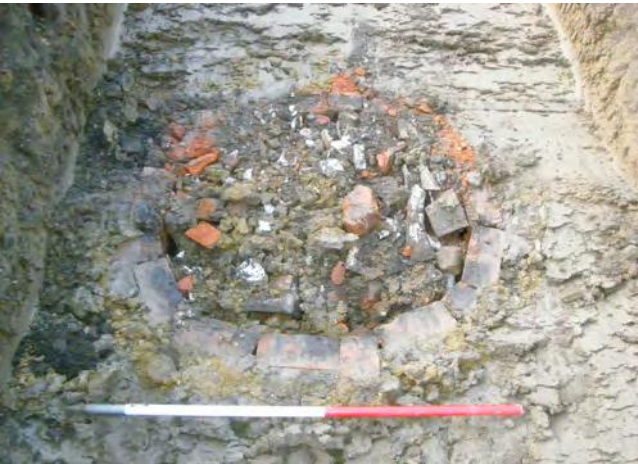
The remains of a brick well or soakaway [507] associated with the Victorian buildings was also present.

Trench 5: 19th-century well/soakaway [507]

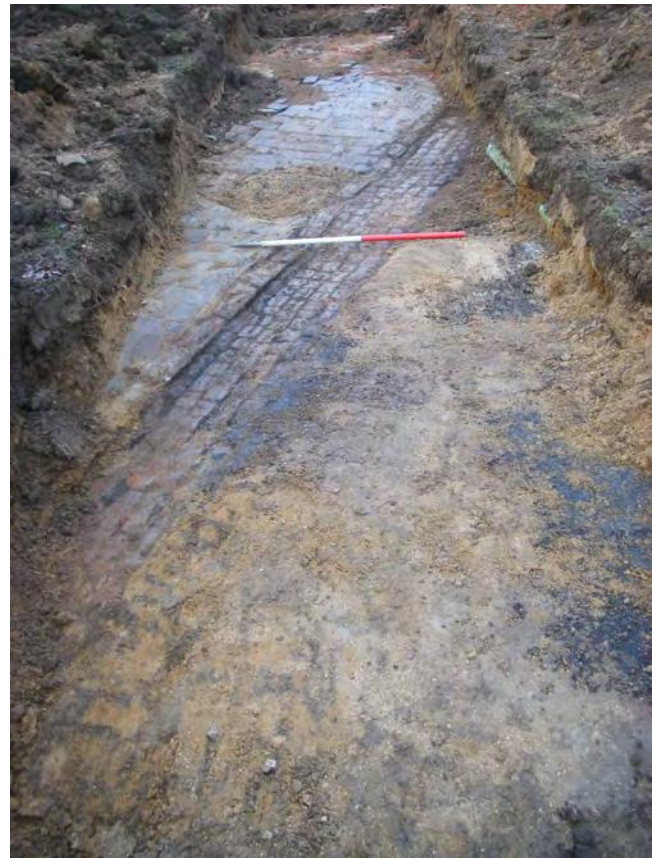
The south-east end of the trench was excavated to a depth of *c.*0.5m. At this level a tarmac road surface (306), cobbled gutter (305) and path (304) were revealed along with a possible lamp post base [307] and the brick foundations of a building (313) running along the former street front.

Trench 3: Extant road (306) gutter (305) and path (304) viewed from the south-east
