**THE OUTDOOR CENTRE
HILLGROUNDS ROAD
KEMPSTON
BEDFORDSHIRE**

**PROGRAMME OF ARCHAEOLOGICAL
OBSERVATION, INVESTIGATION, RECORDING,
ANALYSIS AND PUBLICATION**

Document: 2005/28
Project: OCK1052

Produced for:
Bedfordshire County Council

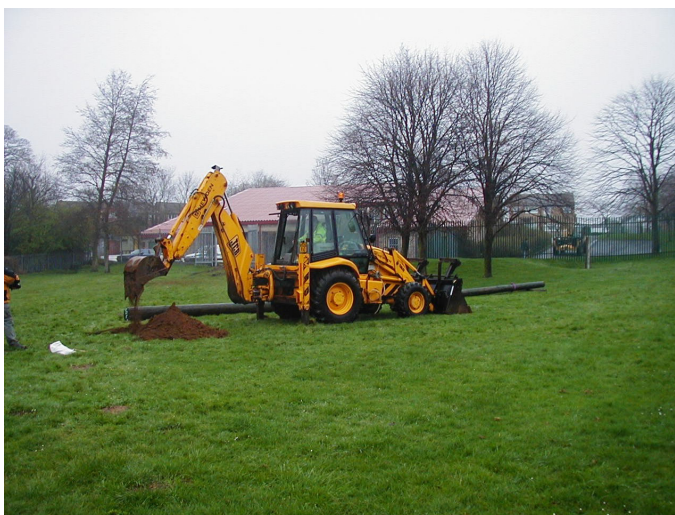
Plate 1:
General shot during excavation

The groundworks consisted of the excavation of six postholes within an area of c.100m² to the south-west of The Outdoor Centre (See Figure 1). The post settings were excavated by a wheeled excavator (JCB) with a 0.5m wide toothed bucket. They were approximately 2.5m in length, 0.6m in width and 2m in depth to accommodate 16m high posts.

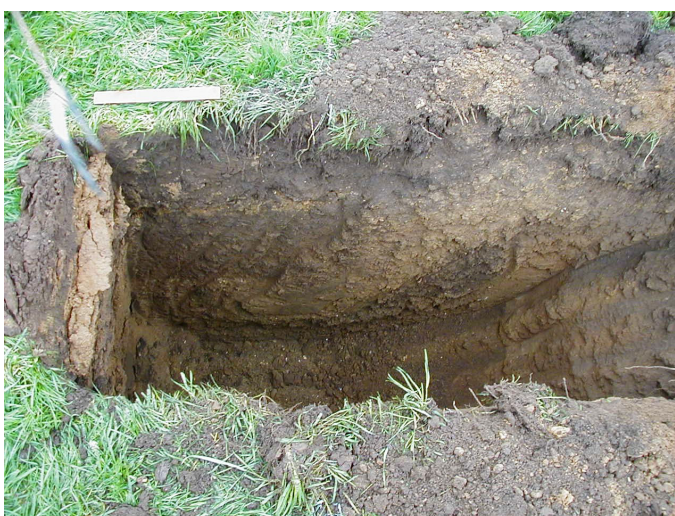
Plate 2:
Representative posthole

Underlying topsoil, a subsoil of likely alluvial origin was encountered approximately 0.4m thick (101), (202), (301), (401), (501) and (601). This has been subject to modern disturbance around postholes 2, 4 and 5 (Section 2.4.2). A further underlying subsoil/alluvial deposit was approximately 0.8m thick (102), (202), (302), (402), (502) and (602). This was observed overlying geological deposits.

The underlying geological deposits (103), (203), (303), (404), (505) and (606) consisted of river gravels and were encountered at approximately 1.6m below the current ground surface.

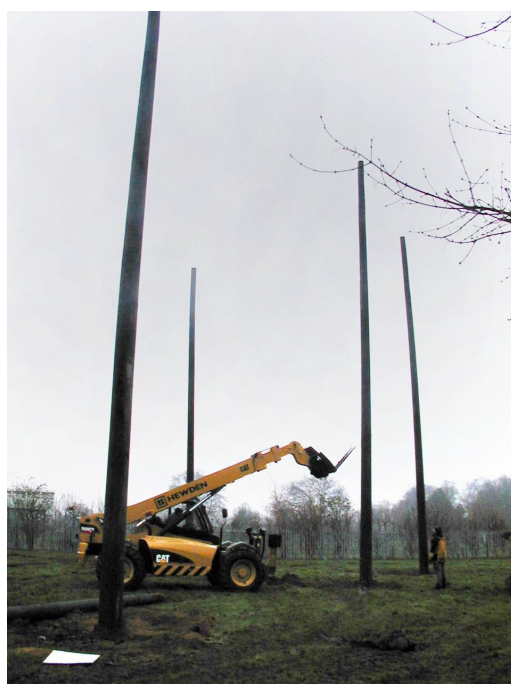
Plate 3:
General shot during post erection
