**LAND AT 29-31 ST JOHN'S STREET  
BEDFORD**

**ARCHAEOLOGICAL OBSERVATION,  
INVESTIGATION, RECORDING, ANALYSIS AND  
PUBLICATION**

Project: SJB 1277

Document: 2013/05

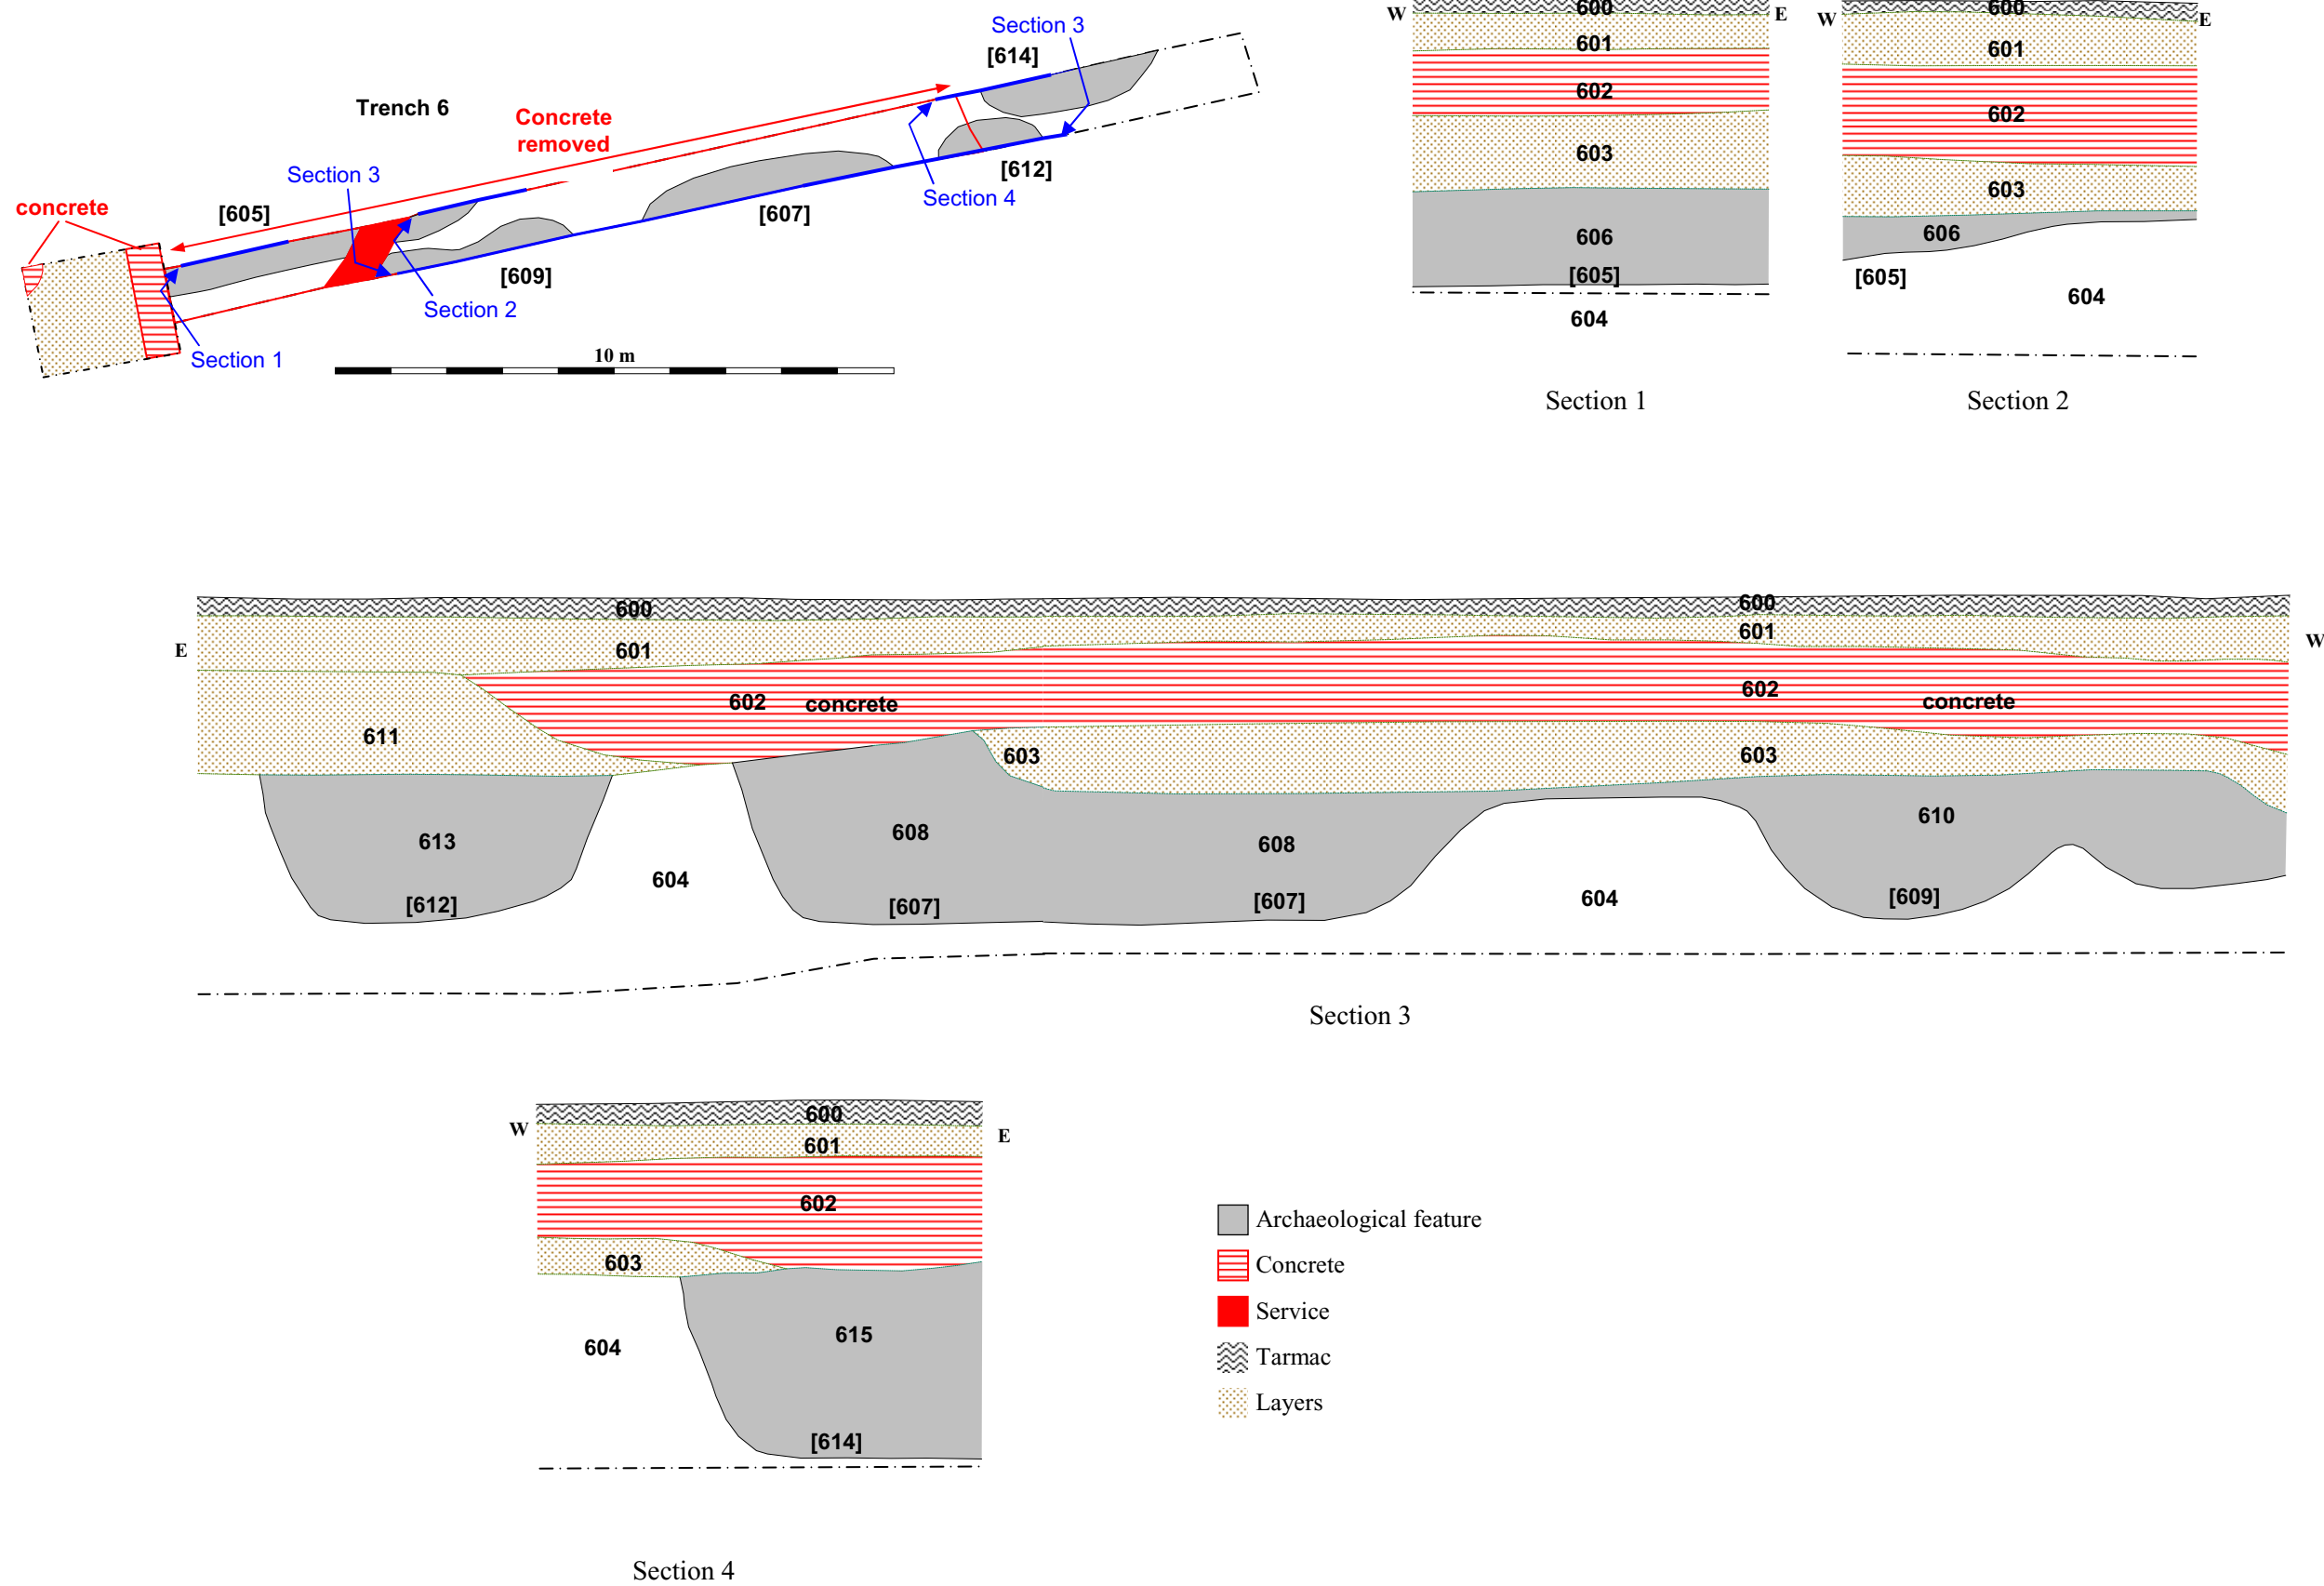
**Figure 3: Sections**

Trench 6 was dug to lay a sewer pipe along the north side of the tower block in the area close to the St John's Street frontage (Figures 2 and 3; Image 1). The trench was 1m wide and 1.9–2m deep. Safety considerations due to the depth of the trench meant that observations were made from the top of the trench with features being identified in section.

The base of the trench extended into an undisturbed geological deposit (604), sandy gravel. At least five separate cuts were identified [605], [607], [609], [612] and [614] cutting into the gravel to depths of 0.6–1m. Some of the pits appeared to be very large features; [605] for example continued for at least 6.5m in section. The complete profile of one pit [612] was visible in section. It was 2m wide and 0.8m deep with steep sides and a flat base. The majority of the other pits were steep-sided with flat bases. Feature [609] appeared to be the remains of two inter-cutting pits with rounded bases. The fills of the pits consisted of dark greyish brown or dark brown sandy silts. No finds were recovered. The archaeological features in the trench were covered by up to 1.2m of modern overburden, which included brick rubble layers and a 0.45m thick layer of concrete (602).

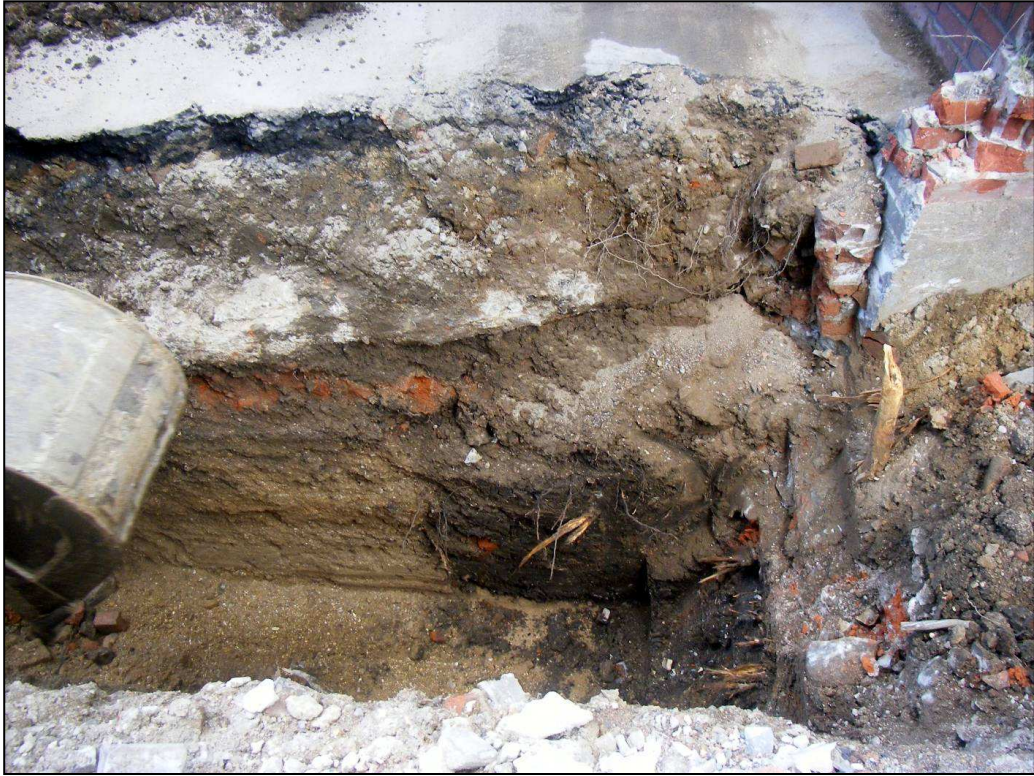
**Image 1: Trench 6 (sewer trench)**  
Showing pit [614] in south-facing section

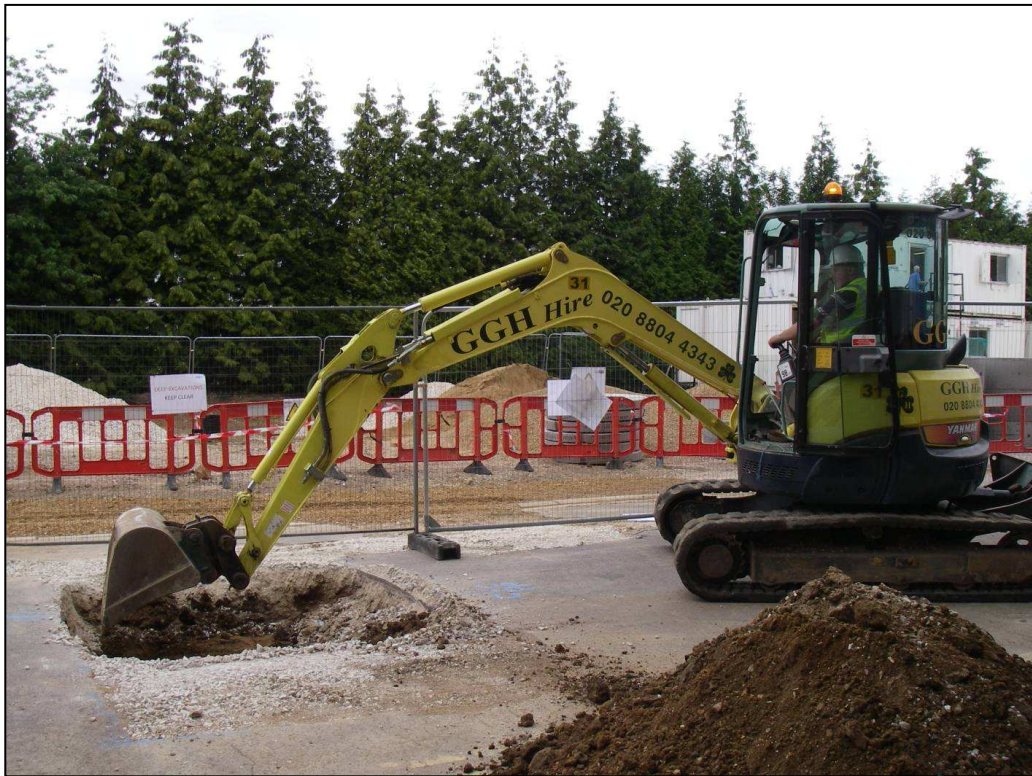
Trench 7 was a 2m square hole that was excavated for the construction of a sewer inspection chamber close to the south-west corner of the tower block (Figure 2 ; Image 2 ). This trench contained a single pit [703] which was partly exposed in the south-east corner of the trench (Image 3). It was steep-sided and at least 0.7m deep, extending below the limit of excavation. A single sherd of St Neots ware pottery was noted in the sole fill of black clayey silt (704). The feature was sealed by 0.5m of modern overburden and had been truncated on its western edge by the construction of a modern sewer trench. No archaeological features were identified during monitoring of construction of the other inspection chambers.

**Image 2: Trench 7 (inspection chamber)**  
Machine excavation

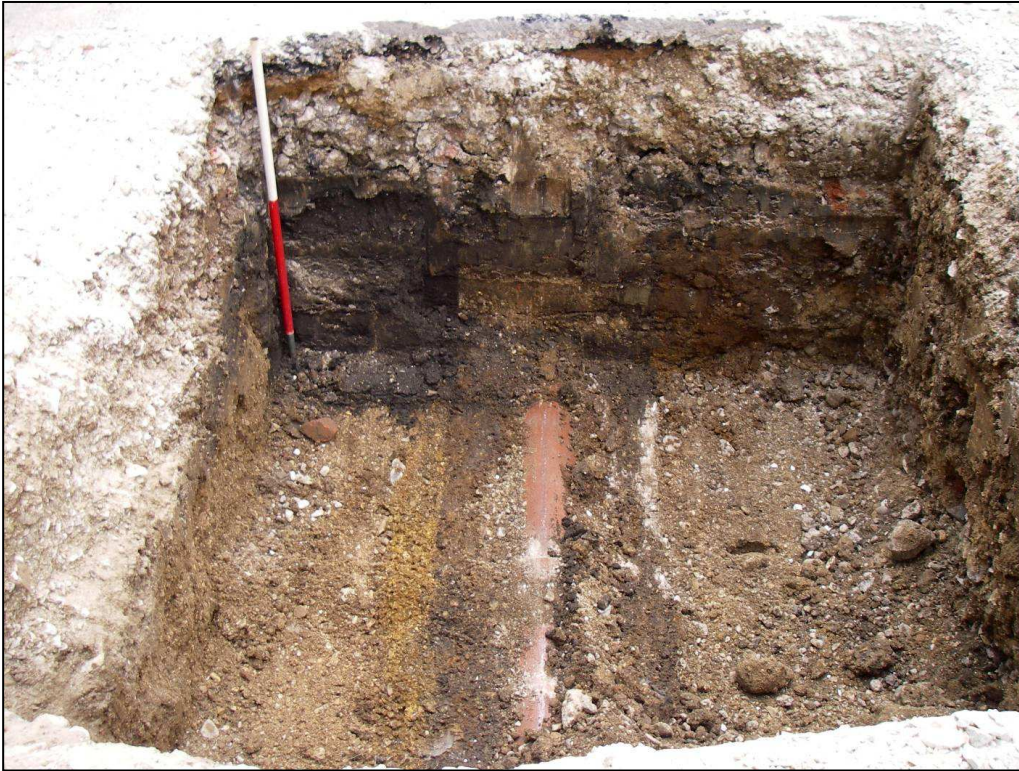
**Image 3: Trench 7, pit [703]**

Showing pit truncated by modern sewer trench in north-facing section  
(1m scale)

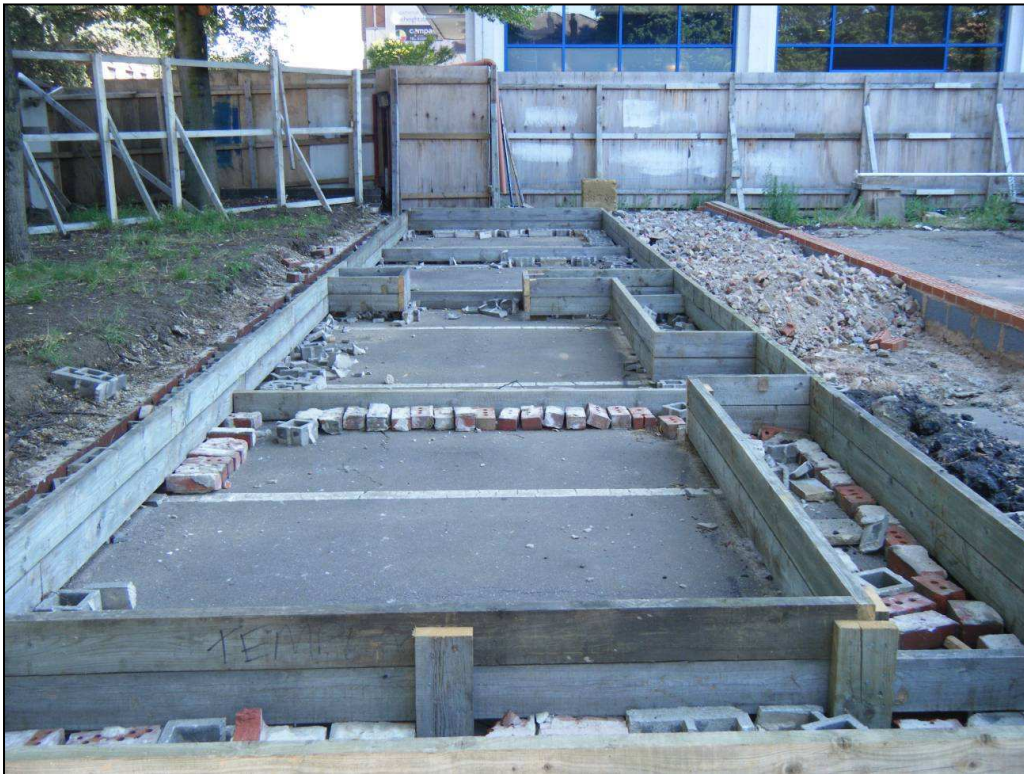
**Image 4: Amenity area**

beneath the existing tarmac surface. Wooden dividers to contain the ‘play bark’, gravel and planting areas were constructed on top of the existing tarmac surface (Image 4). These works had no archaeological impact.

Looking south towards tower block showing retaining wall  
and wooden dividers built up over the existing tarmac surface

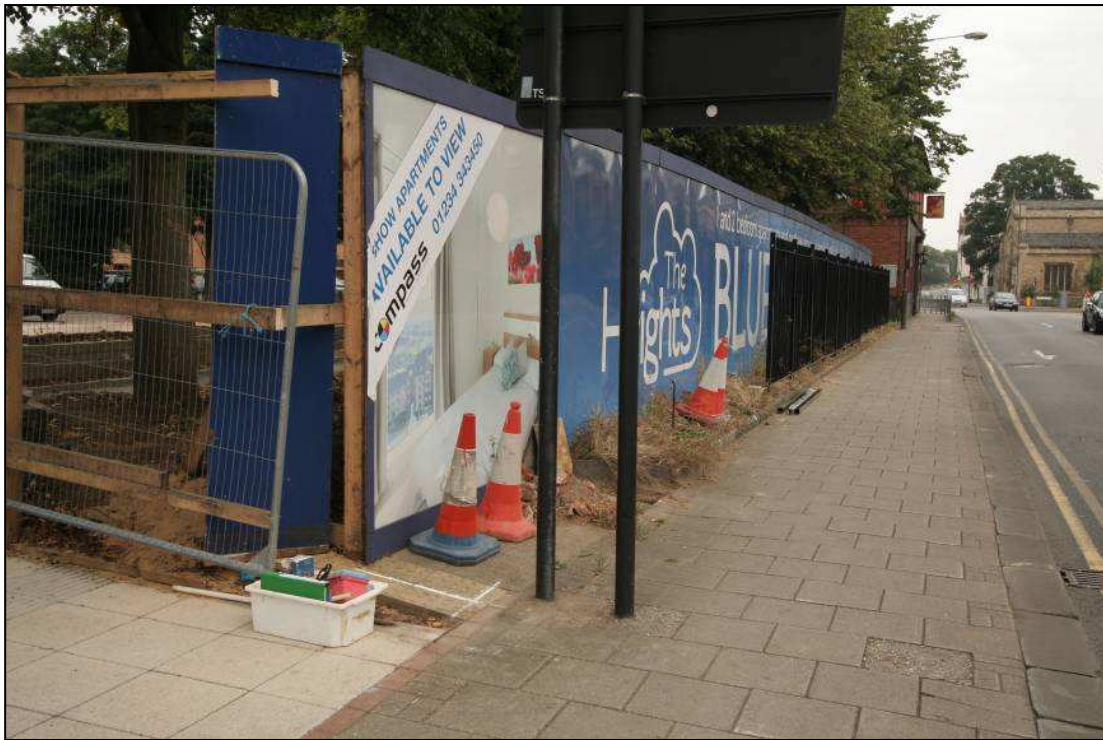
Groundworks during construction of the boundary fence were monitored (Images 5 and 6). Postholes for the fence posts were hand dug by the contractors and inspected by an archaeologist. The holes were 0.4–0.6m deep and approximately 0.3m in diameter. Deposits within the postholes consisted of the existing topsoil above mixed deposits including tarmac, concrete, brick demolition rubble and soil containing small stones and brick rubble.

**Image 5: Amenity area fencing**  
Looking north towards St Mary's Church showing partly erected metal fence

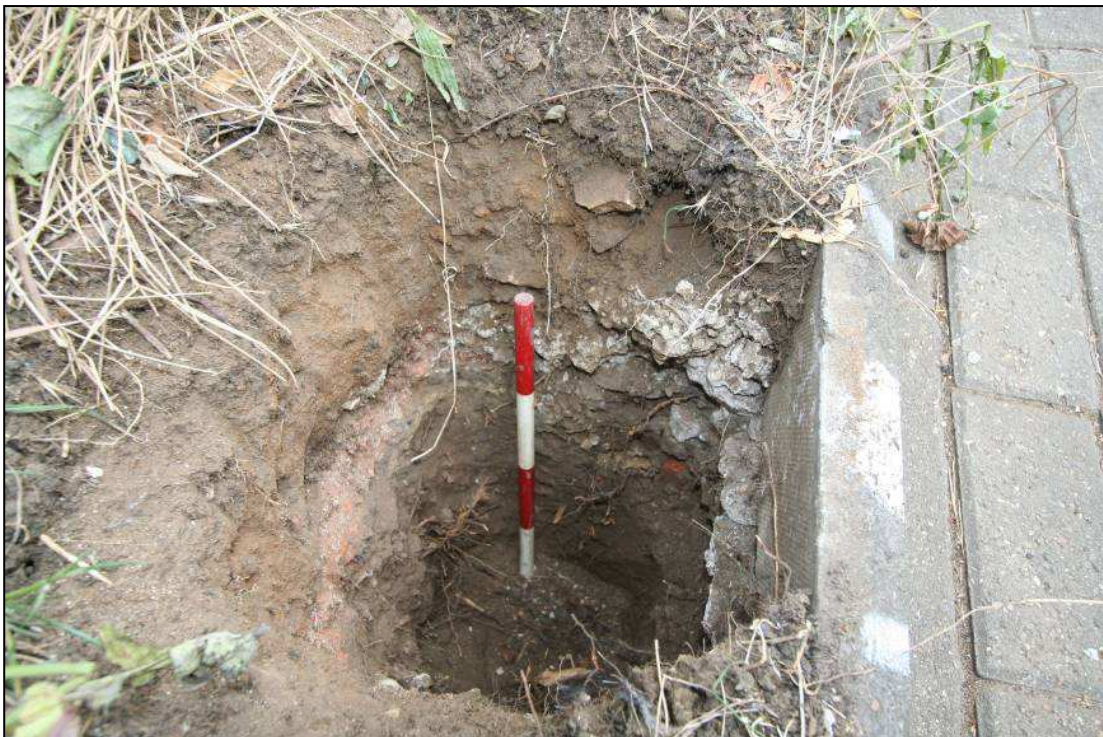
**Image 6: Amenity area fencing**  
Showing typical posthole for fence adjacent to pavement on St John's Street, looking north (40cm scale)
