**THE BOROUGH ARMS PUBLIC HOUSE
DUNSTABLE
BEDFORDSHIRE**

**HISTORIC BUILDING RECORDING
AND ARCHAEOLOGICAL INVESTIGATION**

Project: BA1980
Report no: 2013/46 ver.1.2

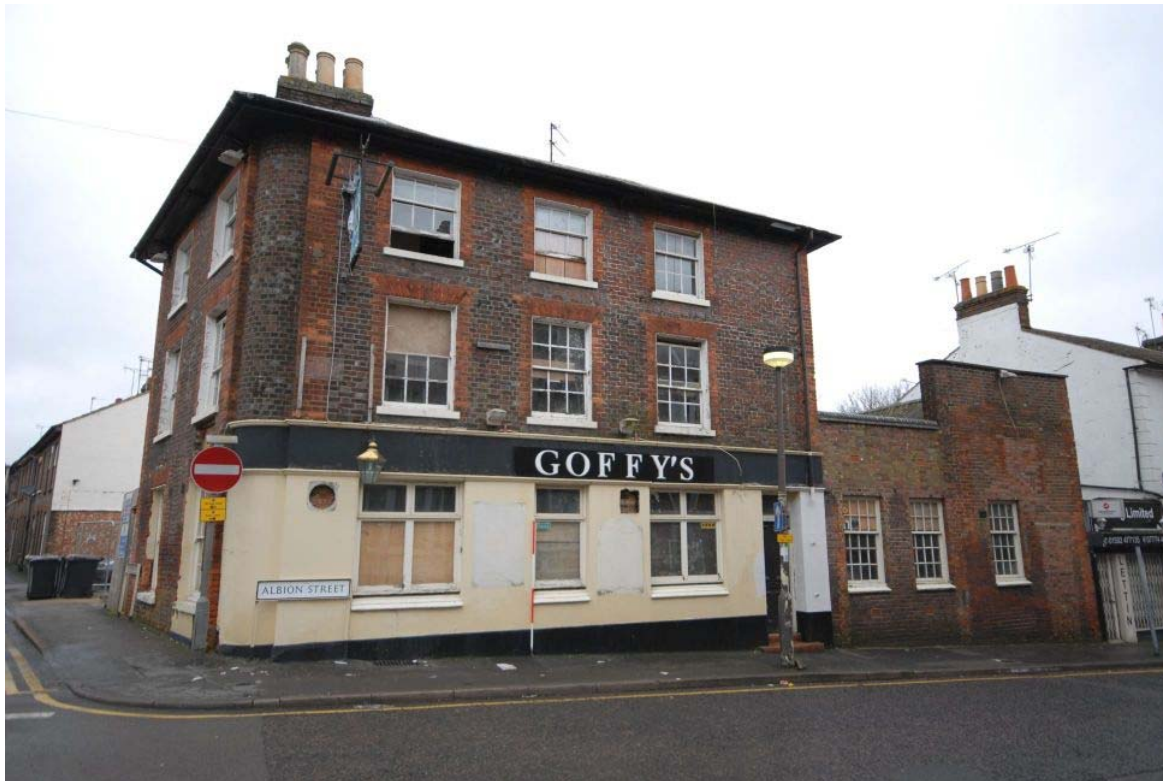
Figure 4: The former Borough Arms, Albion Street frontage

The Borough Arms public house stands on the corner of Edward Street and Albion Street with the main façade facing towards Albion Street (Figure 4). Currently the building occupies the whole south-eastern half of the plot while the rest is formed by an open yard to the rear. A garage building that stood in the western corner of the plot along Edward Street had been demolished by the time of recording.

The main façade faces towards Albion Street and the ground floor is plastered and painted creamy white with a black fascia above the ground floor windows bearing the name “Goffy’s” and previously “The Borough Arms”. The main door to the pub is located towards the eastern edge of the pub and consists of a narrow, single pane door with a rectangular window light above it. Two brick steps lead up to the door, compensating for the slightly downward slope of Albion Street towards the High Street North.

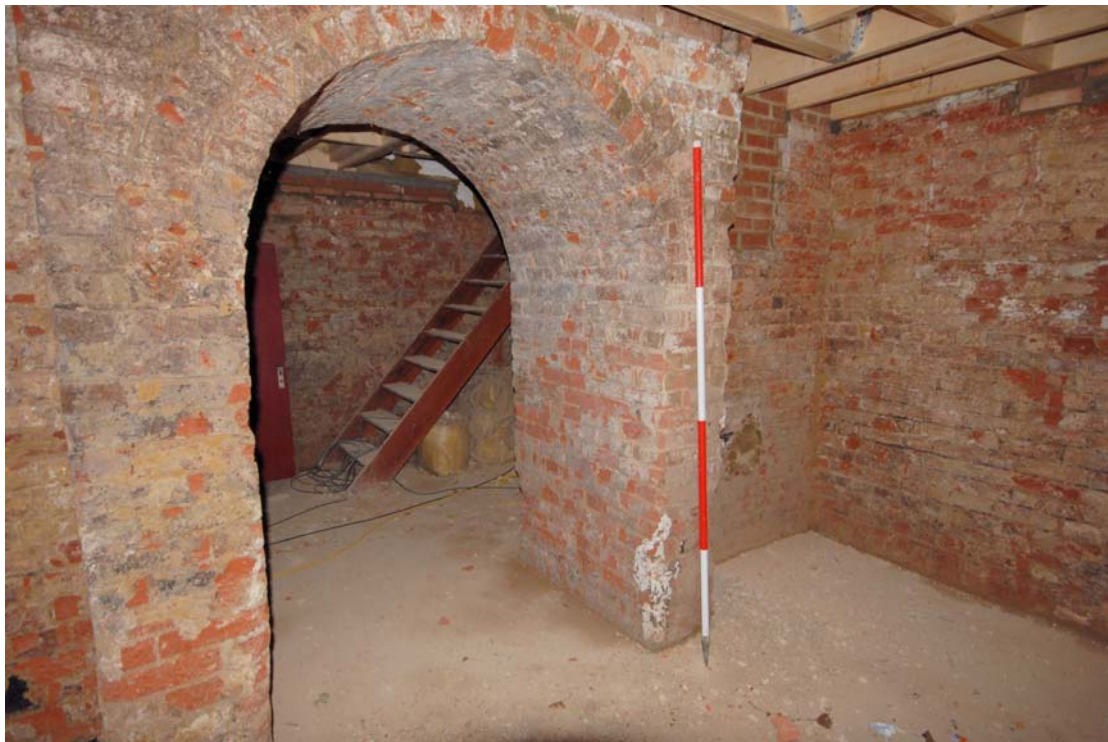
Figure 5: Cellar below main pub room

A cellar lies underneath the main Borough Arms building. It consists of two rooms with an arched passage (Figure 5).

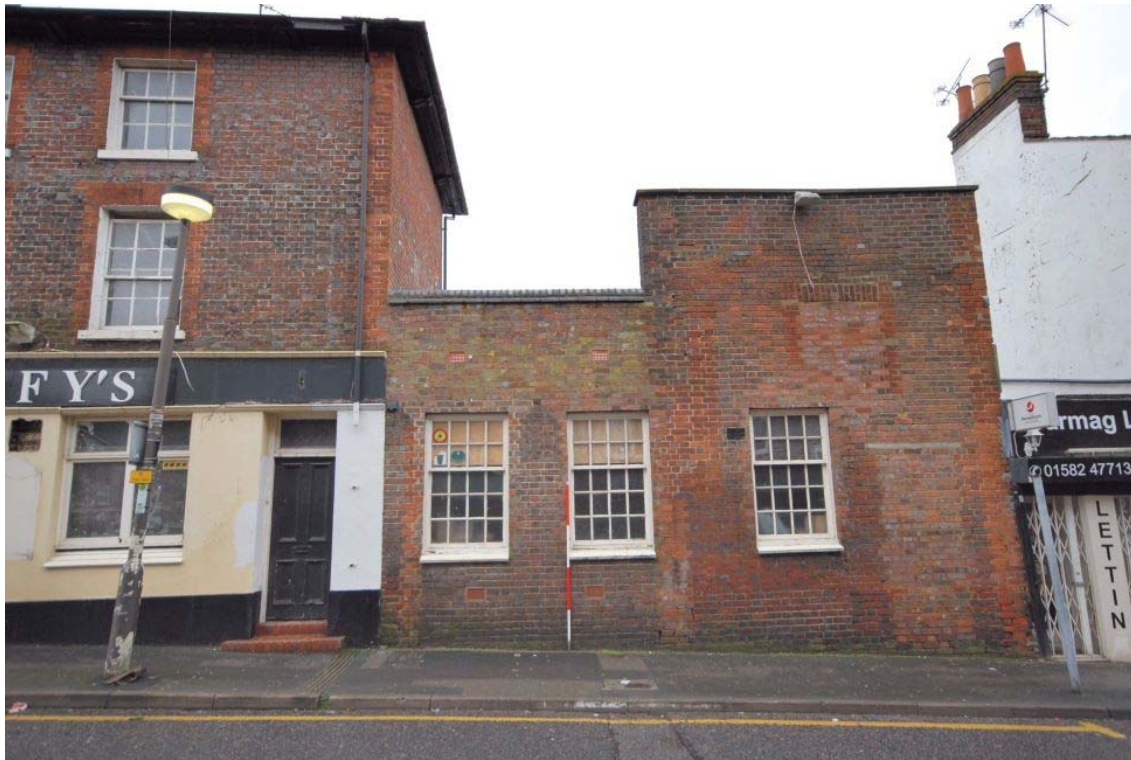
Figure 6: Albion Street frontage, pub (left), stable block with hayloft (right) and infilled wall (centre)

The façade of the former stable block facing Albion Street lies to the east of the main pub building. It consists of a flat rectangular wall, which masks the gabled roof of the stables and hayloft behind it. It is connected to the pub by a simple brick wall. Currently there are three sash windows in the ground floor of these structures. The doorway into the stable block from Albion Street consisted of a narrow single door with a stone lintel. A square window was placed centrally within the wall panel above. Both are now bricked up (Figure 6).

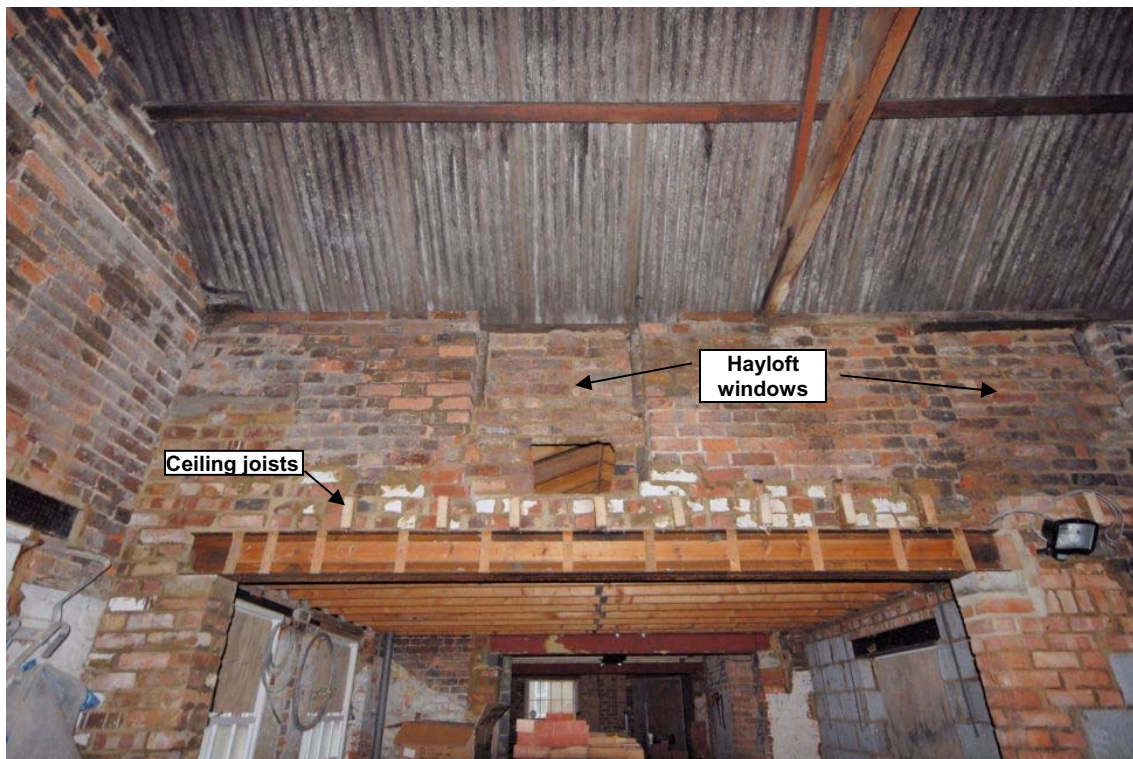
Figure 7: Interior of former stable block and hayloft (looking south-west towards pub main room)

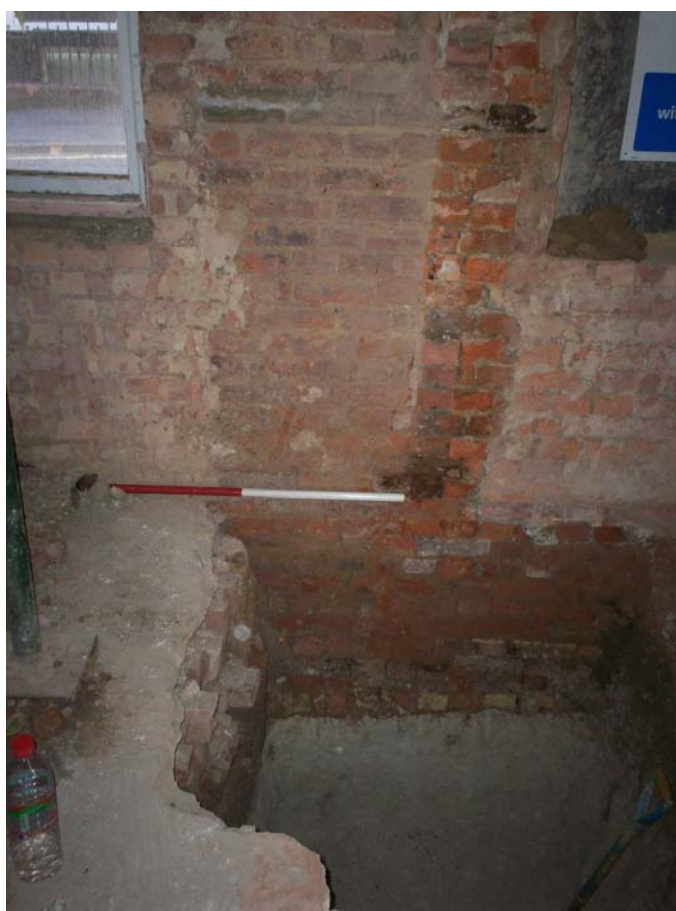
Figure 9: “Ghost” of wall in interior of pub

Evidence for a brick wall [003] and [008] was revealed during the excavation for new footings in the interior of the pub. The wall had been completely removed, but a “ghost” remained as a line of different coloured brick, two bricks wide, running up the interior wall of the pub (Figure 9). The wall’s “U” shaped foundation trench [009] was also observed. This was on a north-south alignment and cut into chalk bedrock (007). There was also a possible buried top- and subsoil (005) and (006) near the south end of the new footing. The foundation cut preserved the remains of a basal chalk fill and occasional brick fragments along its length.

The foundation was up to 1.0m deep below the present floor level of the pub, which indicates that it was for a substantial load-bearing wall. It most likely represents the original external west wall of the Borough Arms. Originally the Borough Arms building was of a squat L-shape with a gap between the pub and the stable block to its west. It is likely that this wall was not removed until 1986 when the interior of the pub was extended westwards to include the former stable block.

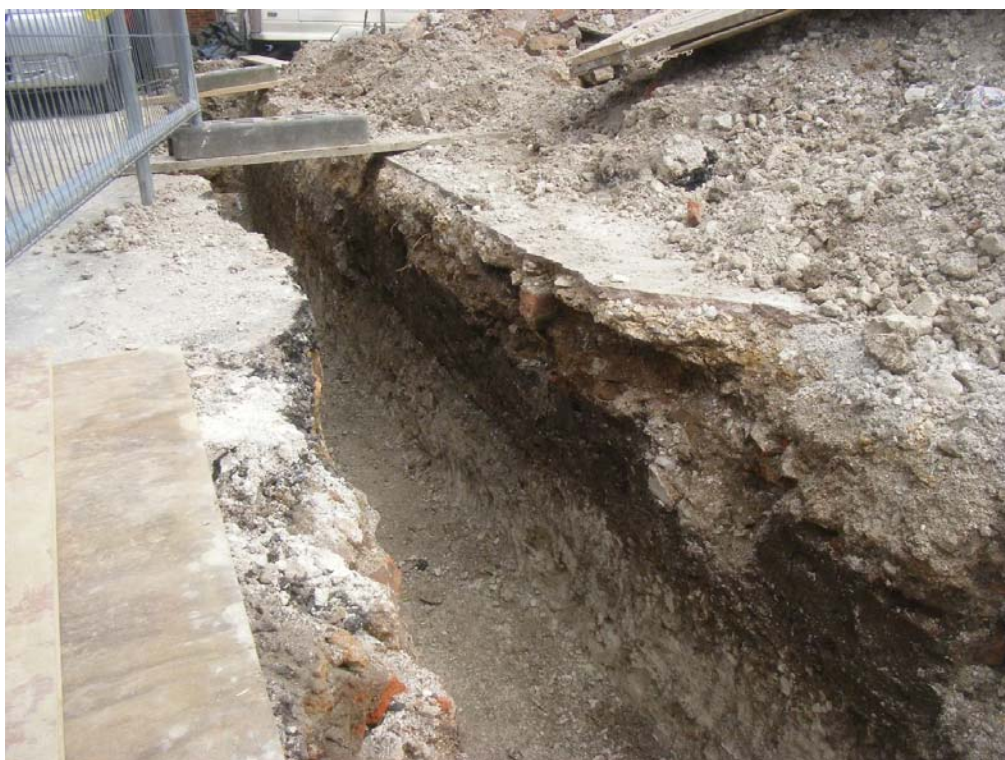
Figure 10: Natural chalk, buried topsoil and make-up layers in yard

To the exterior of the wall, the foundations for the new-build structures in the Borough Arms yard were monitored. In the yard the same buried topsoil and subsoil (021) and (022) were revealed below a 370mm thick make-up layer (013) of firm mid grey clay with inclusions of brick and tile fragments and frequent chalk nodules (Figure 10).

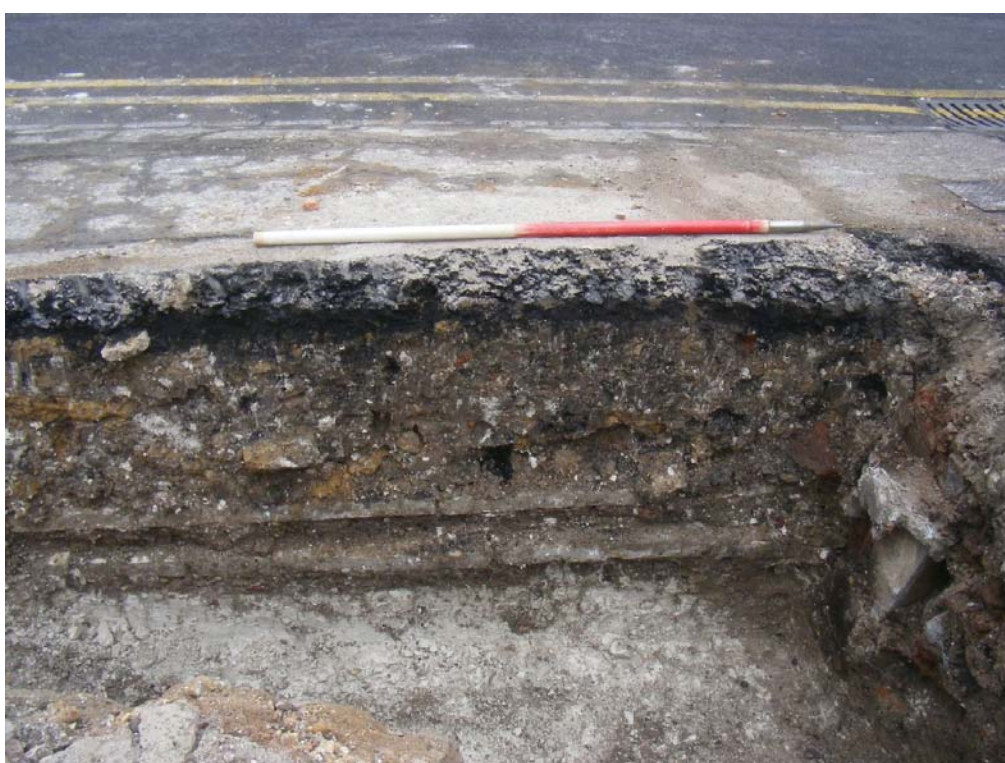
Figure 11: Levelling layers and former yard surfaces

Two layers of concrete slabs and their foundations (014-017) represent remains of former yard surfaces (Figure 11).

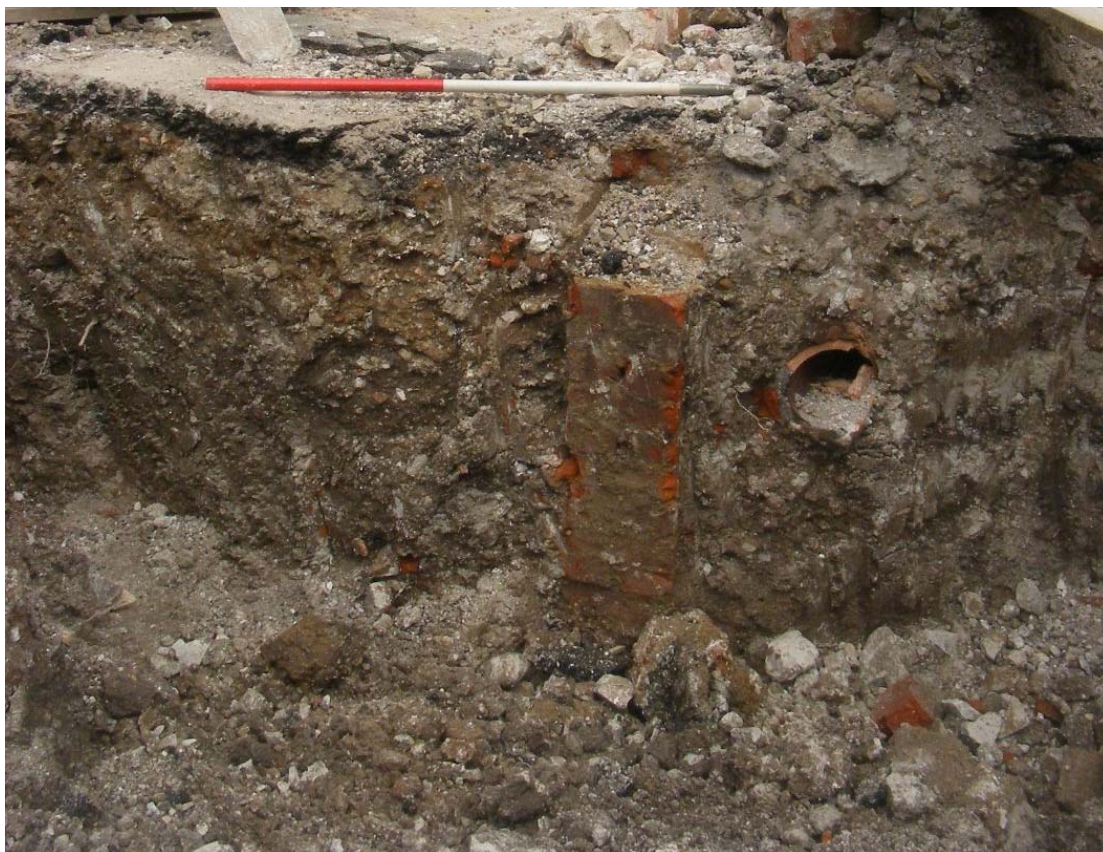
Figure 12: Remains of stable block wall foundation

A brick wall [023] 230mm thick and extending to 1.05m below present ground level, situated on an east-west alignment, was revealed within the foundation of the new-build. This most likely represents the remains of a foundation for one of the stable blocks which were demolished in the early 20th century (Figure 12). Its location suggests that it may have jutted slightly forward from the garage/stable block.
