**The George Inn
Maulden
Bedfordshire**

HISTORIC BUILDING REPORT

Document: 2012/76
Version: 1.0

June 2012

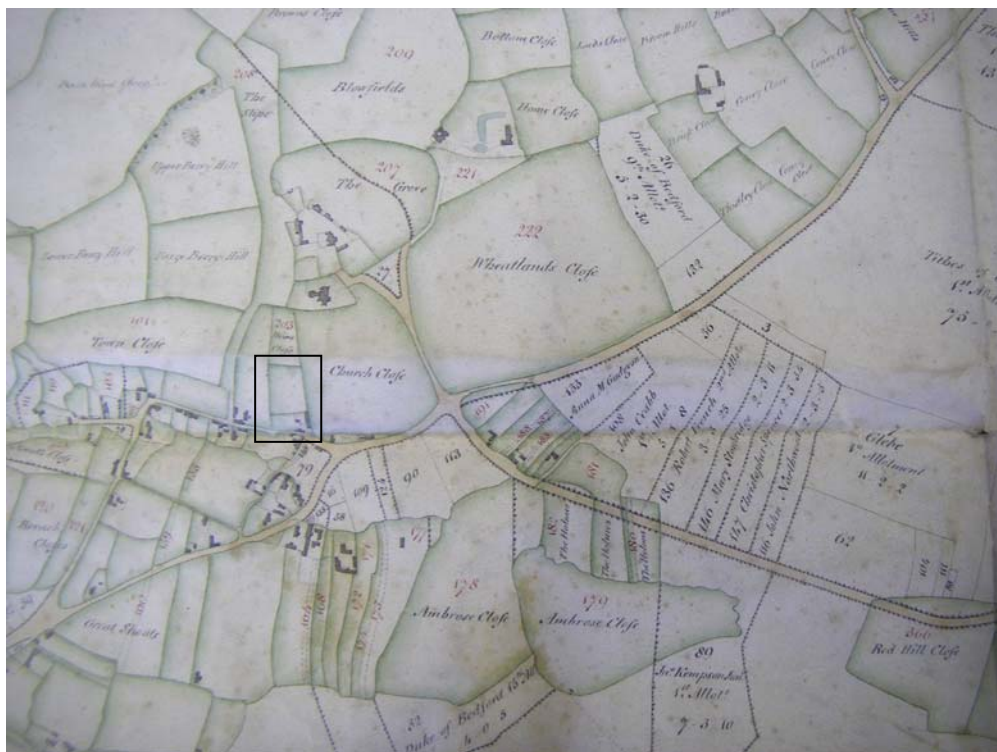
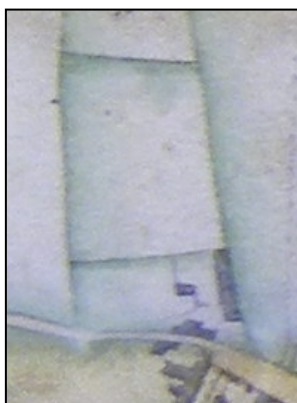
Figure 1: Enclosure map 1797

This map (BLARS ref. MA32) includes detail of the building and its associated outbuildings (Figure 1). The building shown is T-shaped, comprising the main range and the rear wing. Outbuildings at this time consisted of a small building to the north of the inn and a long building situated on the eastern boundary of the plot.

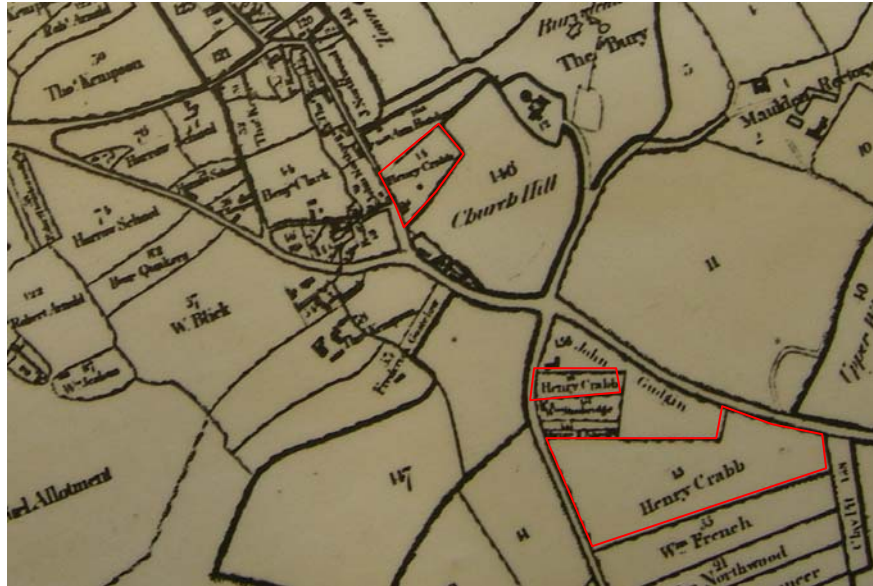
Figure 2: Estate map 1821

An estate map drawn in 1821 (BLARS ref. R1/55) shows land belonging to the Duke of Bedford (Figure 2). The map shows basic details of buildings. The T-shaped outline of the main building is shown but no outbuildings were included in the drawing. Henry Crabb is listed as the owner at this time. He also owned a large field and tenement plot lying 400m to the south-east of the George.

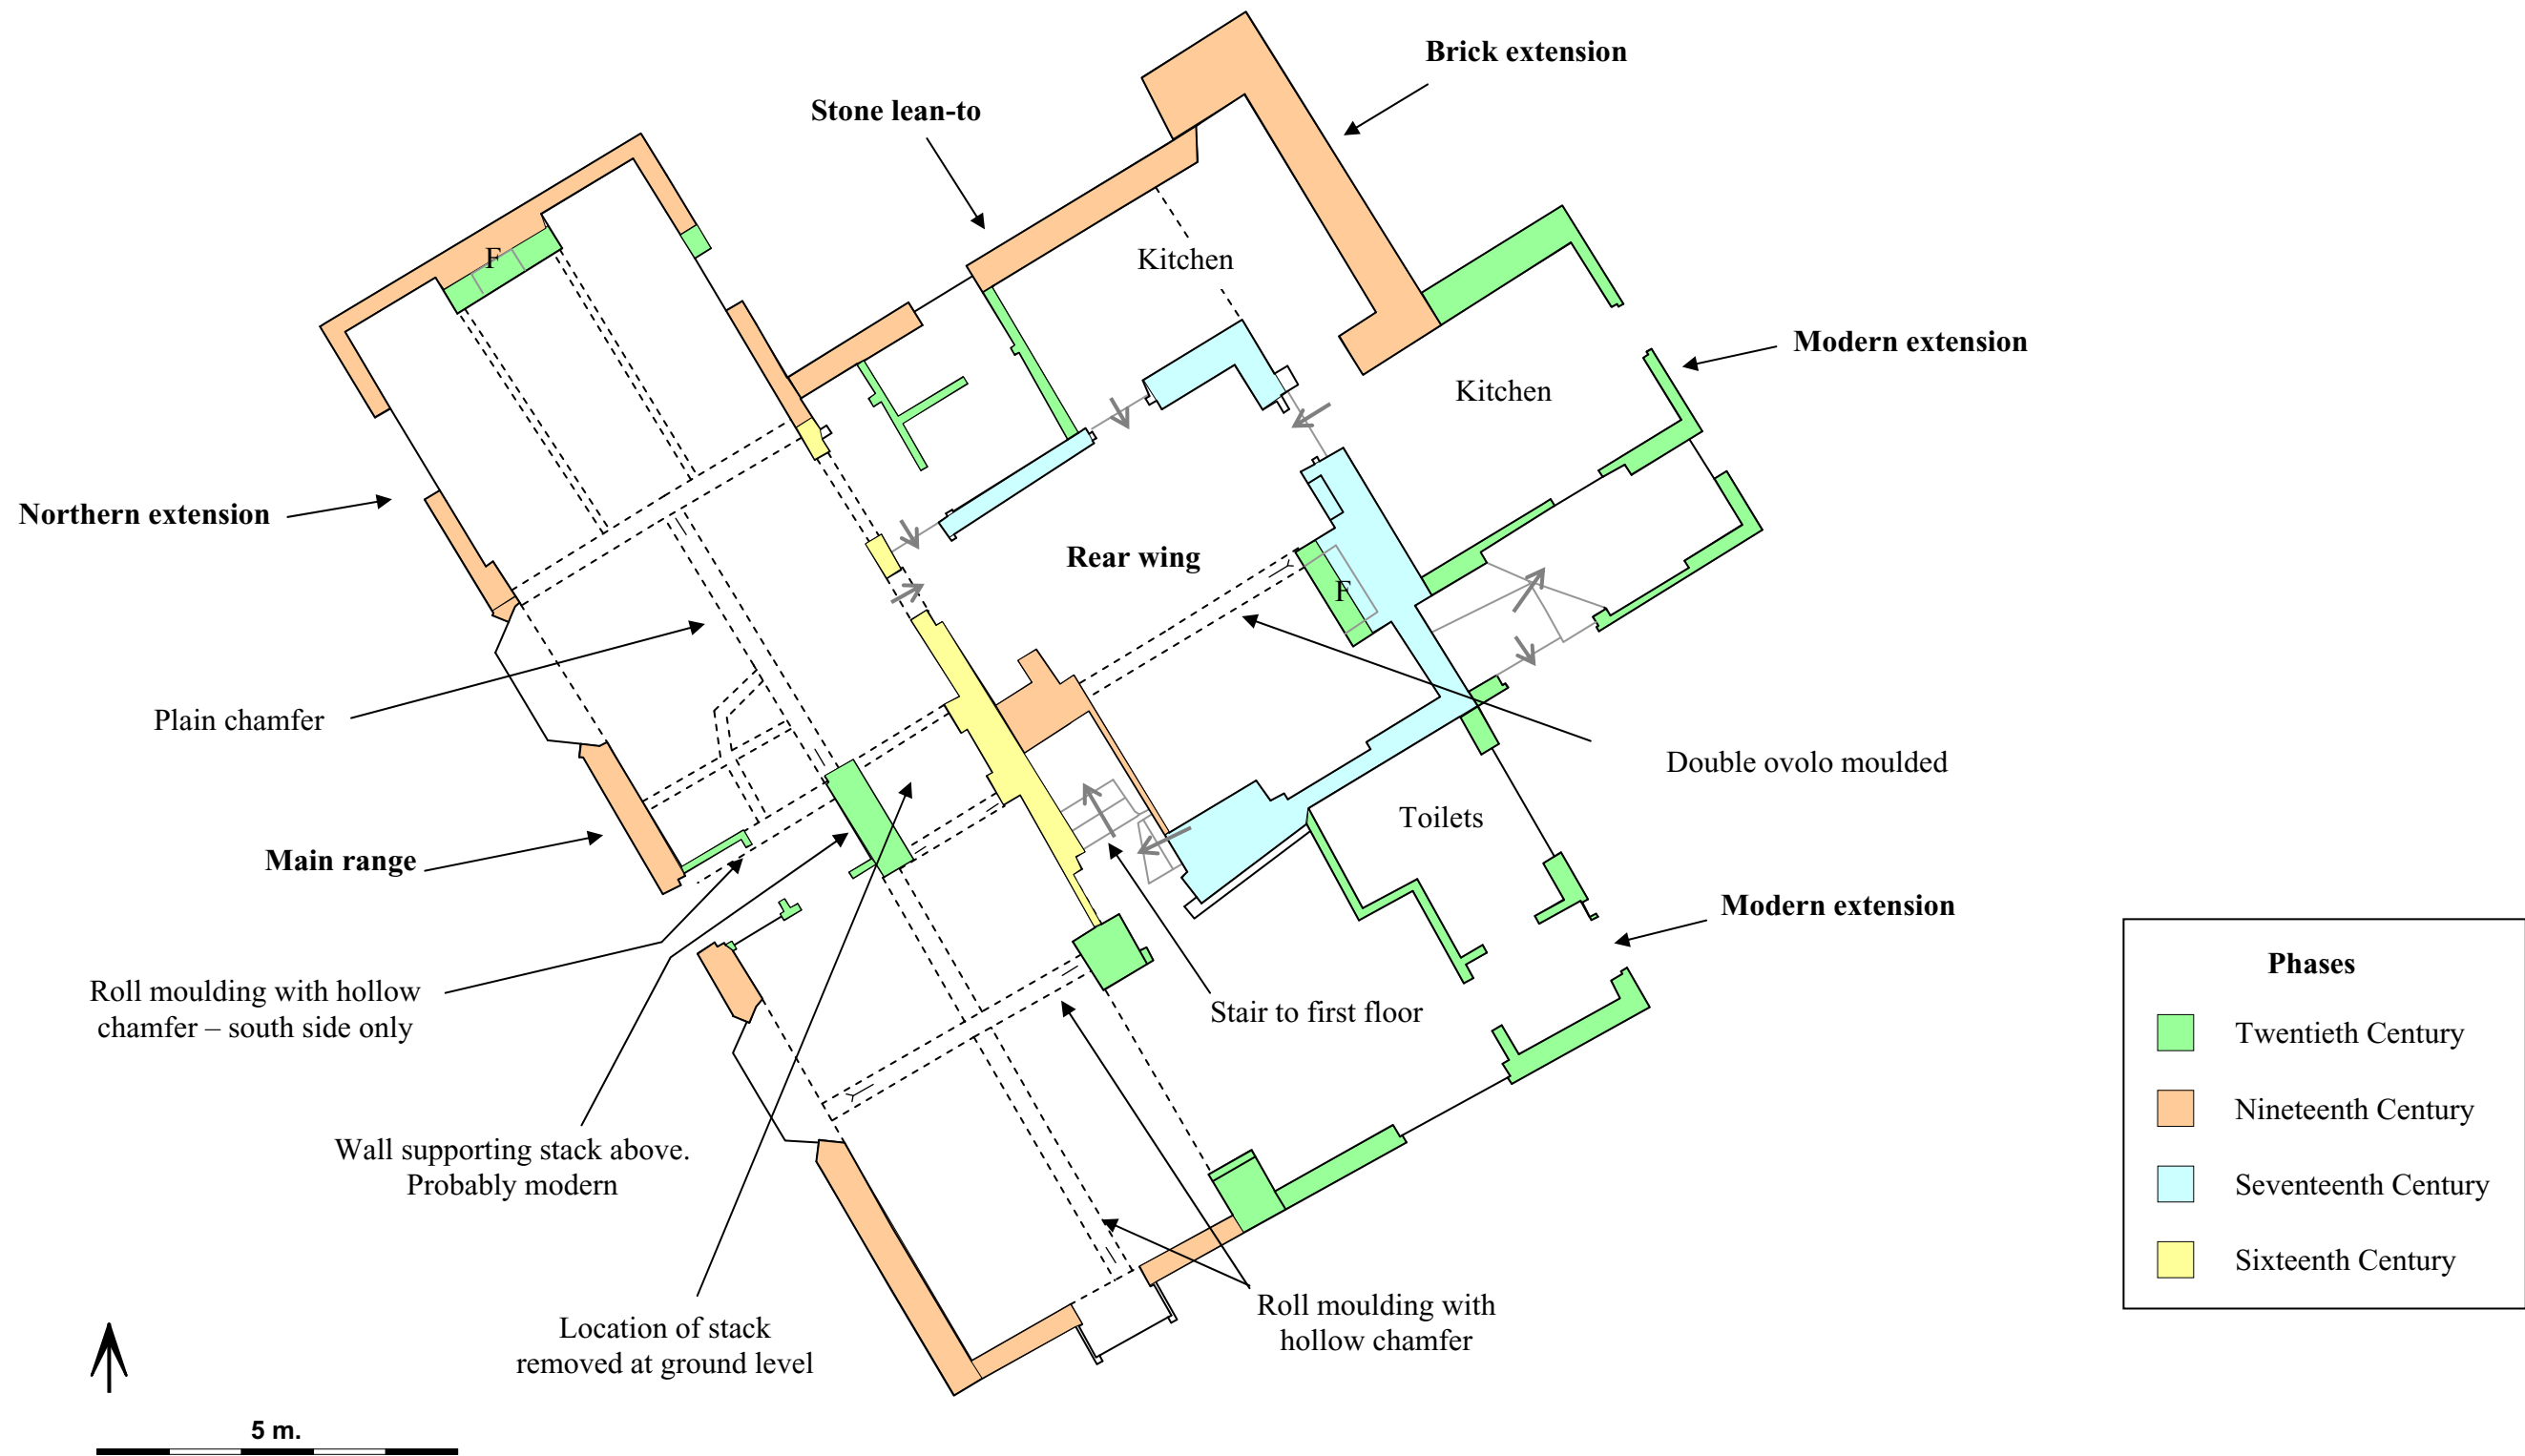
Figure 4: Plan of ground floor

3.5 Ground floor (Figure 4)

The ground floor contains two bar areas; one occupies the north bay of the main range and the northern extension the other is situated in the south of the main range

and the modern extension at the south-east. The ground floor room of the rear wing contains a dining room adjacent to a kitchen in the lean-to on its north side and a modern extension at its east end. The toilets are located in the west end of the lean-to and in the extension at the south-east of the building. The first floor is accessed from an enclosed staircase located between the main range and rear wing.

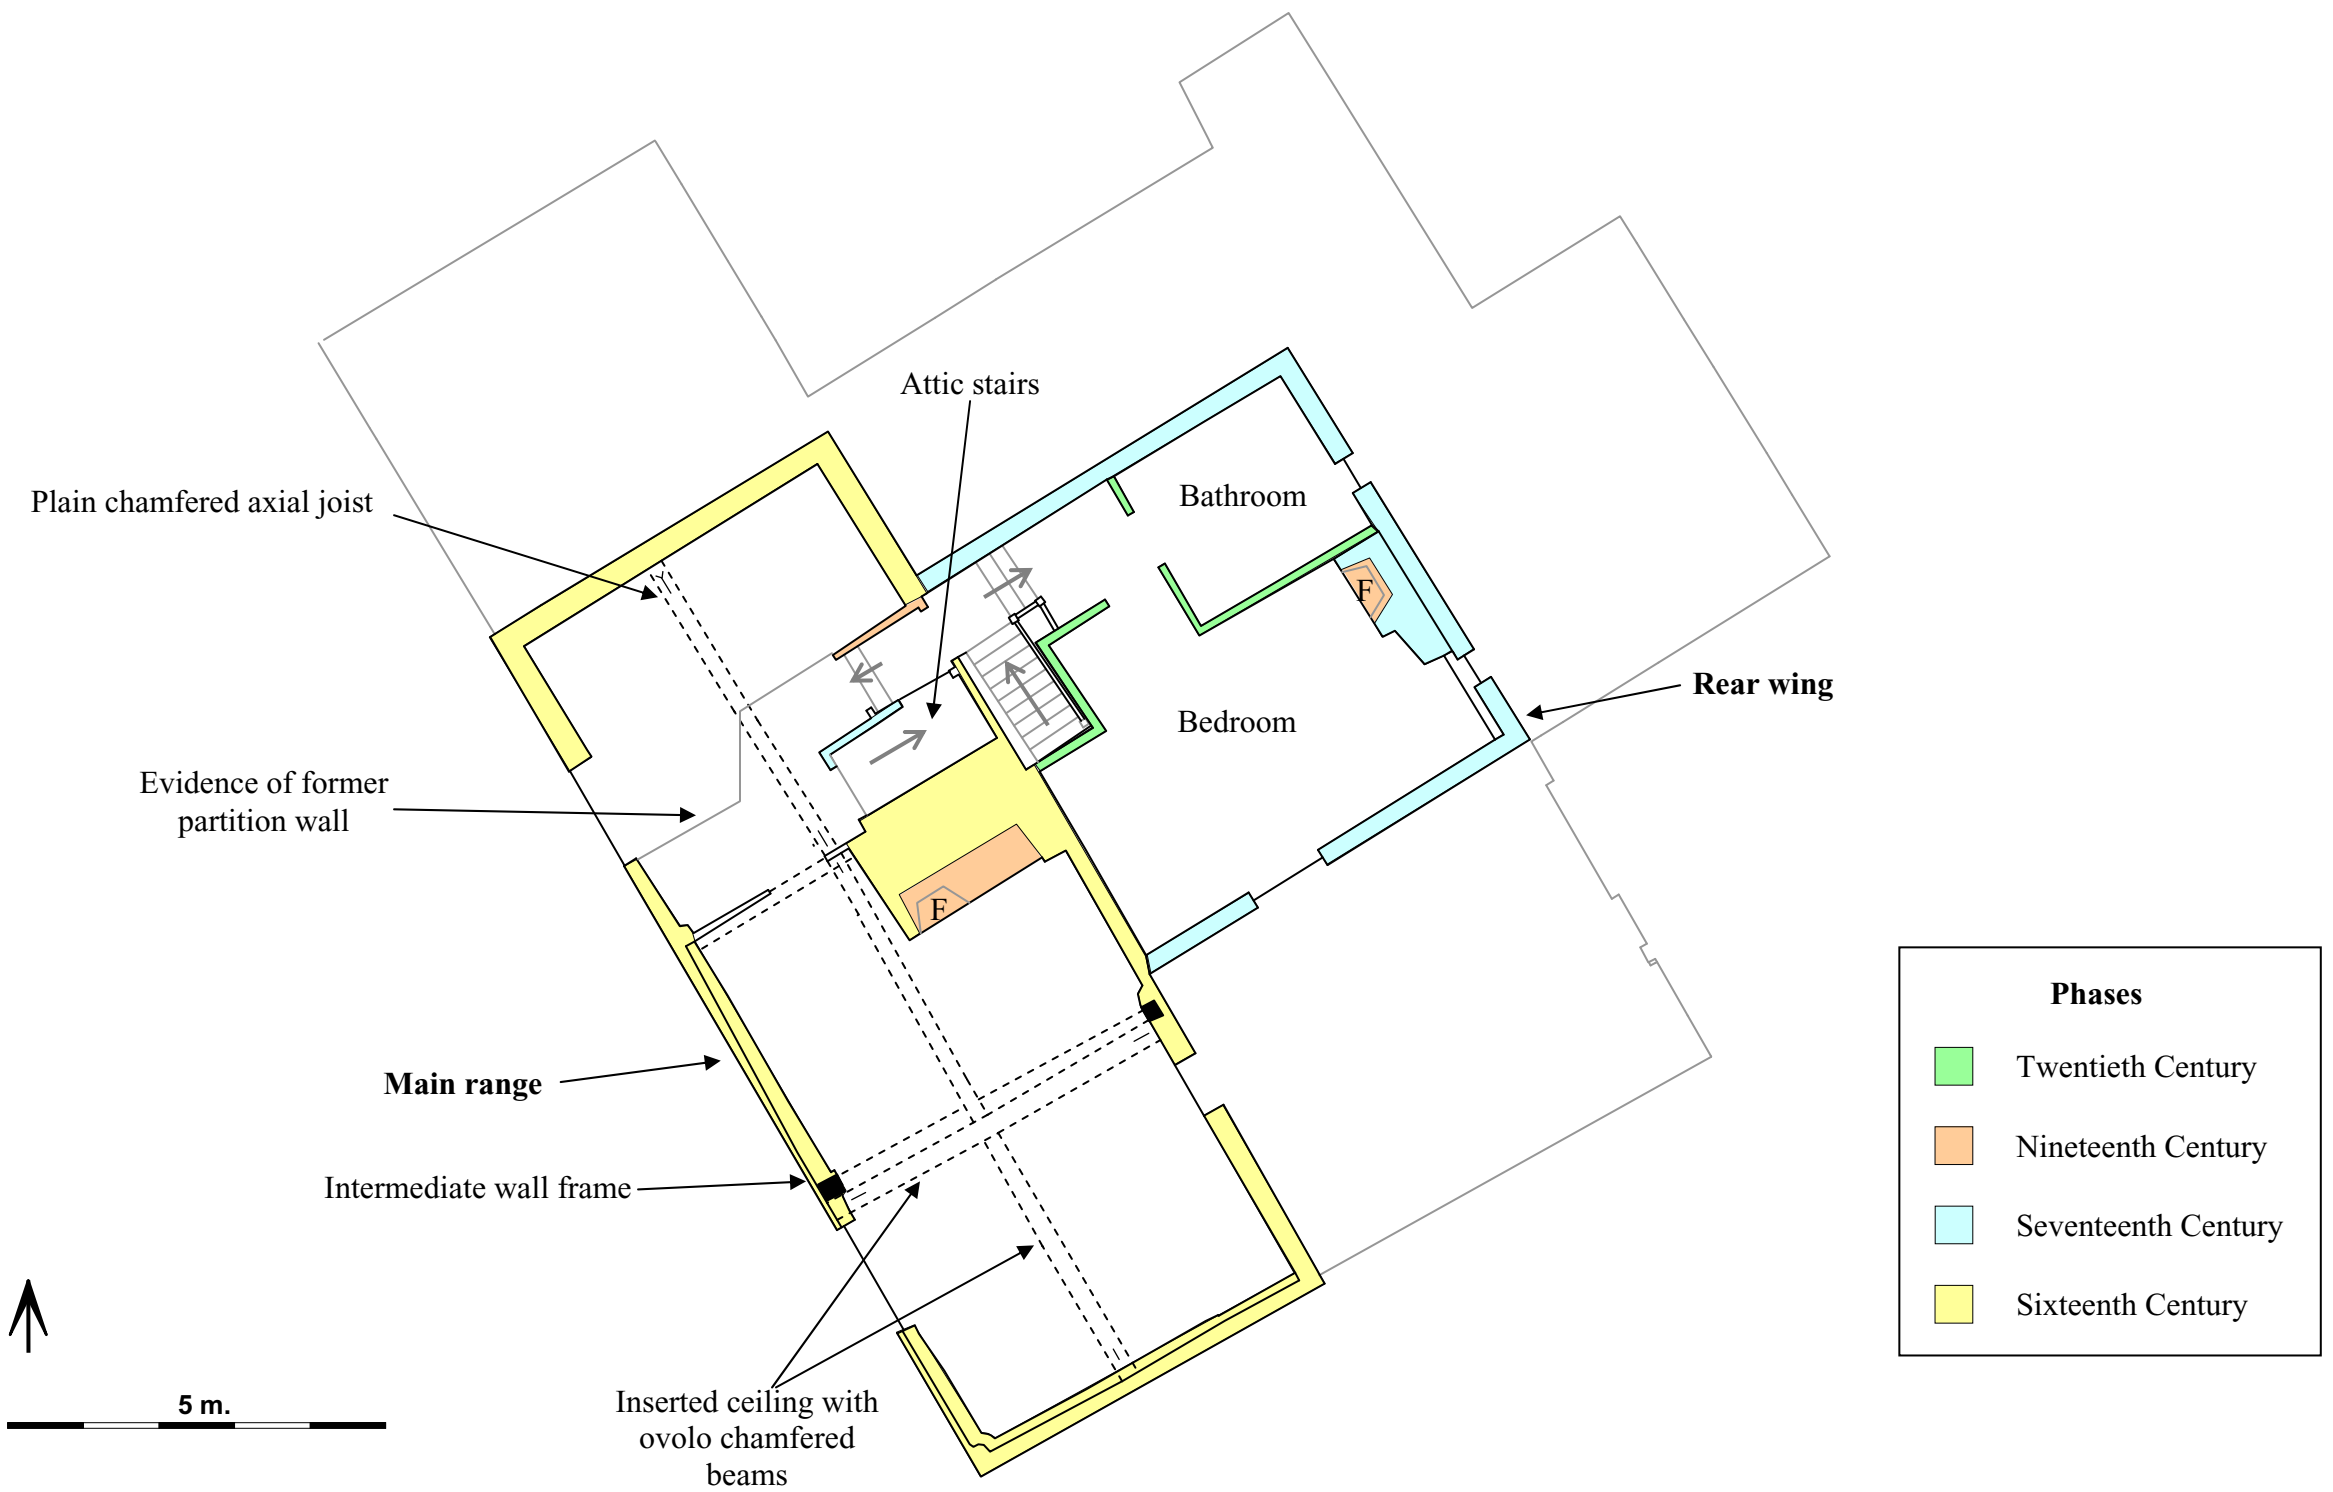
Figure 5: Plan of first floor

3.6 First floor (Figure 5)

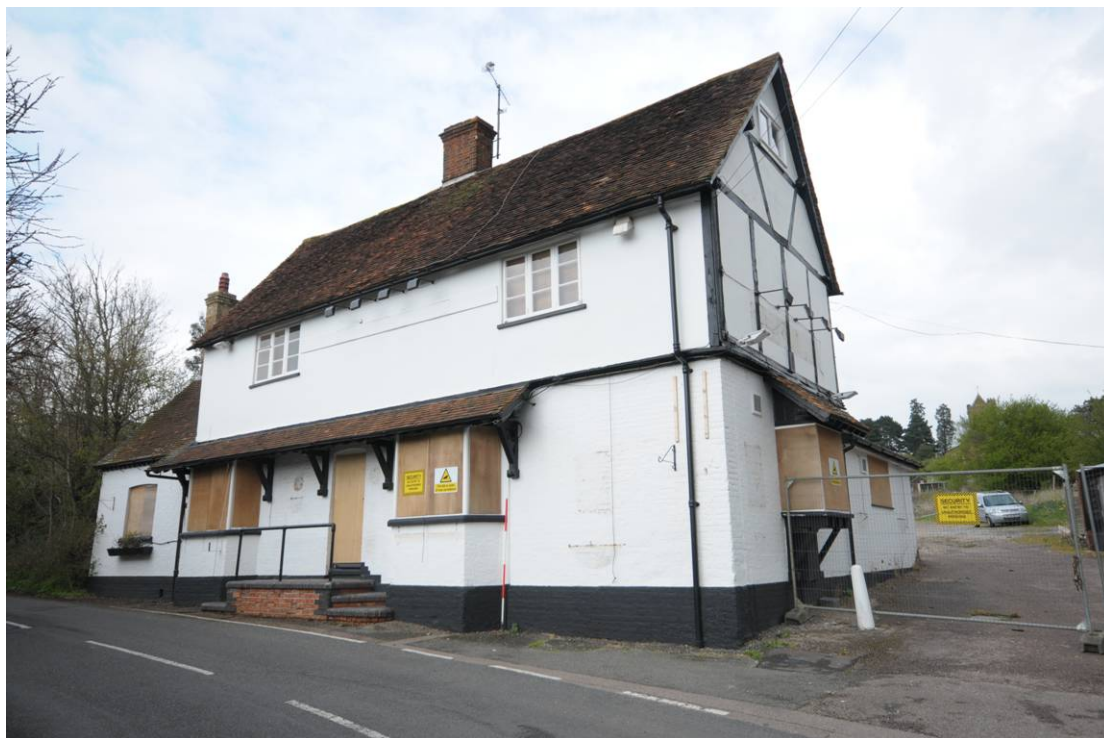
Plate 1: West elevation

Frontage has an off centre front door under a segmental headed opening with two canted bay windows below a tiled pentice roof supported on shaped wooden brackets (Plate 1). The door is accessed via a raised brick platform with steps at either end. This is constructed in red brick in Flemish bond with blue-grey brick dressings including bullnosed edging to the platform and steps. The first floor is slightly jettied and has two three-light windows.

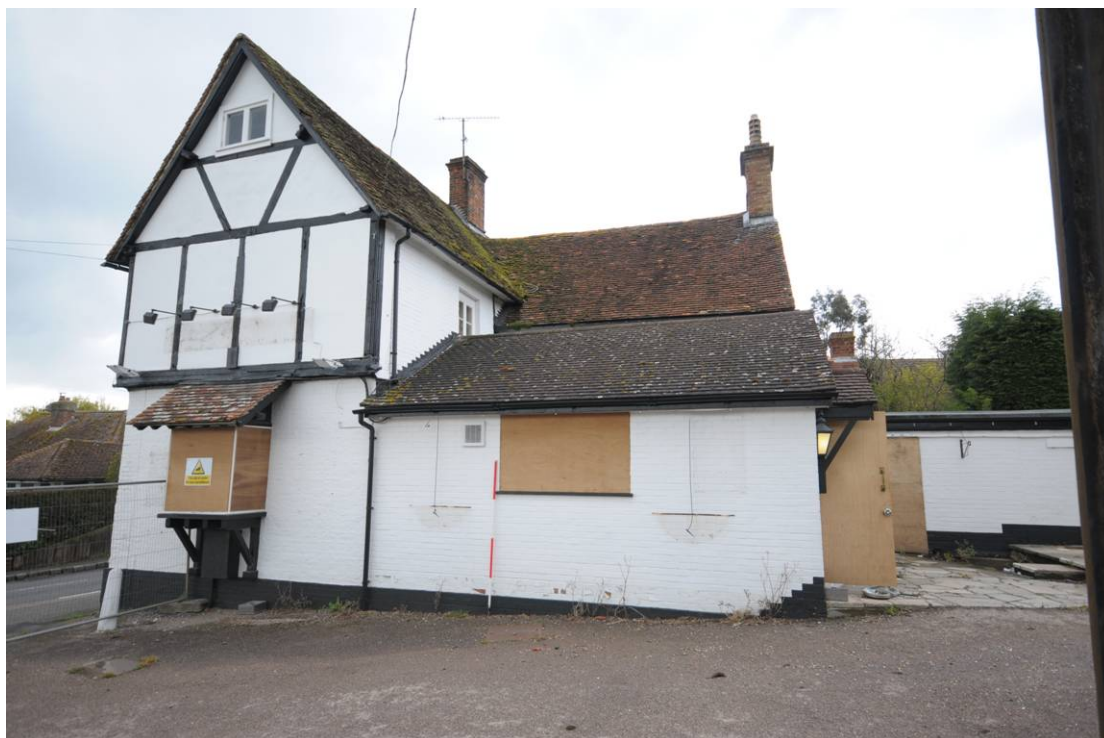
Plate 2: South elevation

The south end has a single bracketed two light window below a tiled pentice roof at ground floor level (Plate 2). The first floor is slightly jettied with exposed timber frame consisting of corner posts and three studs. The gable has a small two light window in its upper part with framing below comprising a collar and raking queen struts.

The southern bay at the rear of the main range has a first floor two light window and a small part of the timber is visible (Plates 2 and 3). The northern gable is covered in smooth white render with no windows or framing visible externally.

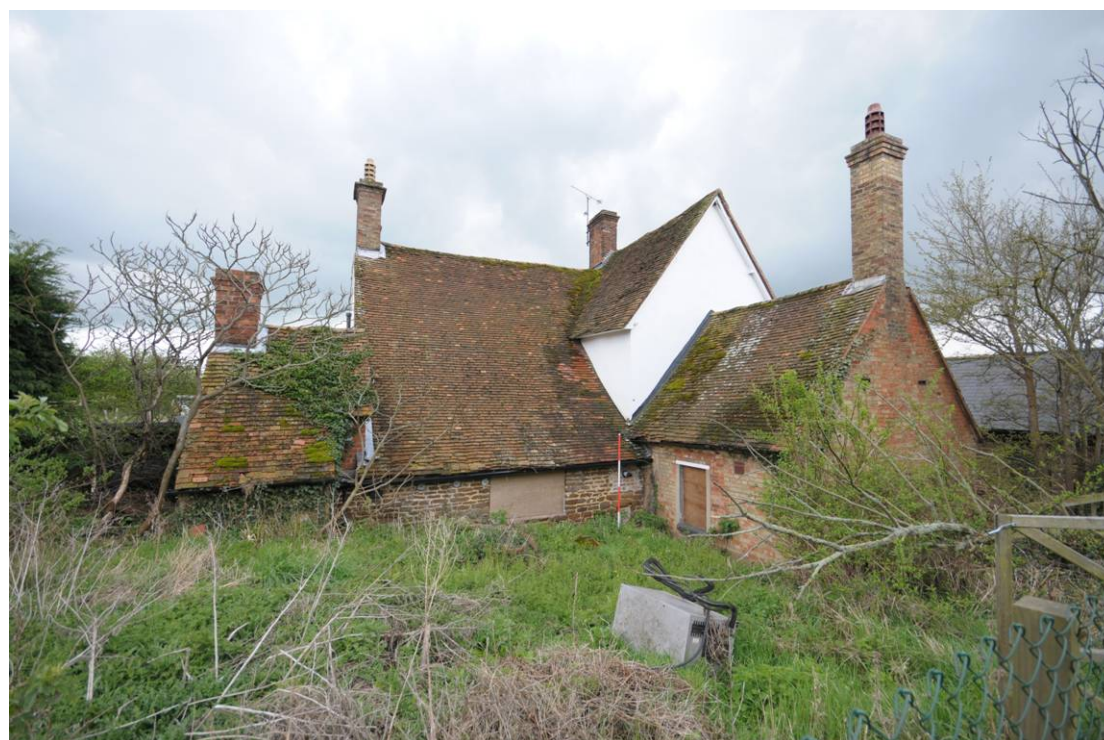
Plate 4: North elevation

This consists of a single storey brick extension located at the north end of the main range (Plates 1 and 4). It measures 5.2m east-west by 4.5m north-south. The west elevation is painted white and has dentilled eaves and a two light segmental headed window. The gable end and east sides are unpainted and show an irregular mixture of yellow and pinkish red bricks laid in Flemish bond. A tall square ridge stack in the same mix of yellow and pinkish brick rises above the gable end. The east wall contains a square headed window opening with cement rendered reveals and a cill of blue-grey bullnosed bricks. The opening is situated inside a larger opening which has been infilled above and to the right of the window with red brick.

This part of the building comprises two distinct elements, a stone lean-to which extends along the north side of the rear wing and small brick gabled building attached to the east end of the lean-to (Plate 4).

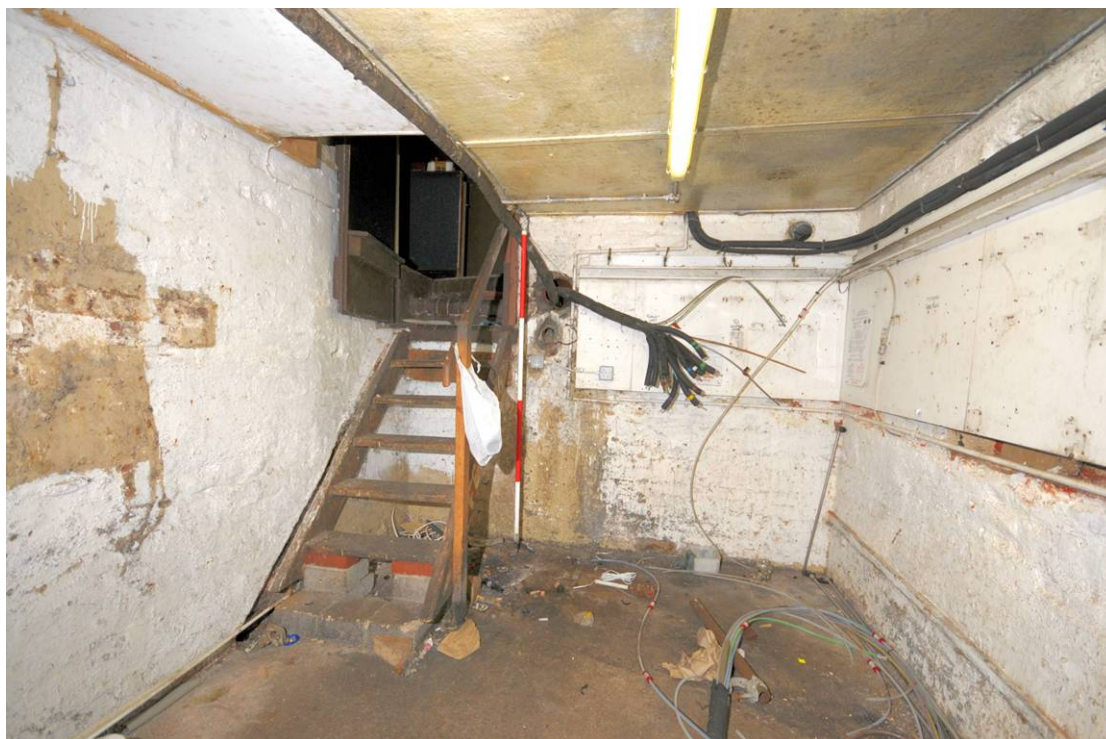
Plate 5: Cellar looking west

A brick-lined cellar measuring 4m by 2.7m lies beneath the southern half of the rear wing (Plate 5). There is an opening for barrels in its south-east corner which communicates with a delivery area in the modern extension at the rear of the building. The cellar is accessed by wooden steps in its south-west corner via a door off the corridor behind the bar.

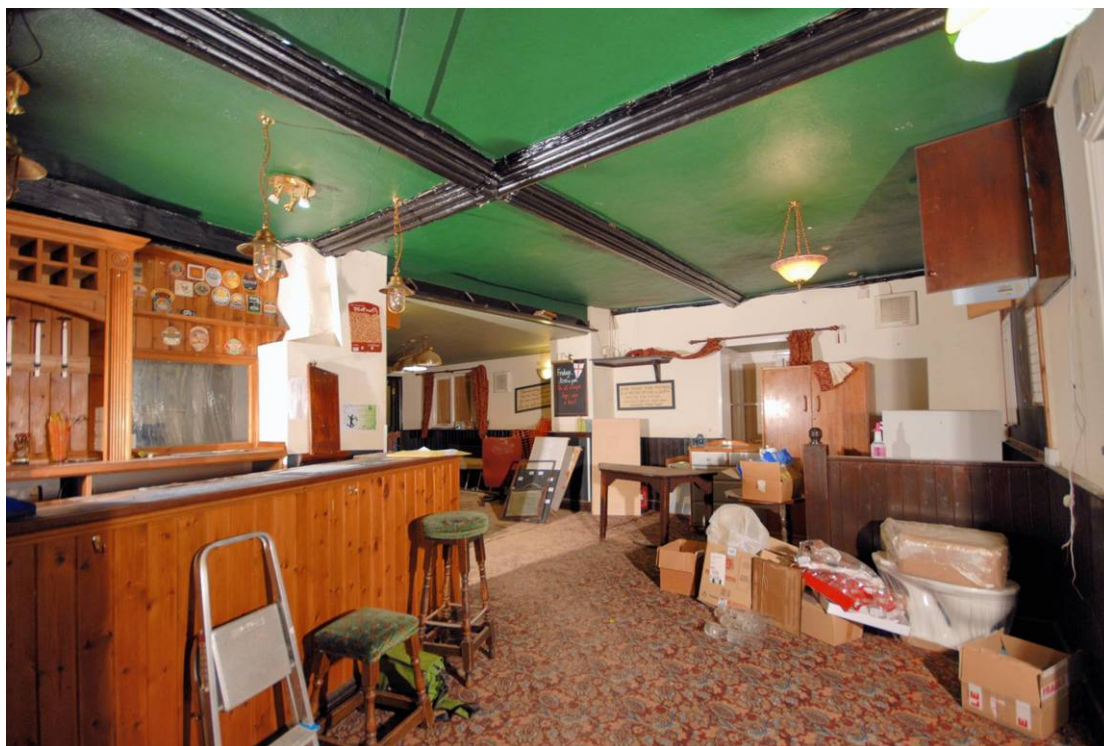
Plate 6: Main range, ground floor looking north from south end

The main range forms the principle bar area of the public house. A small lobby inside the front entrance along with an internal door divides the area into a northern third (Plate 10) and southern two-thirds (Plates 6 and 7). A serving bar fronted in light, yellow pine matchboard occupies the eastern side of the main range. The outer walls are lined with modern matchboard wainscot with a dark brown or black finish.

The building was of three bays, divided into two rooms with a room of one bay at the north and a double bay room to the south. Elaborately moulded ceiling beams in the southern room indicate its higher status (Plates 6 and 7), probably the hall with the smaller room being the parlour.

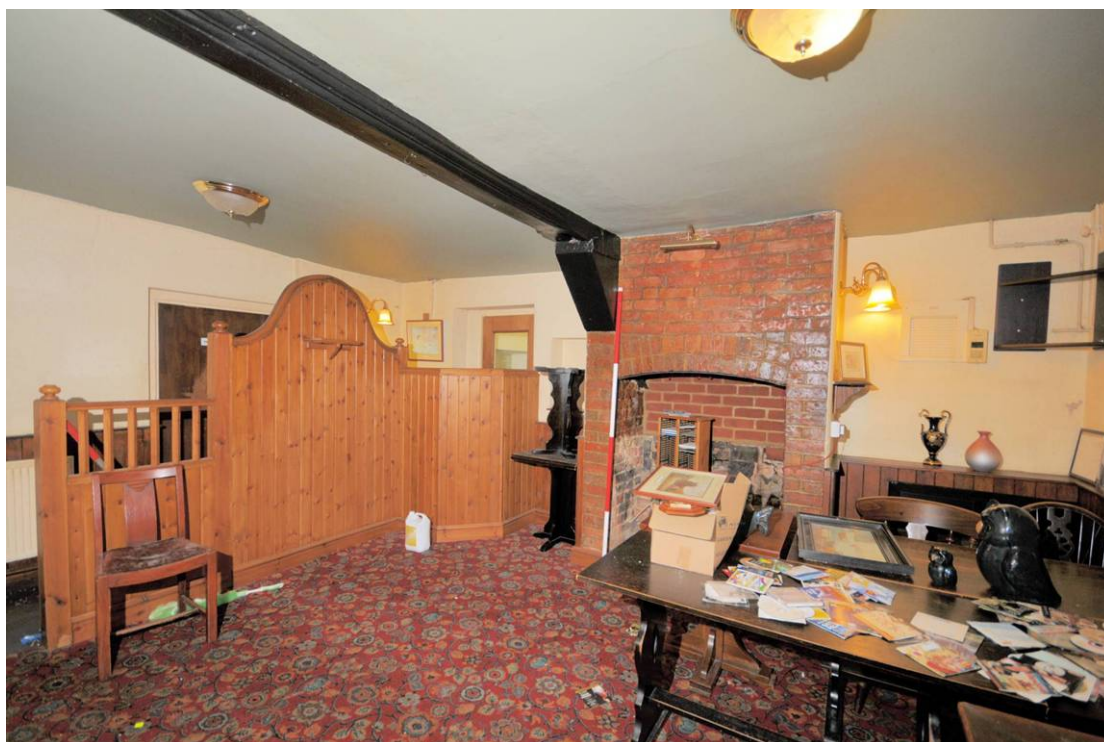
Plate 11: Ground floor, rear wing, looking north-east

This room consists of a dining area (Plate 11). A modern pine screen along the north side of the room separates the dining area from the doors to the kitchen. The walls are lined with modern pine wainscot stained mid brown.

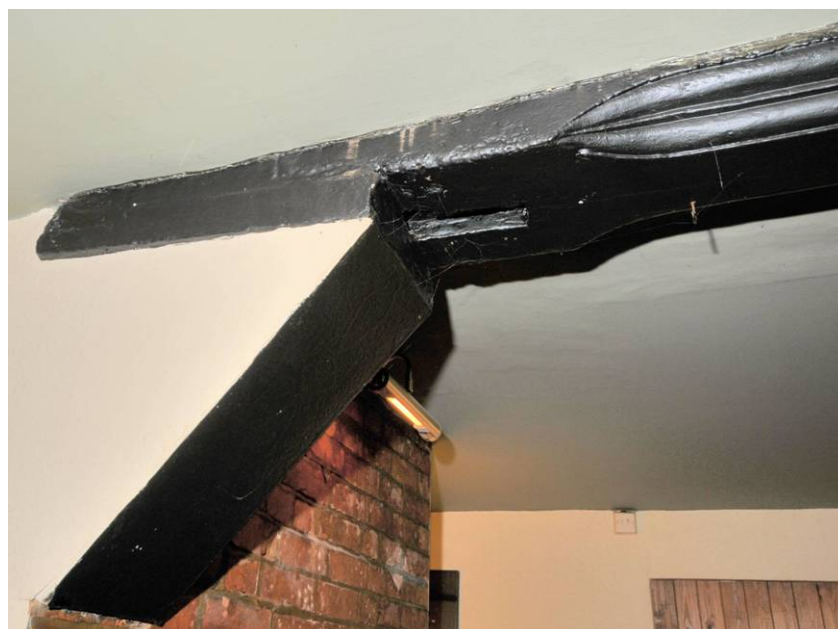
The ceiling is supported by an east-west axial beam. This has a double ovolo and fillet chamfer which ends in a converging stop (Plate 12). The end of the beam is supported on a heavy corbel which projects from the modern fireplace. The presence of an empty mortise in the soffit of the beam indicates that the corbel has replaced an earlier bracket. It is likely that the current fireplace has replaced a larger structure which supported the end the beam.

Plate 12: Converging chamfer stop, rear wing, ground floor
The end is supported by a modern corbel set in the re-built fireplace

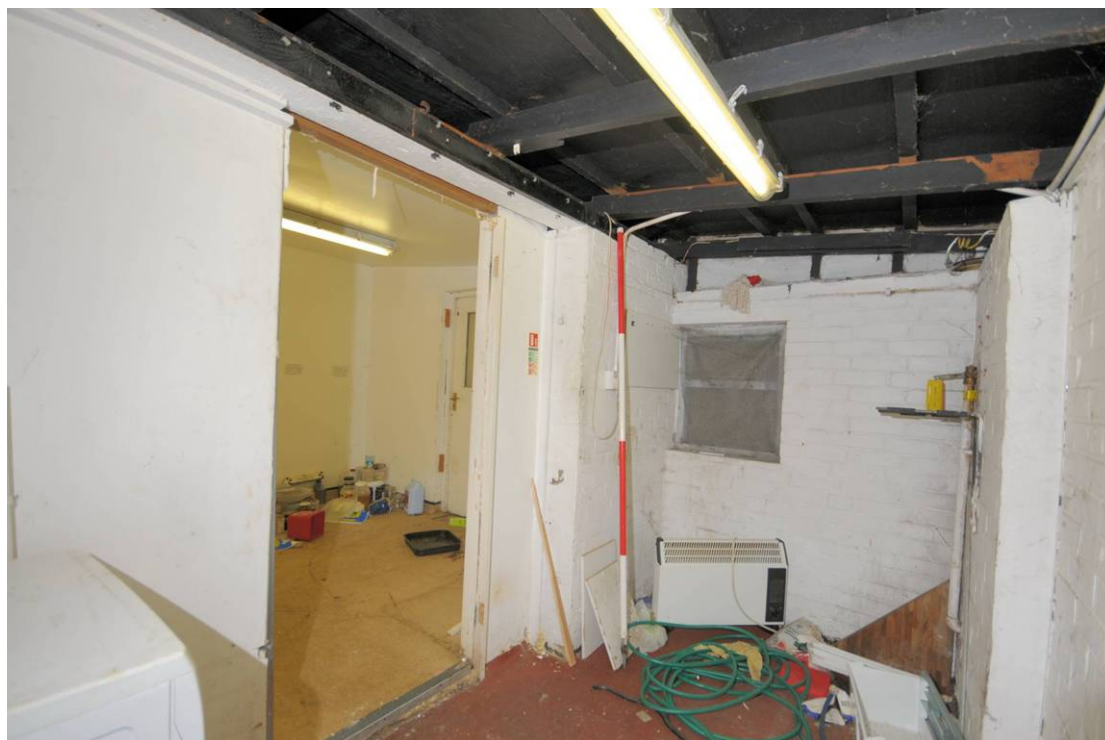
Plate 14: Kitchen showing splayed wall between lean-to and main structure

This part of the building is situated to the north of the rear wing. The interior is divided by modern partition walls to form a ladies toilet at west end and a kitchen at the east. Modern internal work has obscured the original construction details in this part of the building. In the north wall of the kitchen a splay indicates the break between the stone masonry of the lean-to and the brick built section at the east end (Plate 14).

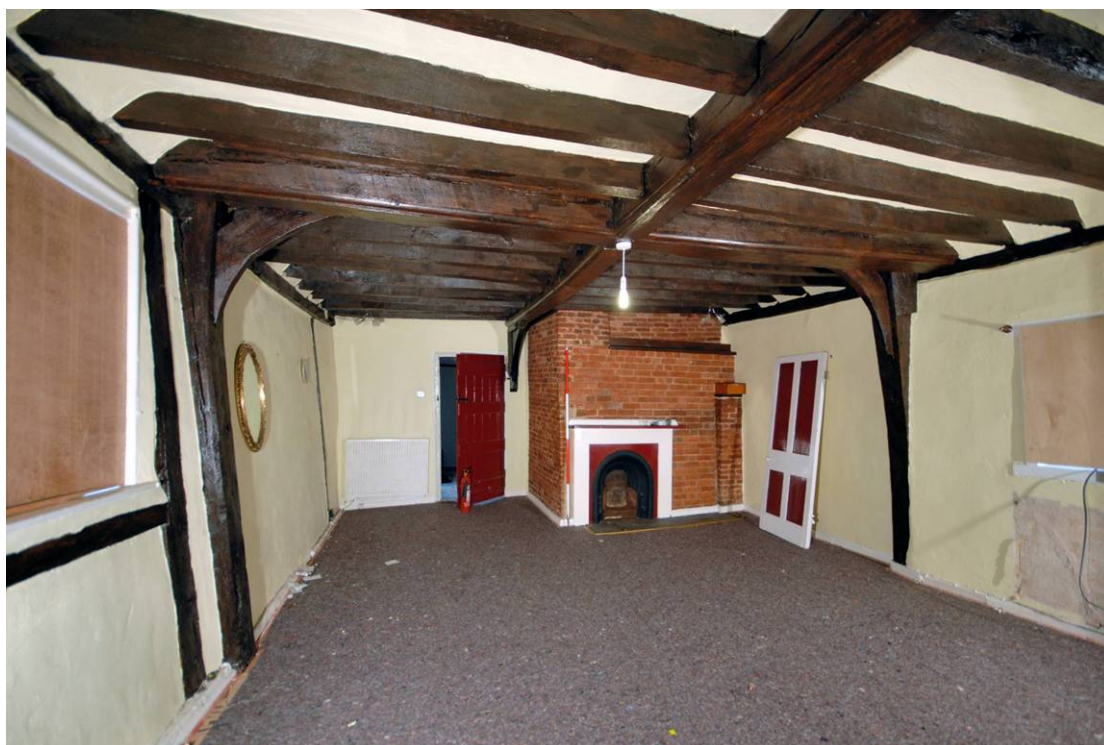
Plate 16: Main range, first floor, south room looking north
Shows original stack with inserted Victorian fireplace and inserted ceiling with ovolo chamfered beams.

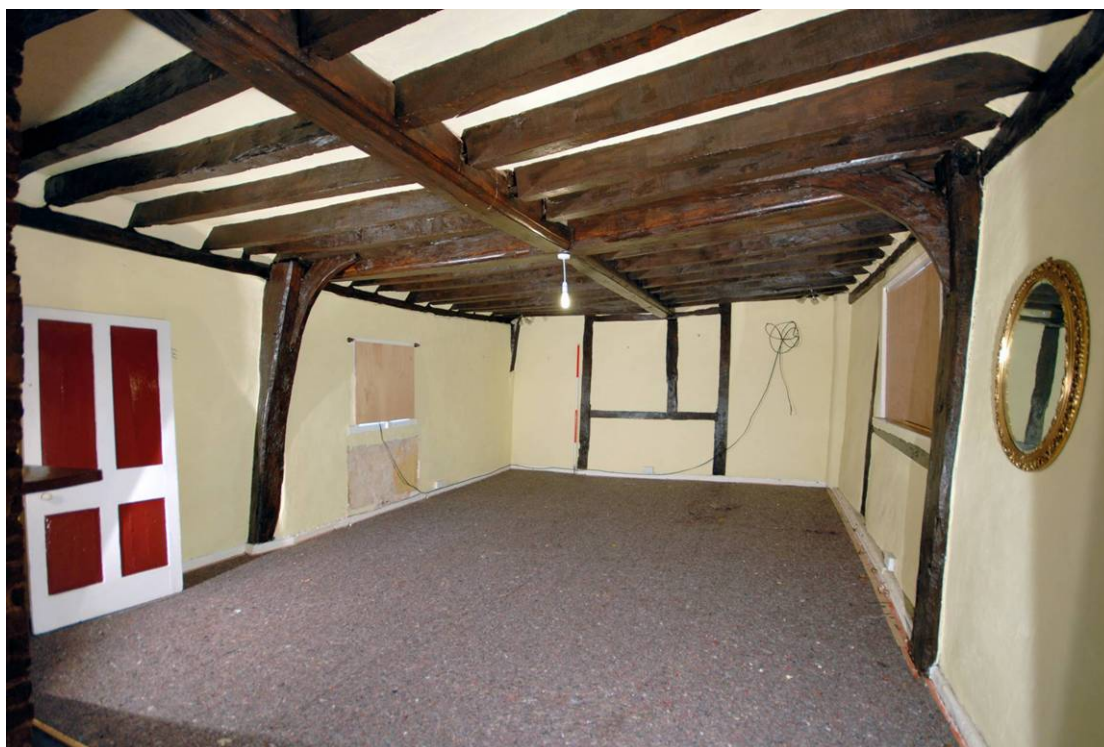
The central and southern part of the first floor is occupied by a room of two bays (Plates 16 and 17). Visible elements of the frame comprise jowelled wall posts, tie beam and arch braces at the bay division, the wall plate and some intermediate posts and rails in the west side and south end of the room. A scarf joint in the wall plate is visible at the north end of the west wall appears to be edge-halved. In the north-east corner of the room is a large exposed brick chimney. This is the stack that has been truncated at ground floor level. The bricks are irregular hand-made bricks between 50 to 55mm thick (2 to 2¼ inches) in English bond with wide mortar joints. A cast iron grate with an arch opening characteristic of the late Victorian period (c.1860 to 1890) has been inserted into the earlier fireplace with the remainder of the original opening infilled with brick.

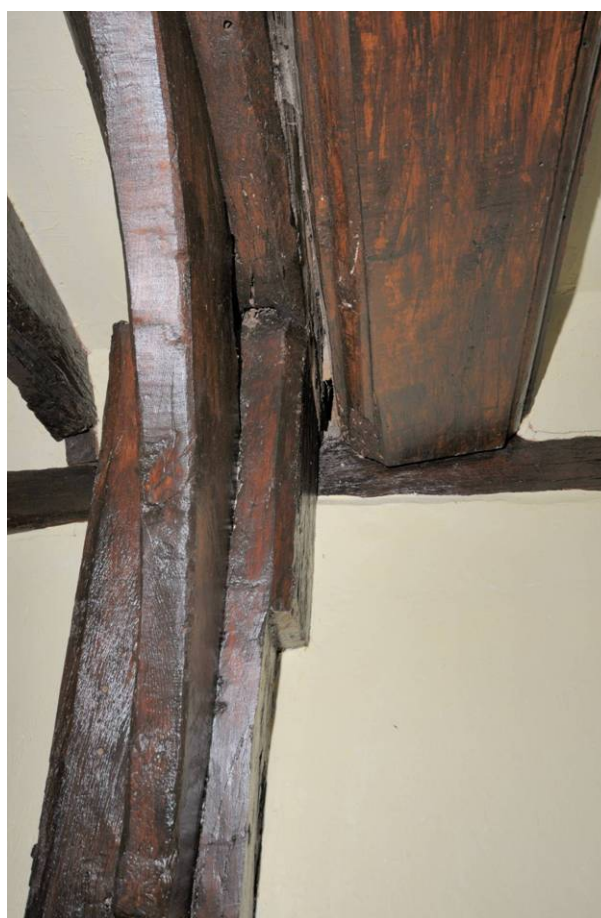
Plate 18: Main range, first floor, south room, frame and chamfered beam
Shows frame with arch brace to left and inserted ceiling beam with ovolo chamfer to the right.

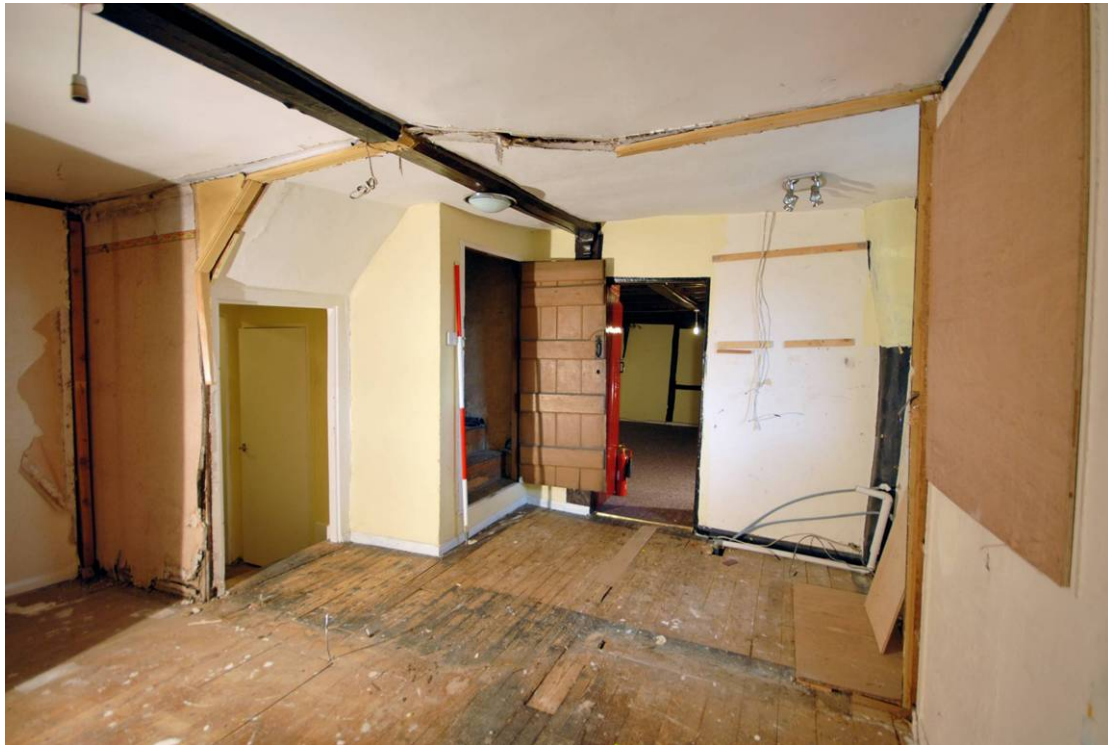
Plate 19: Main range, first floor, north room looking south
Shows traces of former room partition visible on ceiling and floor and open door to the attic in centre of image.

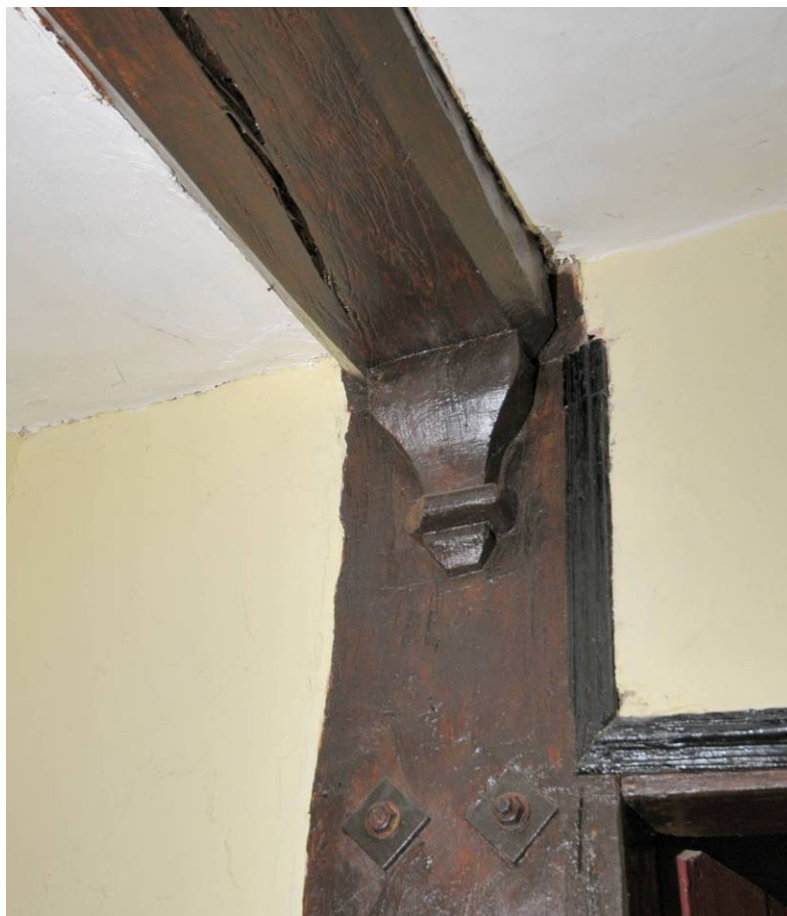
Plate 20: Main range, first floor, north room, chamfered beam and pendant
Pendant at south end of plain chamfered axial ceiling beam.

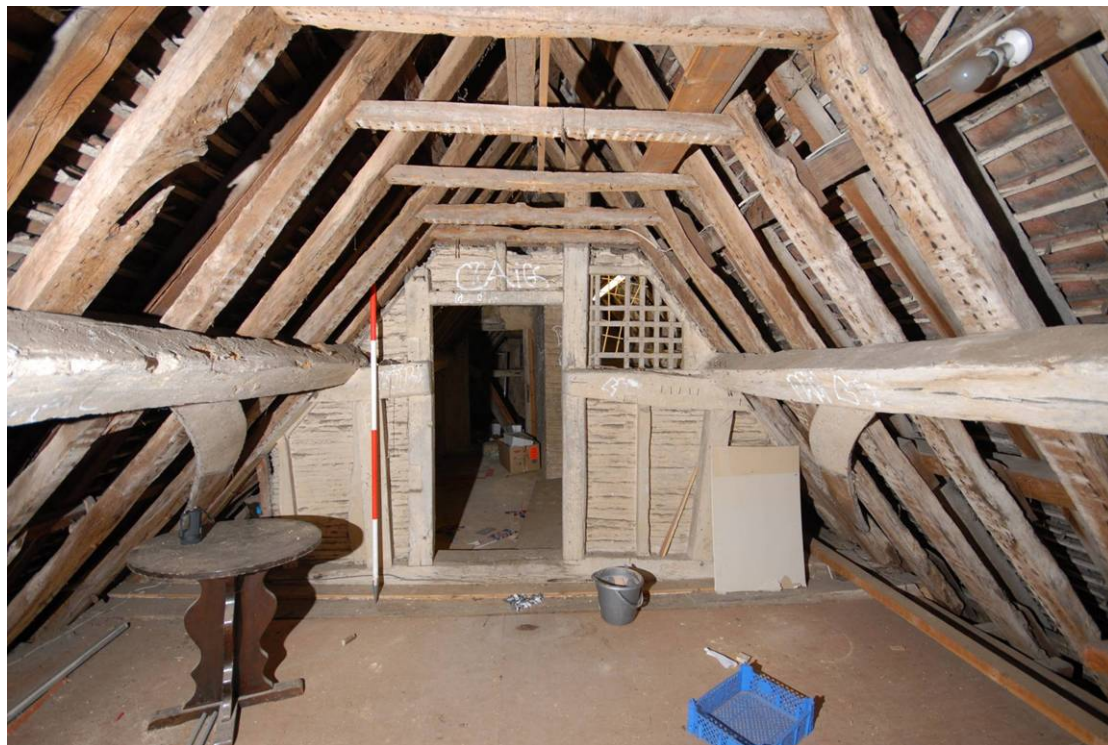
Plate 24: Main range, attic, south bay, looking north

Shows frame at bay division with inserted doorway, lattice 'window' and lath and plaster on north side of partition.

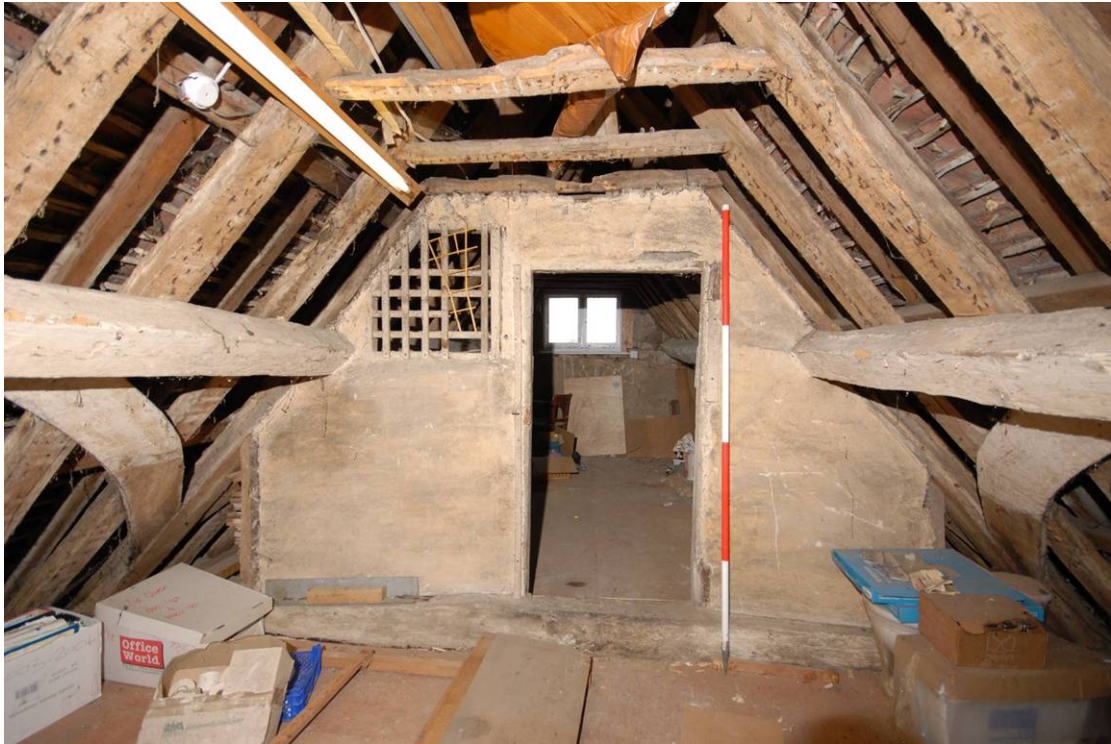
Plate 25: Main range, attic, central bay, looking south
As in previous image looking from the north side.
