**The George Inn
Maulden
Bedfordshire**

HISTORIC BUILDING REPORT

Document: 2012/76
Version: 1.0

June 2012

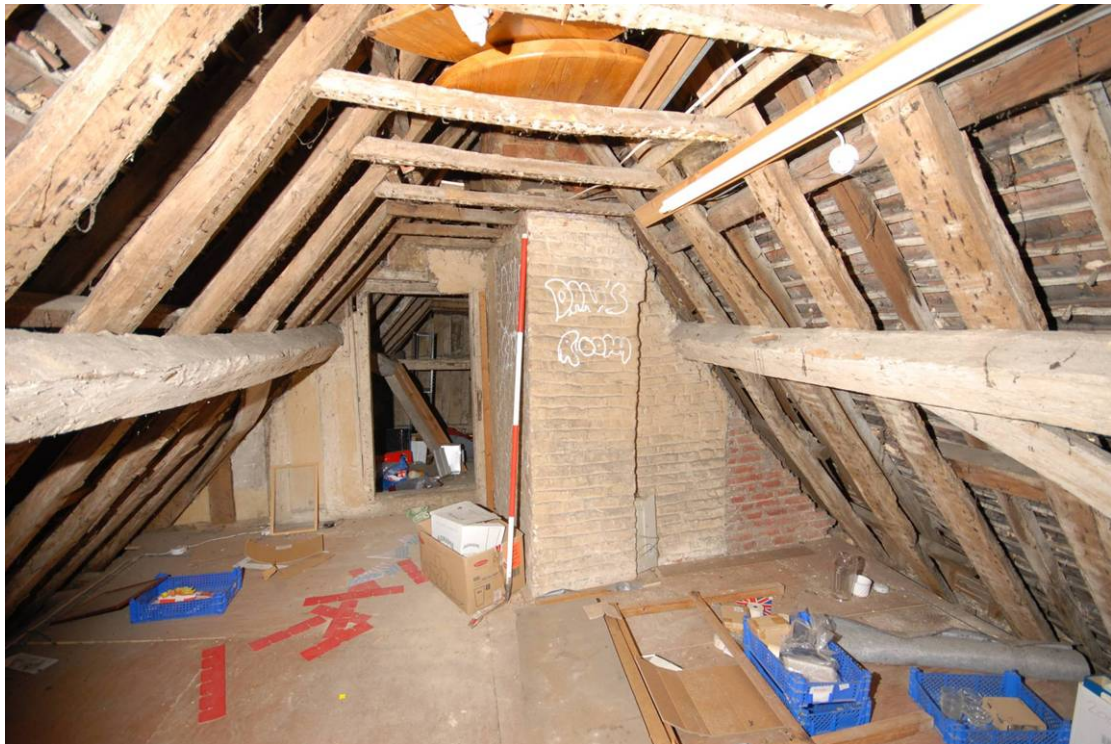
Plate 26: Main range, attic, central bay, looking north
Note vertical line in whitewash on chimney stack showing limit of former lath and plaster lining.

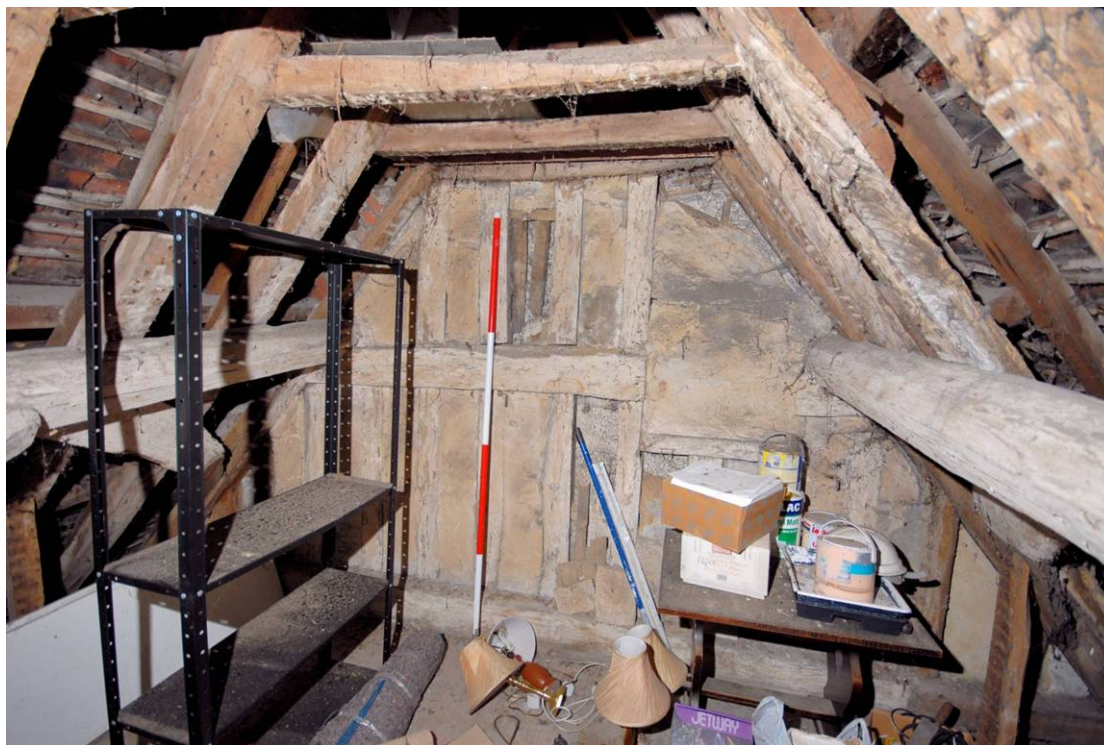
Plate 27: Main range, attic, north bay showing north gable wall.
This shows the close studded gable end with a later blocked window where the collar beam has been truncated on the right hand side.

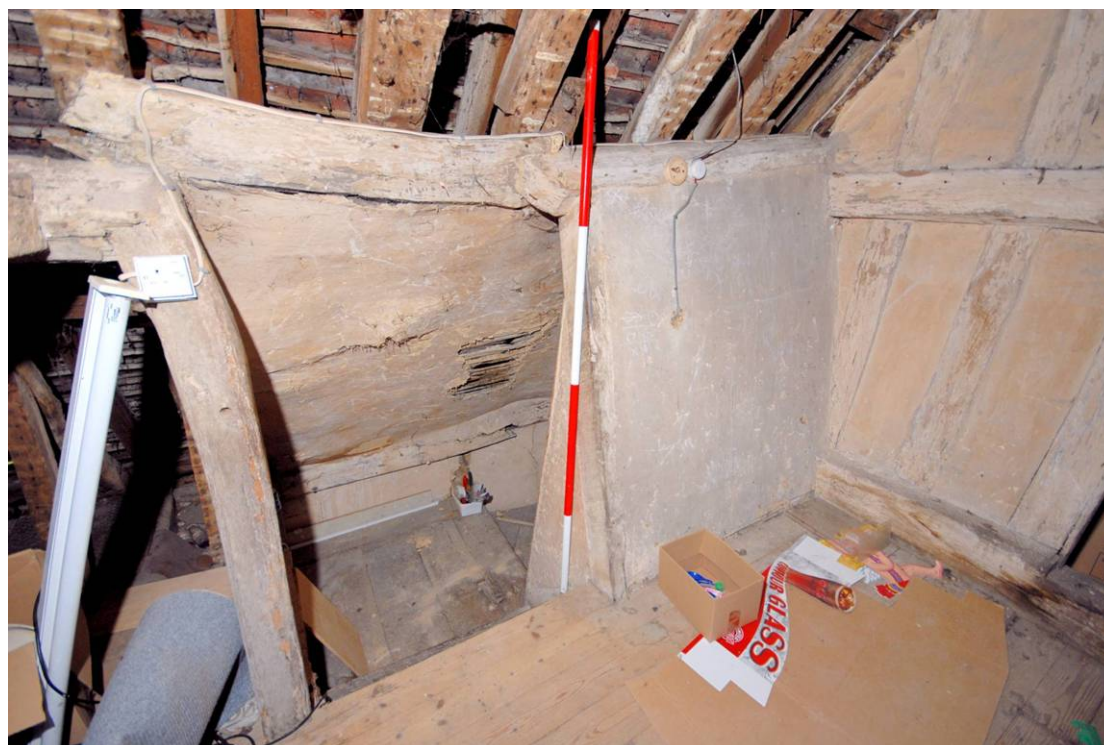
Plate 28: Main range, attic, north bay, showing inserted stair from first floor.
The purlin is truncated above the stair and the lath and plaster partition for the stair abuts the original close studded attic partition in the right of the image.

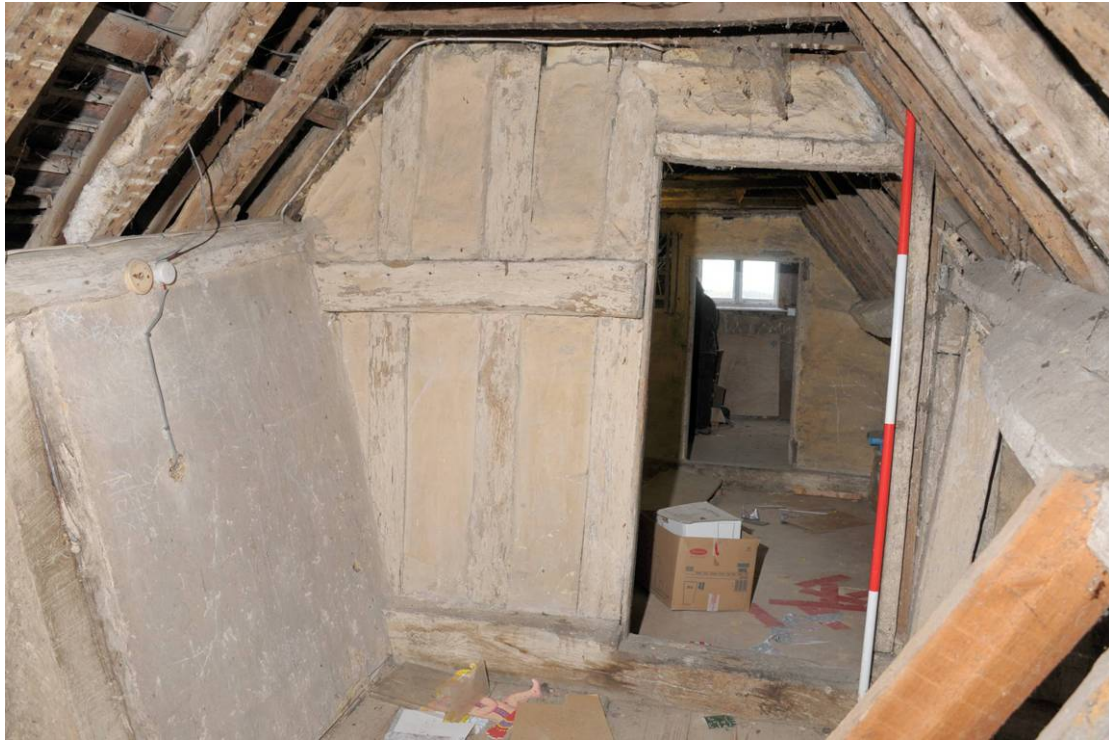
Plate 29: Main range, attic, north bay, looking south
Shows close studded bay division with inserted doorway
