**BUILDING ON McCONNELL DRIVE
WOLVERTON
MILTON KEYNES**

**ARCHITECTURAL
BUILDING RECORDING**

Document: 2013/47 ver.1.1

Produced for:
Kaby Developments Ltd
Milton Keynes

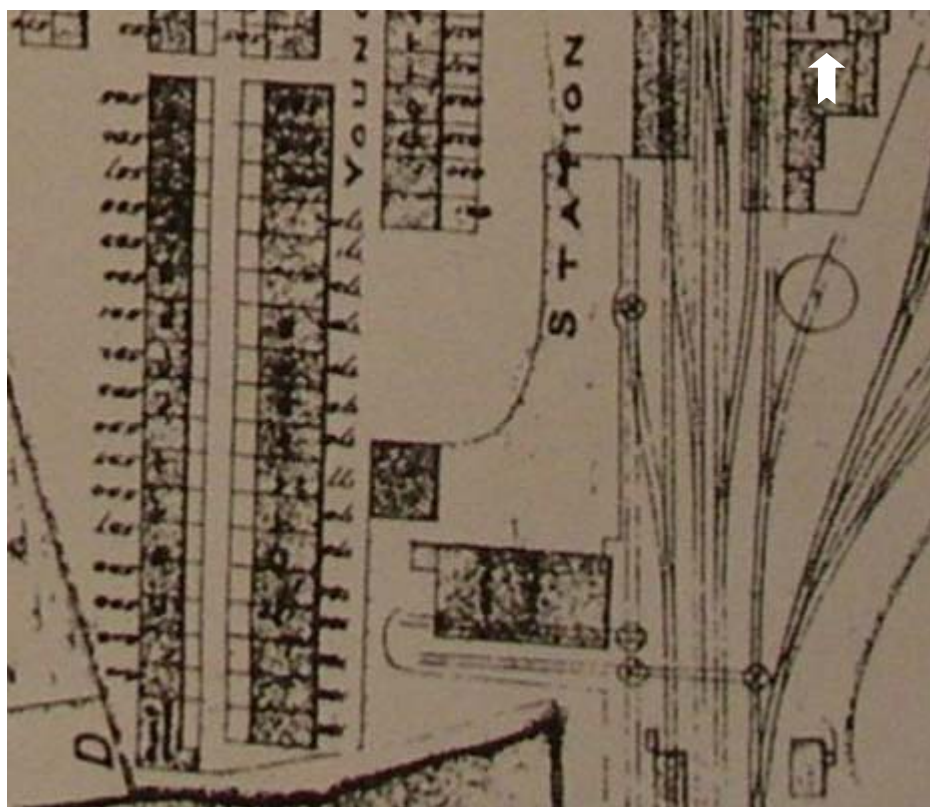
Figure 2: Wolverton Works map 1860

The goods yard and associated building is first shown on a map from 1860 (Figure 2). The yard lies sandwiched between the main north-south railway line to the east and several rows of tightly packed railway workers cottages along Young Street, Glyn Square, Ledsam Street and Creed Street to the west.

The yard consists of an east-west aligned shed with an internal siding and an external siding along its southern side, both of which are connected to the main line via turntables. The railway shed has a small square extension on its north-western side. A larger, detached square building lies to the north-west of the shed. The yard is enclosed by a boundary wall.

The railway tracks leading into and along the building are also enclosed by a black line on the map, suggesting that they may have been within their own cutting. The ground of the goods yard lies at a considerably higher elevation than the main north-south line (and the current McConnell Drive) but the shunting and access of wagons on the sidings into the yard would have needed level ground.

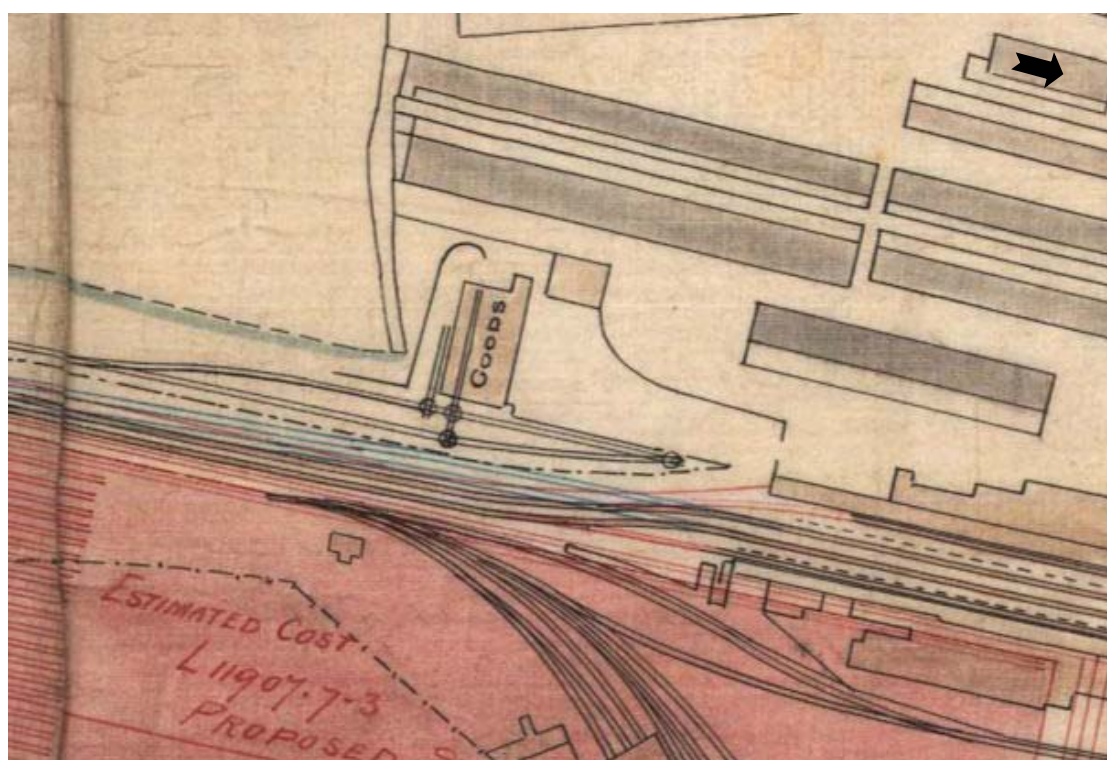
Figure 3: Wolverton Works map 1882

Subsequent maps of the Wolverton Works and the first edition OS map show the layout of the site unchanged but the maps give increasingly detailed information. On a Works map of 1882 the railway shed is marked “Goods” (Figure 3). The latter map also shows a clear access gate within the northern side of the boundary of the yard. This leads the open area to the east of Young Street and the residential part of Wolverton beyond.

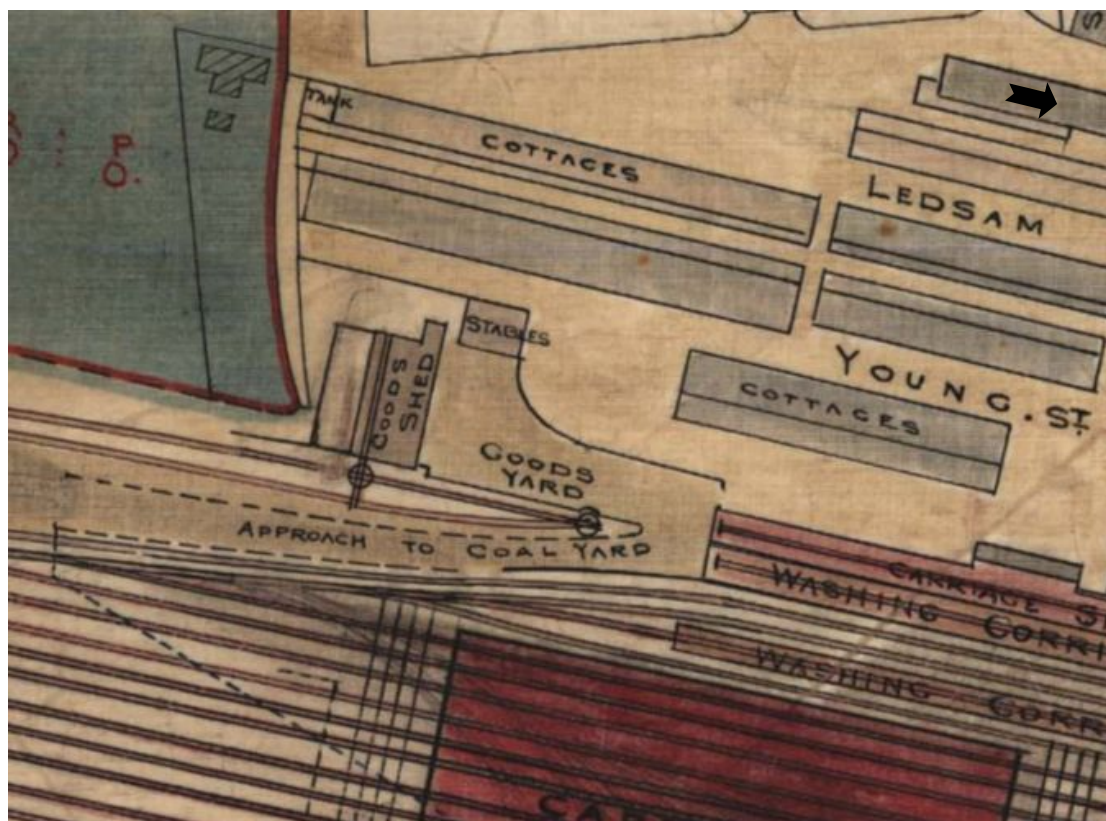
Figure 4: Wolverton Works map 1886

On an 1886 map of the works the small square building on the site of the current building is marked “stables”, the shed “Goods shed” and the approach to the goods yard “Approach to coal yard” (Figure 4). It is possible that a large number of the goods arriving at the yard consisted of coal, that was then transported by horse and cart (stabled on site) to the residential area of the works through the gate in the northern wall of the yard.

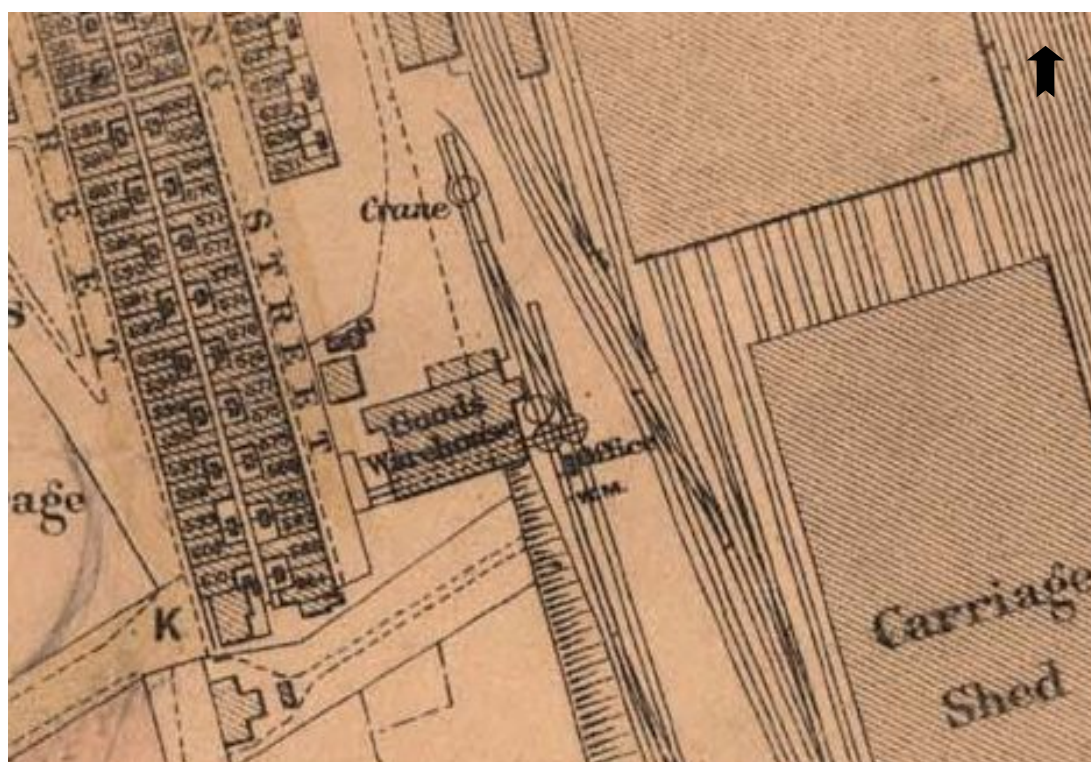
Figure 5: Wolverton Works map 1897

On a map of 1897 the clearly marked “Goods Warehouse” has a narrow extension on its north-western side and the stables building has acquired three small buildings immediately to its north, between the building and the boundary wall (Figure 5). Their function is unclear.

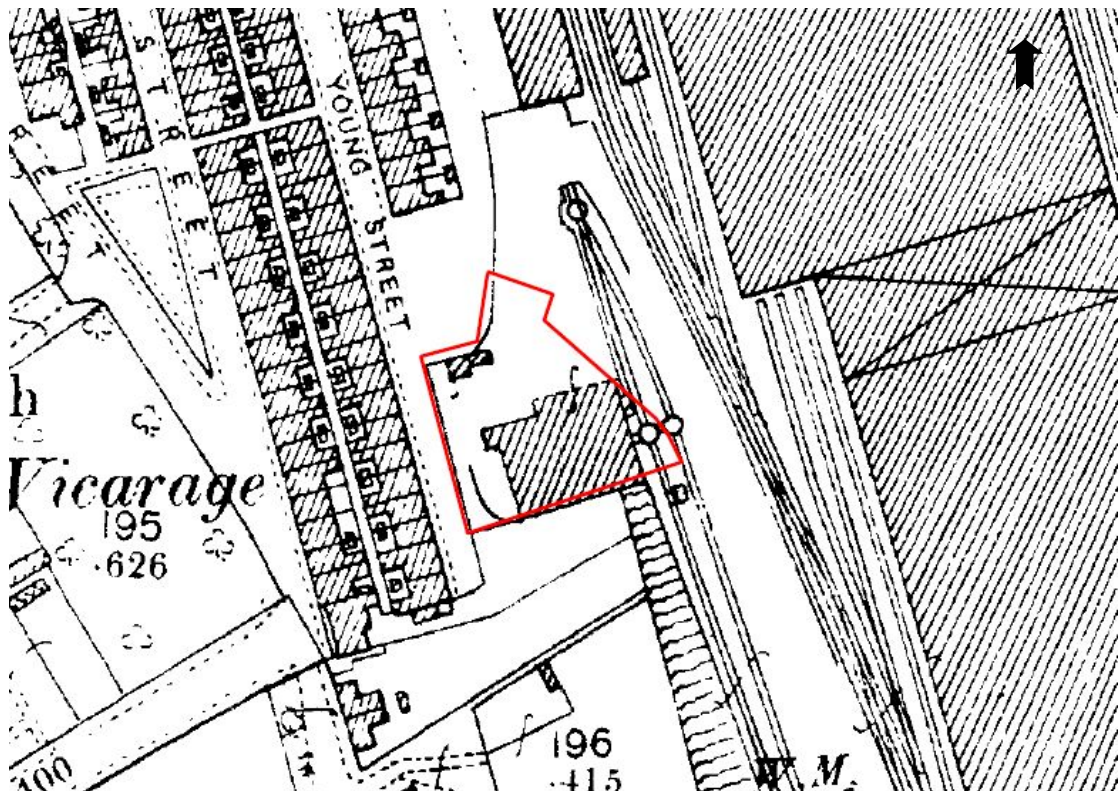
Figure 6: Second edition 25 inch OS map 1900

The second edition OS map of 1900 mirrors this development in that it only shows the goods shed and the small structures near the northern boundary wall (Figure 6). The square building on the site of the current building is not shown.

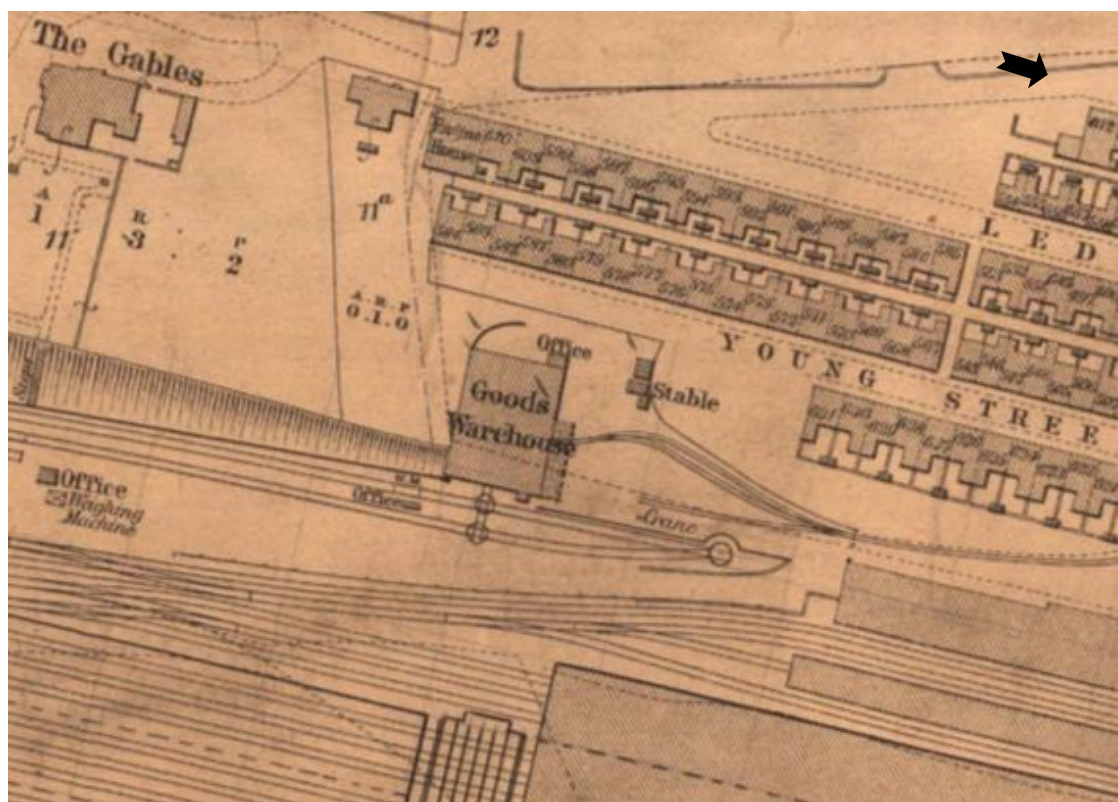
Figure 7: Wolverton Works map, most likely post 1900

Detailed information on the development of the goods yards is given on an undated map of the Works. The HER describes it as “post-1887” but the map regression and comparison with the OS map of 1900 suggests that it most likely dates from between 1897-1900 (Figures 6 and 7). The Wolverton Works map shows that the square stable building has disappeared, most likely it was demolished. The three little buildings near the northern boundary wall still survive and are now marked “stables”. The main goods shed is marked “Goods Warehouse” and its small north-western extension, which had been there since 1860, is marked “office”.

The most interesting development is the track that now runs from the goods shed through the gate in the northern goods yard wall, via Glyn Square and Ledsam Street, to join the *Wolverton and Stoney Stratford District Light Railway*

Originally the office of the goods yard was very small and attached to the western end of the goods shed (Figures 2-7, labelled as “office” in Figure 7). The site of the current building was originally occupied by a stable block, but with the changeover of goods carriage from horse and cart to the tramway and later lorries (see Section 2.2), the stable block was no longer required and the space could be re-used for a larger administrative building.

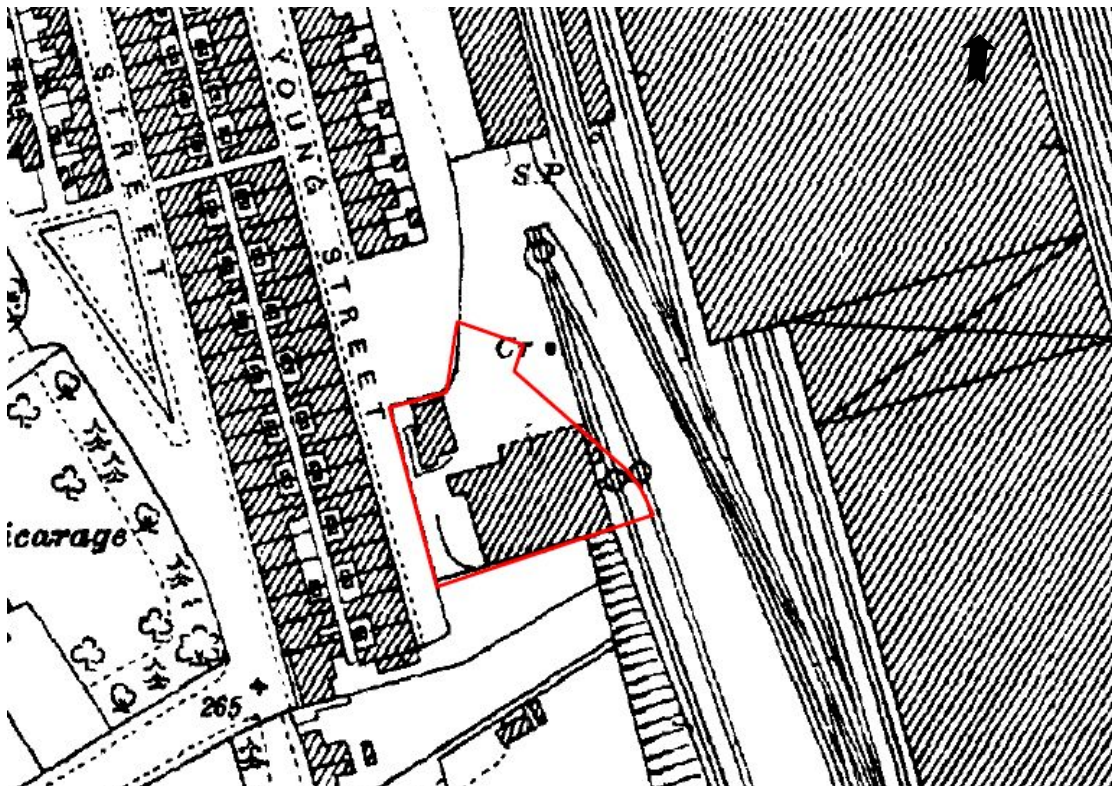
Figure 8: Third edition 25 inch OS map 1925

This map regression shows that the building currently on the site was not built until the beginning of the 20th century. The third edition OS map of 1925 shows the footprint of the building as it is in its current form, including its south-western extension (Figure 8). The external form and fabric of the building suggests that it was built in one phase - later alterations most likely only affected the interior of the building (see Section 3.4).

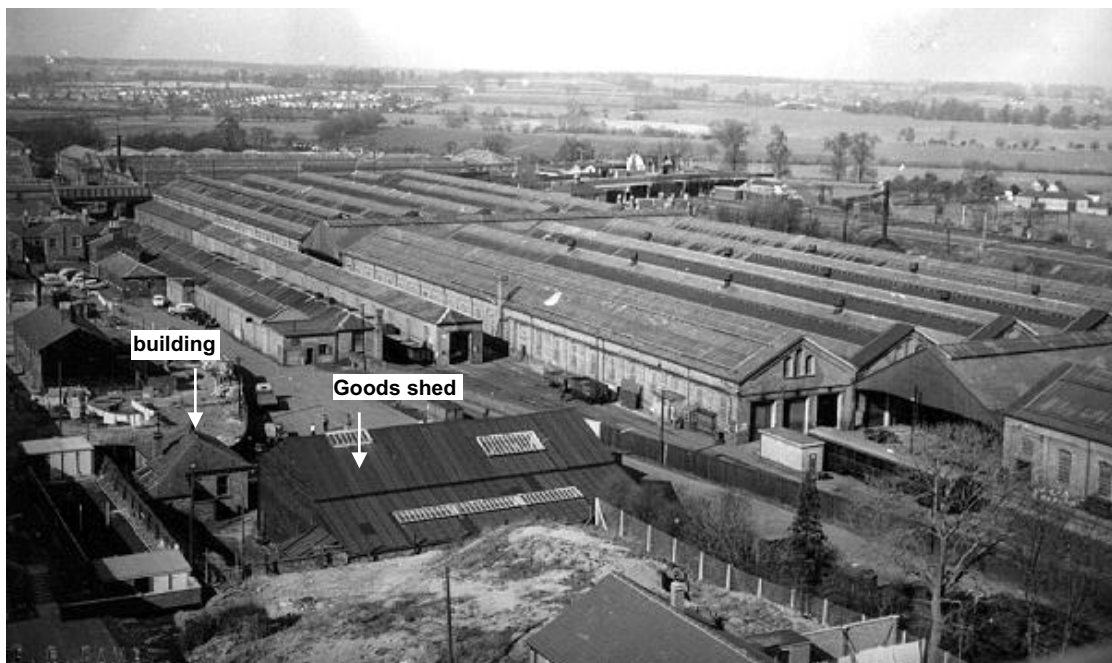
Figure 9: Aerial view of carriage works 1949 – 1959

The goods shed and building stood on the site until at least the late 20th century. An aerial photograph of the works in 1949-59 prior to the construction of McConnell Drive (Figure 9) shows the goods shed and building in the foreground, still being part of the Works.

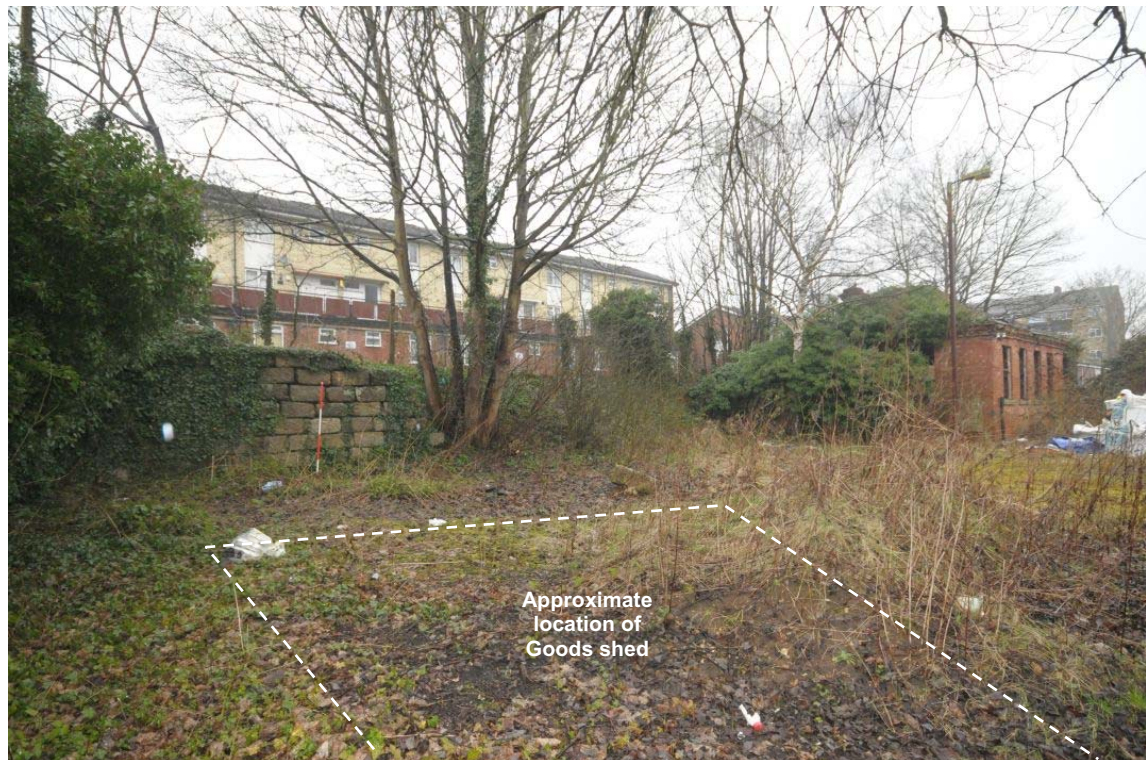
The yard is bounded in the south and west by a substantial wall made out of large granite blocks (Figure 10). This serves as a retaining wall for the rise in topography to the west and south. It is likely that when the yard was part of the Works its surface was considerably lower in order to provide level access from the railway line to the east. The current ground level may have been raised with arisings from the construction of McConnell Drive and there is now a considerable embankment down to McConnell Drive.

The plot is now empty, save for the extant industrial building in the north-western corner of the yard (Figure 10). The building is rectangular in plan and on a NNW-SSE alignment. It consists of a main rectangular cell with an extension at its western and southern side.

Figure 10: Goods yard today, looking north-west.
Revetment wall in left of image (2m scale), building in right of image.

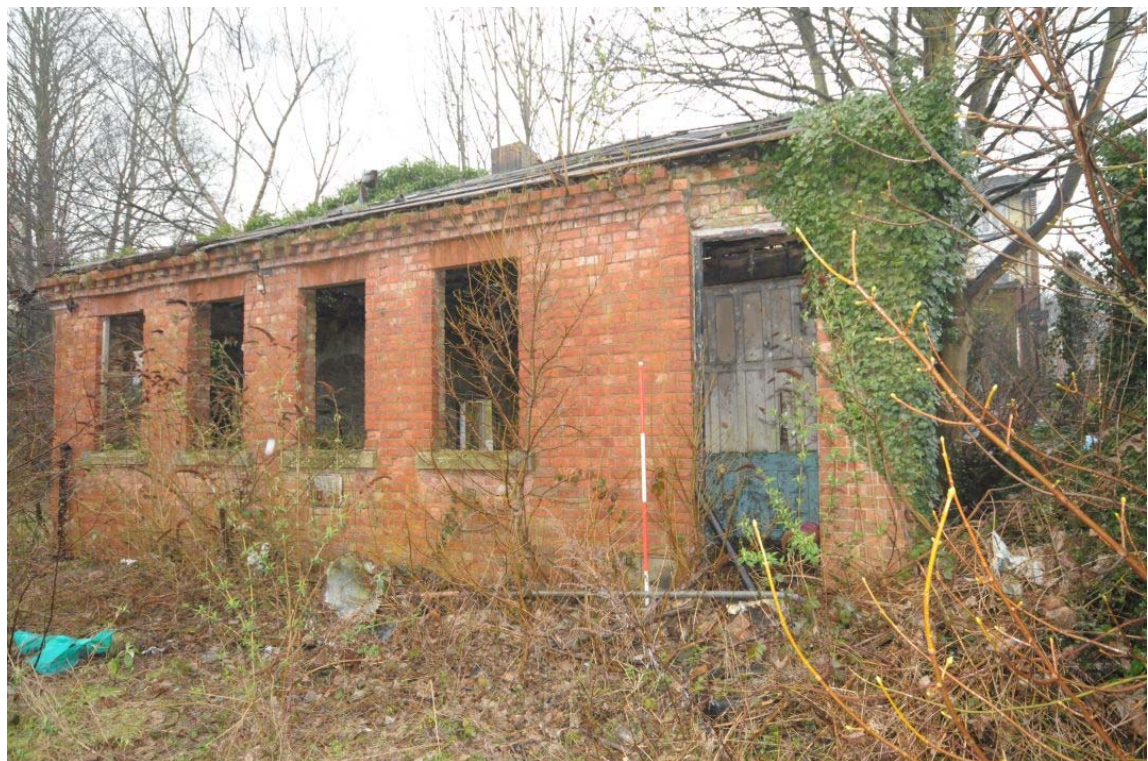
The building is built of red brick in English bond. The main façade faces eastwards towards the yard. It has a single narrow door near the northern side of the building and four equally spaced rectangular high. The northern side of the building has two equally spaced windows and there is also a window in the southern and wall of the building. The latter are close the eastern and southern corner of the building respectively, in order to accommodate the extension curving around the south-western side of the building. All windows have moulded stone sills, flat brick arches and the remains of wooden frames (Figures 11 and 12).

Figure 11: East facing main façade of building. Internal wooden screen visible through main entrance door.

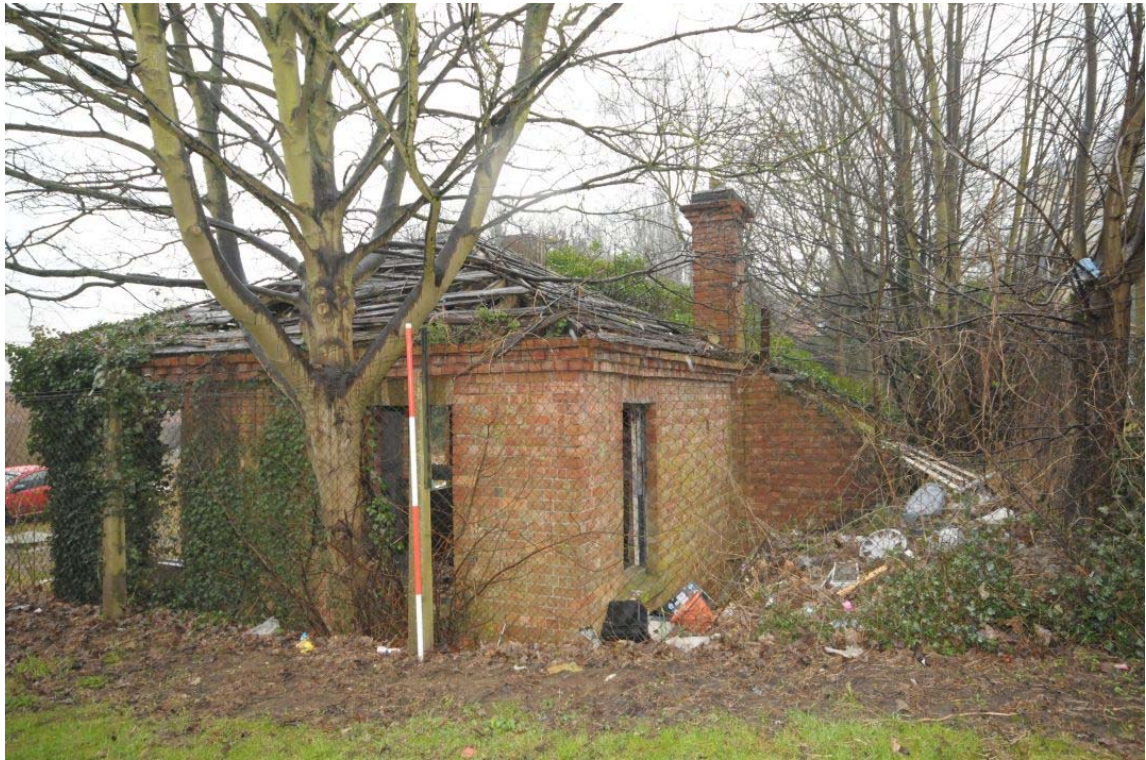
Figure 12: North and west facing sides of building showing extension and main chimney

The main brick-built chimney of the building lies centrally within its eastern wall. This initially served a small open fireplace. This was later blocked and replaced with rectangular and circular openings in order to provide ventilation attachments for an internal oven or heater (Figure 12).

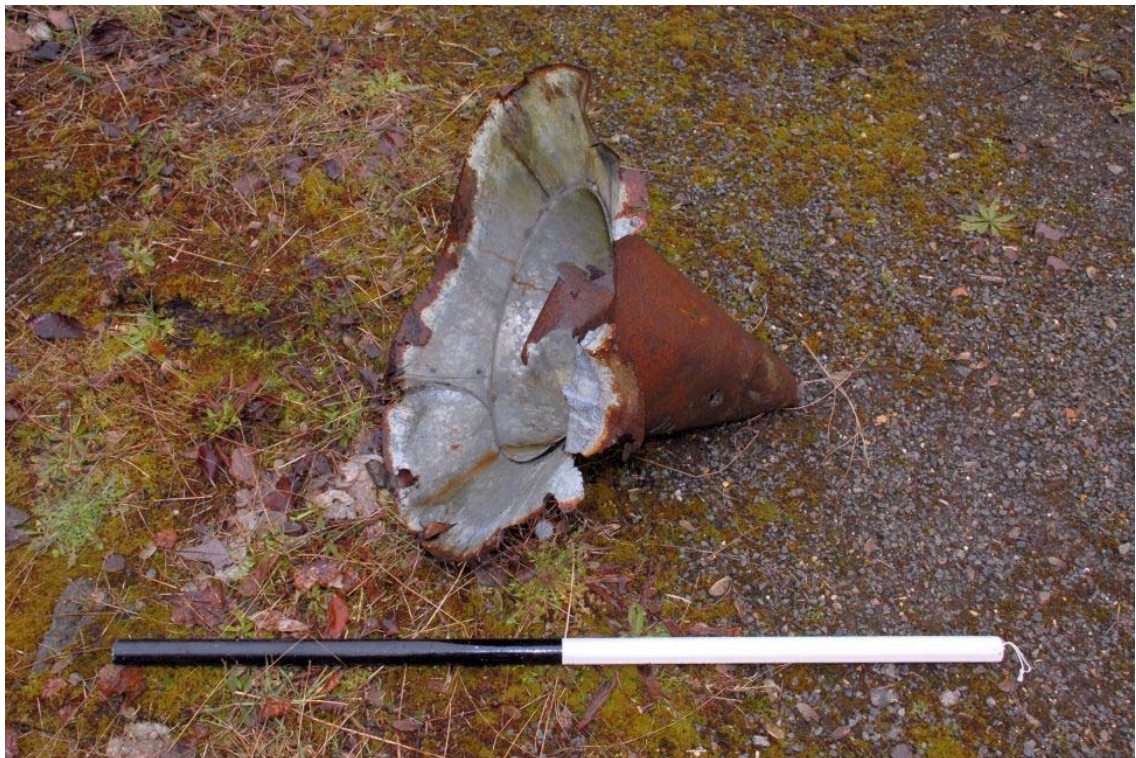
Figure 13: Fallen-down capping of oven pipe chimney

Currently the building has a low hipped roof partially covered in wooden slats. This would originally have been covered in tiles. A wooden ventilation chimney sits centrally on the roof. The remains of a tin oven pipe still hang from the chimney into the interior of the building. A conically shaped ventilation cover had fallen from the roof to the ground (Figure 13).

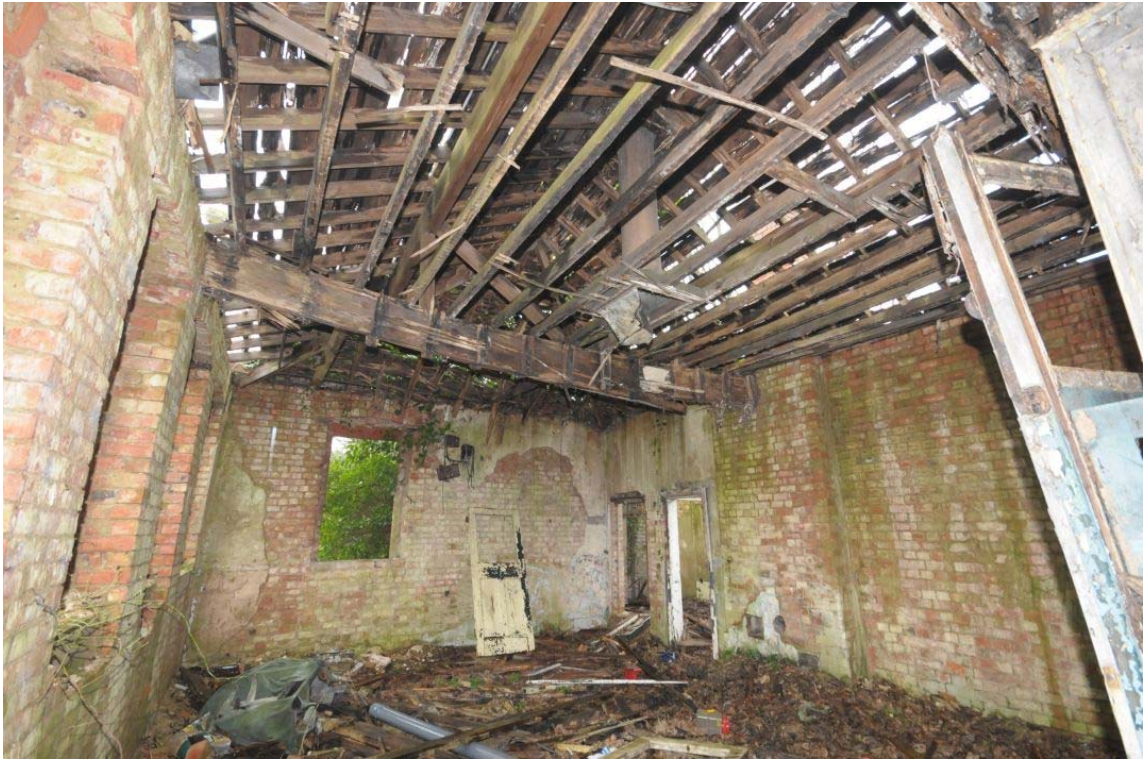
Figure 14: Interior of building, main room looking south

The interior of the building was completely stripped and filled with rubbish and partial demolition debris fallen from the roof. The floor was wooden and had partially decayed to reveal the floor bearing timbers. The remains of plaster survives on some of the walls with the lower part of each wall painted white (Figures 14-16). No original fixtures and fittings survived.

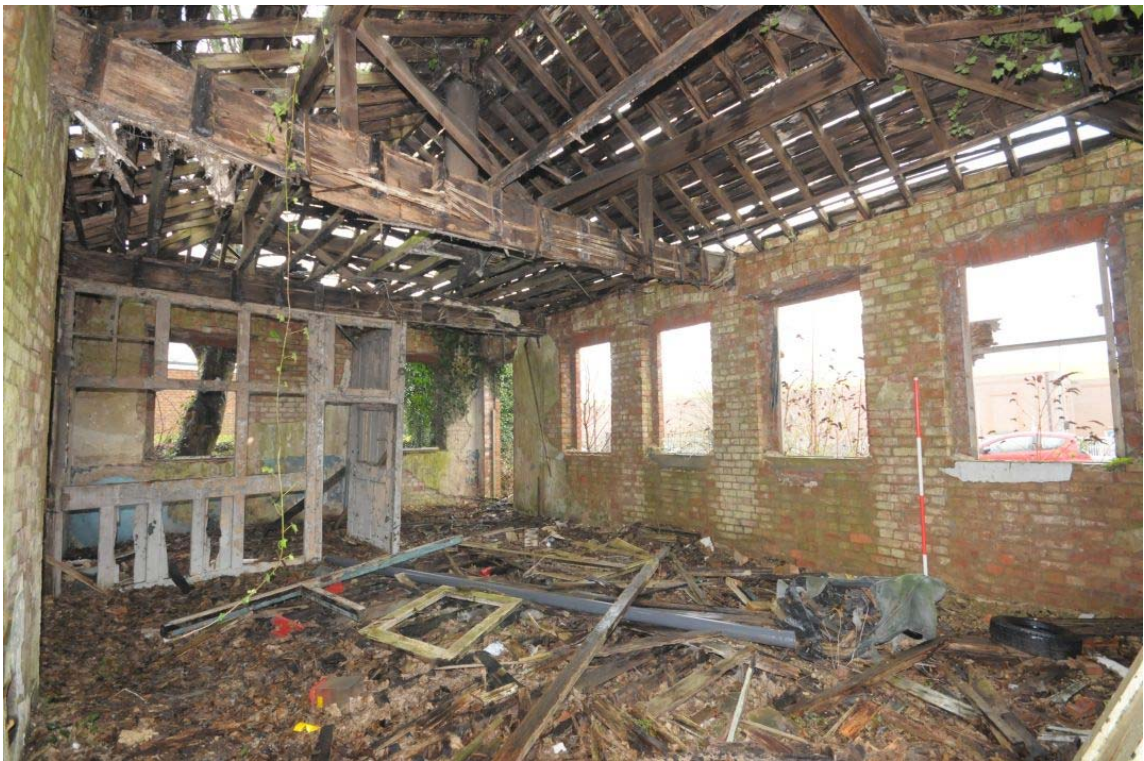
A wooden partition partially survived within the north-western corner of the room (Figure 15). This extended the full height of the room and probably formed a special office area in the corner of the building. It was painted a light blue colour with a darker blue in its lower section. Some of the wooden panels had decayed so it is impossible to say whether the screen contained windows or glass panels or whether it formed a solid wooden partition.

Figure 15: Interior of building, main room looking north-east. Note remains of oven pipe within roof

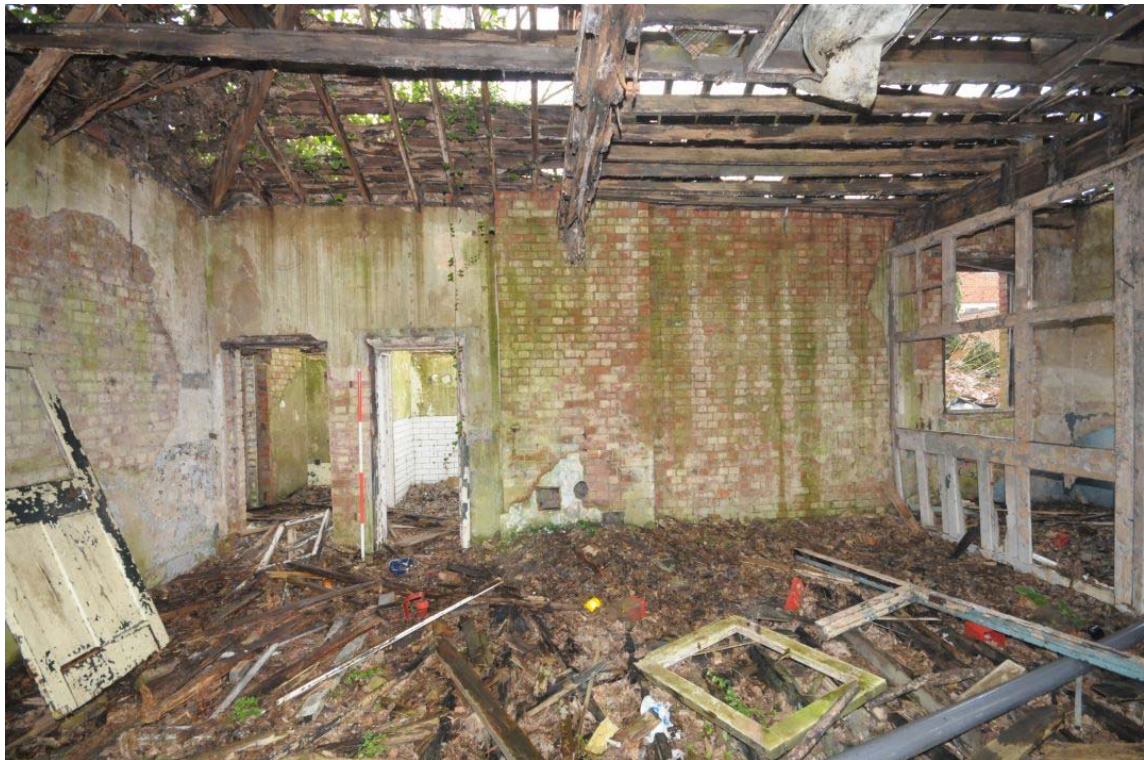
Figure 16: Interior of building, main room looking west

Within the western extension are four small rooms, accessible through two adjacent doors from the main room of the building (Figure 16). The two northernmost rooms had simple, utilitarian white tiles halfway up their walls and were used as toilets and washrooms. The central rooms were plastered with a lower c. 2 foot high painted border, while the southernmost rooms consisted of whitewashed brickwork. All rooms had simple, small and rectangular windows with wooden frames. One four-panelled wooden door survives. A further three-panelled door lies propped against the wall within the main room, suggesting that some of the doors had upper glass panes to let in light.

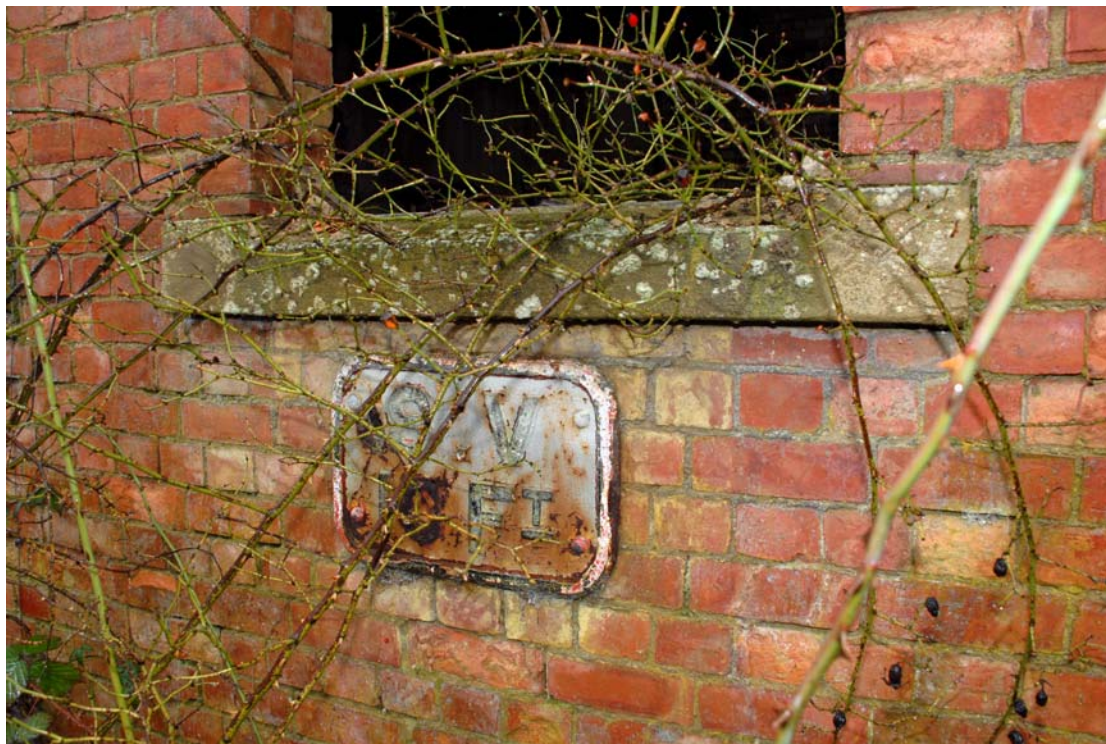
Figure 8: Railway signage underneath window on western façade

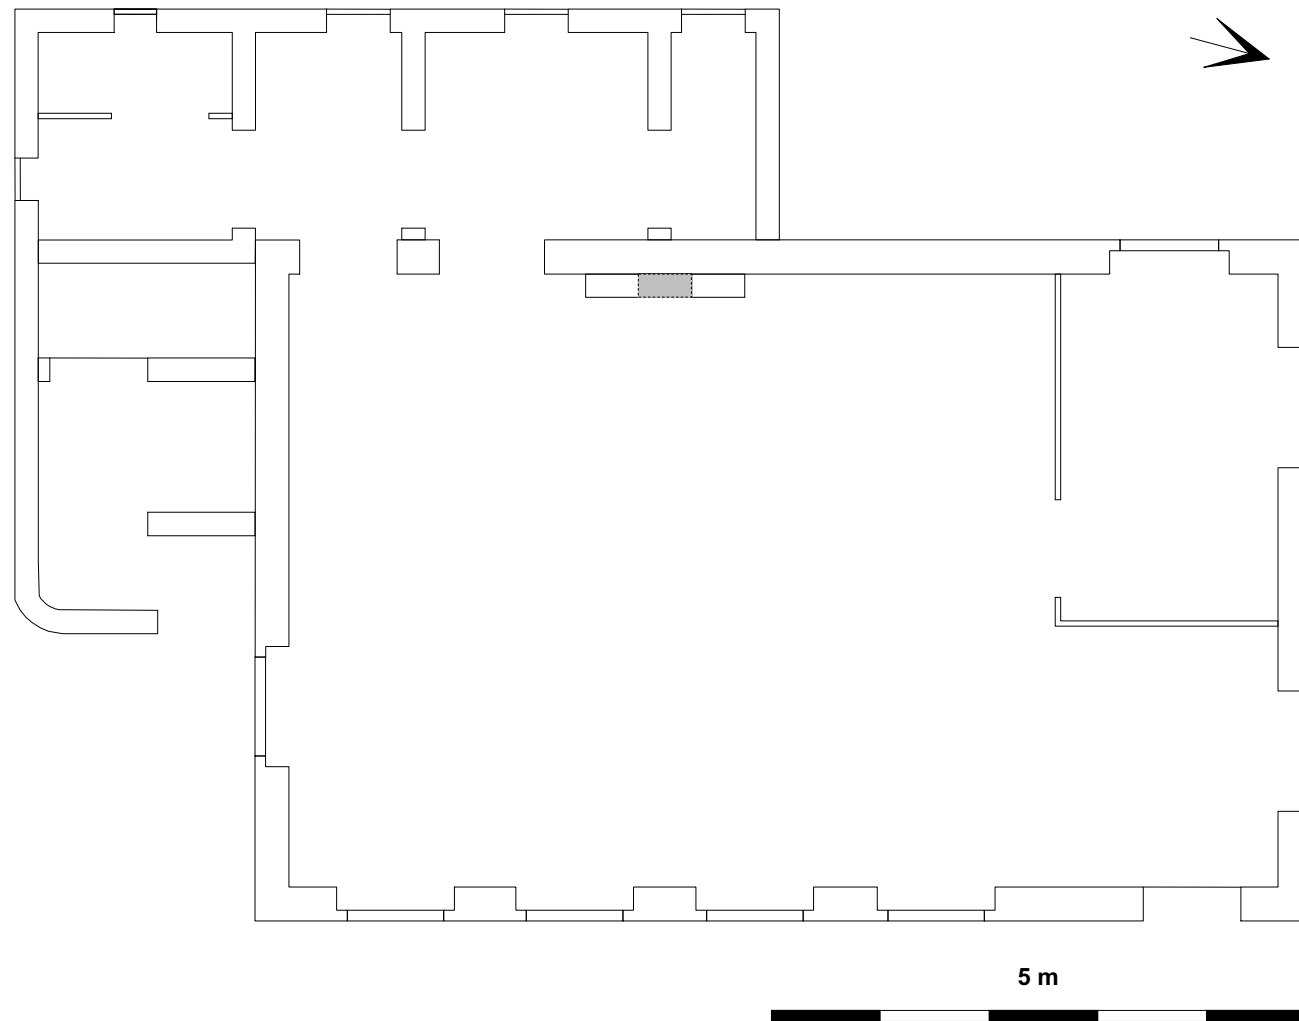
Figure 18: Ground plan of extant building on McConnell Drive.
(not all measurements to scale as some parts of building were inaccessible)
