**RUSTLING END, PIPERS LANE
ALEY GREEN
LUTON**

**ARCHAEOLOGICAL OBSERVATION
INVESTIGATION, RECORDING
ANALYSIS AND PUBLICATION**

Project: RE1929
Museum accession no.: LUTNM 2013/8
OASIS ID: albionar1 -149729
Document: 2013/126
Version 1.0

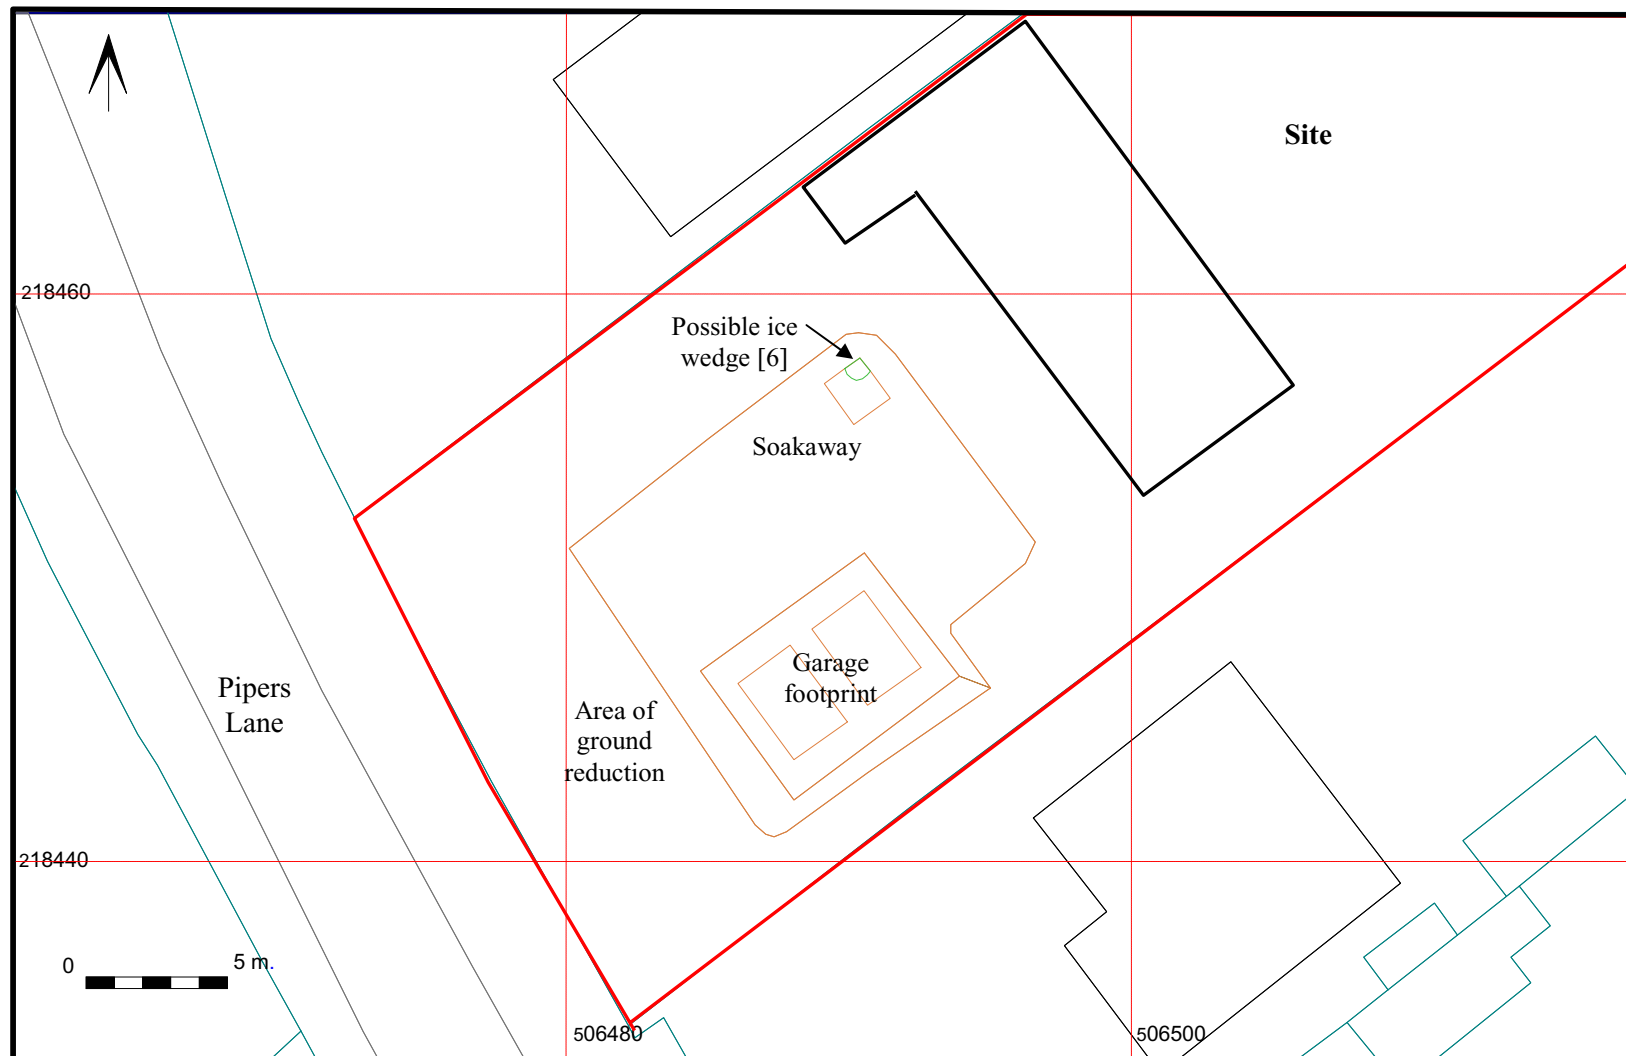
Figure 2: Site plan

On the 25th June 2013 archaeological observation was of the groundworks associated with construction of the detached garage was undertaken. This consisted of ground reduction of an area towards the SW corner of the site (Figure 2), extending up to 1m below the existing ground level, prior to the excavation of a series of footings for the garage and excavation of an adjacent soakaway (Figure 2 and Figure 3: image 1).

The garage footings comprised *c.* 30 linear metres of trench, up to 1.3m wide and 1.7m deep below the level of the terrace. The soakaway pit lay to the north of the garage and was roughly square, 1.8m across by 1.9m deep (Figure 2). Due to the depth of these excavations, the archaeologist did not enter them, with all observations being made from the adjacent area.

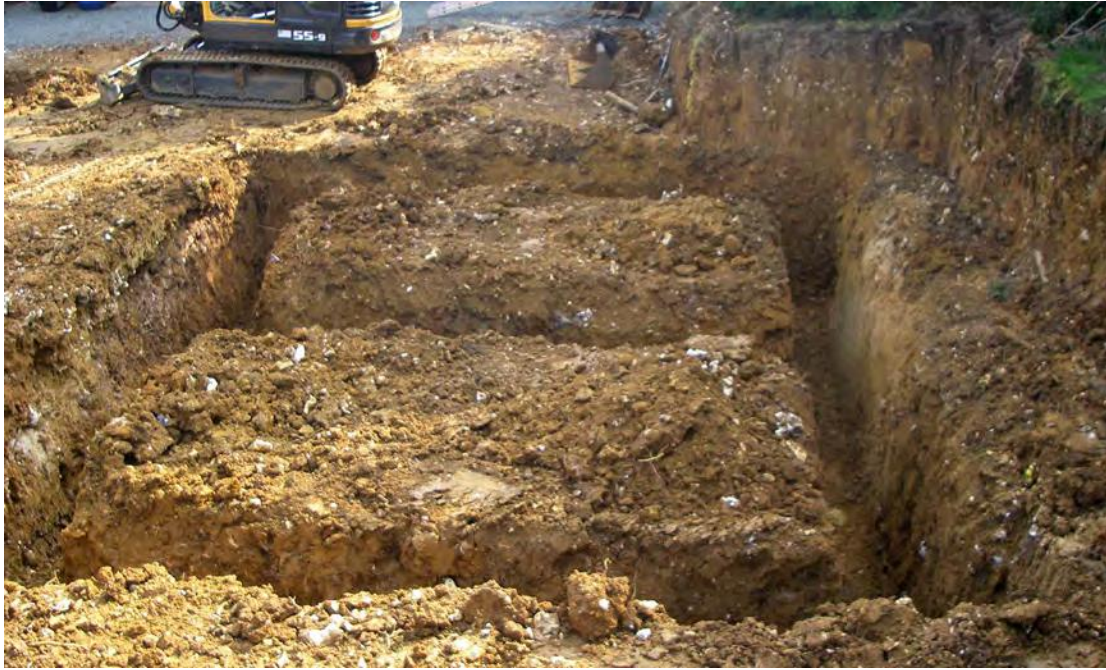
Image 1: General view of excavated footing trenches set within an area of ground reduction. Image is looking towards the house in a north-easterly direction.

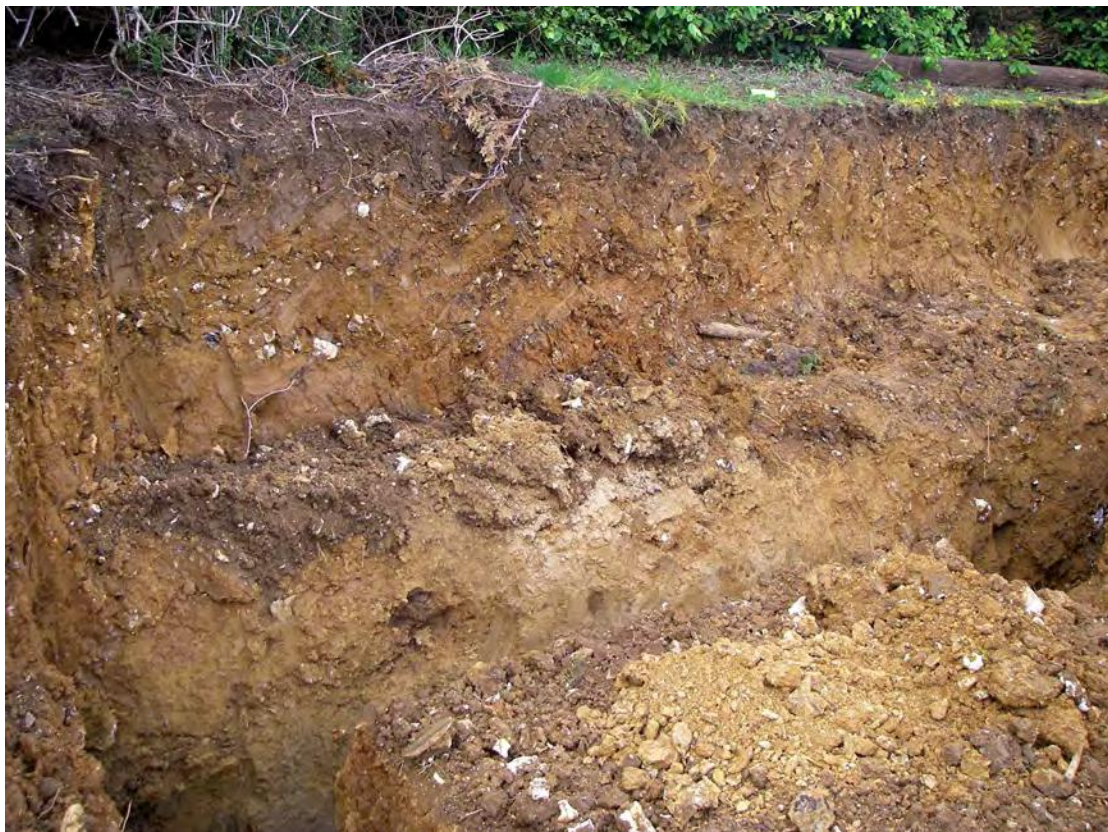
Figure 3: Selected images 1 and 2

The observations revealed a dark greyish brown friable silt clay topsoil horizon (1), which contained moderate small and medium flint fragments. This was up to 0.5m thick towards the house in the NE, though thinning to 0.3m in the south towards the lane (Figure 3: image 2). The tapering profile of this deposit suggests a degree of

landscaping. This would appear to be the remnants of a former cultivation soil, based on the thickness of the deposit, though probably disturbed by activity associated with construction of the dwelling; no artefacts were recovered.

Below this was an extensive mid orange sandy clay deposit (2) (Figure 3: image 2), up to 0.9m thick, which contained unworked flint. The basal part of this deposit was also visible in the top of the soakaway section (Figure 4: image 4). The deposit was darker towards the interface with the topsoil, suggesting that an element of the original profile was present.

Image 2: Stepped section at SE margin of site, the upper step exposes the topsoil (1) and extensive deposit (2), with the lower step revealing yellow clay (4) and brown Clay-with-flints (3) which slope down towards the north.

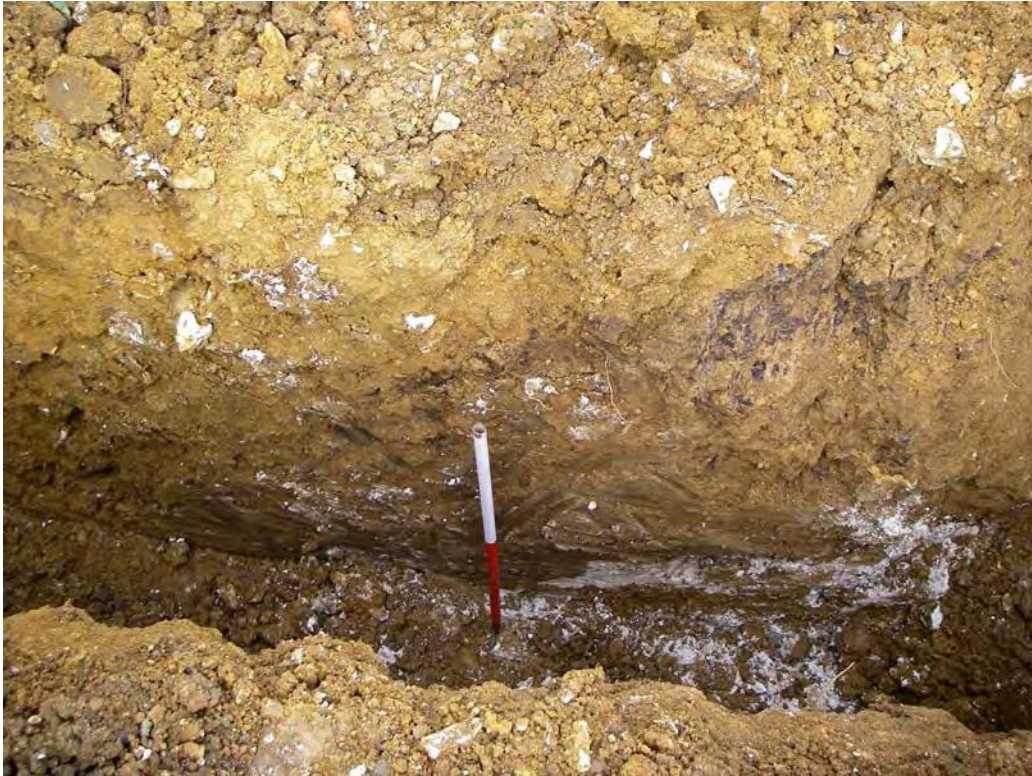
A series of deposits were identified below this level, all of which sloped markedly downwards to the north, into the valley. The earliest was in the south and comprised a small exposure of brashy chalk (5), presumably indicating that the edge of the valley side was close. Above this was dark brownish orange silt clay (3). This was sealed by an extensive and distinctive light yellow clay deposit (4) (Figure 3: image 2, Figure 4: image 3), which was also identified further to the north in the soakaway (Figure 4: image 4). This deposit contained large quantities of flint nodules.

Image 3: Yellow Clay-with-flints (4), above brownish clay (3) with brashy chalk (5) below this. Scale 1m in 50cm divisions.

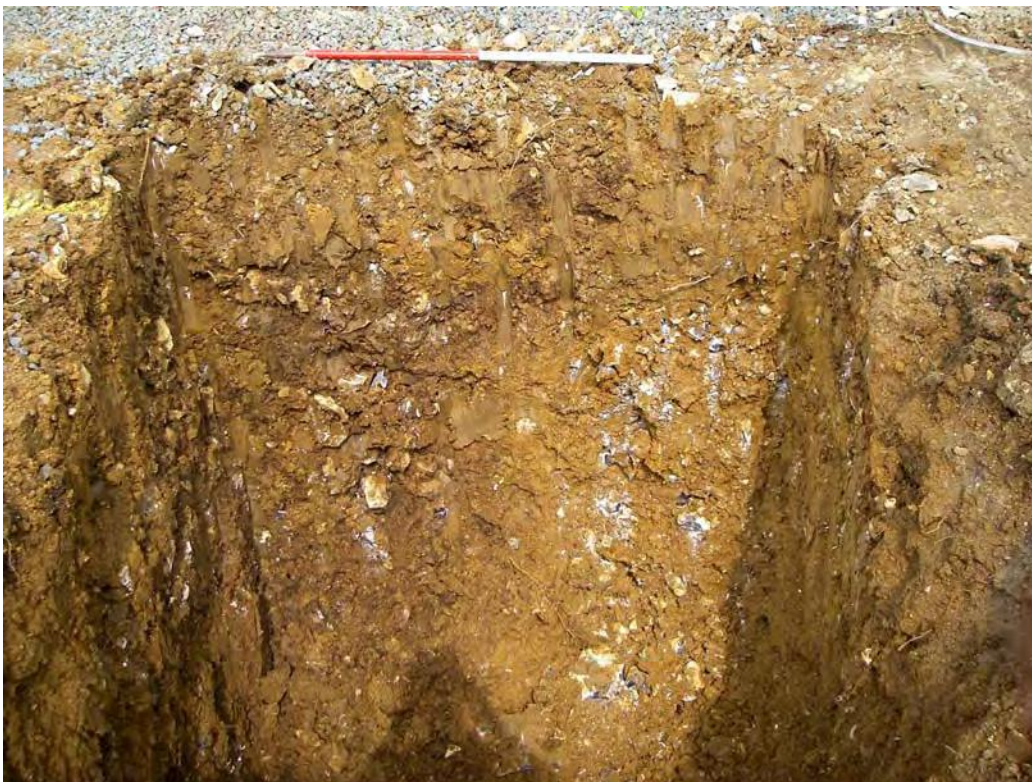
Figure 4: Selected images 3 and 4

The excavation of the soakaway revealed a vertical edge between the continuation of the distinctive light yellow clay deposit (4) and a darker deposit. The darker deposit is considered to be the fill of a periglacial ice wedge [6], rather than a man-made feature (Figure 4: image 4). The mid orangey brown fill contained frequent flint nodules, which were irregular in shape, up to 50cm long, with a thin white cortex (Figure 5: image 5). The nodules appear to have been whole prior to excavation of the soakaway. When broken open, the nodules revealed grey cherty flint with numerous inclusions.

The vertical feature identified in the soakaway is considered to be natural feature rather than a man-made shaft. This is similar to the 'pipe' recorded R A Smith (Scott-Jackson 2000, fig.17, 37).

Image 4: The soakaway section revealed the remains of the horizontal strata (2), overlying a possible periglacial ice wedge [6], defined by the darker vertical band of material on the left hand side of the image. Scale 1m in 50cm divisions.

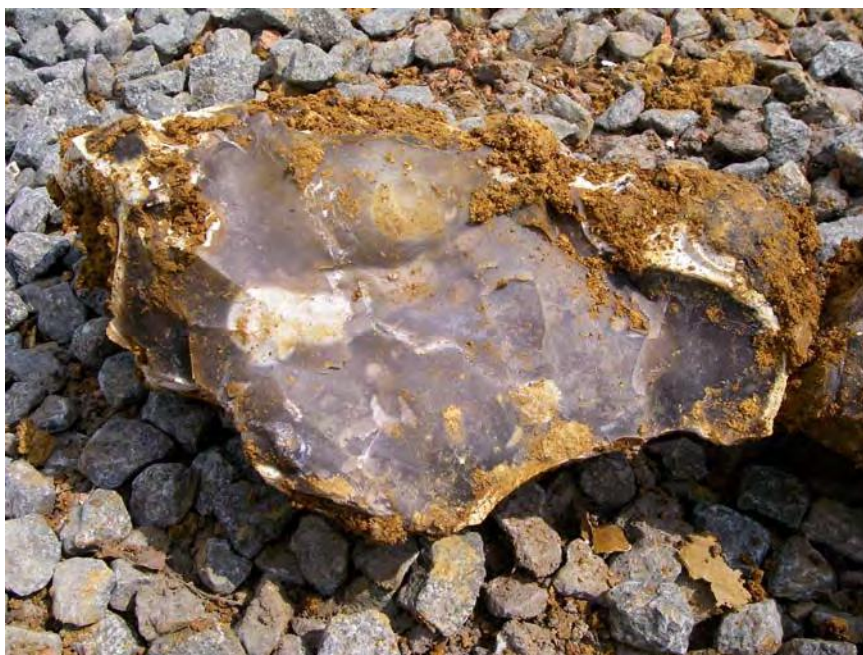
Figure 5: Selected image 5

Image 5: Example of one of the flint nodules recovered from the fill of the ice wedge [6]. The nodule was *c.* 0.4m long. The fracture of the nodule occurred during excavation.
