AUDLEY END HOUSE SAFFRON WALDEN ESSEX

ARCHAEOLOGICAL INVESTIGATION CCTV AND FLOODLIGHTING TRENCH AND ASSOCIATED WORKS

Document: 2005/56-rev.1 Project: 1069

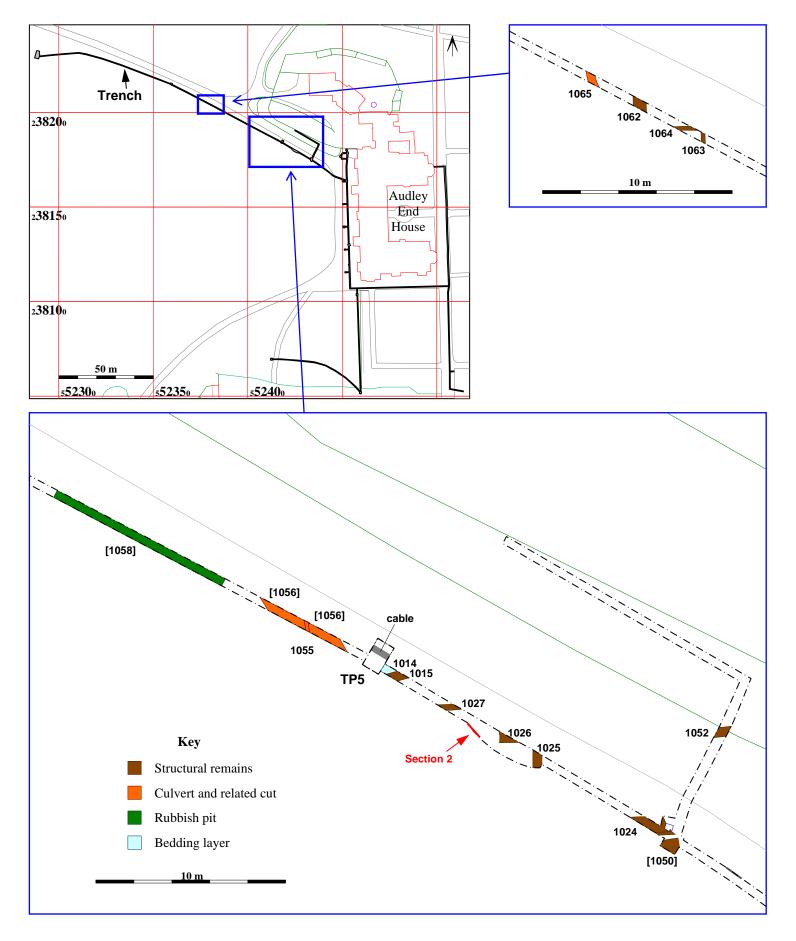
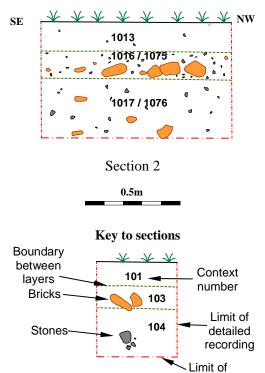
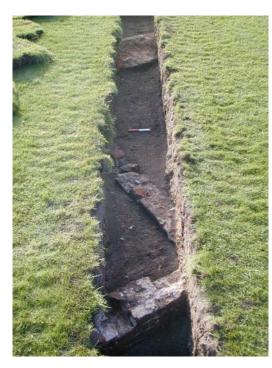
Figure 5: North-West of House

Wall foundations west of house, (1024), (1025), (1026), and (1027)

Courtyard wall (1062) in background, and outbuilding foundations (1063) and (1064)

Wall foundations west of house, (1025) and (1026)

An east-west aligned wall foundation (1027), probably associated with a building within the precinct of Walden Abbey, was revealed in the cable trench to the east of TP5 (Fig. 5). It was 0.32m wide and built of blocks of clunch measuring 140mm-190mm x 200-240m x c.170mm. The blocks were roughly hewn, but had good external faces. The wall was stratigraphically earlier than the Audley End II foundations (i.e., physically below layers associated with Audley End II) seen to the east. As the wall was only visible at foundation level, there was no indication of which surface might have been internal and which external.

A small section of another, rubble-filled foundation trench [1050] was observed c.13m to the east (Fig. 5). Little of it was seen in the trench, so its exact alignment was unclear, but it was at least 0.9m wide and 0.2m deep, filled with a firm, light grey mixture of mortar, clunch and brick rubble. Two pieces of lead sheet and a probable distorted came (part of a leaded window) fragment were retrieved from the rubble fill.

Approximately 2.5m west of wall (1027) and assigned to the same phase were an ill-defined spread of mid-pink, crushed plaster (1014) and a light grey mortar and rubble foundation (1015) (Fig. 5). Layer (1014) is probably a bedding layer for a floor surface. The rubble foundation representing wall (1015) is on roughly the same alignment as wall foundation (1027), although probably part of a different building as the presence of (1014) suggests an internal face to the west. Wall foundation (1015) and surface layer (1014) were located in the base of the excavated trench and as a result they were only seen in plan.

Wall remains (1024, 1025, 1026) associated with the western range of Audley End II were all constructed of mortared red bricks, measuring 210mm x 100mm x 57mm (9½" x 5" x 3½"). (Fig. 5) The walls were uncovered to a limited depth, although up to five courses set in English bond were visible. Wall foundation (1052) was constructed of limestone rubble and brick, and probably represents a

Two north-south aligned brick culverts (1055, 1065) were encountered c.0.5m below the current ground surface, in the cable trench between the house and the river (Fig. 5). Both are shown on the 1981 baseline survey undertaken by the then Central Survey section of the Department of the Environment (ref S625/81). Only the top of each culvert was revealed, so their full dimensions are unknown. Culvert (1055) was within a large, 10m wide cut [1056], although no discrete foundation trench was visible for (1065), suggesting that it was part of a wider programme of earthmoving activity. Although the relationship was a little difficult to ascertain within the confines of the trench, both culverts appeared contemporary with or earlier than the main phase of 18th century landscaping activity represented by layer (1074).

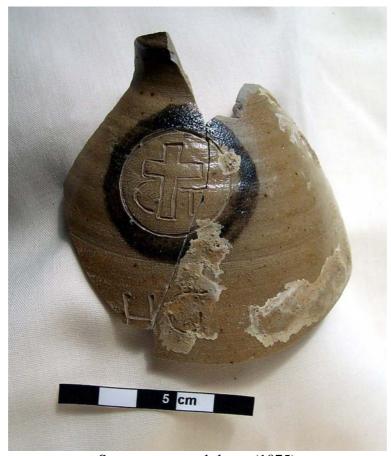
Stoneware vessel: layer (1075)

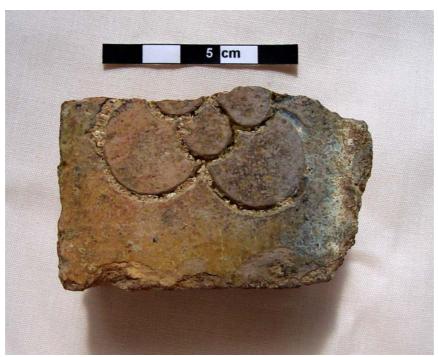
Floor tile: layer (1034)

One tile (1034) is a fragment of medieval line-impressed mosaic paving (Group 1 in Drury, 1982:101-102) (see Fig. 10). It bears a line-impressed rosette and is 29mm thick, in a similar fabric to that described by Drury (orange, containing some grog lumps and sand; buff exterior). The surface is covered with a mottled dark green glaze. The tiles described by Drury were found under the floor of the Howard Sitting Room (first floor, north wing) in 1978.
