**DYNEVOR COTTAGE
RECTORY LANE
AMPTHILL
BEDFORDSHIRE**

**ARCHAEOLOGICAL OBSERVATION
INVESTIGATION, RECORDING, ANALYSIS
AND PUBLICATION**

Project: DC2180

Document: 2013/90
Version 1.1

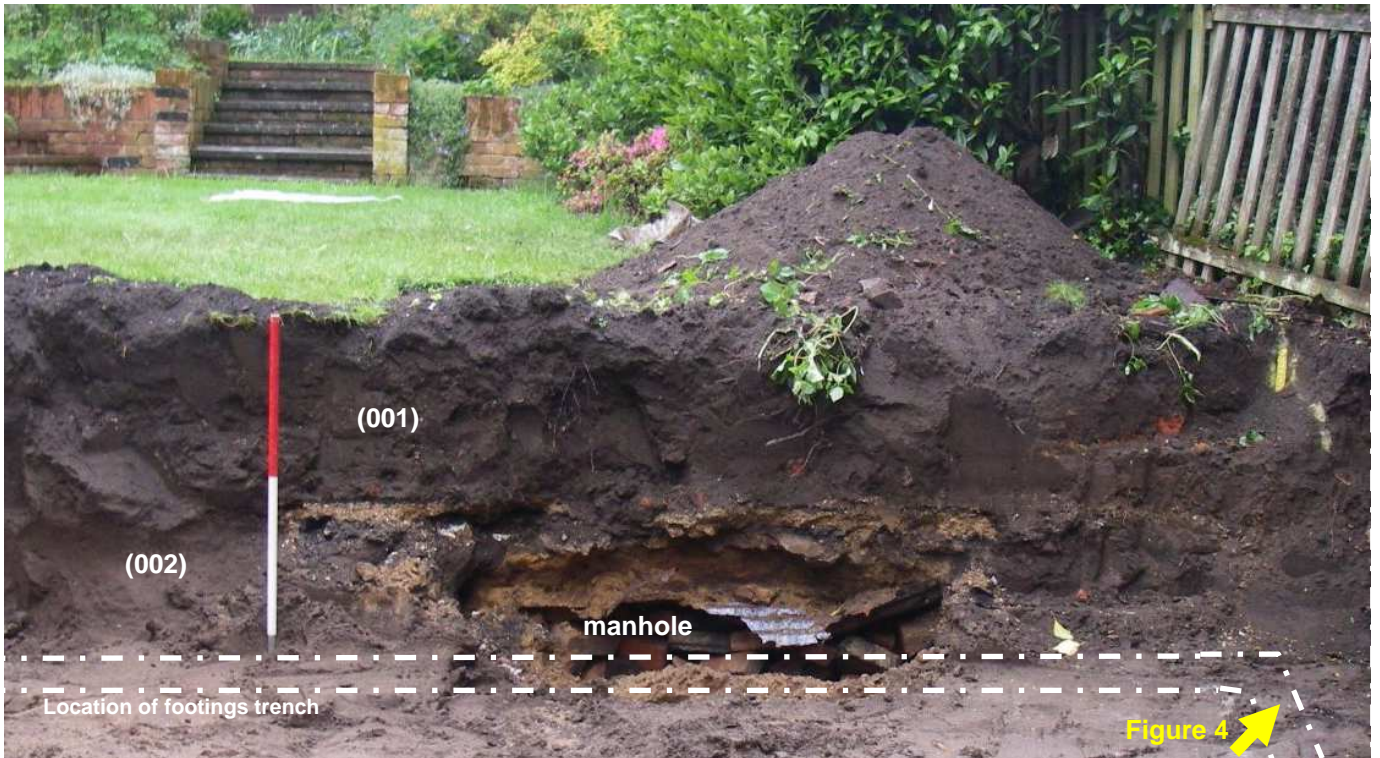
Figure 3: Ground reduction prior to construction of footings

As the existing ground level within the site differed considerably from west to east, a terrace had to be excavated to create a level ground to accommodate the footprint of the new building. This resulted in ground reduction of *c.* 1.20m in the west and up to 0.50m in the east prior to the excavation of the new footings (Figures 2 and 3). The dimensions of the footings trenches were 0.65m wide and 1.00m deep.

A modern service trench (now disused) for the existing cottage cut diagonally across the footprint of the building and a manhole was located in the northern central part of the site (Figure 3). This had truncated the deposits described below.

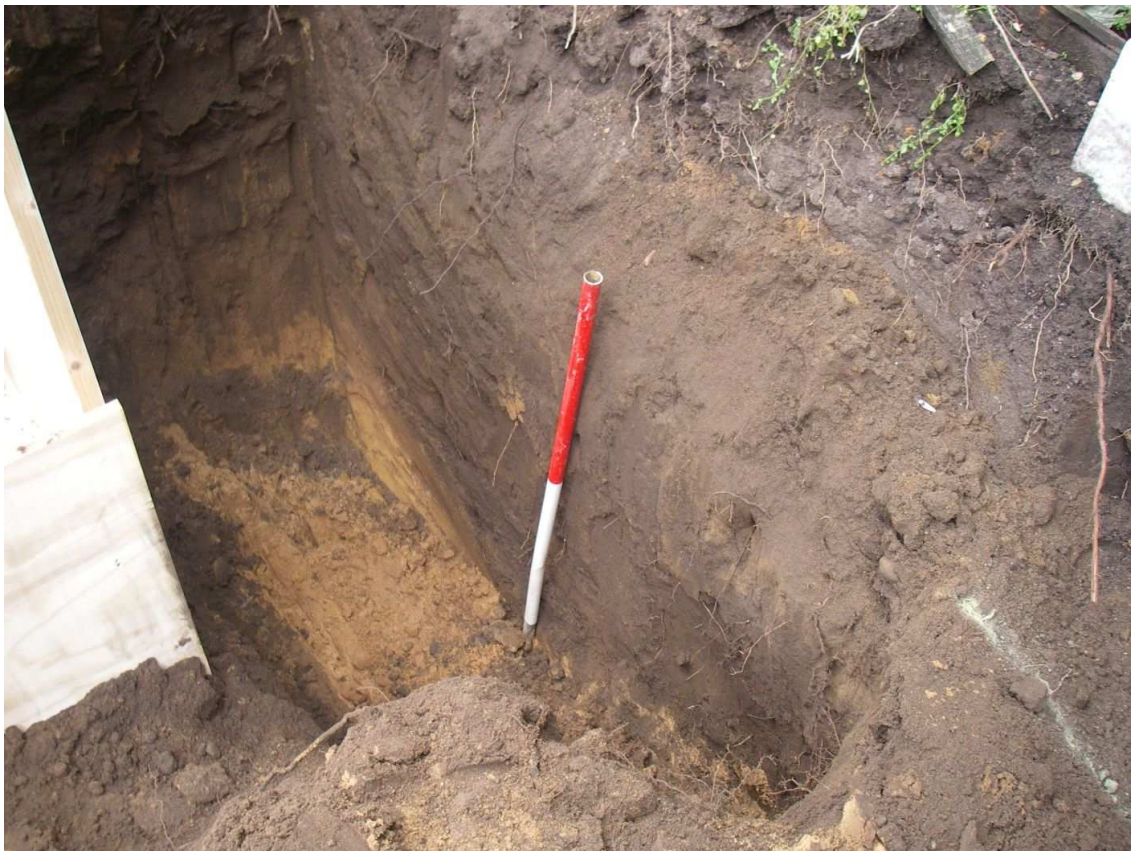
Figure 4: Possible pit and location of pottery fragments (western end of E-W footing)

A small assemblage of medieval pottery and animal bone was retrieved from layer (002) within the western end of the E-W aligned northern new garage foundation trench. The pottery and bone were located towards the base of the layer at a depth of *c.* 1.10m below present ground level (Figure 4). The area was cleaned by hand and machine but no archaeological feature, such as a possible pit, could be clearly distinguished.

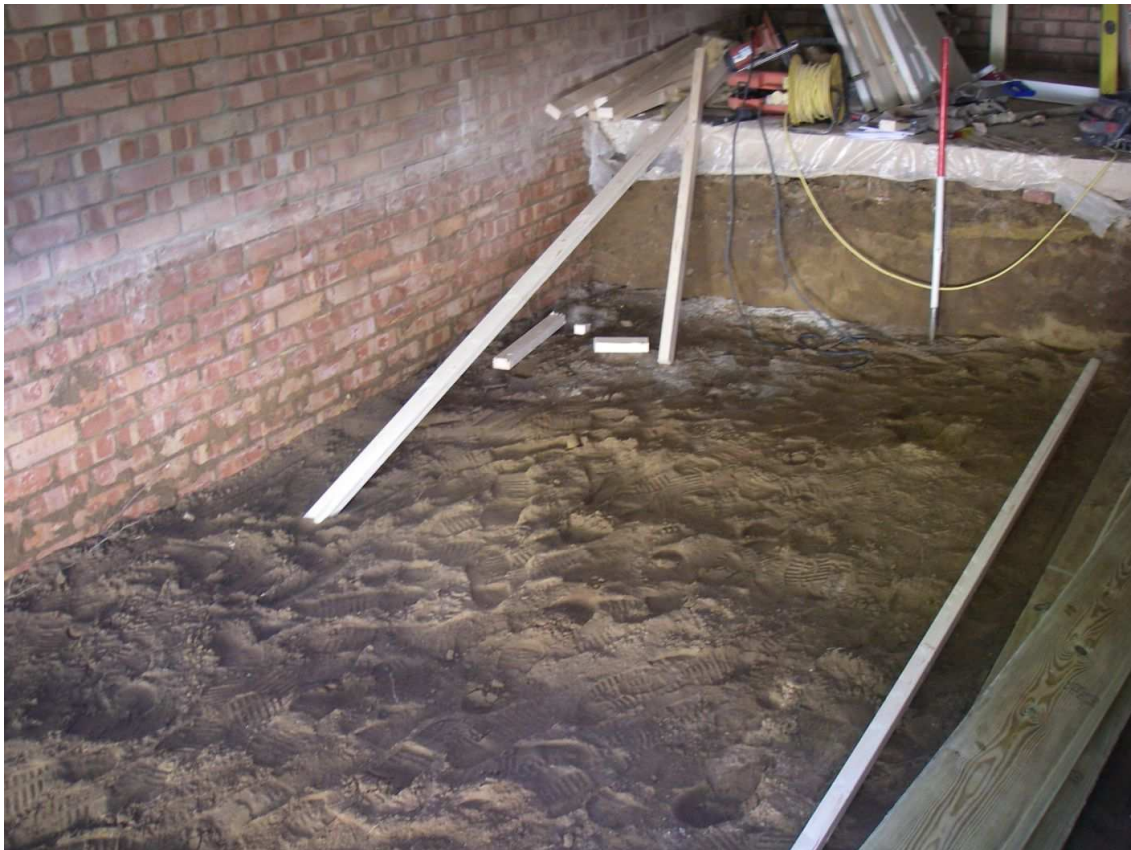
Figure 5: Ground reduction within garage

Ground reduction within the existing garage was 0.50m (Figure 5).
