**ST PAUL'S CHURCHYARD, BEDFORD,
BEDFORDSHIRE**

ARCHAEOLOGICAL FIELD EVALUATION

Document: 2004/82
Project: SP1025

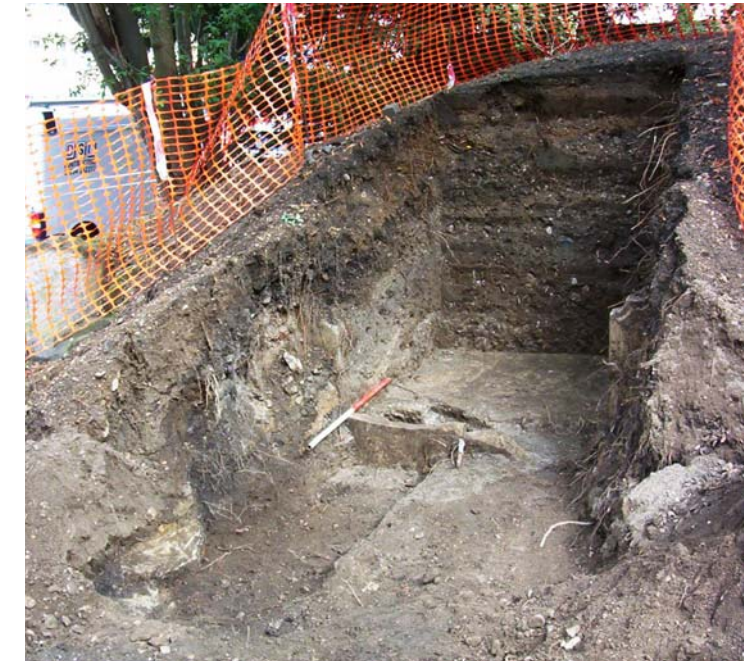
Trench 1, looking north-east. Scale 1m

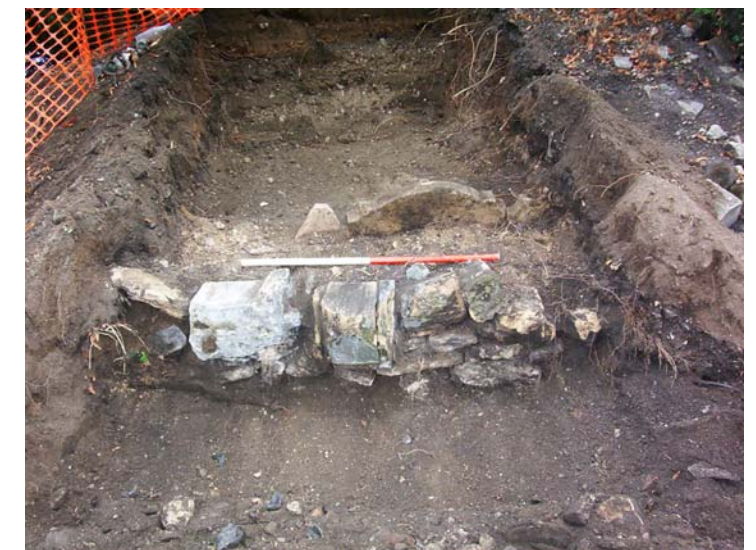
Retaining wall (106) [101], constructed in Phase 1, was modified by the addition of wall (110) made up largely of demolition rubble. This consisted of limestone blocks probably representing railing piers from the demolished north churchyard boundary. These had been placed against the westward side of the Phase 1 gravestones (106) in order to increase the height of the retaining wall which bounded the mound.

Wall 110, before removal. Scale 1m

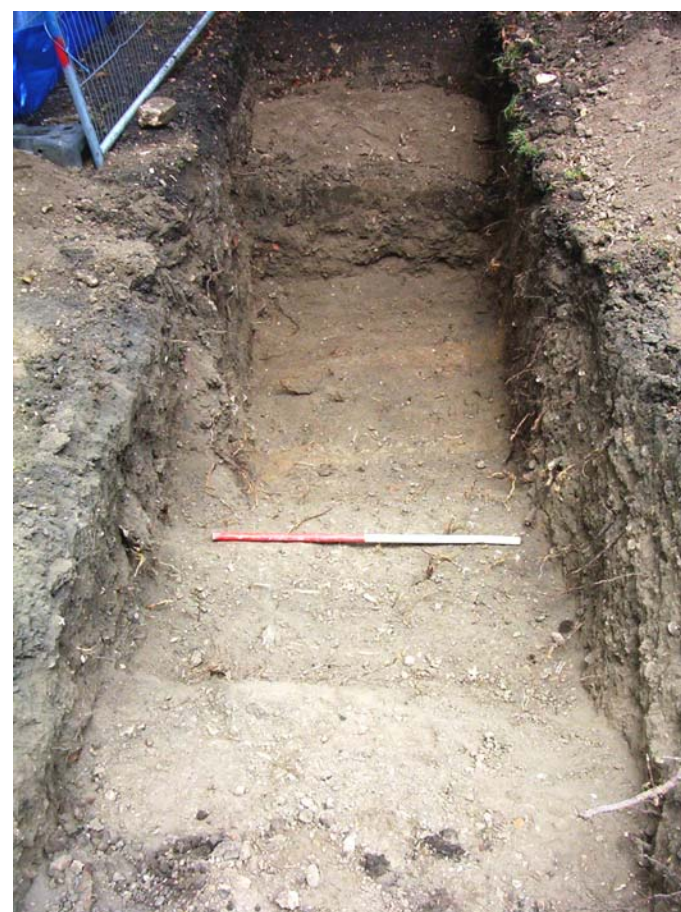
Trench 2, looking north. Scale 1m

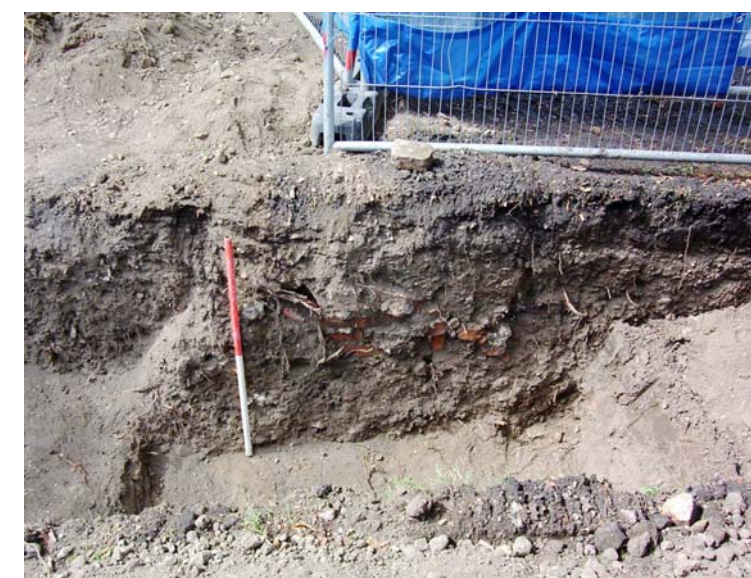
A modern pit [211] was observed towards the north end of the trench and truncated graves [201], [203], [205] and [207]. It was concave in profile and contained 19th century red brick.

Feature [211], looking west. Scale 1m
