**PRIORY LADE  
NORTH END  
RAVENSTONE  
OLNEY  
MILTON KEYNES**

**ARCHAEOLOGICAL FIELD EVALUATION**

Project: PL2178  
Document: 2013/184  
Version 1.0  
27th November 2013

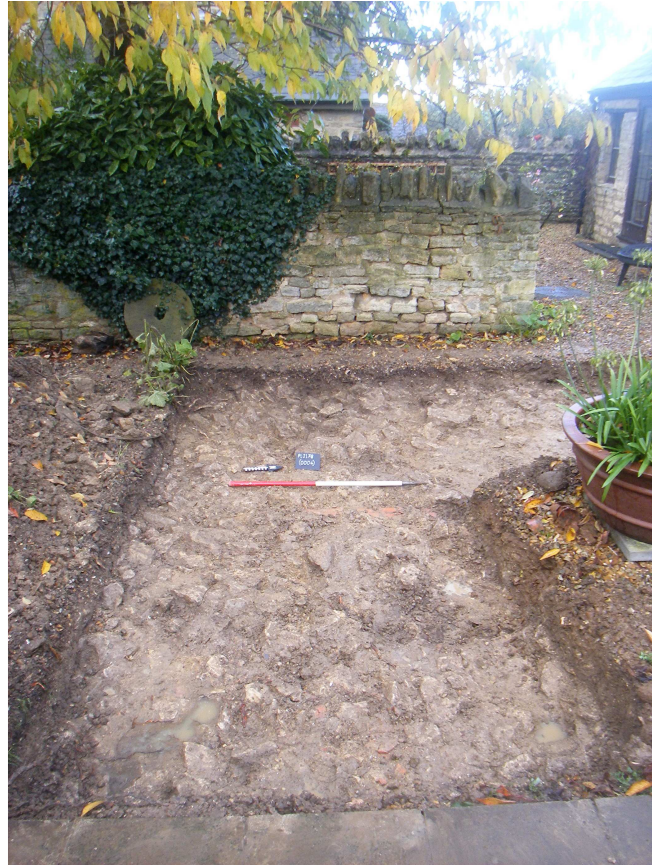
**Image 1:** General view of demolition spread (4) looking west along trench. Scale 1m in 0.5m divisions.

The area of investigation was covered by a gravel surface 0.04m thick (1). It overlay a thin band of material (2) only 0.08m thick, which appears to have been derived from topsoil. Below this was an extensive layer of loose material (3), 0.25m thick, which contained modern debris including construction materials as well as earlier finds. It is likely that this is related to ground disturbance associated with the conversion of the buildings in the mid 1980s.

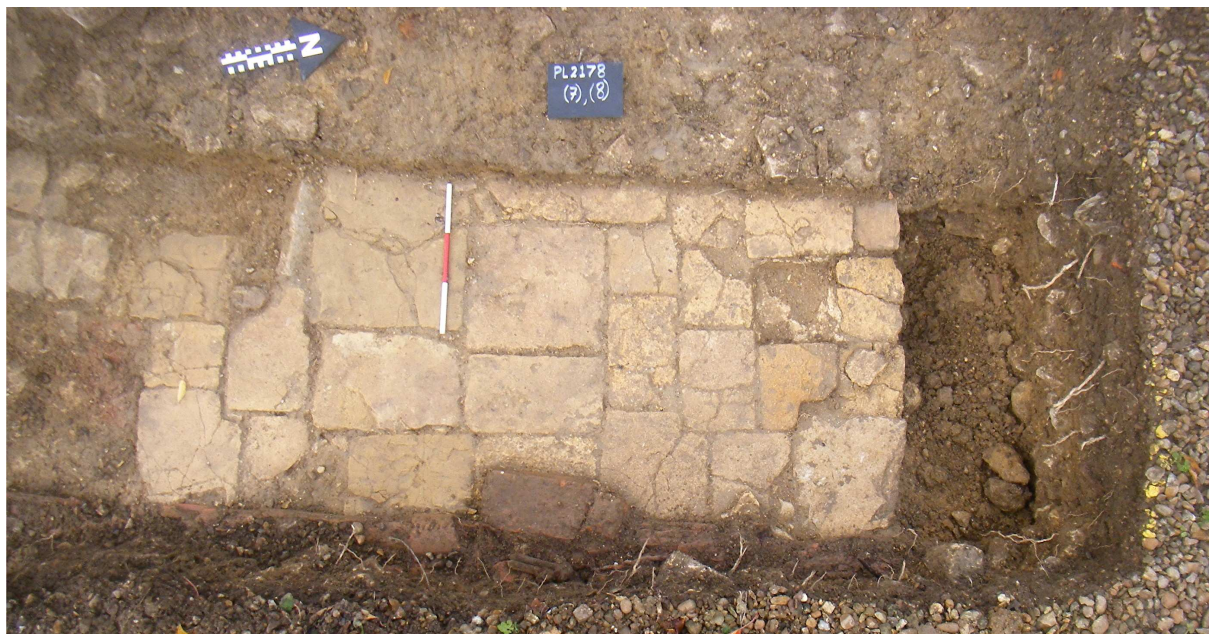
**Image 2:** General view of limestone paving (7), showing the various sizes of slabs, including several re-used pieces. The robber trench is at the right (north end of the paving) with the sewer trench just clipped by the northern limit of the trench. Make-up layer (8) is visible to the left of the floor. Scale 0.3m in 10cm divisions.

The larger slabs were generally aligned roughly WNW-ESE. Several examples showed evidence of shaping, mostly angular cut-outs and occasional curves, indicating that the stones had been relayed in their current location. It is likely that RA14 found in the backfill of the southern robber trench [11] was also derived from flooring, as were angular slabs RA7 and RA10.

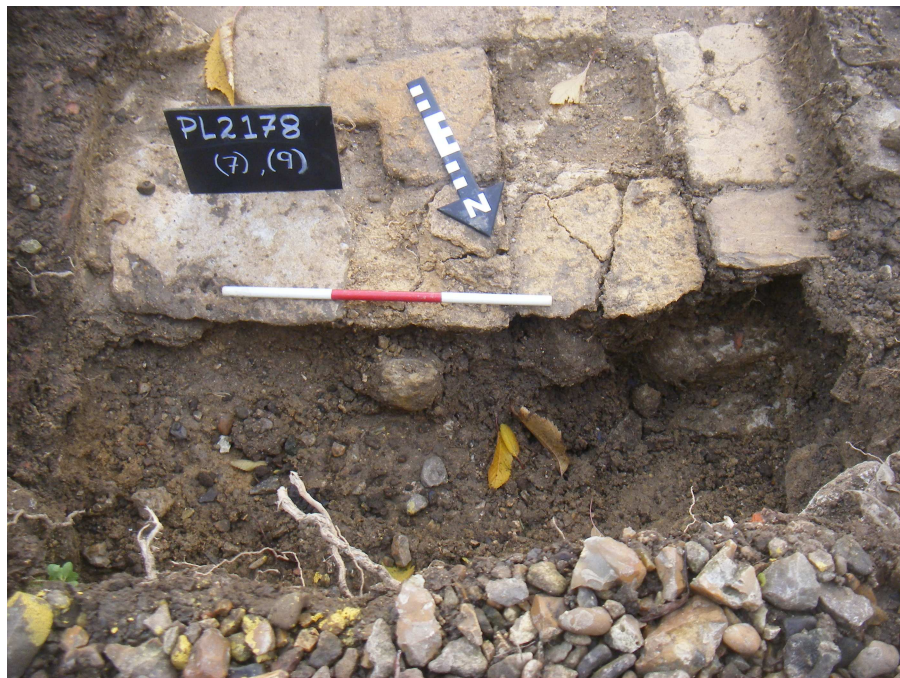
**Image 3:** Northern limit of limestone paving (7) showing underlying make-up layer (9) with stones of robber trench [18] just visible. The sewer trench is mostly obscured by limit of investigation. Scale 0.3m in 10cm divisions.

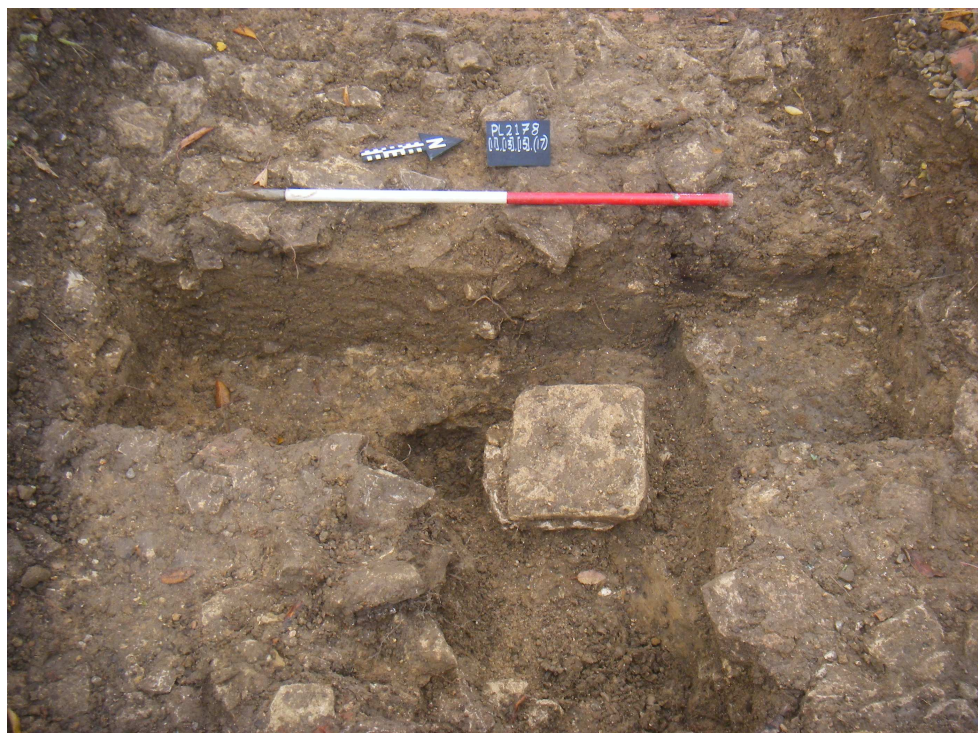
**Image 4:** General view of eastern sondage looking to west, showing demolition layer (4) with posthole [5] visible at the right hand edge of the scale. The robber trench [11] and underlying foundation trench [23] with mortar raft are visible to the left of the displaced floor slab (RA14). The blue grey fill of [15] is to the east. In the foreground a patch of undisturbed geological strata is visible in the north side of the foundation trench. Scale 1m in 0.5m divisions.

The second feature beneath the robber trench fill was yellow-brown mortar footing (24) for wall foundation trench [23] – orange stipple on Figure 2: section 2 and Figure 4: image 4). The wall footing was aligned NE-SW. It was at least 0.6m wide, continuing beyond the southern margin of the trench. The edges appeared to be near vertical, cutting the firm geological strata. The feature was not fully investigated, but would appear to be at least 0.15m deep. This foundation trench is not parallel to stone floor (7).

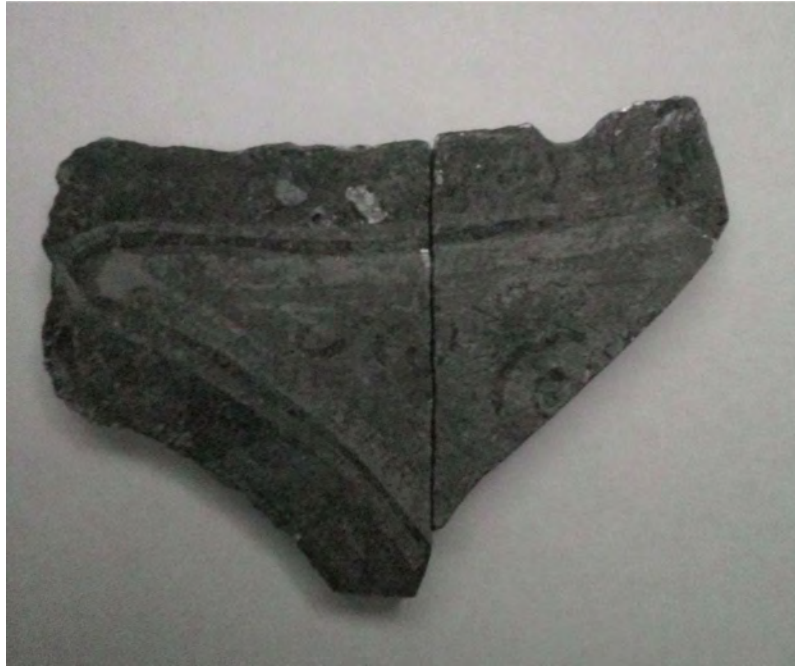
**Image 5:** Two joining pieces of sub-triangular? quarry from demolition deposit (4). The pieces measure 32mm by 48mm with red painted triangular motif. The triangle has a narrow linear border within which is a thicker border, with internal decoration.

Window. Opaque 'black', some brown black corrosion products. Two joining pieces of sub-triangular(?) quarry with red painted triangular motif (Figure 5: image 5) Three edges grozed. The triangle has a narrow linear red outline (1mm wide) within which is a further wider triangular border (c. 2mm wide). The area within the inner border has a lighter wash of red which features 'stick work' (the pattern being picked or scratched out of a matt wash with a stick). This appears to comprise three circles of descending size, the two smaller circles enclosing what appears to be a ring. The larger circle borders what may be a petalled flower, the centre of the flower indicated by a further inner ring. L. 32mm; w. 48mm; th. 4.2mm.

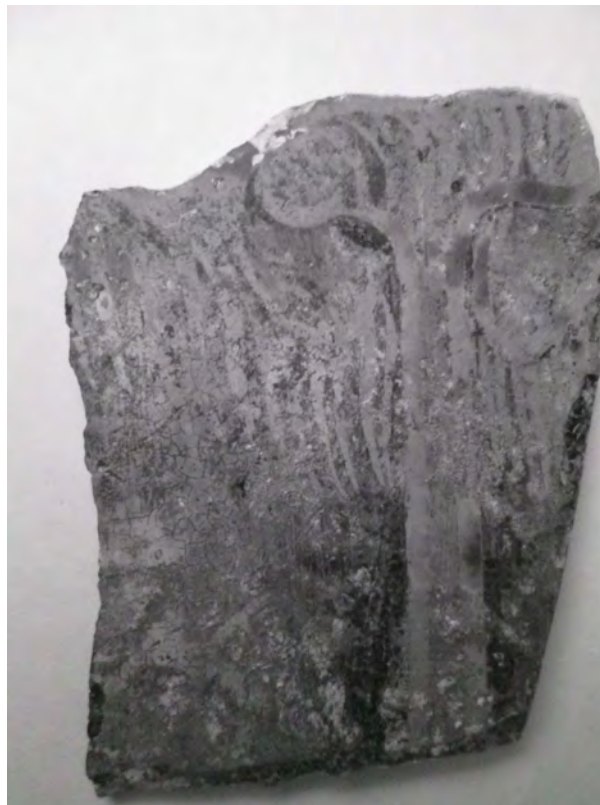
**Image 6:** Fragment of painted window glass measuring 50mm by 63mm from backfill (12) of robber trench [11].

Window. Opaque 'black' glass. Quarry with remains of two grozed edges with sinuous curves. Red painted design, straight stem (bold outline, lighter interior) with fruiting buds and leaves(?), fronds hanging down? - (Figure 5: image 6). Further decoration in corner, form unclear. L. 50mm; w. 63mm; th. 4.9 to 5.5mm.

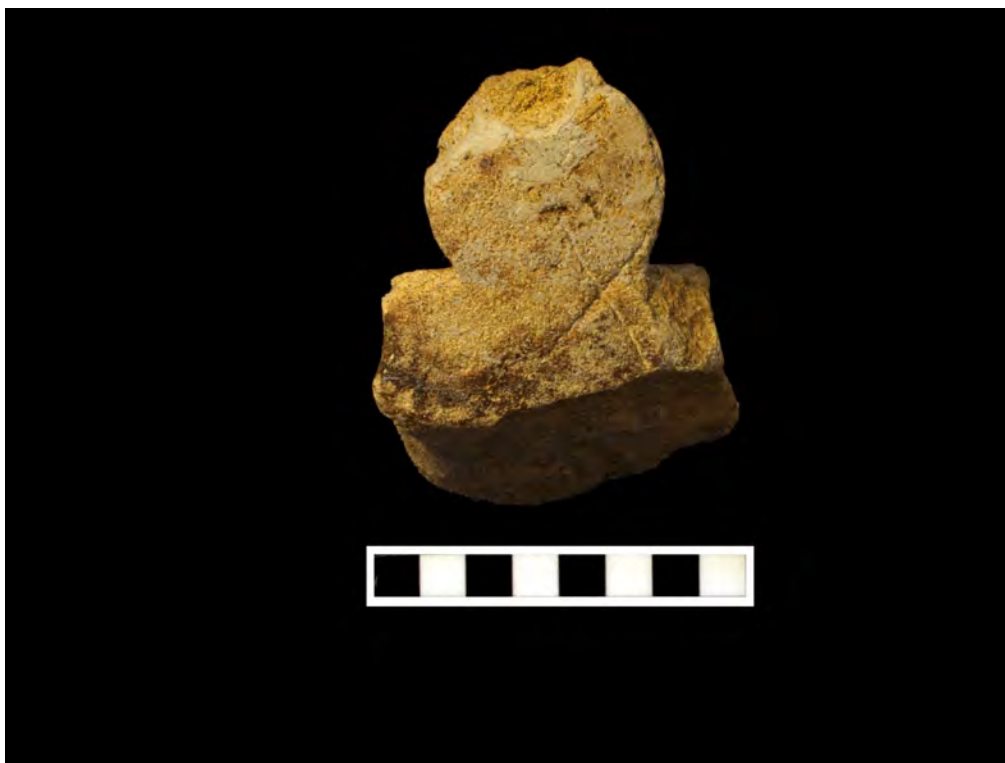
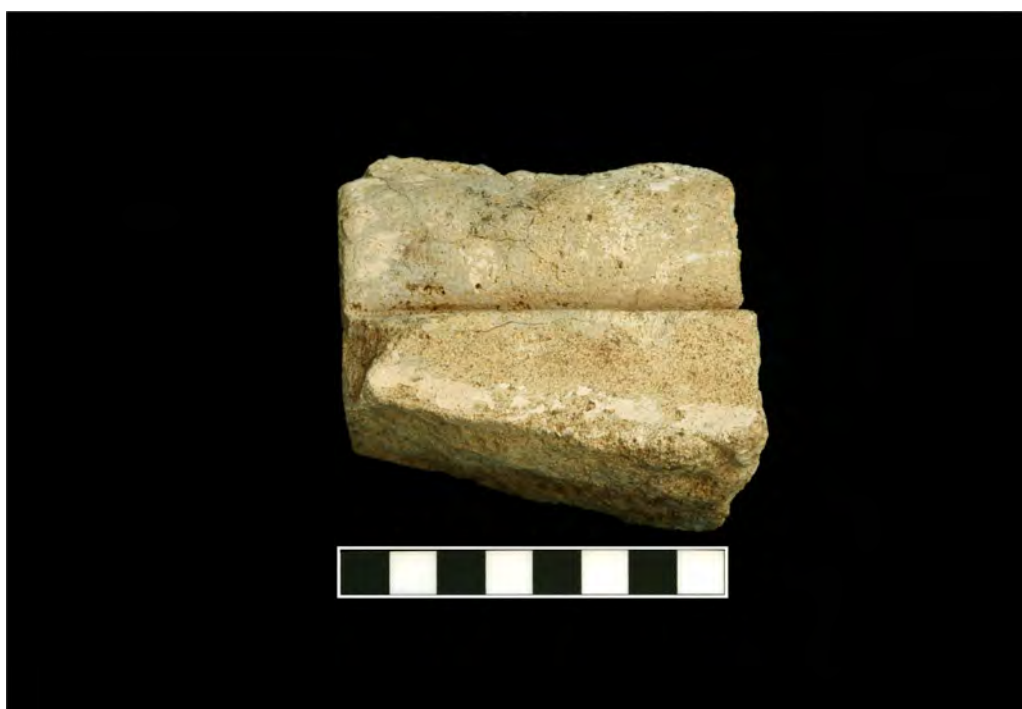
**Figure 6:** Images of architectural fragment RA1

**RA1** Fragment of moulding. Limestone - hollow chamfer surmounted by roll with frontal fillet. 'X' inscribed on flat surface - makers mark? Recovered from demolition layer (4). Scale 8cm in 1cm divisions.

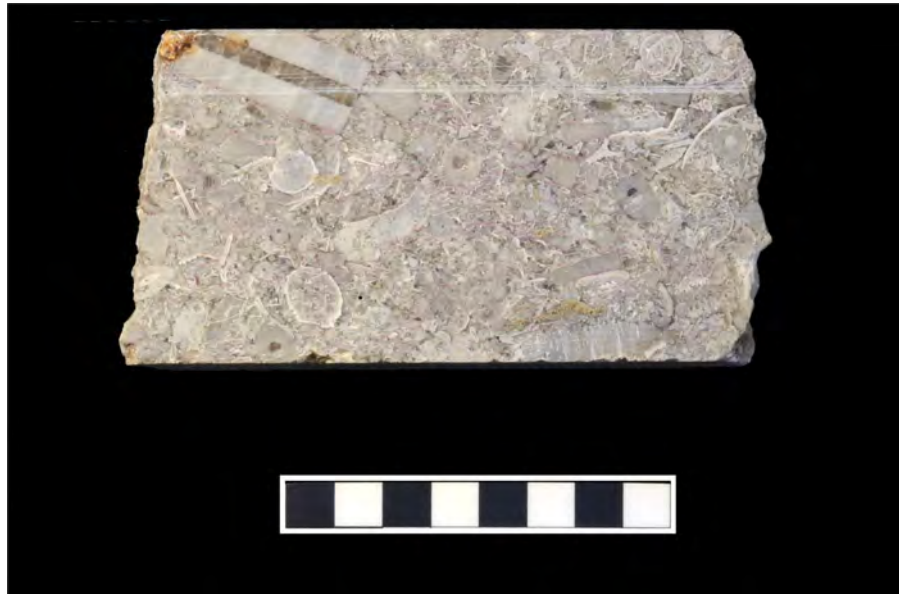
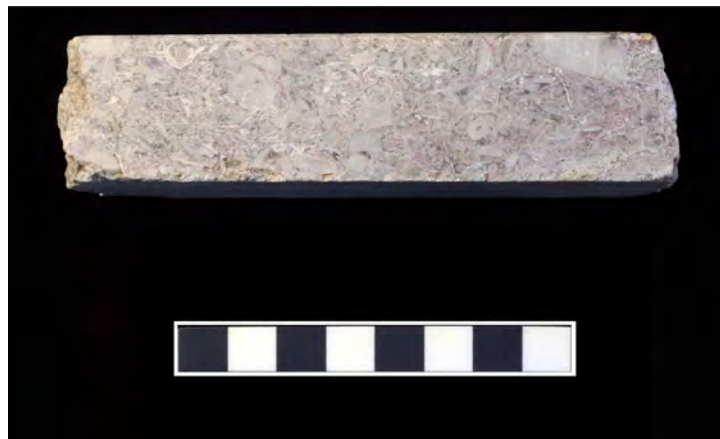
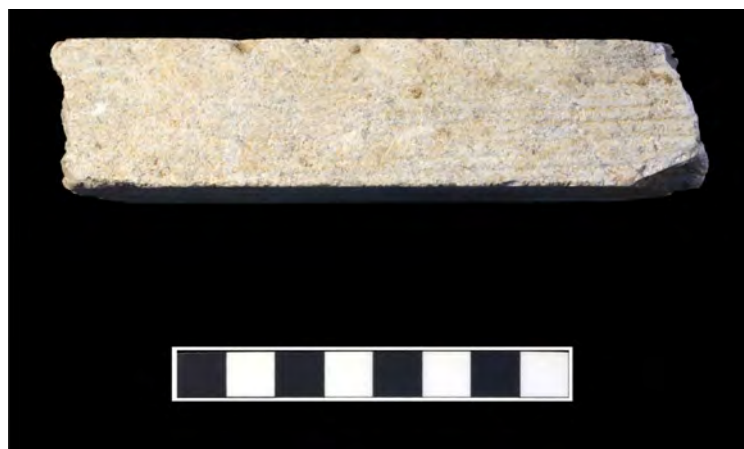
**Figure 7:** Images of architectural fragment RA2

**RA2** Limestone (fossiliferous, quartz-rich). ?Sawn slab, one edge and one face polished smooth, opposing surface and back edge unpolished but flat. Back edge has *c.* 11 close set (*c.* 2.25mm) longitudinal grooves along its length. Recovered from demolition layer (4). Scale 8cm in 1cm divisions.

Side view showing bevel at top of image.

Side view showing unpolished edge with toolmarks.

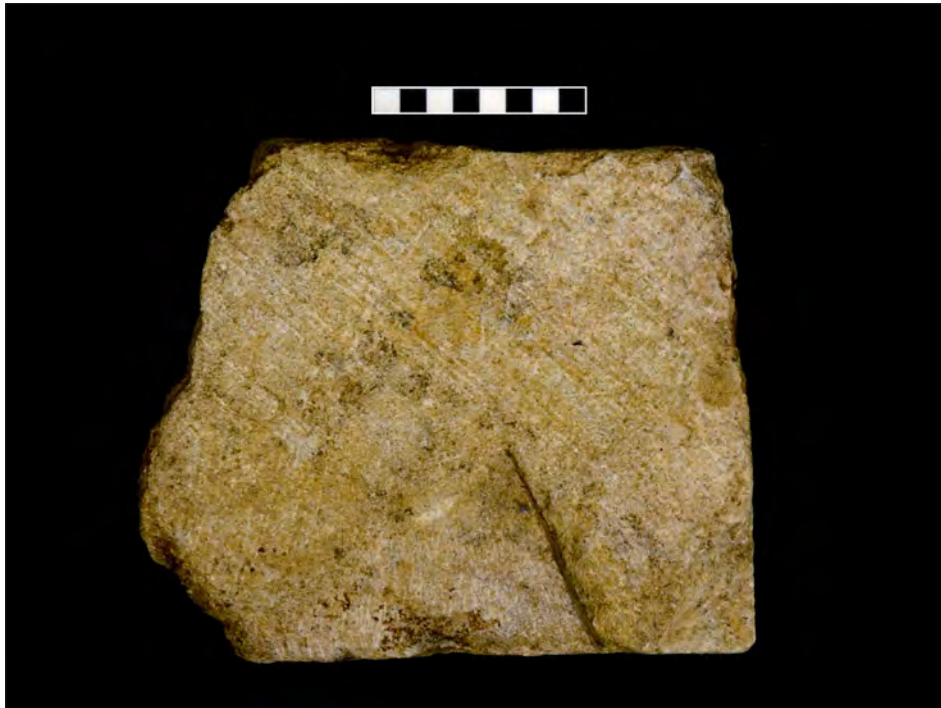
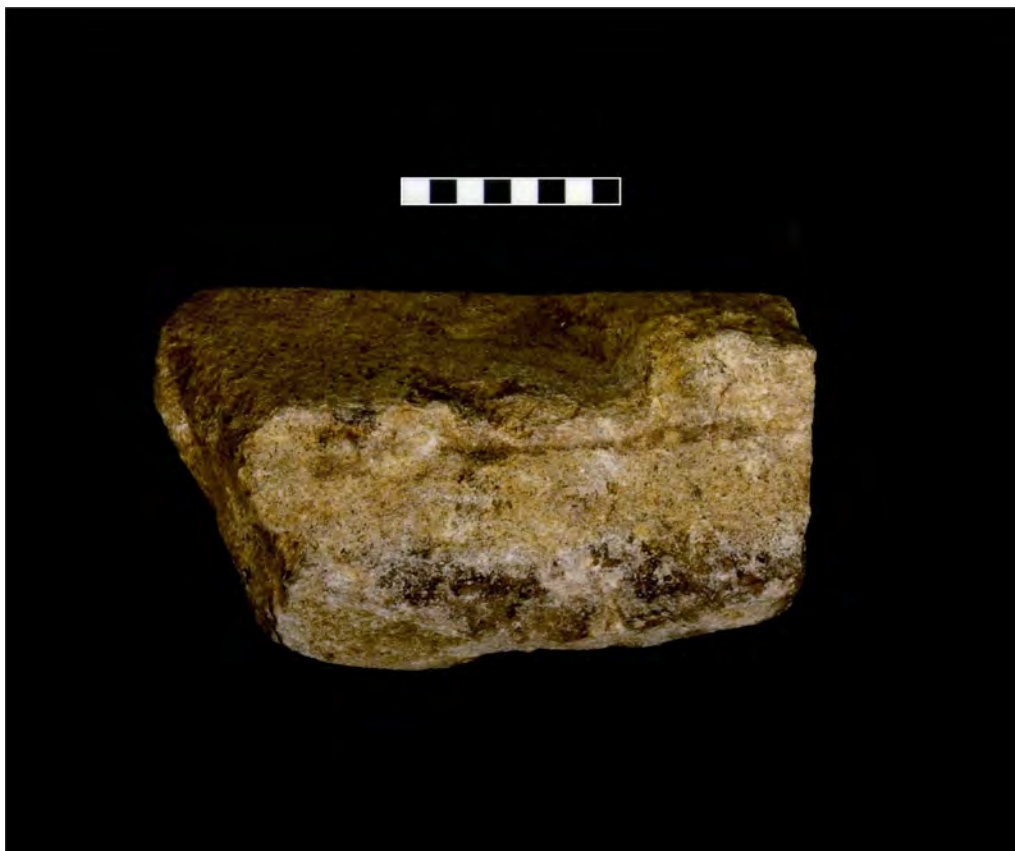
**Figure 8:** Images of architectural fragment RA3

**RA3** Limestone (creamy white). Chamfered sill. Base of sill displays rough diagonal tooling (blade width *c.* 9-10mm). Chamfer displays finer and more closely spaced horizontal tooling; tooling marks on edges have been smoothed. Recovered from demolition layer (4). Scale 8cm in 1cm divisions.

**RA3** Front face of sill. Scale 8cm in 1cm divisions

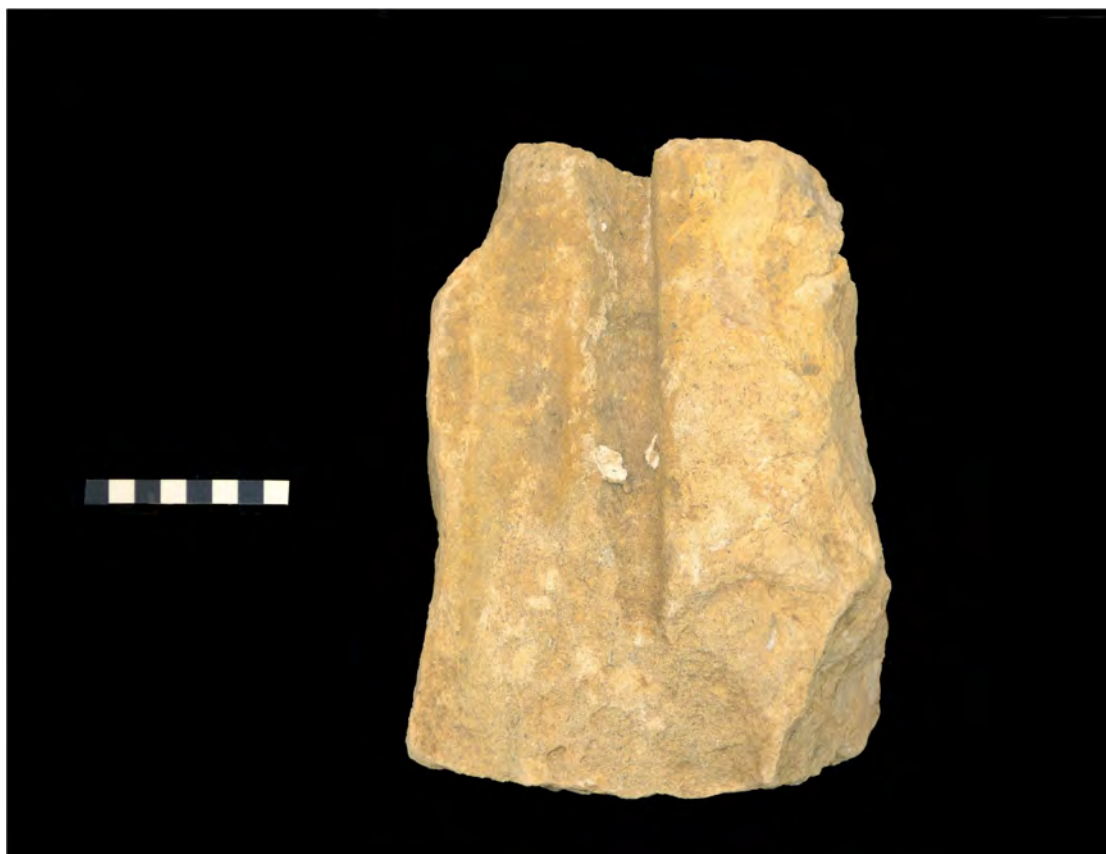
**Figure 9:** Image of architectural fragment RA4

**RA4** Architectural stone. Limestone. Roughly shaped and unfinished block with U-shaped channel along length (18.5mm wide, 20mm deep) retaining patch of lead caulking. This was recovered from demolition layer (4). Scale 8cm in 1cm divisions.

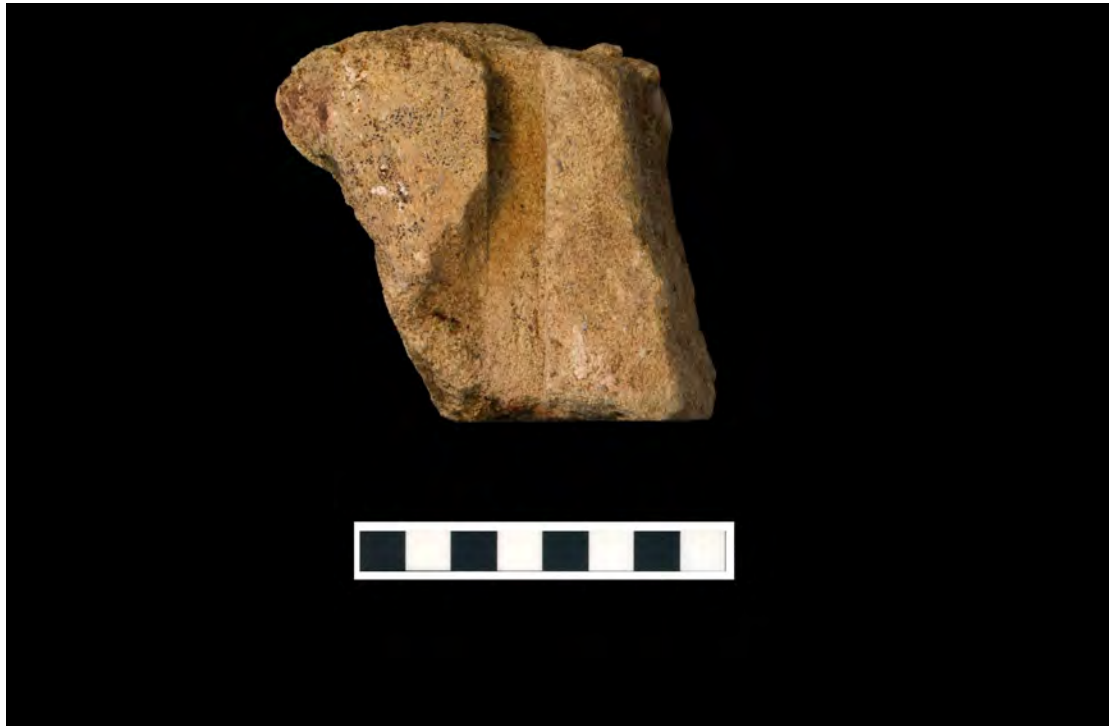
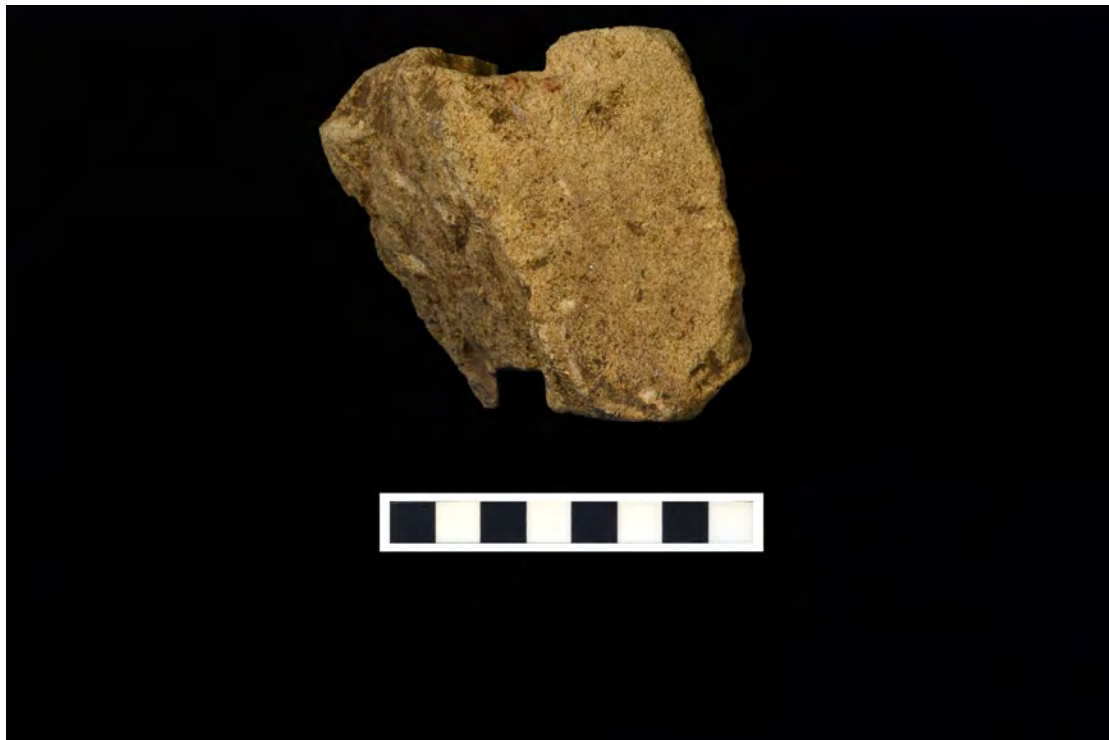
**Figure 10:** Images of architectural fragment RA5

**RA5** Window mullion. Limestone. Exterior faces both missing. Rectangular slot, 12.18mm wide and *c.* 9–10mm deep, cut into flat and finished sides of mullion. Flat, finished base. Recovered from robber trench fill (12). Scale 8cm in 1cm divisions.

**RA5** Base showing slots. Scale 8cm in 1cm divisions.

RA5 Window mullion. Limestone. Exterior faces both missing, rectangular slot, 12.18mm wide and c. 9-10mm deep, cut into flat and finished sides of mullion - Figure 10. Flat, finished base. Ht. 103mm; w. 90mm; th. 78mm.

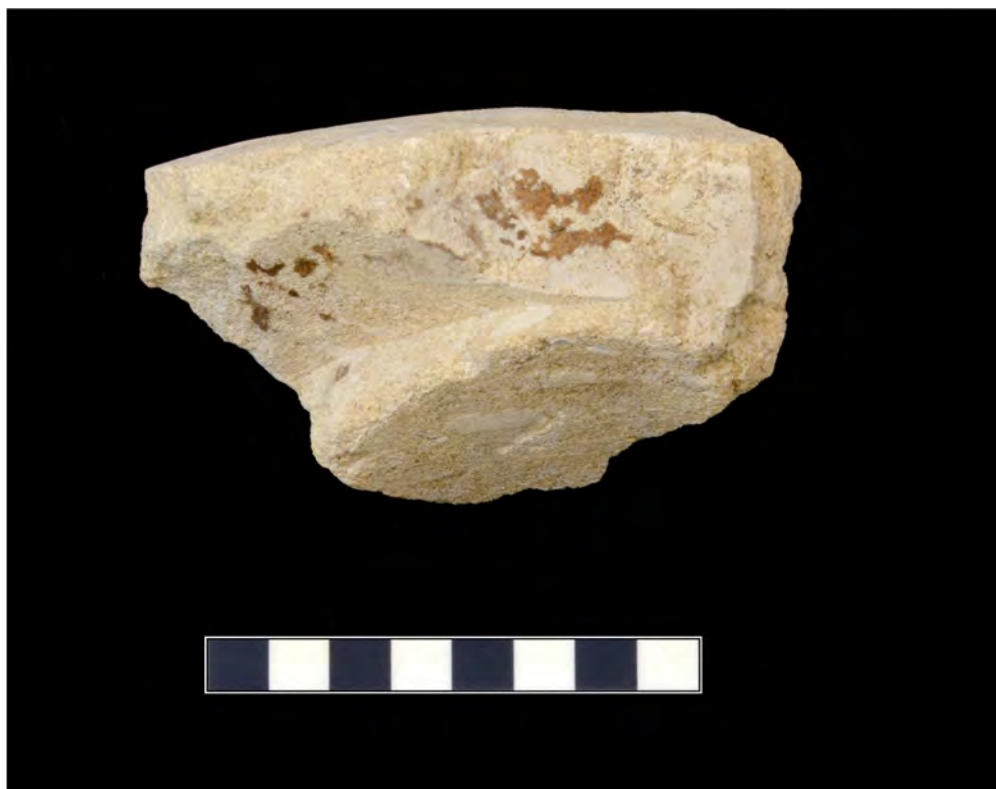
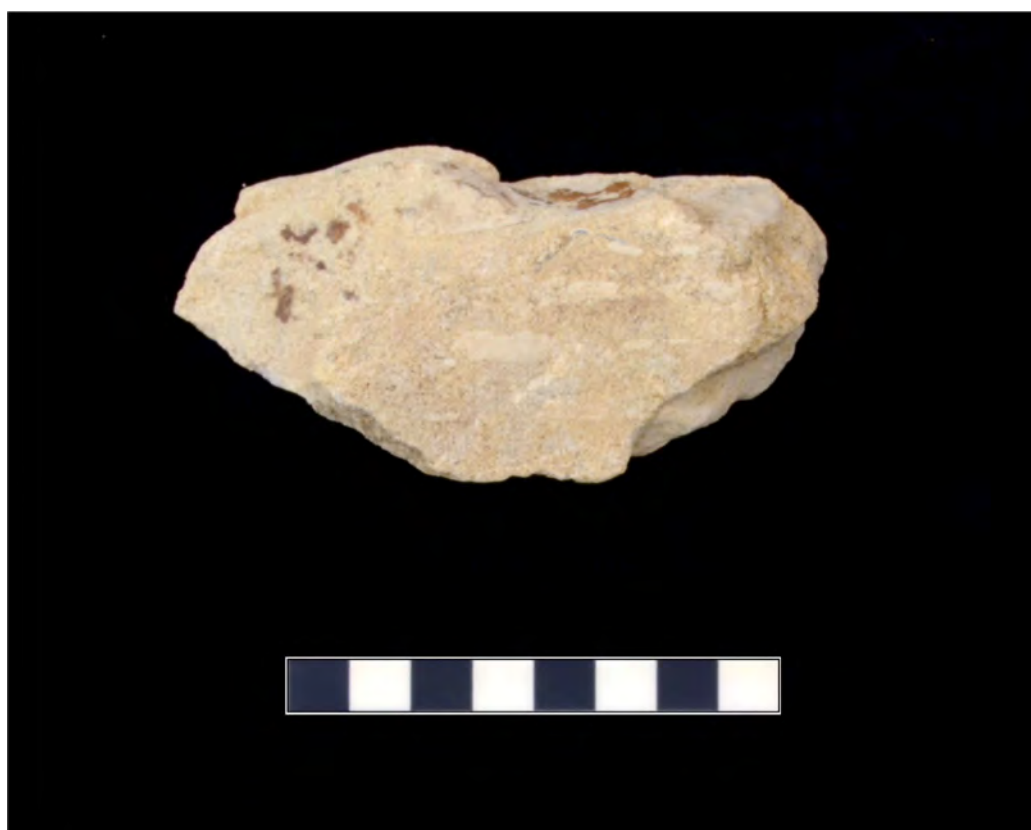
**Figure 11:** Images of architectural fragment RA6

**RA6** Limestone (with 'chalky' blobs within matrix). Tracery moulding fragment; all surfaces smoothed. Scale 8cm in 1cm divisions.

Although much of the stonework is damaged and incomplete, some of the moulding can be tentatively dated. RA6 is a small piece of window tracery, not dissimilar to the larger piece of curvilinear window tracery reported on during the 1984 watching brief, thought to be from an early 14th-century Decorated window (Halsey 1993, 118 no. 4 and pl. II). Moulding RA11, although heavily damaged, appears to be from a spandrel perhaps from an arcade or hood cover. RA1 has hollowed chamfers and a roll with frontal fillet, the fillet relatively broad. This combination of features could suggest a date towards the end of the 13th to the earlier 14th century (Forrester 1972, 13 and 17). A second fragment, RA9, also has hollow chamfers and a roll, but the face of the roll has apparently been truncated (Figure 12).

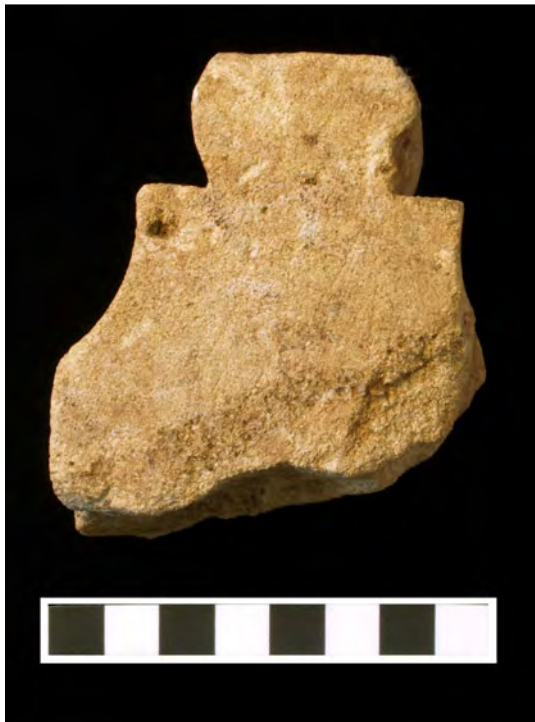
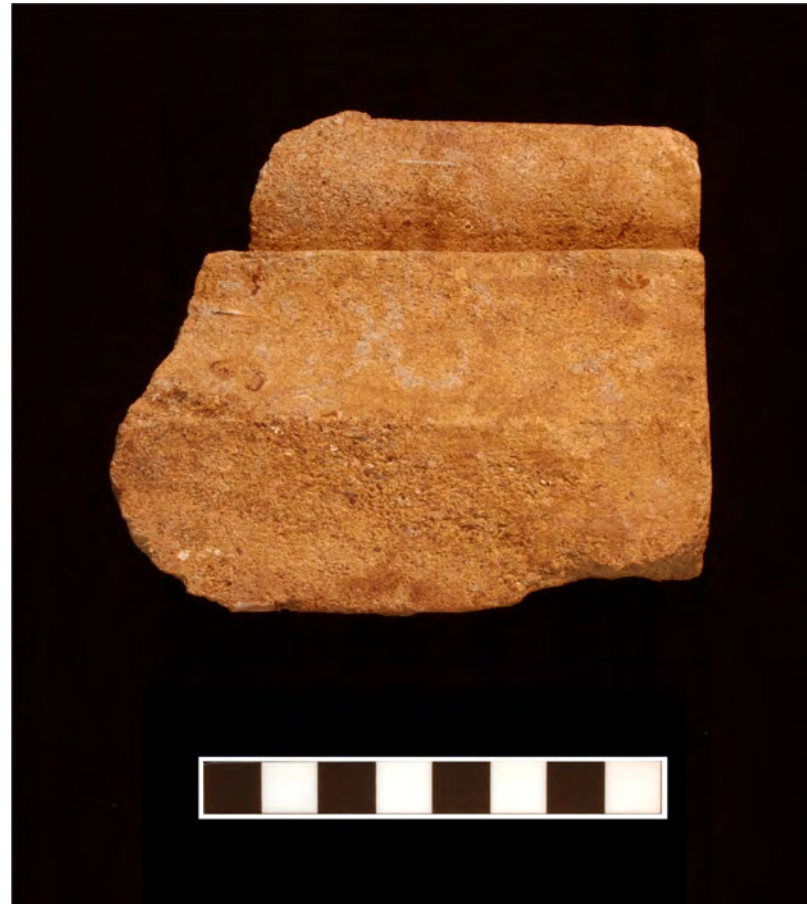
**Figure 12:** Images of architectural fragment RA9

**RA9** Moulding. Limestone. Two hollow chamfers surmounted by a roll, top of roll truncated and flat (alteration?). Recovered from robber trench fill (12). Scale 8cm in 1cm divisions.

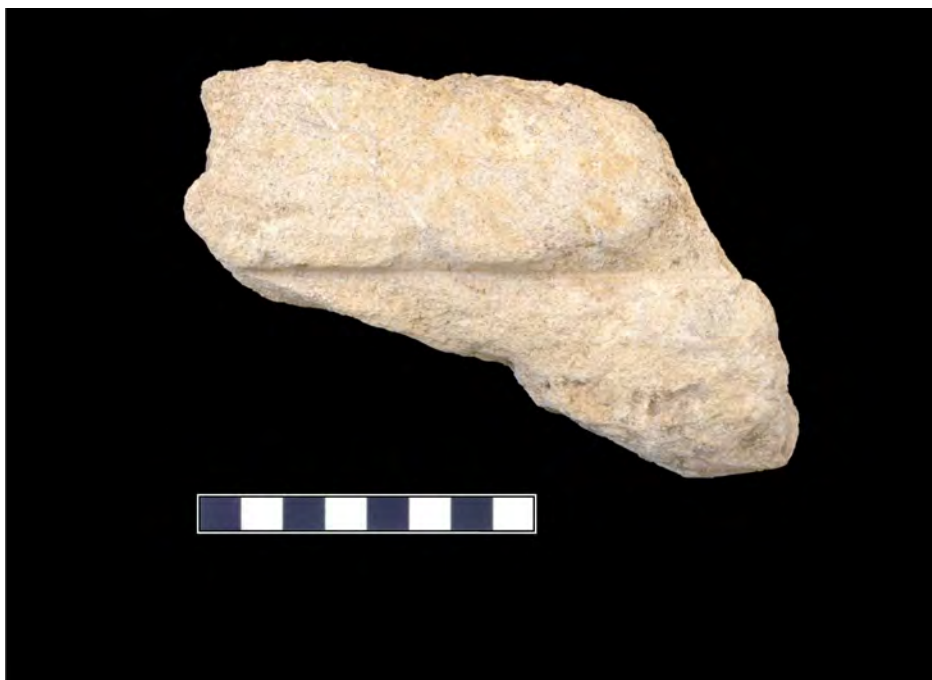
**Figure 13:** Image of architectural fragment RA11

**RA11** Limestone. Moulding, possibly from spandrel in arch (arcade or hood cover??). Two, tapering flat finished sides and start of roll (damaged)? Base and back missing, upper surface damaged. Scale 8cm in 1cm divisions.

RA11 Architectural. Limestone. Moulding, possibly from spandrel in arch (arcade or hood cover??). Two, tapering flat finished sides and start of roll (damaged)? Base and back missing, upper surface damaged. L. 145mm; w. 90mm; th. 90mm - Figure 13.

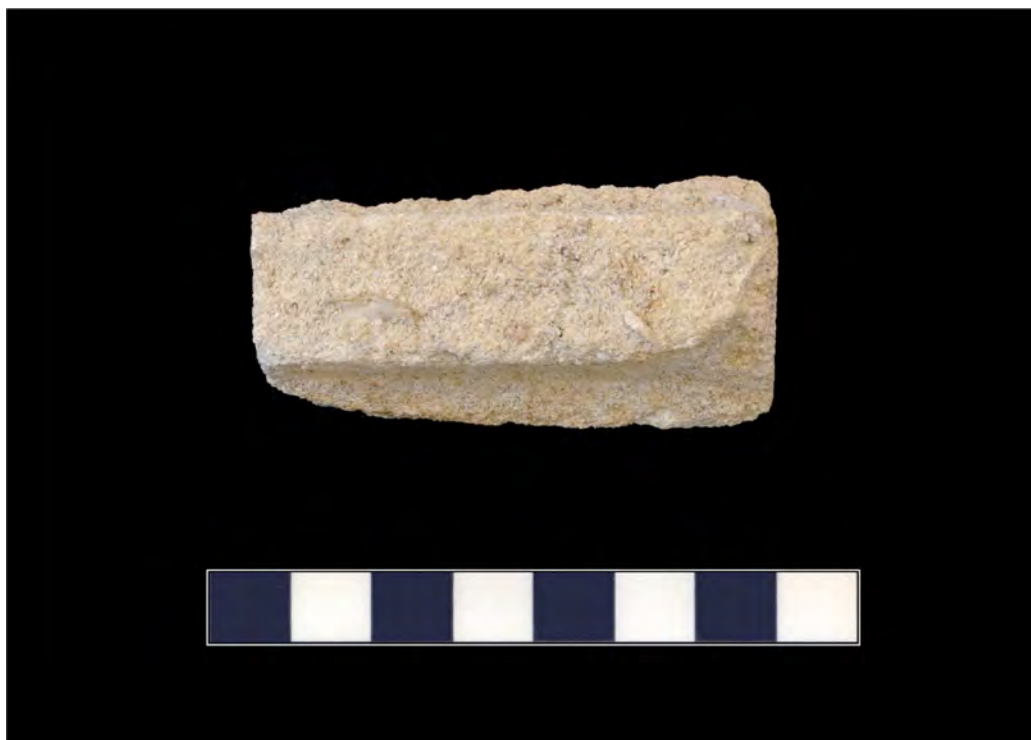
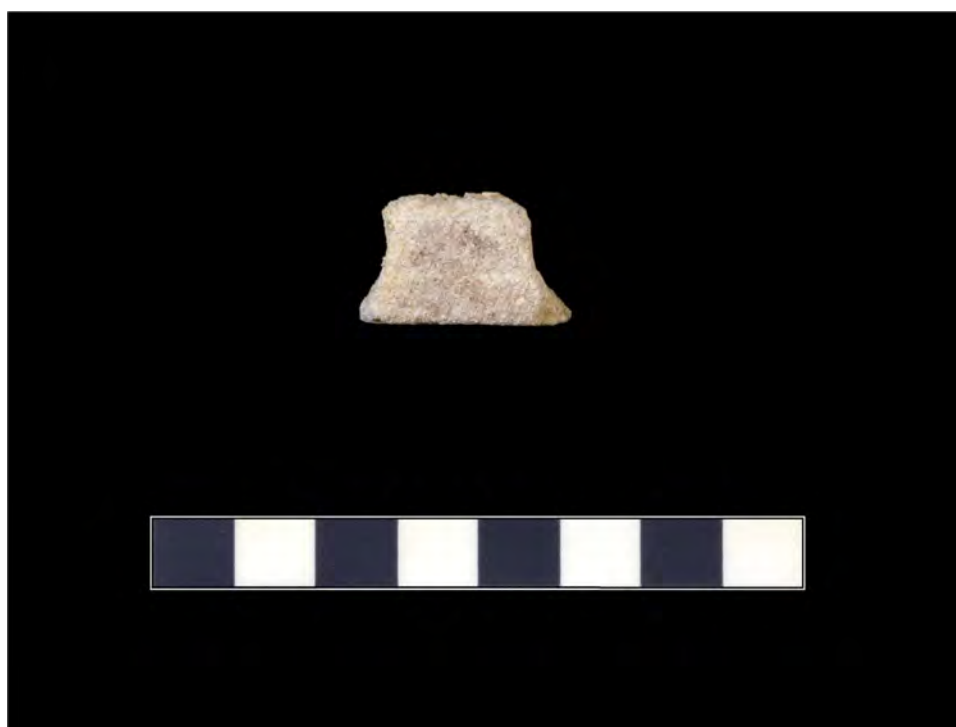
**Figure 14:** Images of architectural fragment RA13

**RA13** Limestone. Part of small moulding? Flat smooth face, hollow chamfers, one smooth one slightly rough, both ends flat and smoothed. Reverse surface broken off. Scale 8cm in 1cm divisions.

RA13 Uncertain. Limestone. Part of small moulding? Flat smooth face, hollow chamfers, one smooth one slightly rough, both ends flat and smoothed. Reverse surface broken off. L. 61.85mm; w. 30.6mm; th. 17.10mm - Figure 14.

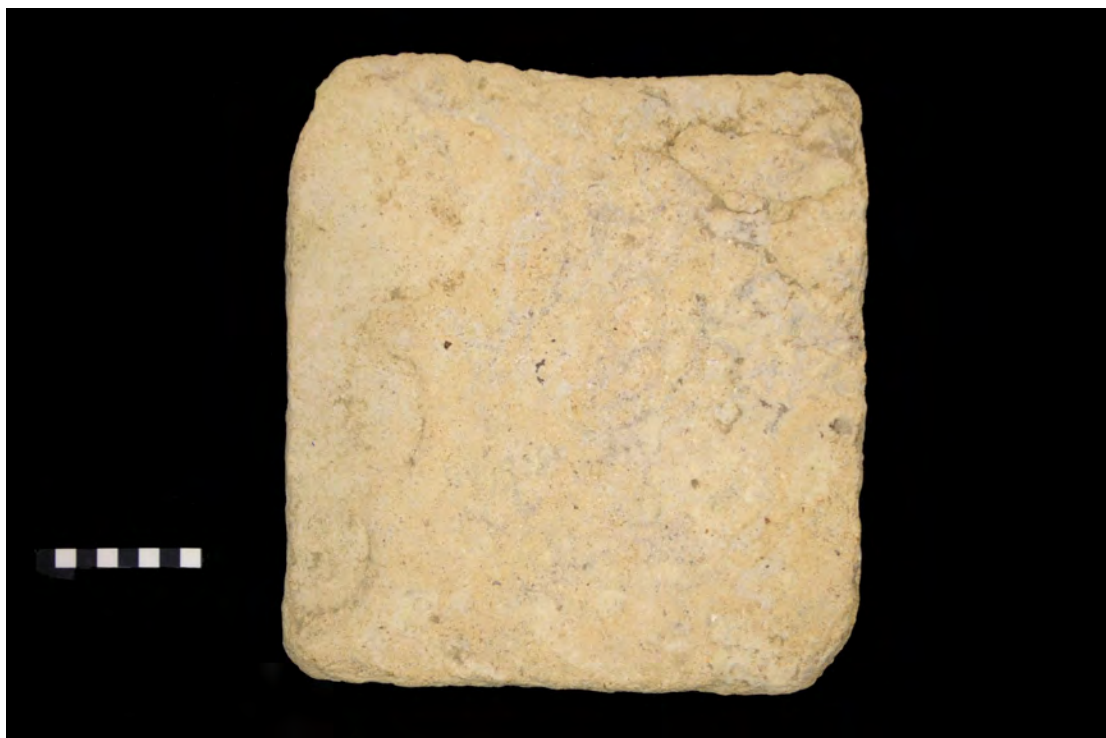
**Figure 15:** Image of floor slab RA14

**RA14** Flooring. Limestone. Flat rectangular floor slab, rectangular in section. Rough irregular base, some chisel marks, chisel marks along edges, worn smooth obverse face. Scale 8cm in 1cm divisions.

RA14 Flooring. Limestone. Flat rectangular floor slab, rectangular in section – Figure 15. Rough irregular base, some chisel marks, chisel marks along edges, worn smooth obverse face. L. 280mm; w. 310mm; th. 70mm.

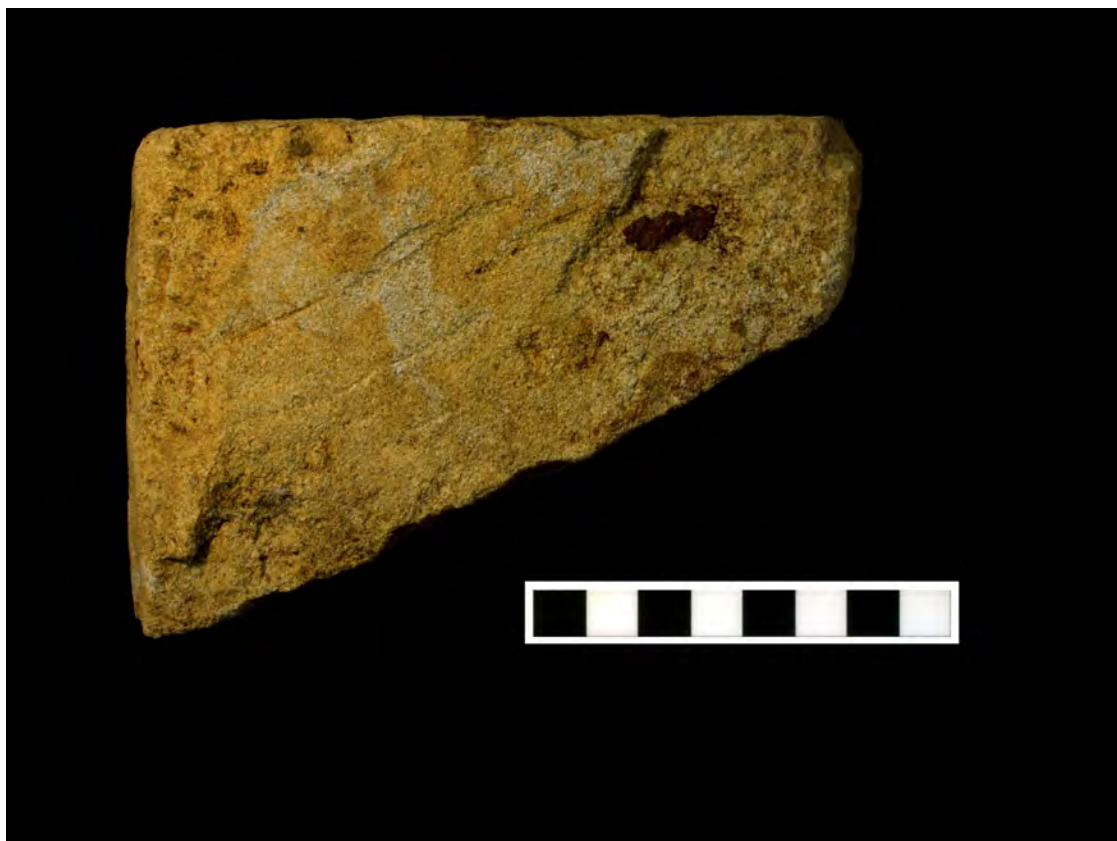
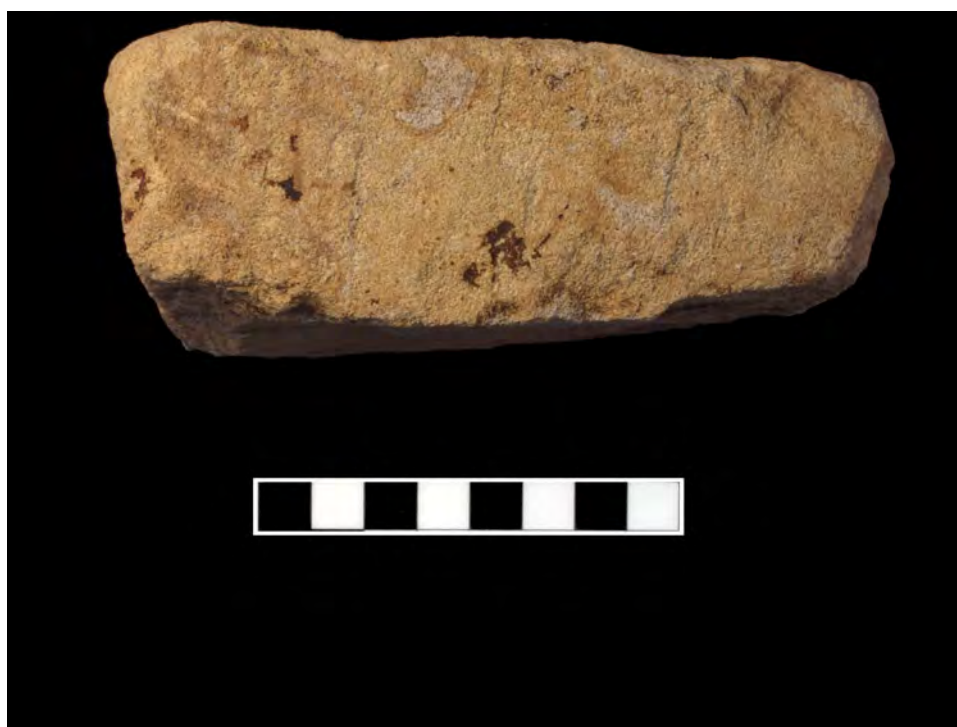
**Figure 16:** Images of floor slab RA7

**RA7** Flooring. Limestone. Flat rectangular sectioned floor slab cut into triangular shape, flat surfaces, chisel marks on edges. Recovered from robber trench fill (12). Scale 8cm in 1cm divisions.

**RA7** Edge showing toolmarks. Scale 8cm in 1cm divisions.

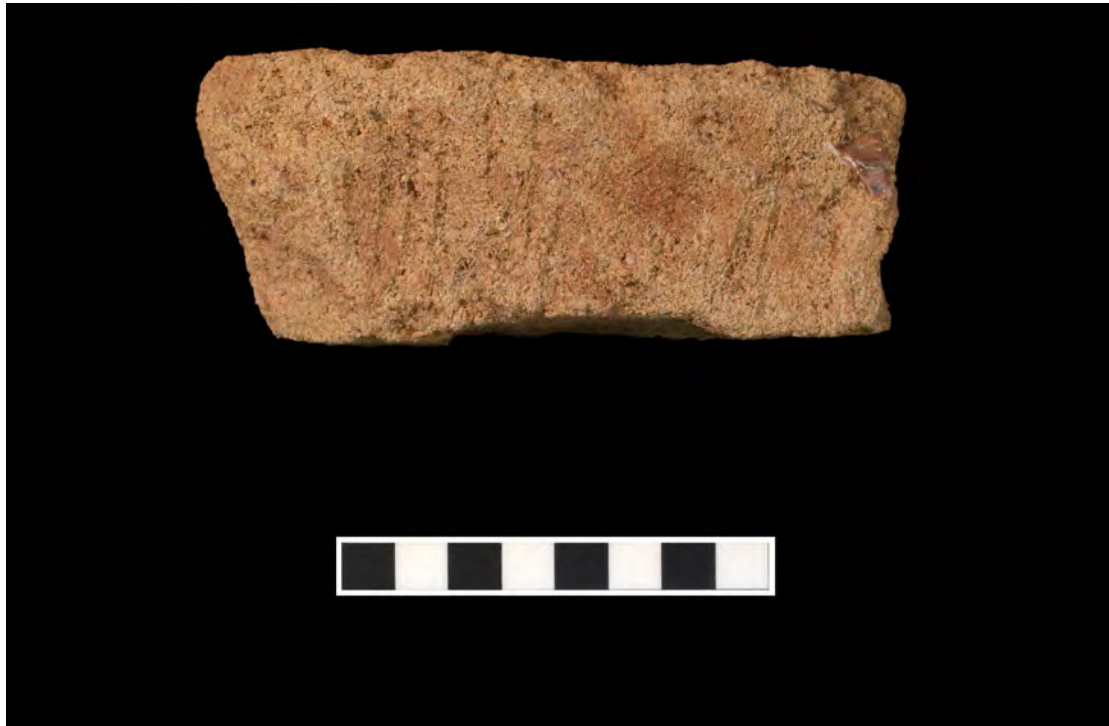
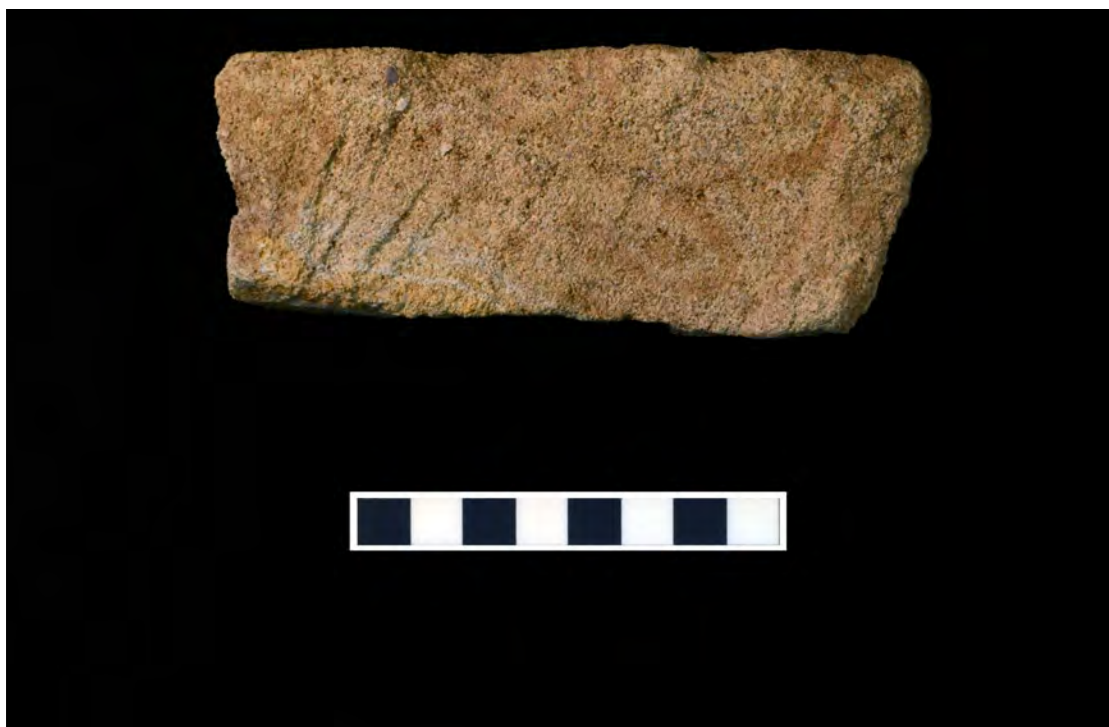
**Figure 17:** Images of floor slab RA10

**RA10** Flooring. Limestone. Trimming off a flat rectangular sectioned floor slab? Narrow rectangular in plan, both ends missing. Three edges roughly cut, chisel marks visible. Recovered robber trench backfill (12). Scale 8cm in 1cm divisions.

**RA10** Toolmarks. Scale 8cm in 1cm divisions.

RA10 Flooring. Limestone. Trimming off a flat rectangular sectioned floor slab? Narrow rectangular in plan, both ends missing. Three edges roughly cut, chisel marks visible - Figure 17. L. 136mm; w. 40.6mm.; th. 55.25mm.
