## Colworth Science Park Gas Main, Sharnbrook, Bedfordshire

### Archaeological Watching Brief – Summary of Initial Visit

### Archaeological Watching Brief – Summary of Second Visit

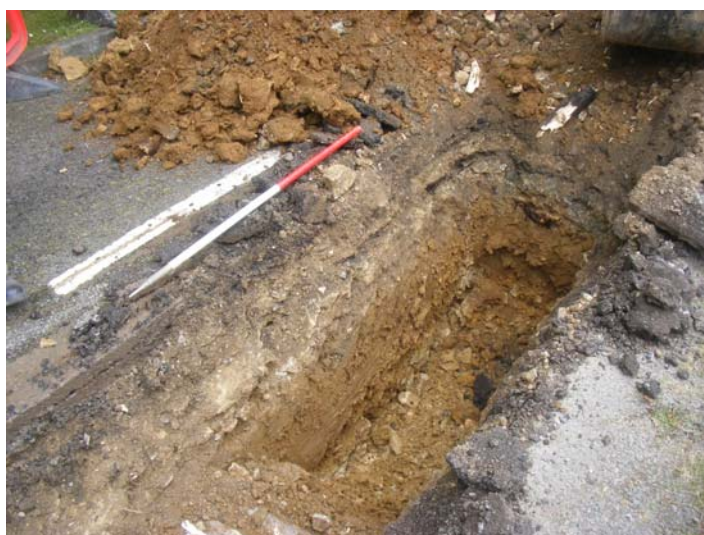
This was dug as an additional pit, *c.* 40m from the last pit on the main access road due to difficulties in getting the drill onto the right alignment after the bend. The pit was *c.* 11m from the junction. It measured *c.* 1m by 3m and was excavated to a depth of *c.* 1.3m. Modern services were encountered in the NE half of the pit.

The soil profile comprised *c.* 0.1m of tarmac, which capped a 0.4m thick layer of hardcore make-up comprising bands of limestone rubble, dark cinder-type material and gravel. These make-up deposits overlay a 0.5m thick deposit of mid red brown sandy clay, which is likely to represent the underlying geological strata. Bedrock was encountered at a depth of *c.* 1m. No archaeological features were observed during the excavation.

**Figure 1: Pit 1 looking east, 1m scale**

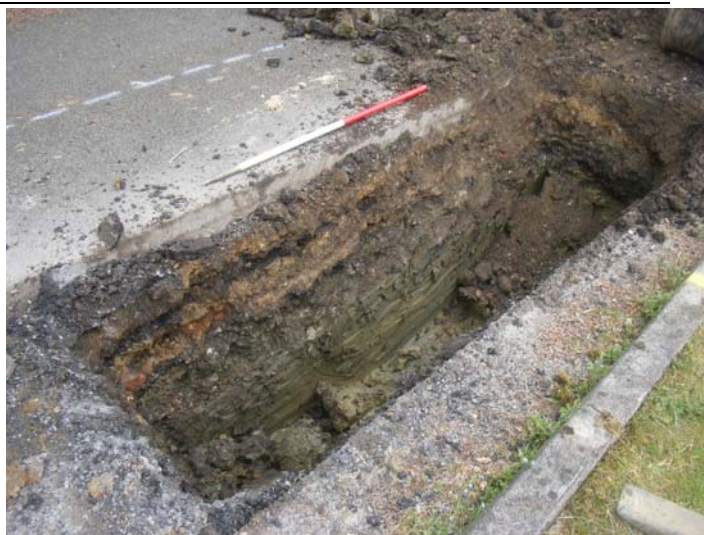
Pit 2 was located *c.* 100m from the last pit on the main access road down the side road to the west. It measured *c.* 1m by 3m and was excavated to a depth of *c.* 1.2m.

The soil profile comprised 0.1m of tarmac on top of *c.* 0.4m of hardcore, similar to that observed in Pit 1 but also containing some ceramic building material fragments. This road make-up layer directly overlay the undisturbed geological strata, comprising mid blue-grey brown silty clay; bedrock was not encountered. No archaeological feature were observed during the excavation

Figure 2: Pit 2 looking west, 1m scale

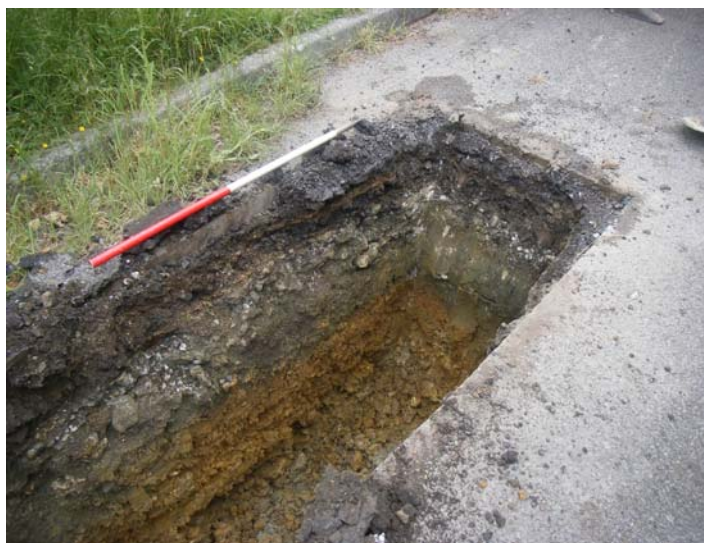
Situated 100m to the west of Pit 2, Pit 3 measured *c.* 1m by 3m and was excavated to a depth of *c.* 1.4m. The soil profile comprised 0.1m of tarmac, overlying a 0.4m thick hardcore deposit comprising several layers of stone rubble, gravel and dark cinder-type material. This overlay a *c.* 0.2m thick deposit of mid brown grey sandy silt/clay, which could represent a buried subsoil. The undisturbed geological strata comprised mid orange brown sandy clay. At a depth of 1.35–1.4m, light blue grey clay was visible in patches at the base of the pit. No archaeological features were observed during the excavation.

Figure 3: Pit 3, looking north, 1m scale

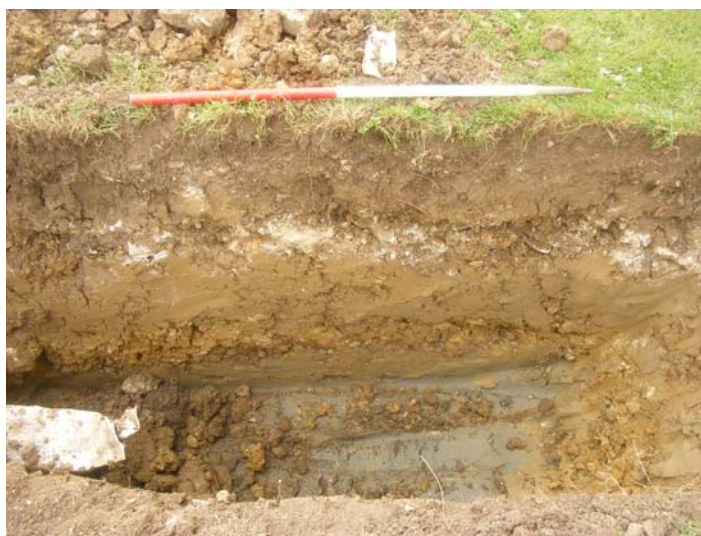
Located *c.* 100m west of Pit 3, on the grass verge immediately south of the access road (Figure 1), Pit 4 measured 1m x 3m x *c.* 1.25m deep. The northern section was disturbed on its entire length by a modern cable trench. The soil profile comprised *c.* 0.2m of dark grey brown clay silt topsoil above mid grey brown subsoil *c.* 0.13m thick. Below this was a layer of limestone rubble, *c.* 0.2m thick with mid brown clay silt (Figure 2). This layer extended beyond the limits of the pit. It appears to be an external surface; the overlying deposits probably represent material brought in for landscaping.

Directly beneath the stone layer was a mid grey brown silty clay deposit, 0.2m thick. This appears to be the truncated remains of the soil profile, suggesting that the topsoil had been removed prior to spreading of the stone layer.

Below this, the sequence comprised mid orange brown sandy clay, *c.* 0.2m thick, above mid blue grey and mid blue brown silty clay. These deposits are likely to represent undisturbed

geological strata. The orange brown sandy clay layer corresponds to a similar deposit in Pit 3. It is much thinner here, possibly due to erosion within the lower part of the valley. No archaeological features apart from the (probably) recent landscaping deposits were observed.

Figure 2: North facing section Pit 4, 1m scale

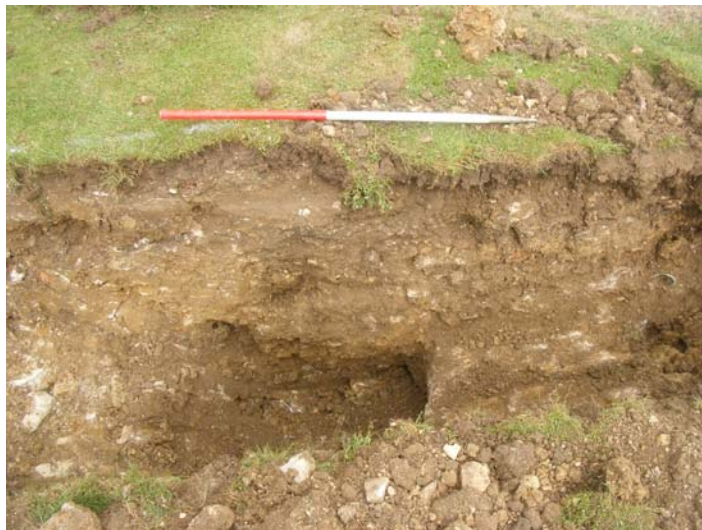
The pit revealed a series of deposits (Figure 3). Dark brown topsoil, 0.15m thick, overlay 0.2m of subsoil. Below this was the vertical-sided cut of a pipe trench, visible on the right hand side of Figure 3. Its fill was darker than the adjacent deposits and contained fragments of concrete. At a depth of 0.95m a concrete slab was revealed, protecting a pipe.

**Figure 3: South facing section Pit 5**

A 1.15m-thick series of deposits were visible upslope to the north. They comprised mid yellow brown mixed clay silt and sandy clay, with thinner, darker bands. This material contained frequent medium to large stones and brick fragments. It appears to represent a series of extensive deposits, designed to infill and level the base of the valley (Figure 4). Given the extensive and homogenous nature of this material, it was probably laid down in recent times rather than being associated with landscaping of the grounds of the house.

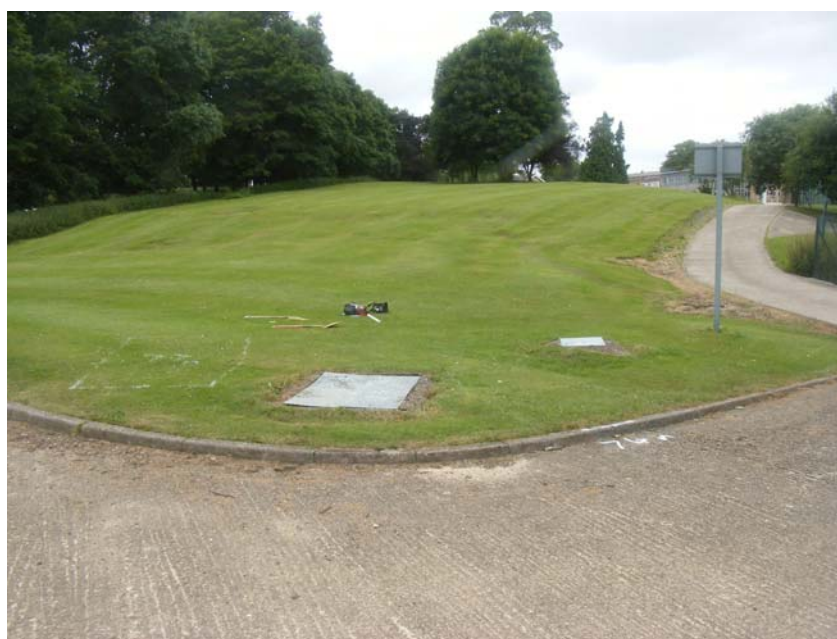
south-west of Pit 4, in the vicinity of the sewage works. The area was heavily disturbed, with a large manhole immediately to the north; a further three smaller manholes were visible along the edge of the access route leading up to the science centre buildings to the north-east (Figure 4). The pit was c. 1m x 3m x 1.5m deep.

**Figure 4: Area of southward running stream, now level. Pit 5 marked out on the grass**
