**6a HIGH STREET
EYEWORTH
BEDFORDSHIRE**

**ARCHAEOLOGICAL OBSERVATION,
INVESTIGATION, RECORDING, ANALYSIS AND
PUBLICATION**

Project: HS2203

Document: 2013/191
Version 1.0
Issue date: 13th January 2014

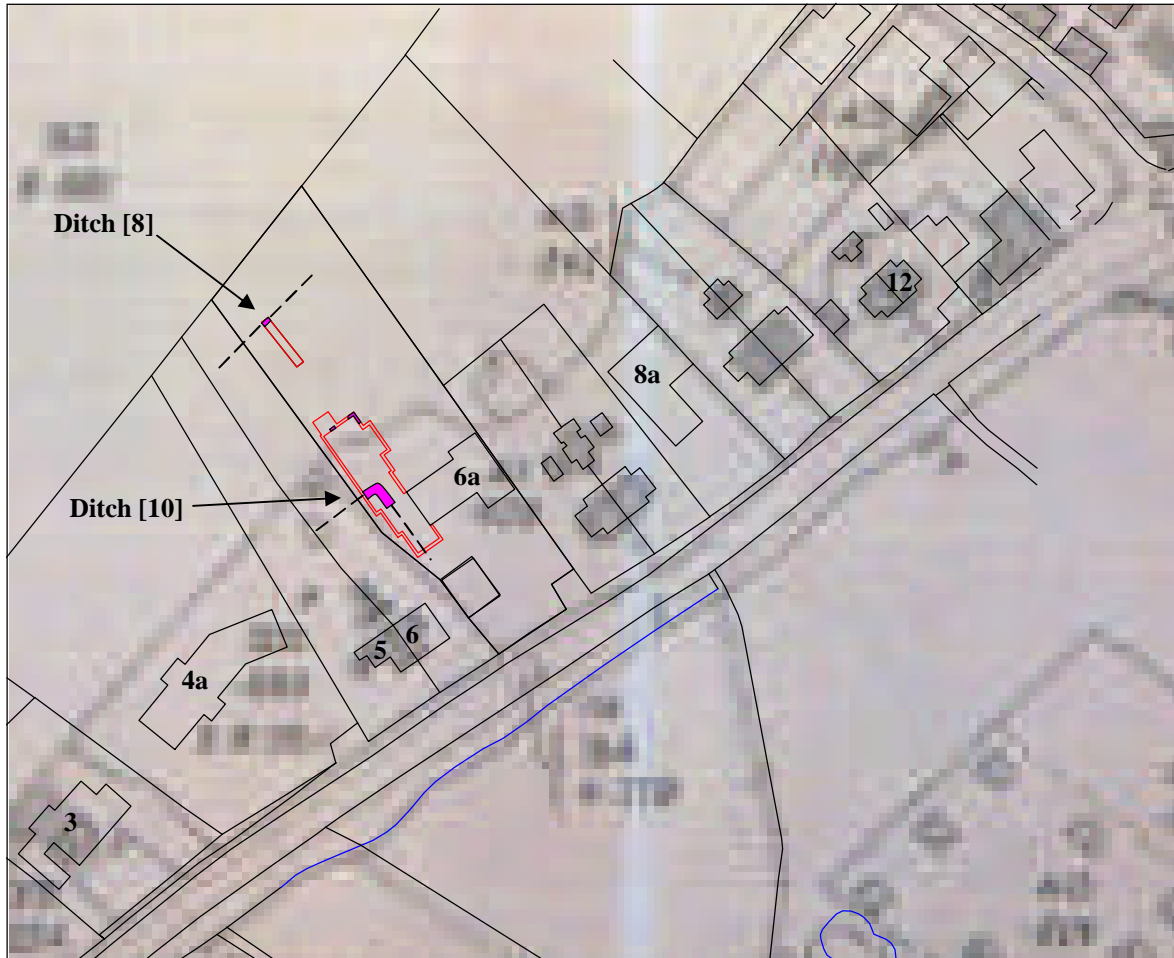
Figure 4: Modern map and archaeological features overlaid on 1901 OS map

Ditch [8] located at the north of the plot lies *c.* 70m from the road frontage and appeared to run approximately parallel to the road. Its fill (9) was a clean, well-sorted deposit with a higher proportion of sand compared to both the underlying geological deposit and the overlying subsoil. The ditch is located close to the northern edge of the garden and may be a precursor to the present boundary (Fig. 4).

Ditch [10] was found *c.* 35m from the road frontage and consisted of a right-angled corner with its northern arm aligned parallel to the High Street. It contained a dark fill (11) that produced no finds. A continuation of the north arm of the ditch extends into the garden of no. 6 High Street in the form of a shallow earthwork which is visible in the lawn. Local information relayed by the groundworks contractors indicated that the garden of 6a also contained a depression in this location which had been infilled. The northern arm of the ditch is located close to the line of a historic boundary which defined the rear edge of plots along this side of the High Street (Fig. 4). This boundary is shown on Ordnance Survey maps dating from 1882, 1901 and 1926. The ditch is likely to represent the northern extent of the plot prior to its northwards extension later in the 20th century.

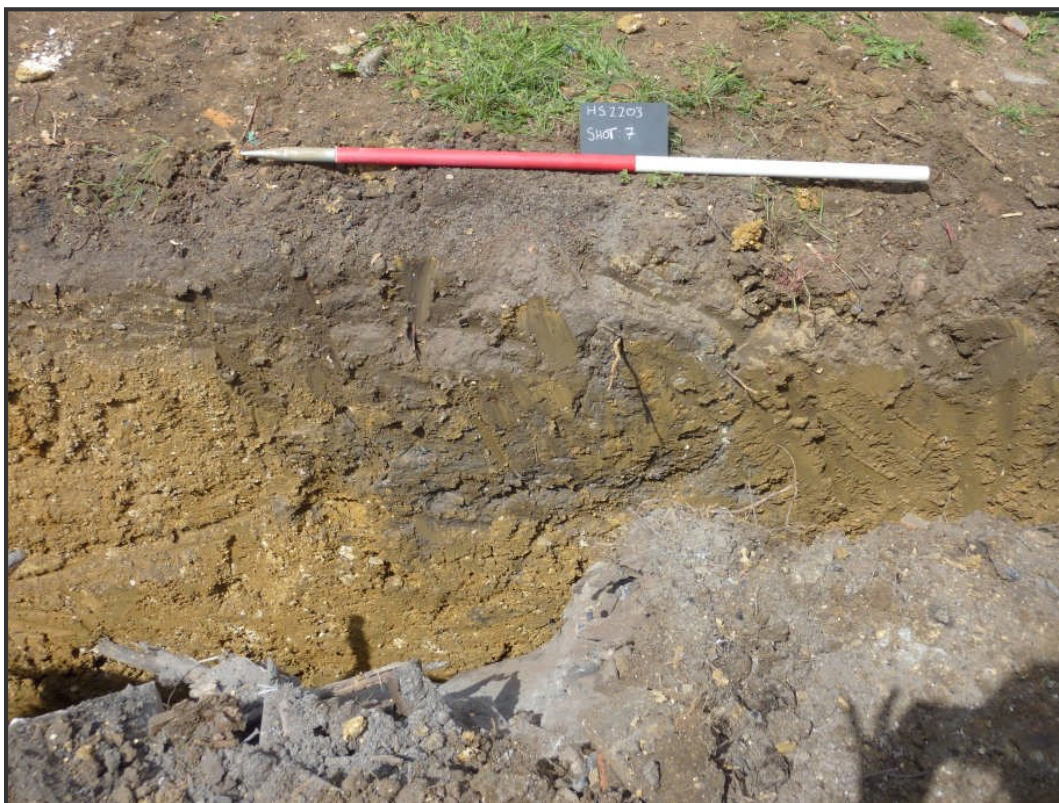
Within the foundation cuts at the northern end of the extension two discrete pits [4] and [6], up to 0.7m deep, were identified (Figs 5 and 6). They lay beneath a thin layer of topsoil (1) and were cut into the underlying subsoil (2). The fills of the pits consisted of loose soil mixed with modern debris including ash, iron fittings, tarmac, concrete, brick and plastic bags. Further dark soil with modern debris was noted during subsequent machining for the swimming pool.

Figure 5: Pit [4]
Pit containing modern debris cut through subsoil (looking NW, scale 1m)

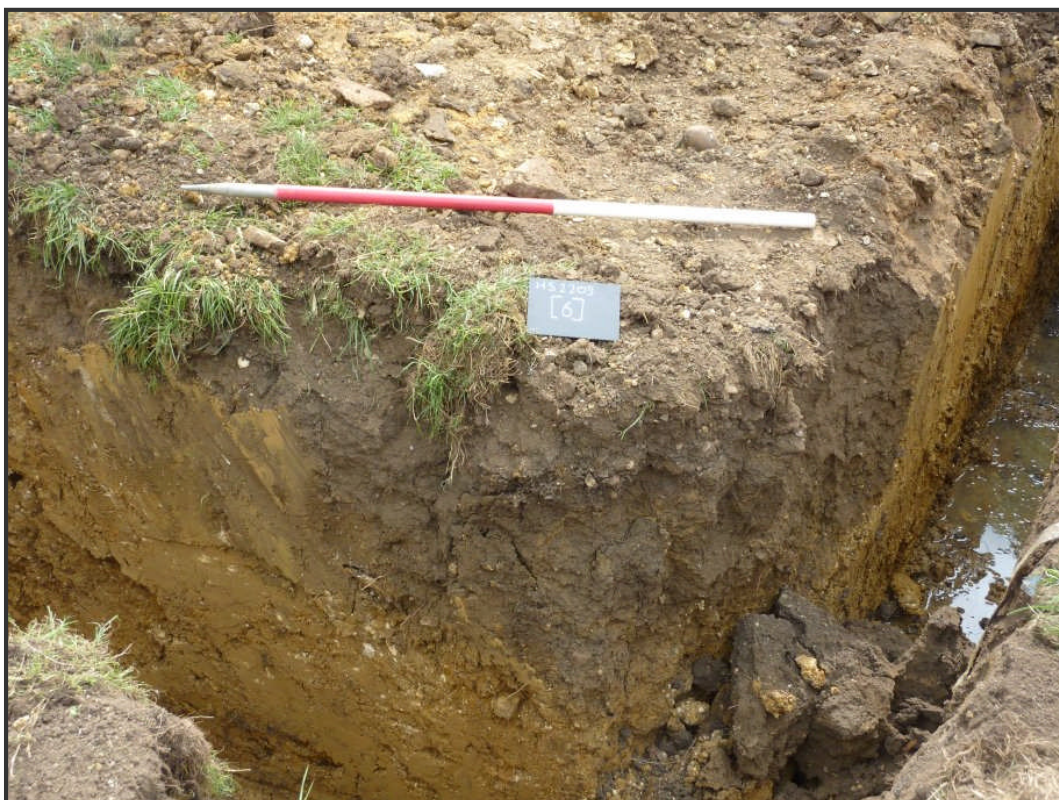
Figure 6: Pit [6]
Pit containing modern debris cut through subsoil (looking south, scale 1m)

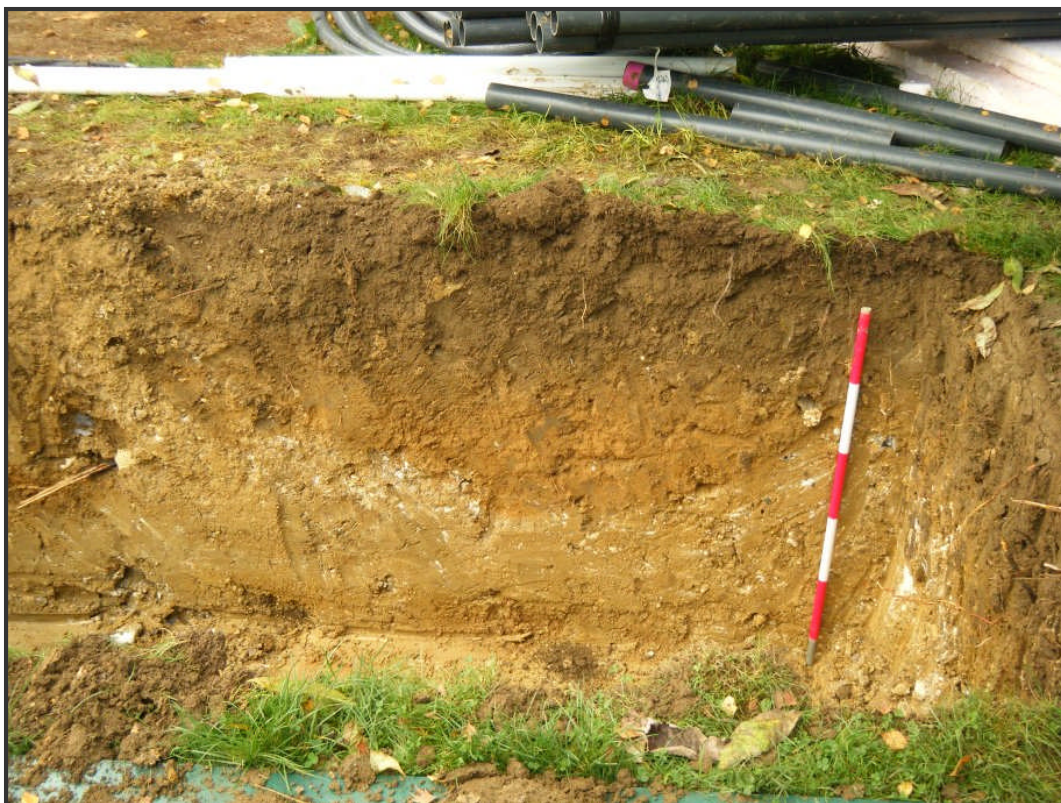
Ditch [8] was found at the north end of the soakaway trench located in the northern end of the garden (Fig. 3: A and Fig.7). This NW-SE aligned feature was 1.6m wide and 0.45m deep with a shallow, concave profile. The ditch was cut into the natural strata (3) and covered by subsoil (2). Ditch [8] contained a single undifferentiated fill (9) of mid red brown clayey sand with no obvious inclusions.

Figure 7: Ditch [8]
Ditch with clean sandy fill sealed beneath subsoil (looking SW, scale 1m)

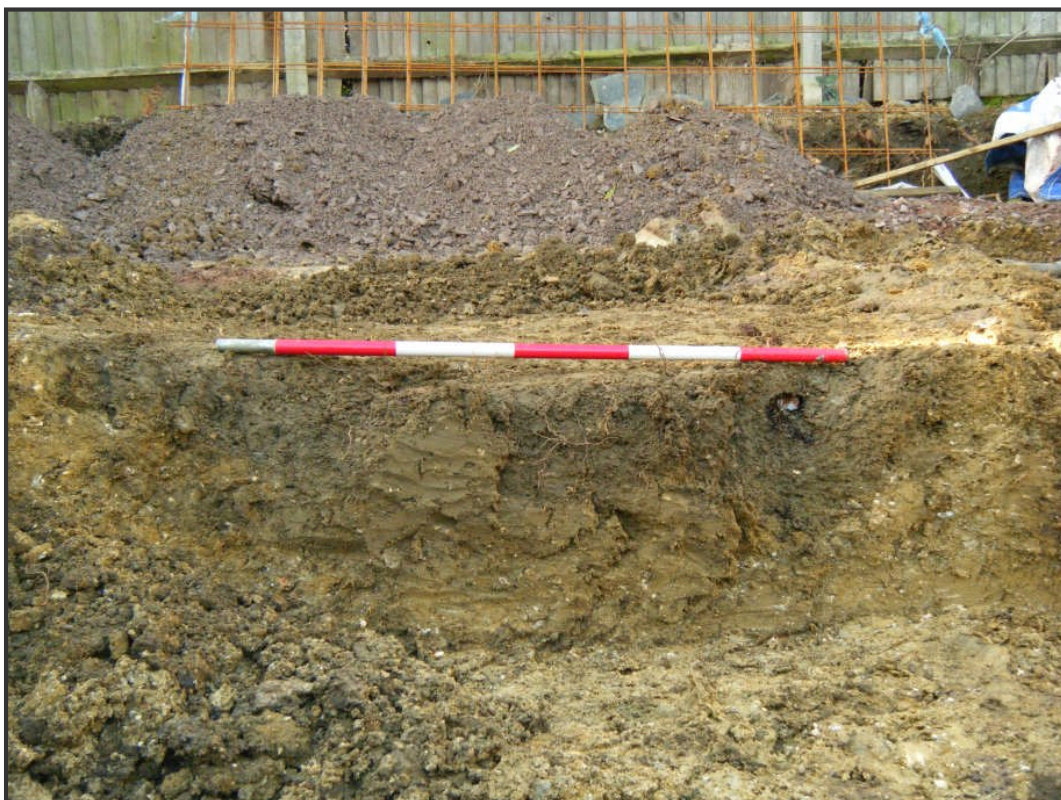
Ditch [10] was found during ground reduction for the foundations of the swim spa close to the existing house (Fig. 3: B and Fig. 8). The ditch was not observed during the earlier excavation of the adjacent wall footings; however the upper part of the ditch was obscured by a layer of dark soil containing modern debris (see section 2.1).

Sections of ditch [10] aligned SW-NE and NW-SE formed a right-angled corner. The ditch was 1.5–1.8m wide with steep sides and a concave base. At its top it appeared to have been partially truncated and was covered by dark soil containing modern debris. The base of the ditch was at a depth of 0.9m below the present ground surface. To the west the line of the ditch appears to be continued as a linear depression which crosses the lawn of the adjacent property.

Figure 8: Ditch [10]
Ditch with dark fill found beneath layer of modern disturbance/infill (removed)
(looking SW, scale 1m)

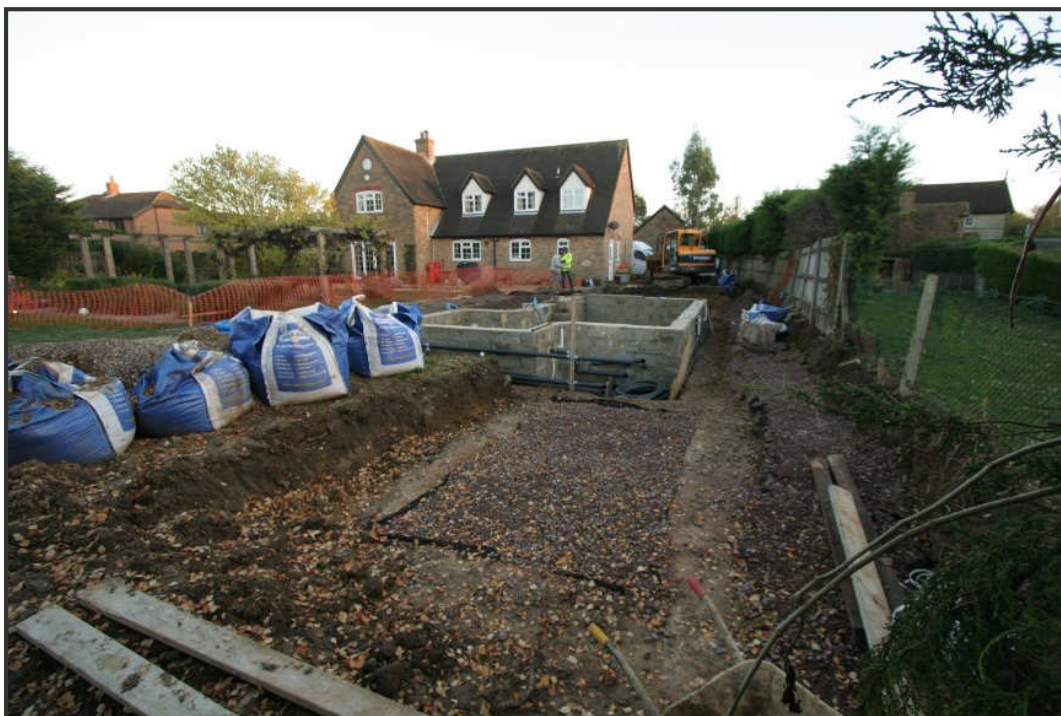
Figure 9: General view of the site from the south
The lawn visible at the right hand side of the image contains a depression that appears to correlate with the westward continuation of ditch [10]
