**BEDFORD COLLEGE TECHNOLOGY BUILDING
CAULDWELL STREET
BEDFORD**

ARCHAEOLOGICAL FIELD EVALUATION

Document: 2016/134
Version 1.0

Project: BC2184

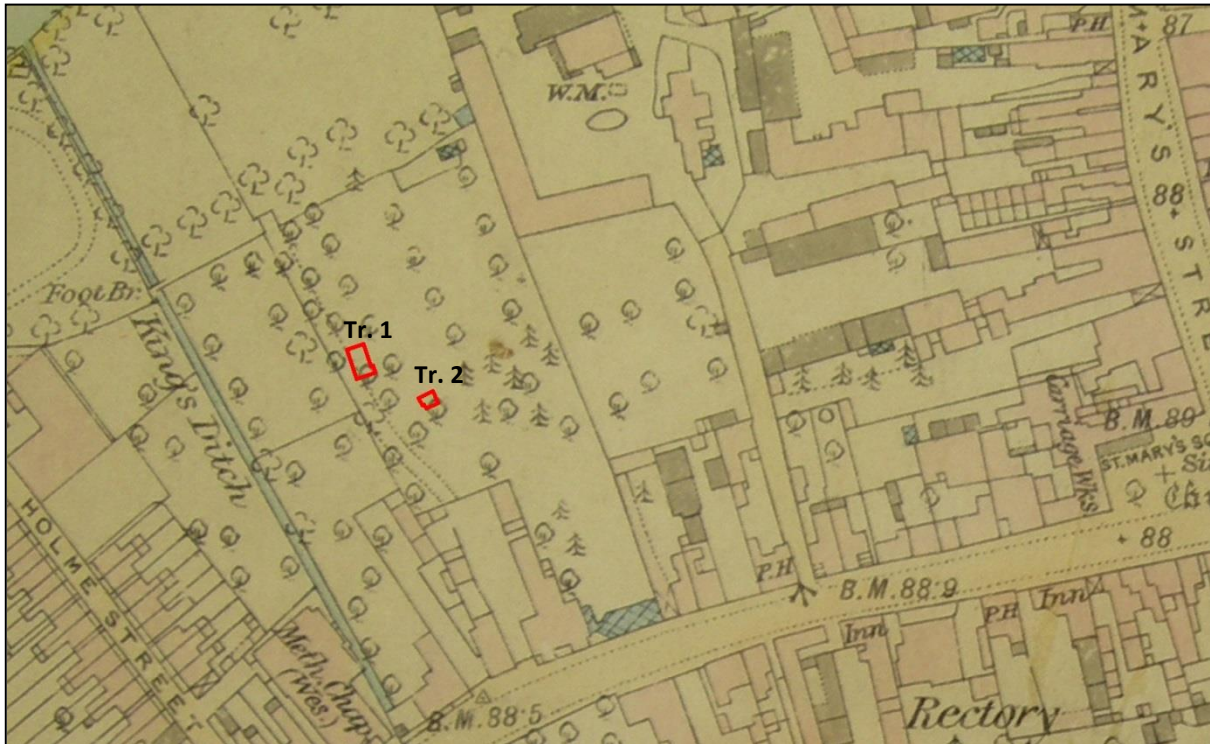
Image 1: 1884 Ordnance Survey map with trench locations

Map shows the line of a path which corresponds to a path and path-edging found in Trench 1

Trench 1 revealed an edged gravel path [103]/(104) that coincided with the line of a path depicted on the OS map of 1884 and still shown on the OS map of 1926. It is possible that the path ran between a number of urban smallholdings or gardens. Though it is interesting to note the survival of this path, it is of no more than local significance. The path also serves as dating evidence (*terminus ante quem*) for the post-medieval make-up deposits below it.

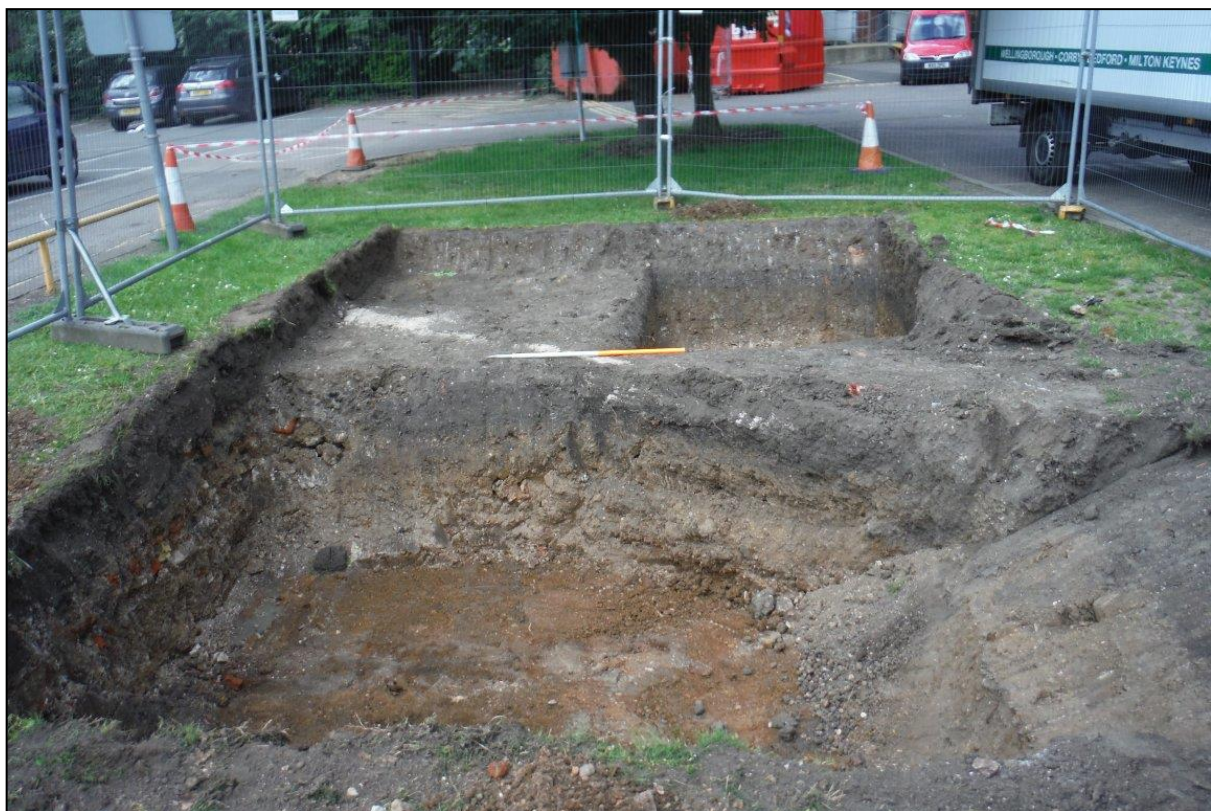
Image 2: Trench 1, looking north

Trench 1 measured 7m x 3m, and was located to avoid a number of live services associated with the existing buildings. One unrecorded service was encountered during excavation; it spanned the width of the trench from north-west to south-east and prevented the excavation of approximately 50% of the area of the trench. Therefore, two smaller areas within the trench were excavated either side of the service pipe (Image 2).

Excavation in the middle part was obstructed by a modern surface-water drain that crosses the trench close to the ground surface.

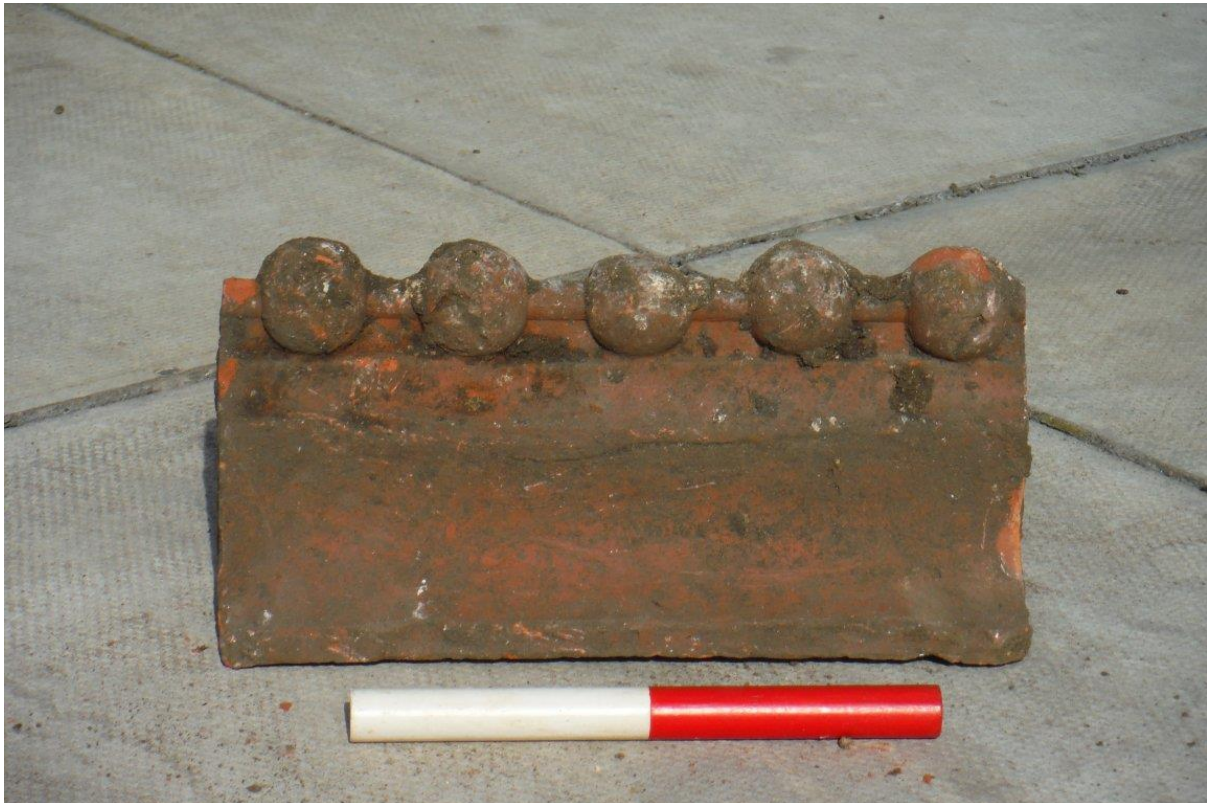
Image 3: Trench 1, path-edging tile

The upper part of these deposits was formed by a buried soil and a path. The buried soil (102) was dark brown-grey clay silt up to 0.24m thick. The path consisted of a construction cut [103] that contained loose brown-orange sandy gravel, forming the path surface (104). The path was aligned north-south and was at least 0.9m wide (Figure 3) by 0.3m deep. A moulded ceramic path edging was set into concrete along the excavated length (Figure 3). It was asymmetrical, with a triangular-shaped base and a series of spherical decorations on the top (Image 3).

Edging tile found *in situ* defining western edge of path [103] in upper part of trench (Scale 20cm)

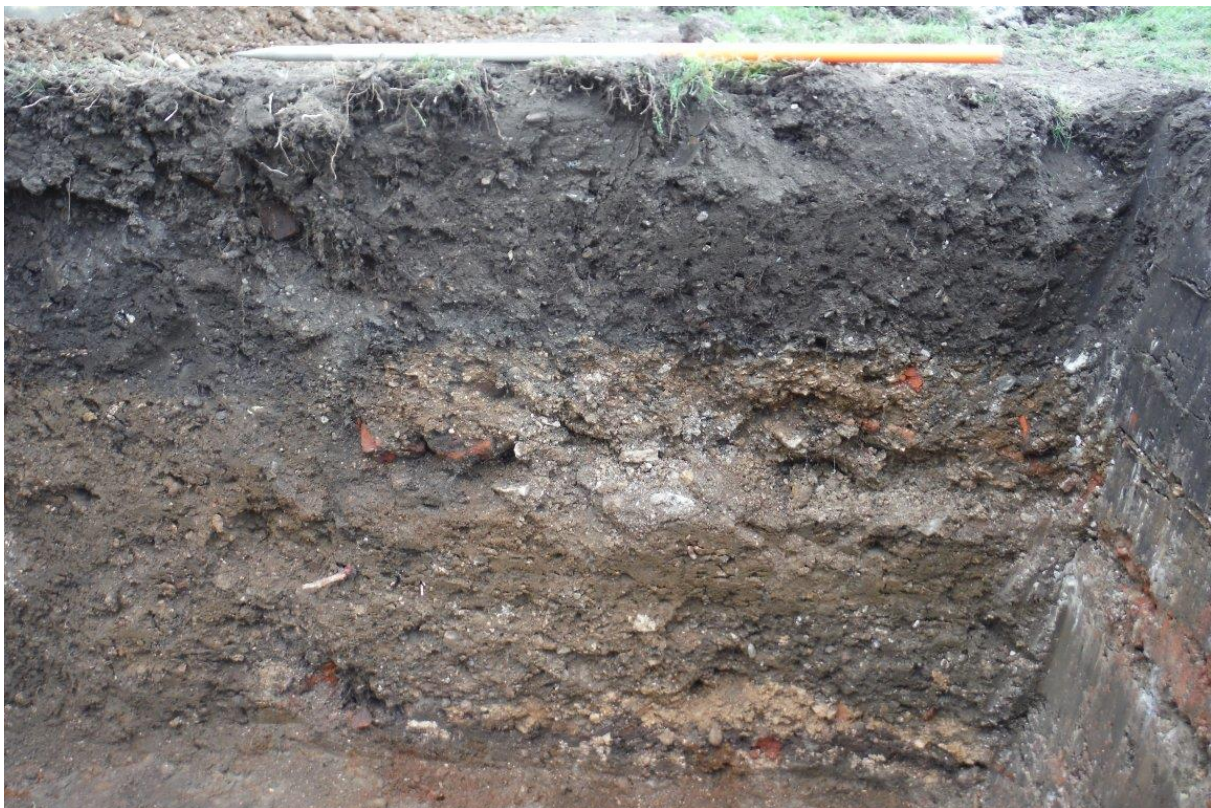
Image 4: Trench 1, Section 1

Make-up layers (105) to (107) each had a maximum thickness of 0.47m and formed the majority of the overburden (Figure 4). Deposits (105) and (106) were probably imported soil layers of mid orange-brown sandy silt. At the base of these deposits was a thin layer (107) of brown-yellow silty sand; it contained a large number of ceramic building material fragments and stones (Image 4).

Shows path construction in right-hand part of section (Scale 1m)

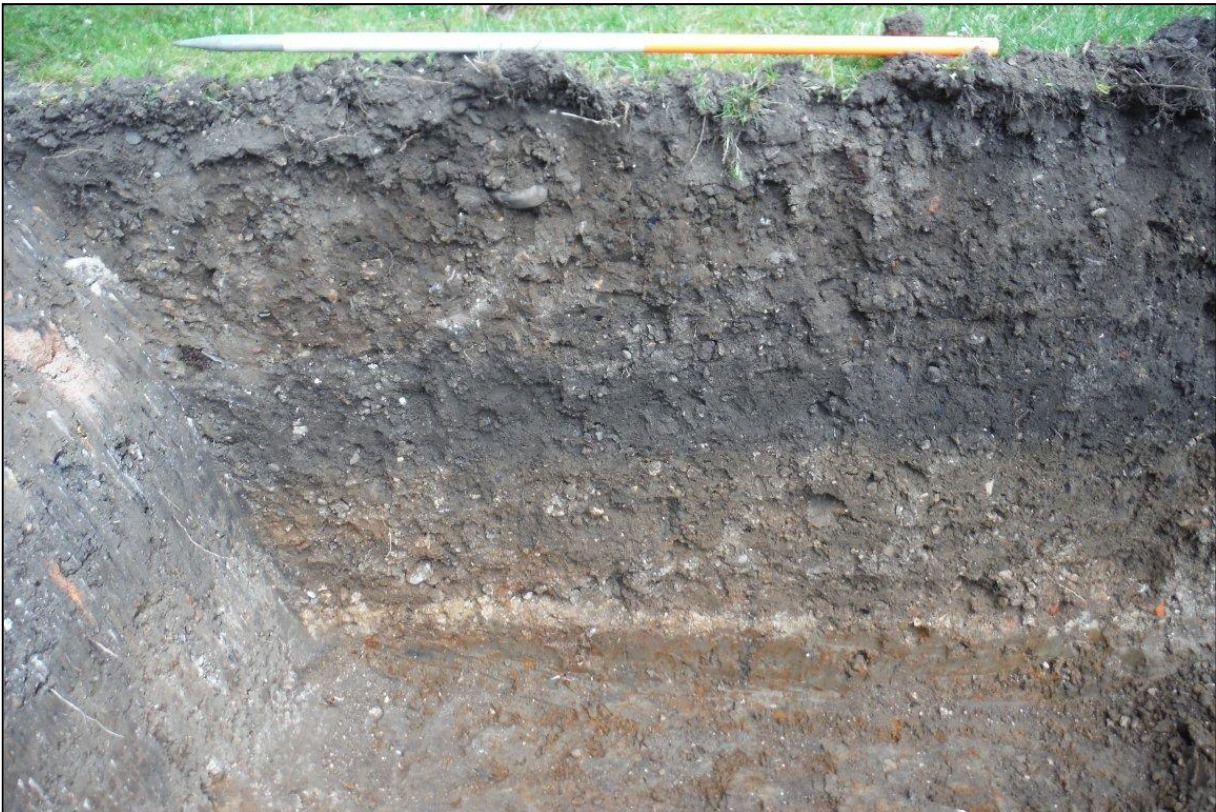
Image 5: Trench 1, Section 2

Shows a clear view of the accumulated soil layers which occur in the evaluation area (Scale 1m)

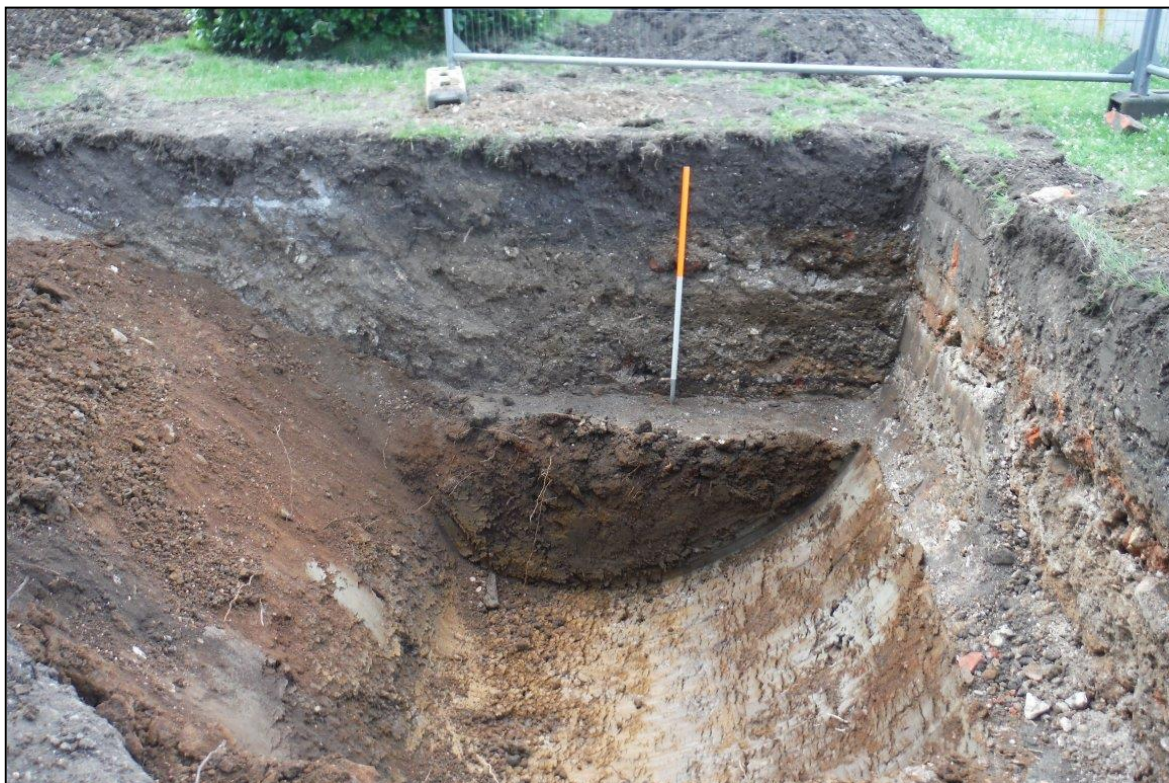
Image 6: Trench 1, machine-excavated section

The existing ground surface lay at 26.5m OD, according to the client's site survey. Deposits extended below a safe working depth for hand excavation. Therefore, to test the depth of the deposits, a machine section was excavated down to 2.5m below ground level to determine the depth of undisturbed geological deposits (Image 6).

Layer (109) was a mid-red-orange clay silt, found at a depth of 0.94–1.9m below the ground surface (Figure 4 and Image 6). It appeared to be alluvial in

Machine excavation next to Section 1, showing the full soil profile with clay gravel at the base of the trench (Scale 1m)

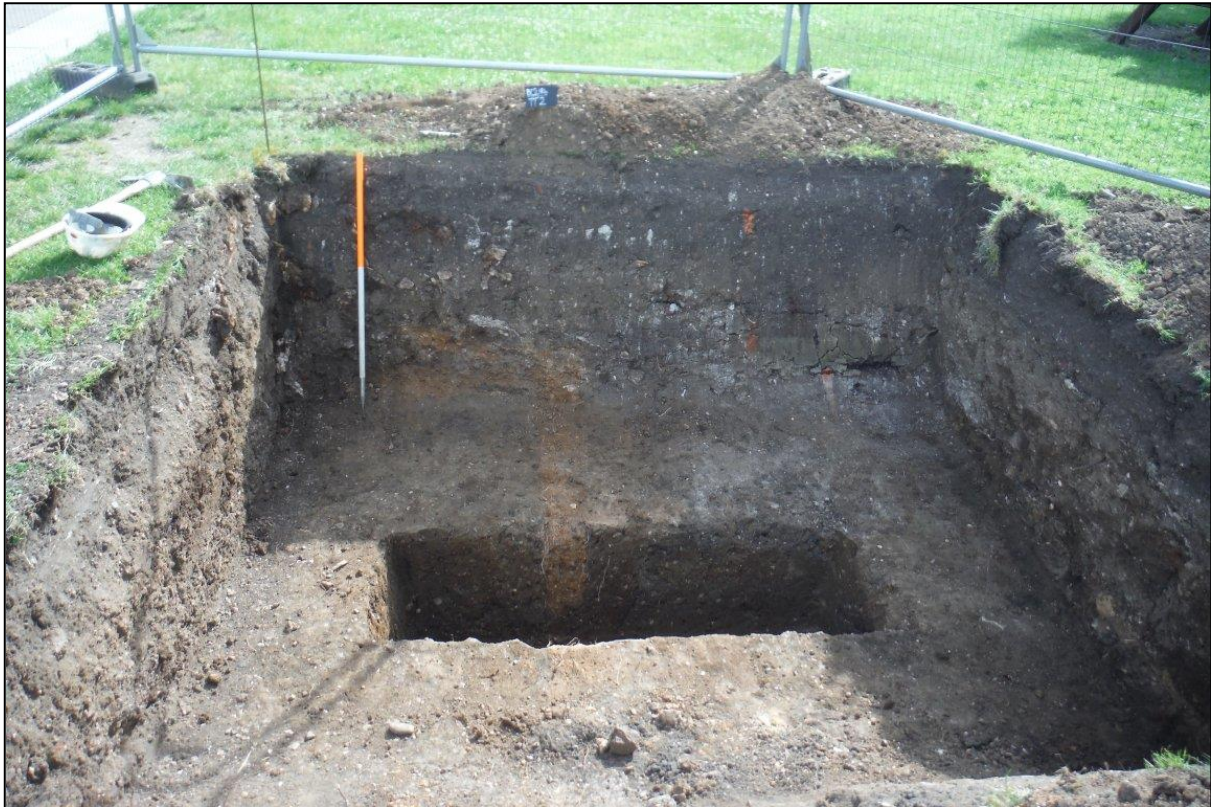
Image 7: Trench 2, looking east

Shows trench with hand-dug section through lower deposits in the centre of the trench (Scale 1m)

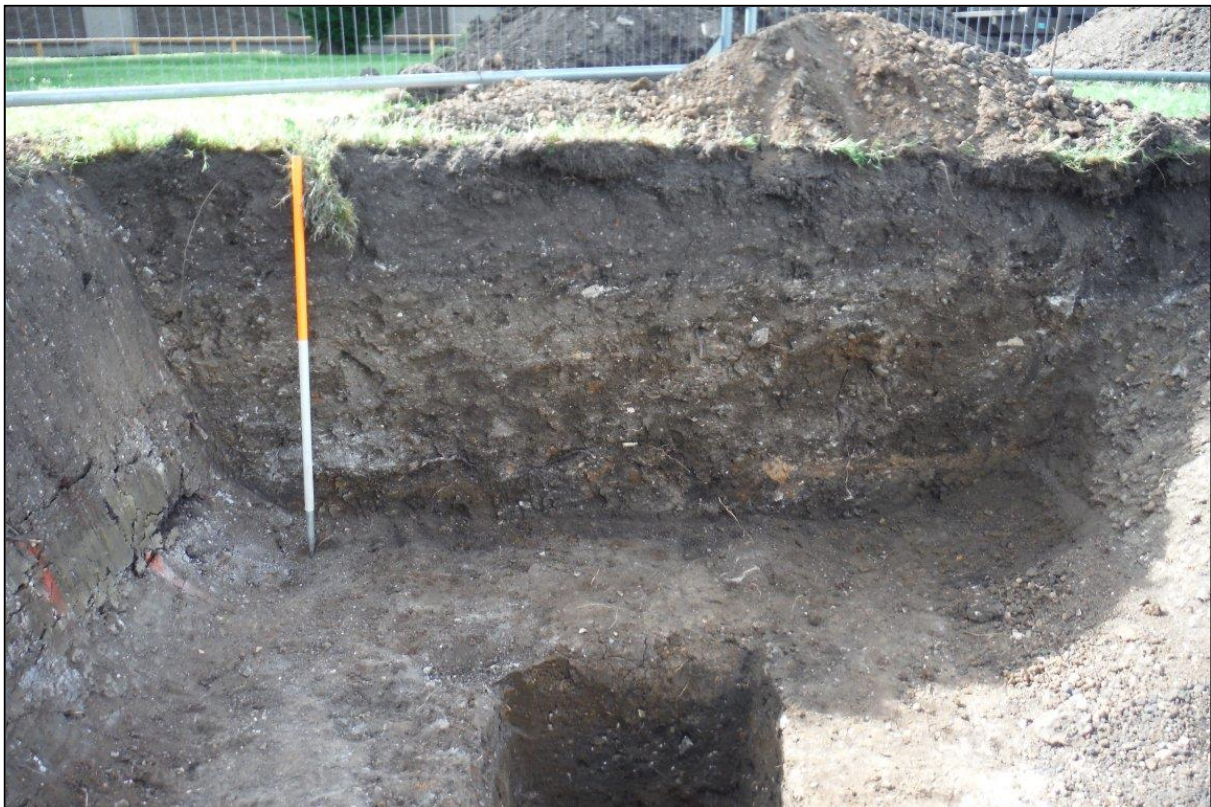
Image 8: Trench 2, Section 3

Below the topsoil the deposits consisted of imported soil layers extending to a depth of approximately 1.2m below the ground surface (Figure 4 and Image 8). The bulk of this consisted of deposit (201), a 0.43m-thick layer of mid-grey silty clay containing occasional fragments of brick and tile. This lay above a 0.13m-thick layer (202) of light brown-grey soil with ceramic building material comprising plain red brick fragments and plain roof tile. The lowest deposit (203) was a layer of clay, up to 0.2m thick, seen in the southern part of the trench.

Shows south side of trench with topsoil (200) and made ground layers (Scale 1m)

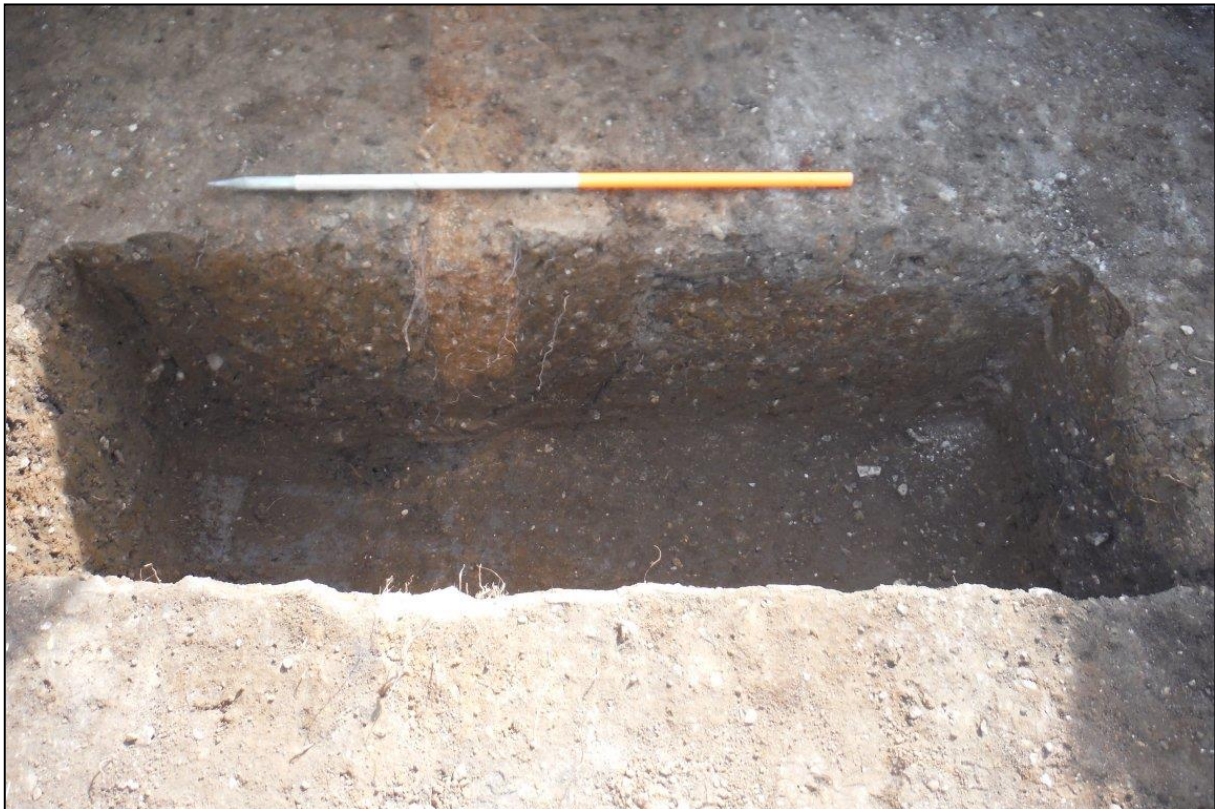
Image 9: Trench 2, Section 4

The deeper, hand-dug section in the centre of the trench revealed layers (204) and (205). These were partially truncated by pit [206] (Figure 4 and Image 9).

Shows section through earlier deposits (producing late Saxon pottery) in base of trench

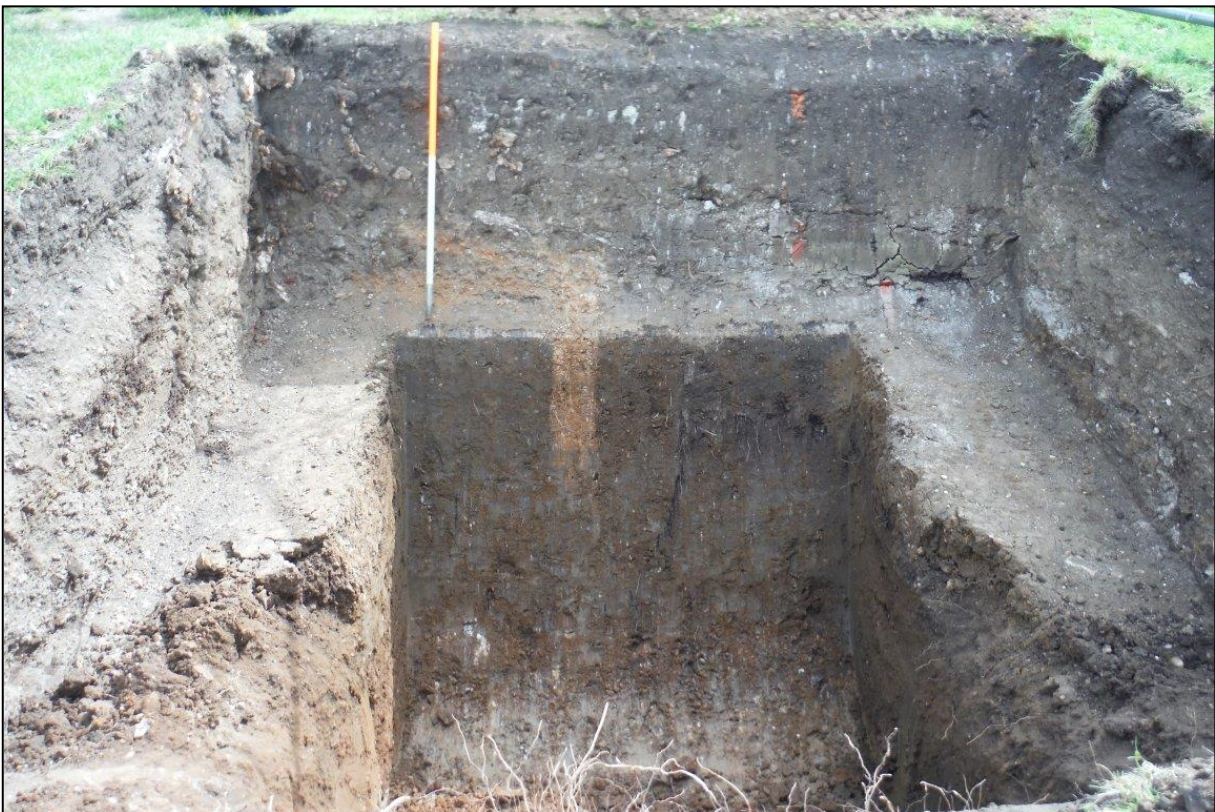
Image 10: Trench 2, machine-excavated section

The uppermost part of the trench contained a layer of dark brown-grey topsoil (200) up to 0.42m thick. The topsoil lay above the fill of a deep, narrow, vertical-sided linear cut [209] with a loose sandy gravel fill (210) (Figures 3 and 4; Image 8). This might have been a service trench where the service was either not installed or has been removed (Image 10).

A machine-excavated section was dug in the base of the trench to examine the deposits that lay below the limits of the hand-dug trench (Image 10). This showed that layer (204) was 0.86m thick and overlay (211), a more sterile, mid-brown-orange clay silt. An abraded rim sherd from a late Saxon St Neots-type ware jar (14g) and two animal bone rib fragments (22g) were collected from layer (211).

Machine-excavated section to natural strata. View looking east (Scale 1m)
