**ONION DRYING SHED
VALLEY FARM
STEPPINGLY ROAD
FLITWICK
BEDFORDSHIRE**

ARCHAEOLOGICAL BUILDING RECORDING

Document: 2013/153

Issue date: 25th November 2013

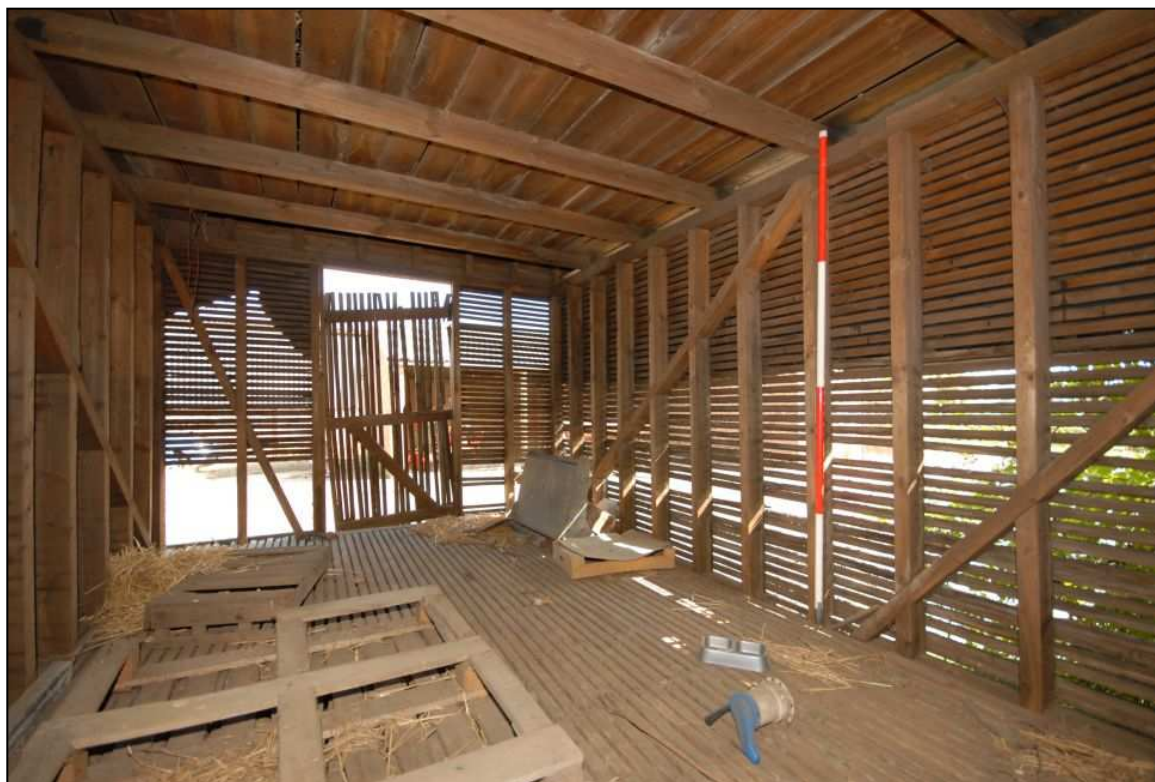
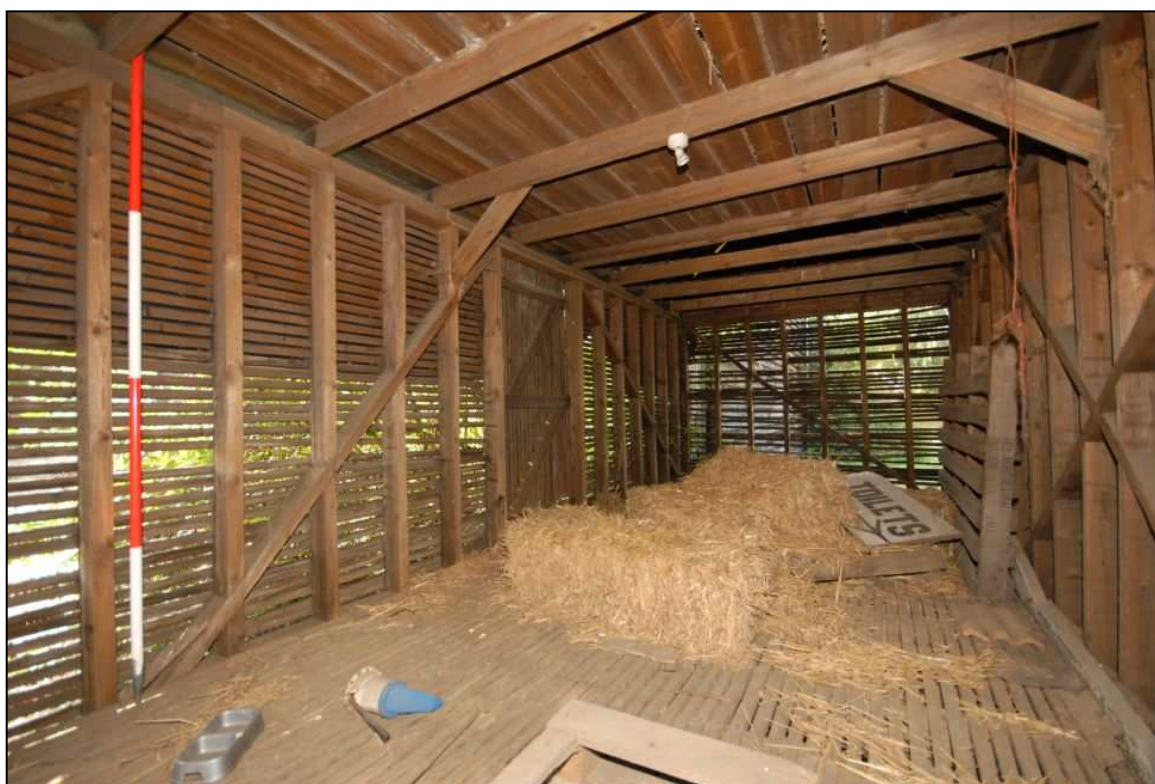
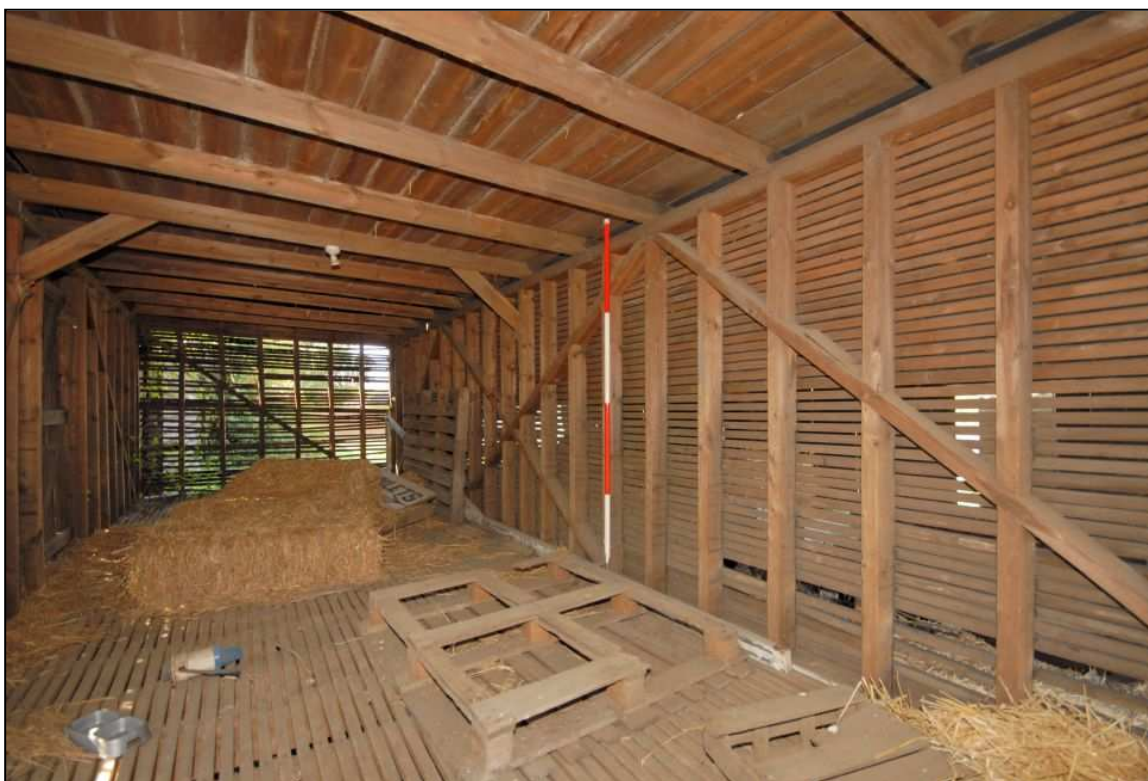
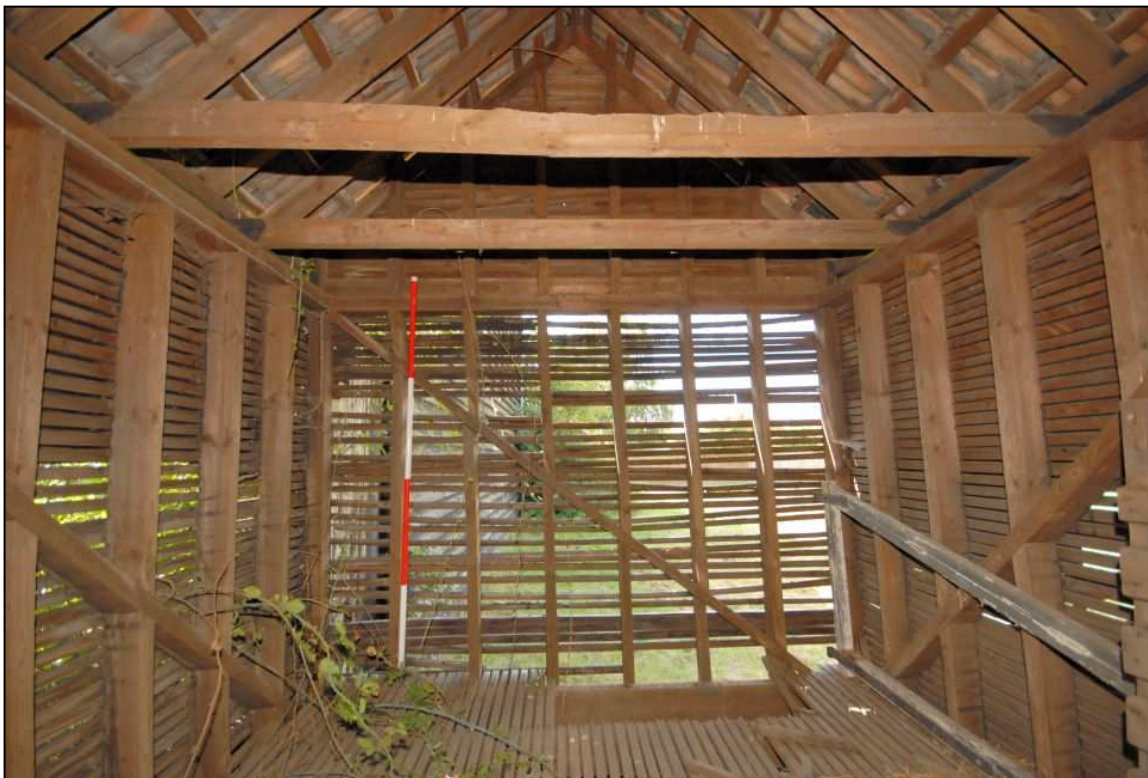
The walls are framed with four corner posts (100mm x 80mm), closely spaced studs and diagonal primary braces (both 100mm x 50mm) (Images 7 -10). The studs are nailed to the braces and tenoned into the wall plate above (Image 15). The bases of the studs were obscured by the floor and external cladding and the details of their fixing could not be observed.

Image 7: Interior view showing the north end and east side walls (scale 2m)

Image 8: Interior view showing the south end and east side walls (scale 2m)

Image 9: Interior view showing the south end and west side walls (scale 2m)

Image 10: Interior view showing south end wall (scale 2m)

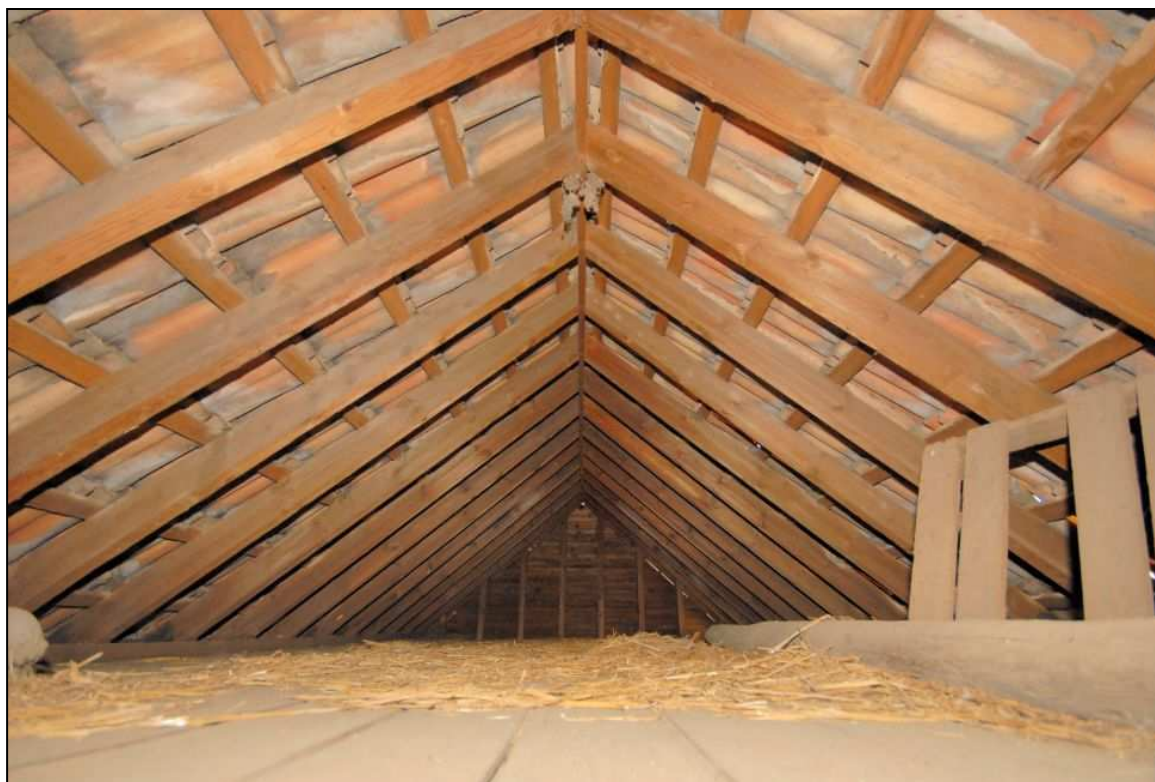
Image 12: Interior view showing loft and roof structure

Tongue and groove boards laid across the joists form a loft floor. This floor covers the northern two thirds of the shed with a short gap left at the north end.

It is not clear whether the flooring over of part of the shed to form a loft was an original feature or was done at a later date. It is constructed with tongue and groove boards over the rafters and could have been added at any time.

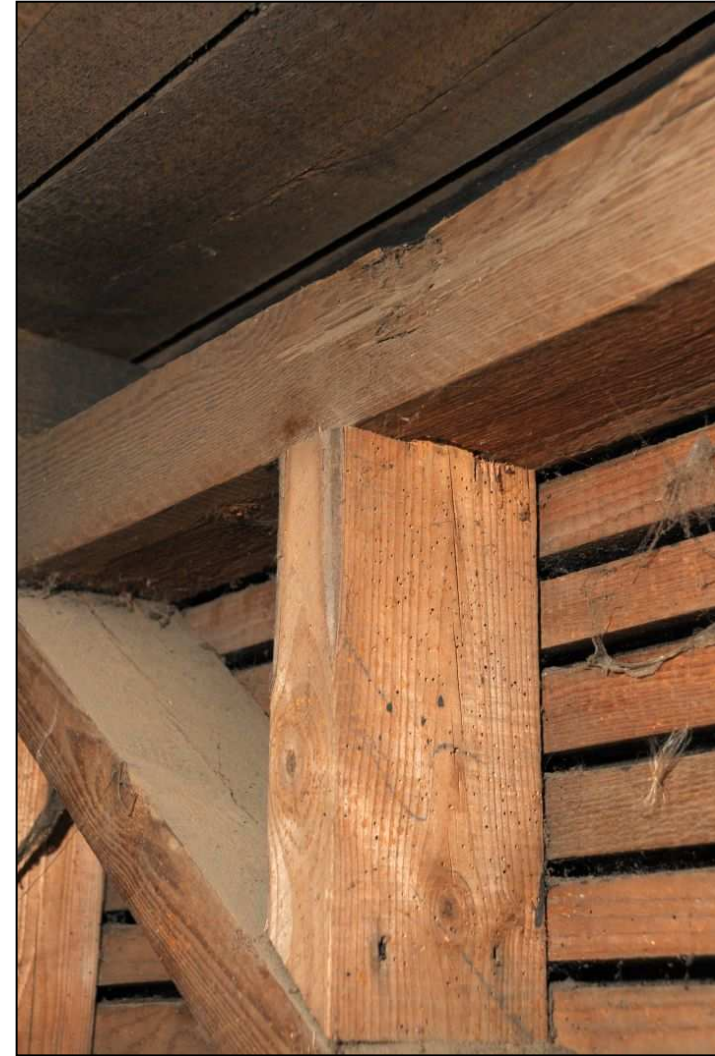
Image 15: Interior detail showing upper part of west side wall

The image shows the top of a stud which is mortised into wall plate at top and nailed to a diagonal brace below
