**LAND AT THE FORMER  
BRITANNIA IRONWORKS  
KEMPSTON ROAD  
BEDFORD**

**ARCHAEOLOGICAL  
FIELD EVALUATION**

Document: 2006/62  
Project: BR1187

Produced for:  
BMH Construction Company (Clifton) Ltd

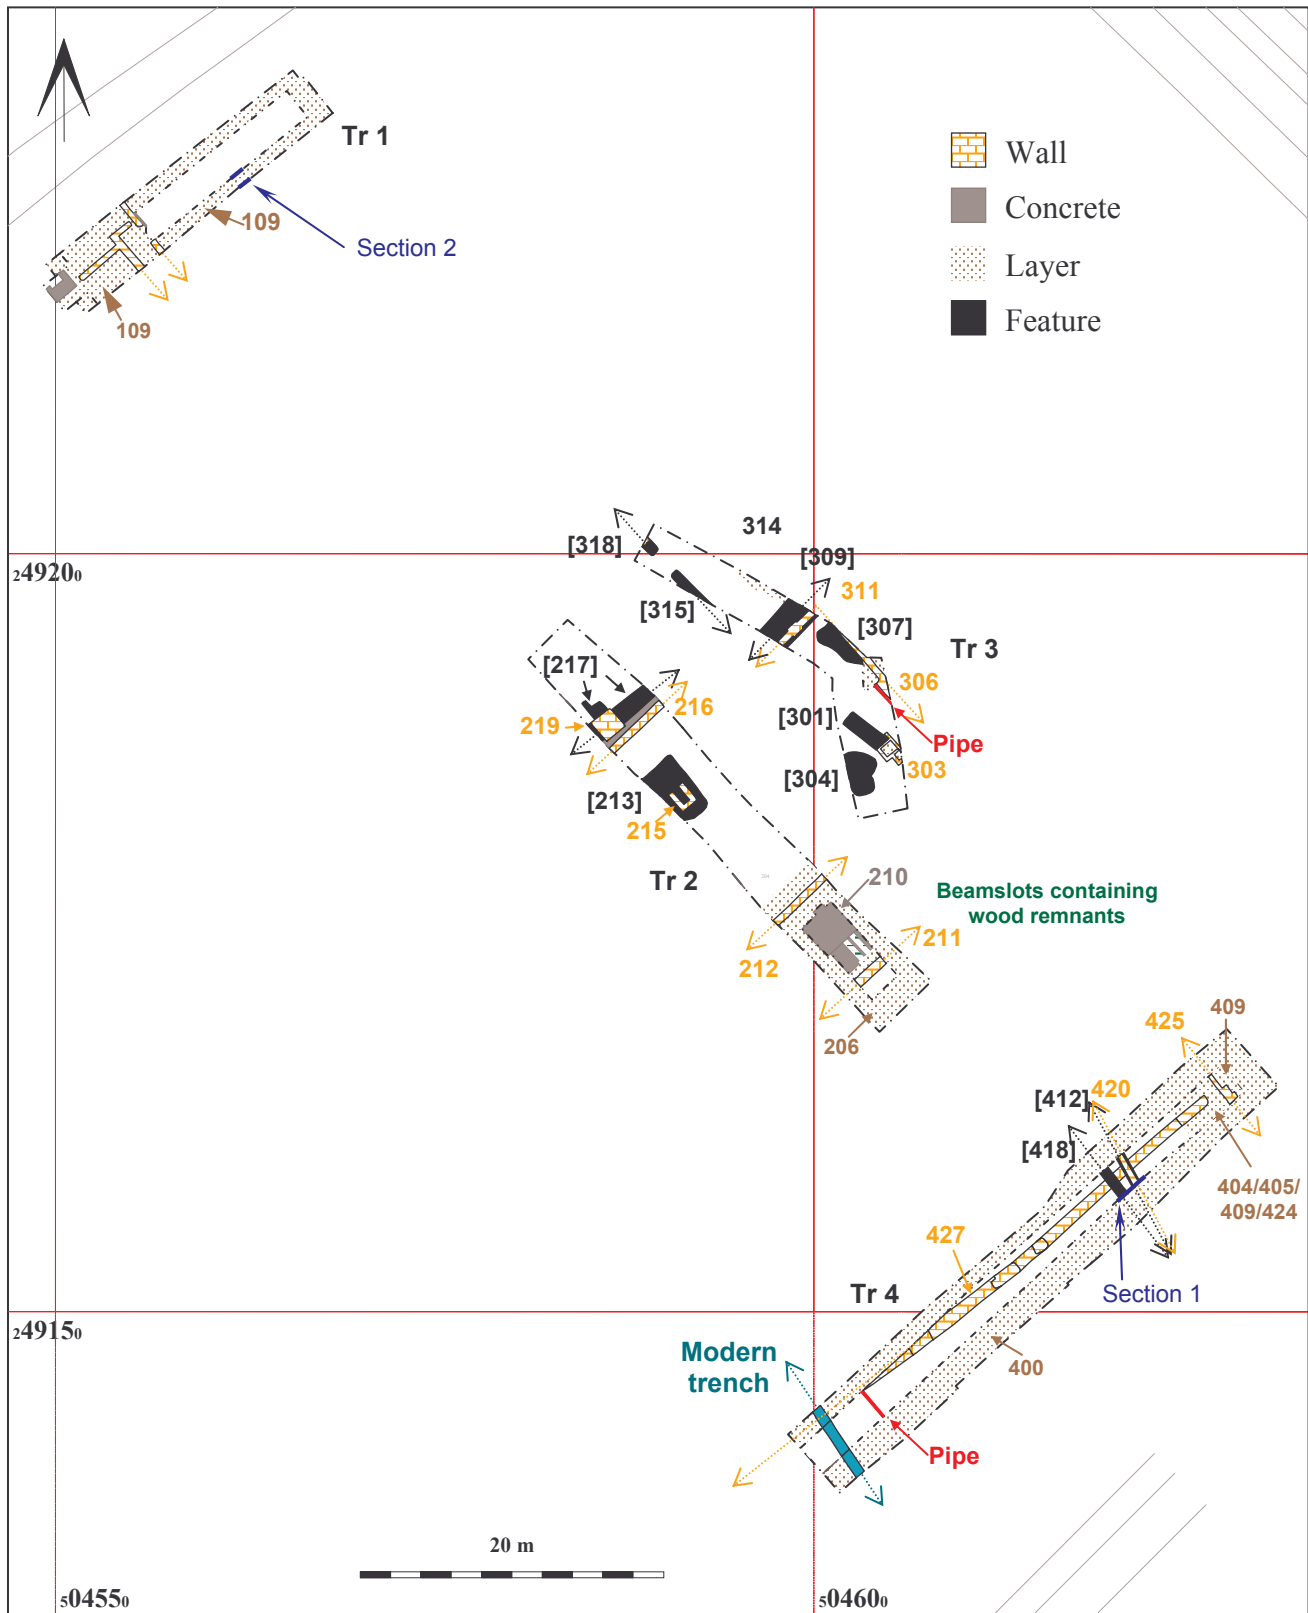
**Figure 2: All features plan**

Trench 1 (Figure 2) was located on the northern edge of the development area, parallel to the River Great Ouse, oriented south-west to north-east. It was 22m long by 8m wide overall. The eastern end of the trench was excavated up to 1.6m deep, with the sides stepped in so that the central part of the trench was 2.20m wide. The water table was encountered at 1.40m below ground level. The western third of the trench was not excavated to its full depth, but was taken down to the top of a series of demolished brick walls.

Trench 2 (Figure 2) was located in the western part of the development area and was oriented NW-SE.

Trench 3 (Figure 2) was located in the eastern part of the development area. It was oriented broadly NW-SE. Deposits observed in this trench were very similar to those observed in Trench 2, situated only 10m to the west.

Trench 4 (Figure 2 and Figure 3, Section 1) was located in the southern part of the development area. It was aligned NE-SW.

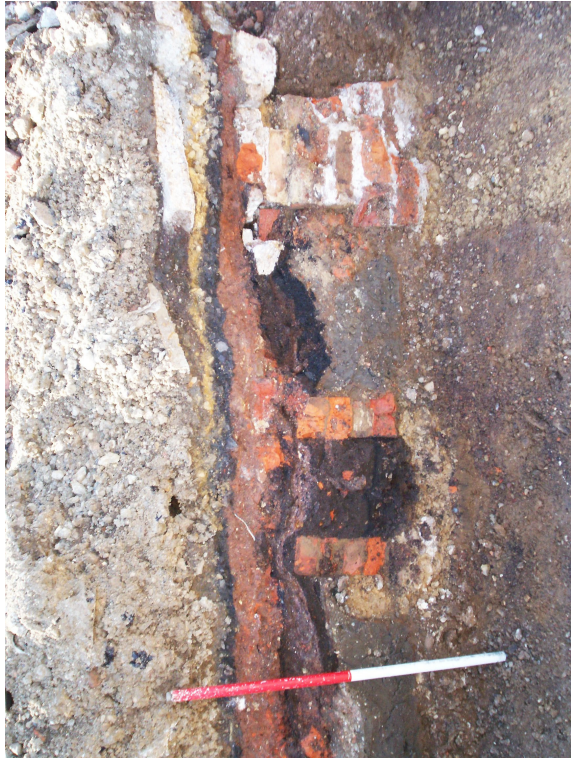
Photograph of section 1. Scale 1m

Undisturbed geological deposits (411) were encountered at *c.*2m below the present ground surface. These deposits were sealed by subsoil (410) which in turn was overlain by a possible relict topsoil layer (409). This material would have been the land surface prior to the construction of the ironworks, after which it became sealed beneath 19<sup>th</sup>/20<sup>th</sup> century construction layers.

The relict topsoil was truncated in several places by the foundations of a series of walls. These included foundation trench [428] of wall (427), which was traced along most of the length of the trench. Foundation trench [418], wall (425) and drain [412] also truncated this layer.

A series of make-up layers, floors and external surfaces were found in association with the walls. These consisted of various materials (gravel, cinders, brick rubble and concrete) and cumulatively formed a deposit up to 0.4m thick.

Sealing these structural remains and layers was a 1.2m thick layer of loose soil mixed with modern construction debris. This layer was limited to the southern part of the downstream site.

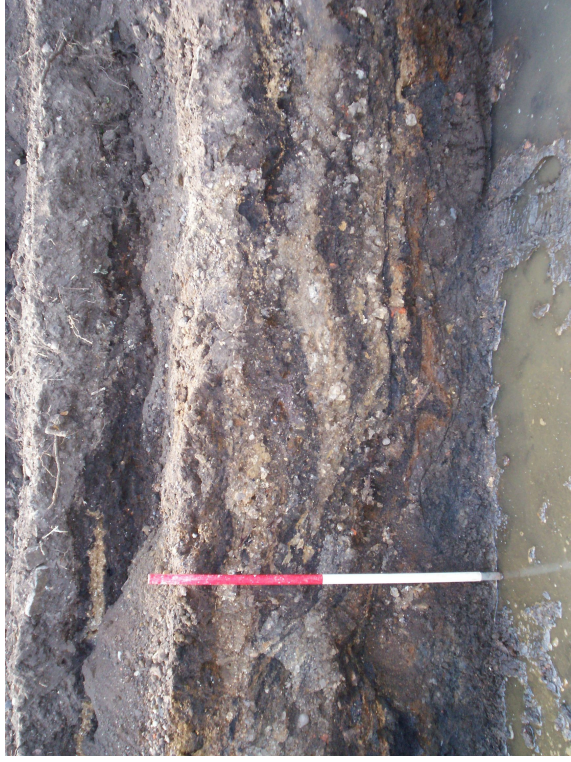
Photograph of section 2. Scale 1m

A mixture of organic silts and alluvial clays (100) were encountered at a depth of 1.2m below the ground surface (Figure 3, Section 2). These layers appear to be natural deposits, associated with the river.

Above this, make up layers of sandy-clay with brick fragments (101) and light yellow brown, sandy gravel (102) were sealed by a layer, up to 0.05m thick, of hard, naturally cemented, cinders (fuel waste) and small fragments of coal. These three layers appear to represent an initial attempt to stabilise or consolidate the former river bank area, using clay and gravel excavated from elsewhere and industrial waste from the ironworks, used to form a hard surface layer.

Above the hard layer, a series of alternating layers (104 to 108) of yellow brown sandy gravel and grey sandy silt with inclusions of brick, coal, clinker and small stones, formed a deposit up to 0.6m deep. These appear to be a series of dump deposits, used to build-up the ground adjacent to the river, raising it to the same level as the rest of the development area. Another layer of dumped material (109), dark grey silt with occasional stones and frequent fragments of calcium silicate “glassy” slag, represents a continuation of this process of dumping industrial waste.

The uppermost layer observed in Trench 1 (110) was loose, grey sandy silt that contained occasional fragments of concrete. This layer may represent soil that was deposited or disturbed during the demolition of the factory buildings.
