**WOODLAND PANELS DRAINAGE DITCHES
WREST PARK
BEDFORDSHIRE**

**ARCHAEOLOGICAL INVESTIGATION
AND MONITORING**

Document: 2009/107
Project: WP1221

Produced for:
English Heritage

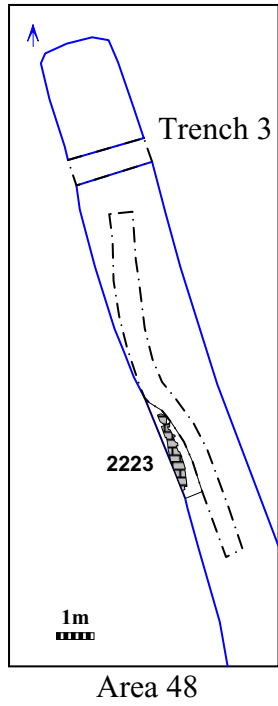
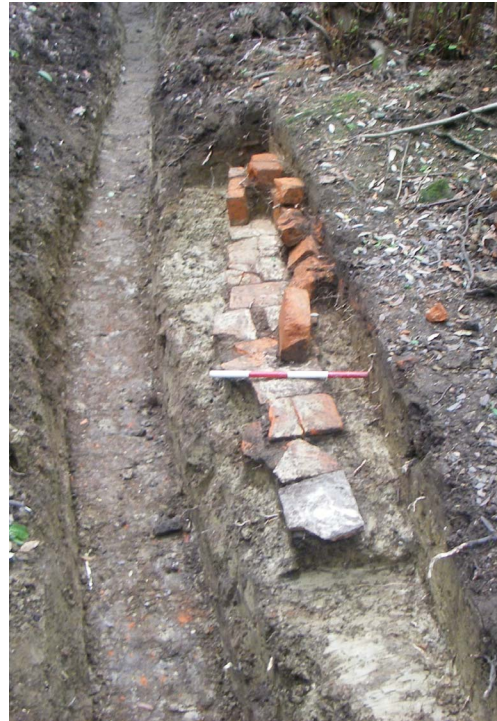
48. ditch clearance	<i>Culvert</i> Disturbed remains of a brick culvert orientated N-S visible for 2m in length and measuring c. 0.3m wide and 0.3m deep. Consisted of a ceramic tile base overlain with a stretcher course of bricks 'on edge', overlain by a capping of a header course of bricks on bed.	Near A3	0.1	52.1	Found in location of N-S path marked on <i>De Grey</i> map.
49 crossover	<i>Path</i> Layer (0.25m thick and 6.5m across) of reddish brown sand with occasional small stones located beneath the topsoil.	H7	0.1	50.75	Associated with NE-SW path marked on historic maps from Lawrence onwards. However, the location of the ditches the culvert would connect to, suggests the culvert is most likely to date to no earlier than the <i>Rocque</i> layout.
	<i>Culvert</i> Brick culvert orientated NW-SE visible for 9m and measuring 0.4m wide and surviving for 0.15m deep. Sides formed by two stretcher courses of bricks laid on bed. Probably same form as that in Trench 26. A later ceramic pipe has been placed within it.	H7	0.5	50.35

Culvert (2223) in Area 48.
Looking south. Scale 40cm

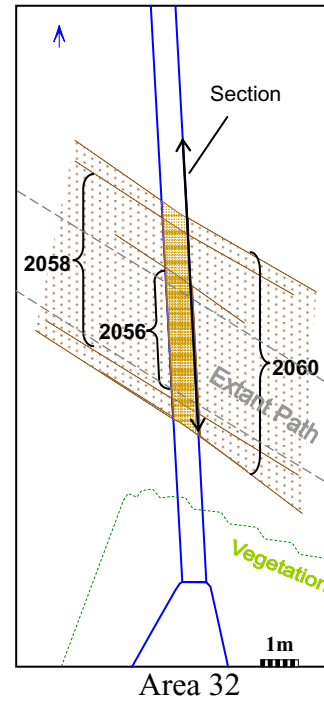
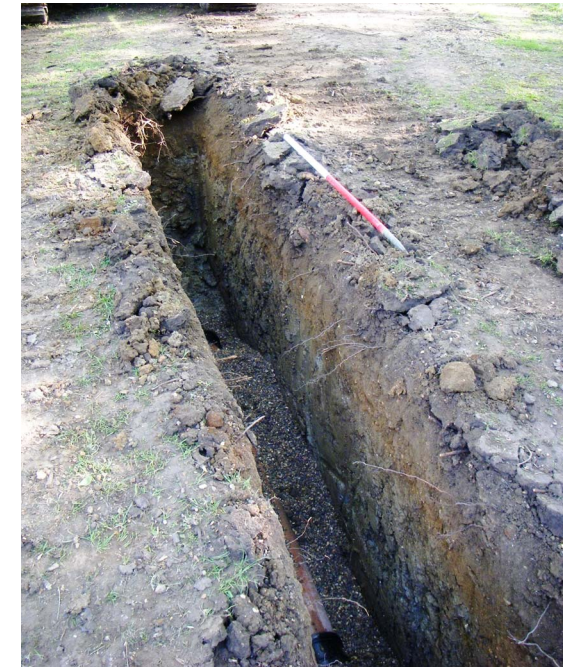
32. Pipe replacement	<i>Paths</i> Two earlier path layers visible beneath and on the same orientation as the current path surface. They consist of sandy gravel layers, the earliest (2060) being 0.16m thick and the later (2058) being 0.06m thick.	A3	0.26 (2058) 0.40 (2060)	52.22 (2058) 52.07 (2060)	Path is marked in this location from <i>Lawrence</i> onwards.

Path layers in Area 32. Looking south-west.
Scale 1m

Headwalls probably dating to the 19th century survive in the locations of several of the crossovers along this route. Sand path layers found in Area 32 are associated with the north-west-south-east path crossing Ditch A and marked on maps from 1719 Lawrence onwards. Secondary ditches in the northern half of Ditch 'A' define the Large Round, a garden feature marked on all the historic maps from Lawrence (1719) onwards.

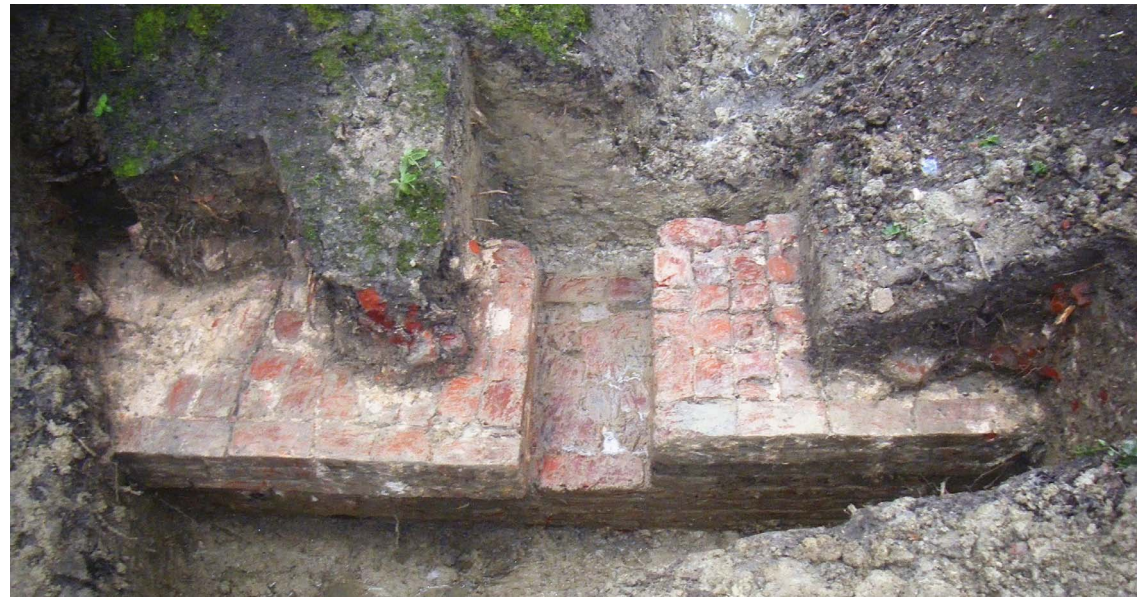
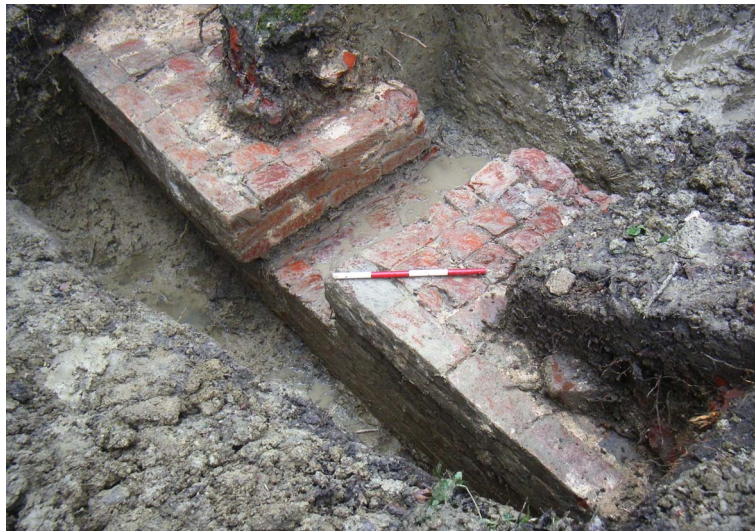
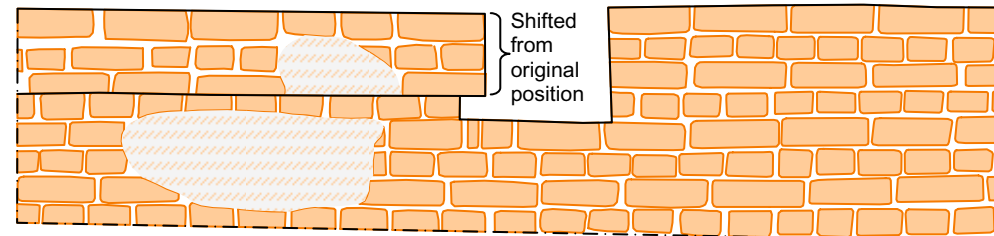
Trench 8

The function of the wall is not clear, though its somewhat decorative nature suggests it is unlikely to be a load-bearing wall for a building or substantial garden structure. A rectangular indentation in the top of the wall shows signs of wear on the corners of the northern face and base suggesting the indentation may have channelled water. This, together with the width of the wall and its location, suggests a possibility that it was associated with a walkway across a small water

Trench 8: wall 2032

Trench 8: wall 2032. Scale 40cm

SSE facing elevation of wall 2032

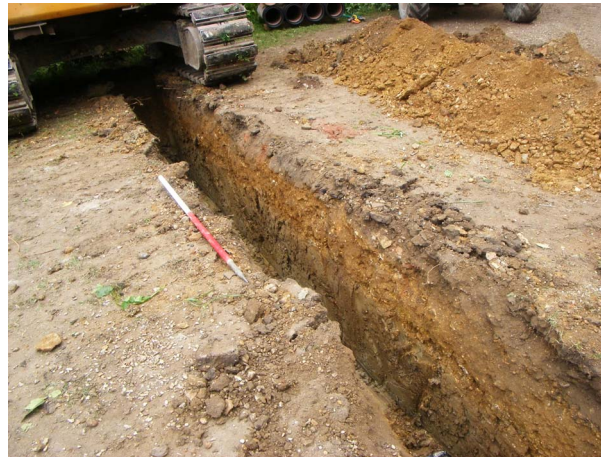
Area 59

Path layers in Area 59. Scale 1m

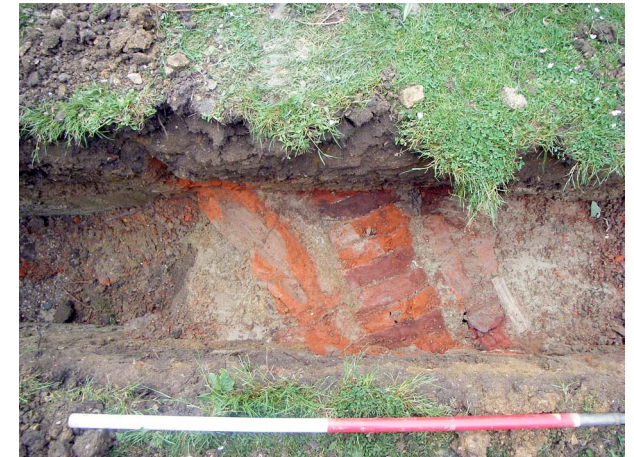
these were precursors to the current drain pipes, as in Areas 49 and 53 (Figs. 16-18). A sequence of three brick culverts and a ceramic pipe was revealed in Area 59 (Figs. 8 and 9), and likely to represent replacement and renewal of crossovers associated with the north-south path depicted on maps dating from the 1719 Lawrence map onwards.

Culverts in Area 59. Scale 1m

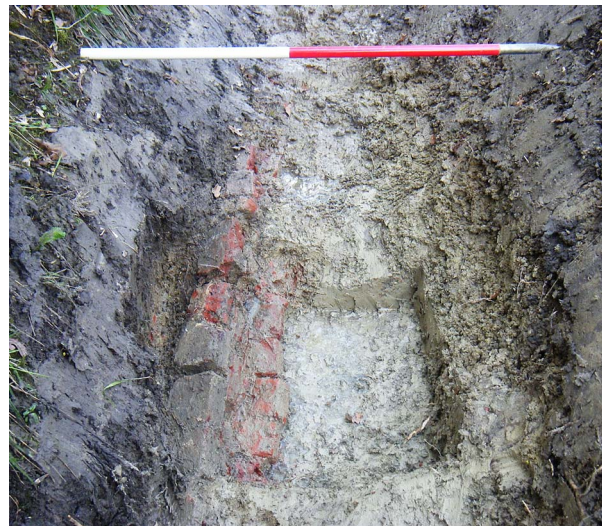
Areas 27 and 28

Culvert 2183 in Area 28. Scale 1m

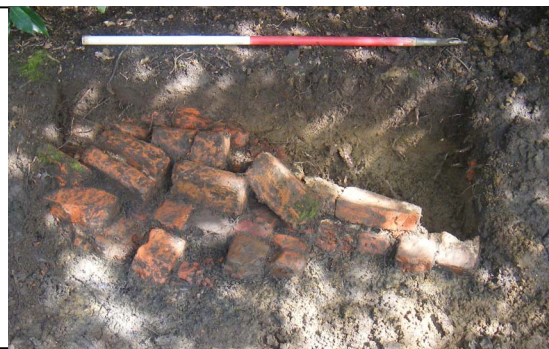
Culvert 2066 in Area 33. Scale 1m

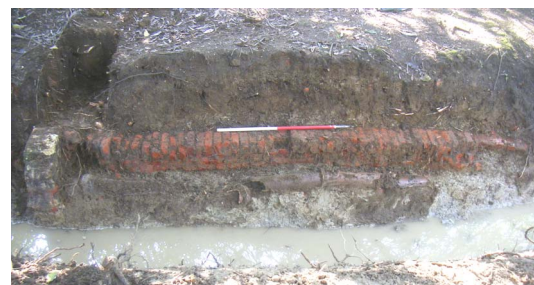
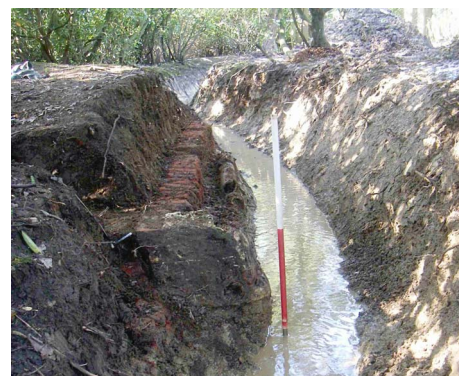
29. Ditch clearance	<i>Culvert</i> Brick culvert similar to that in Area 26 visible for around 5m in length and aligned NNW-SSE. This was replaced by a ceramic pipe likely to be associated with a partially surviving brick headwall that appears to truncate the brick culvert. The brick headwall and ceramic pipe have been damaged by the drainage ditch.	Between E2 and E3.	0.4	51.77 culvert and headwall	Brick culvert prob. ties in with path on 1719 map. Ceramic pipe and surviving headwall prob. ties in with path on 1882 OS map.

Culvert and headwall in Area 29. Scale 1m

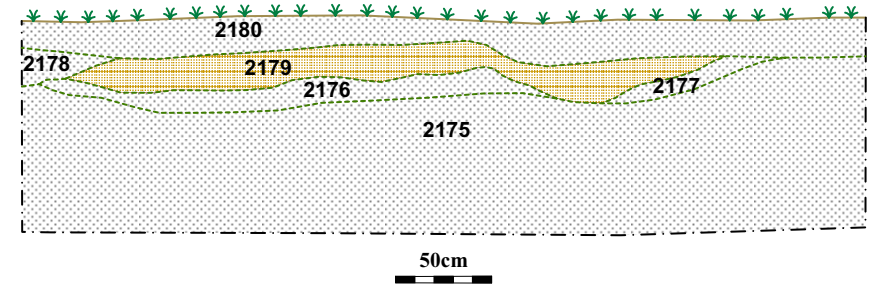
Area 43

West facing section of Area 43, showing path 2179

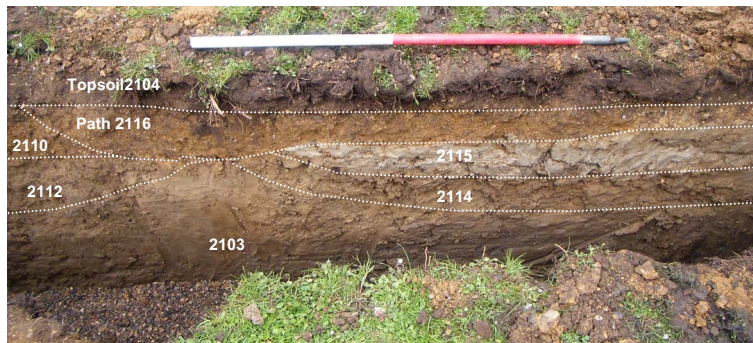
Area 38, showing path layers 2110 and 2116 and associated make-up layers.

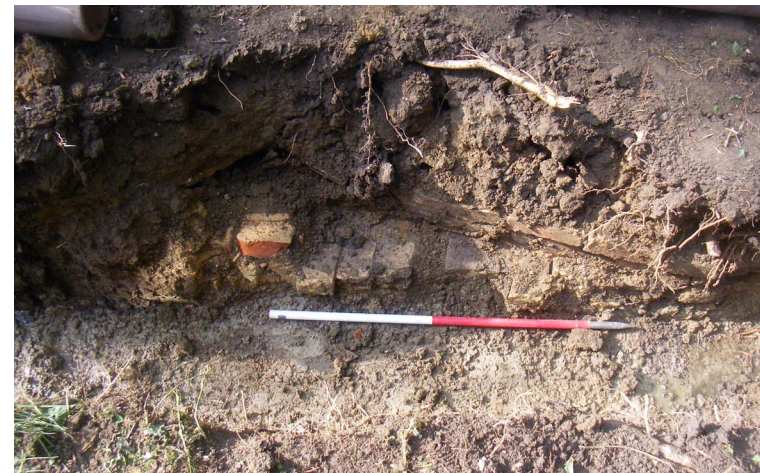
Area 55

Evidence for a sand path layer and remains of a brick culvert were however found in Area 55.

55. New course of drainage pipe.	<i>Path</i> Layer (0.2m thick and 3.5m across) of yellow-clay and gravel located beneath the topsoil. <i>Culvert</i> Badly damaged brick culvert – 3 courses visible – what appears to be the base is formed by a header course on bed which are overlain by two stretcher courses on bed forming the sides	G3	0.3	49.6	Location of current path is more or less the same as that shown on all historic maps from <i>Lawrence</i> onwards.

Area 55, culvert 2277. Scale 1m

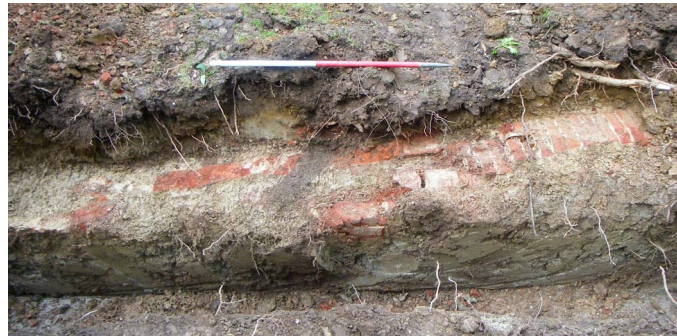
Area 45

Culvert 2196 in Area 45. Scale 1m

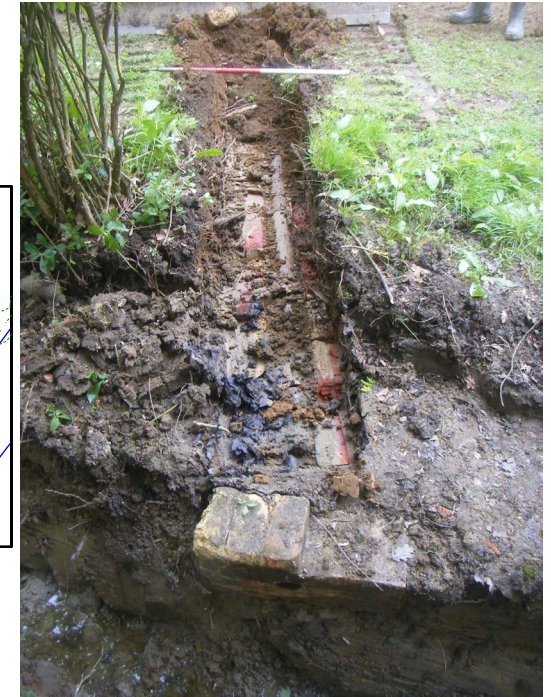
Area 49

Culvert and headwall in Area 49. Scale 1m

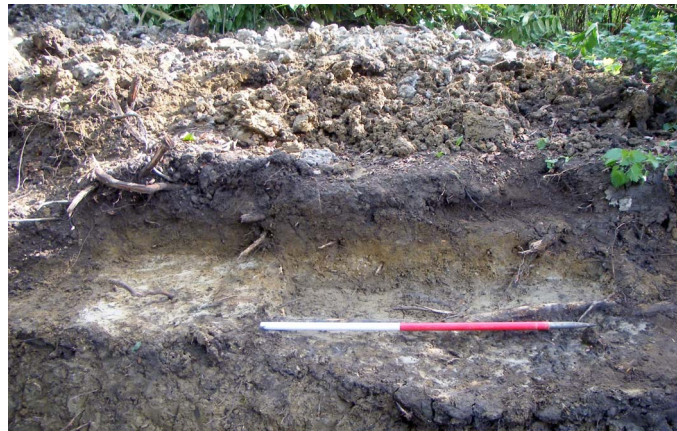
Area 30

A sand path which appears to be shown on the 19th-century De Grey plans was revealed in the side of the ditch (Area 30) to the south east of the East Sand Round. Trench 22 excavated across Hh1 to investigate possible 18th and 19th-century paths running adjacent to the ditch failed to reveal any significant remains.

Path layer 2047 in Area 30. Scale 1m

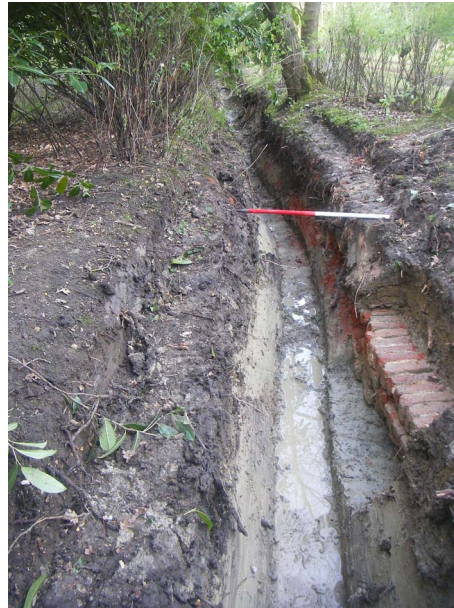
Area 26

Culvert 2006 in Area 26. Scale 1m

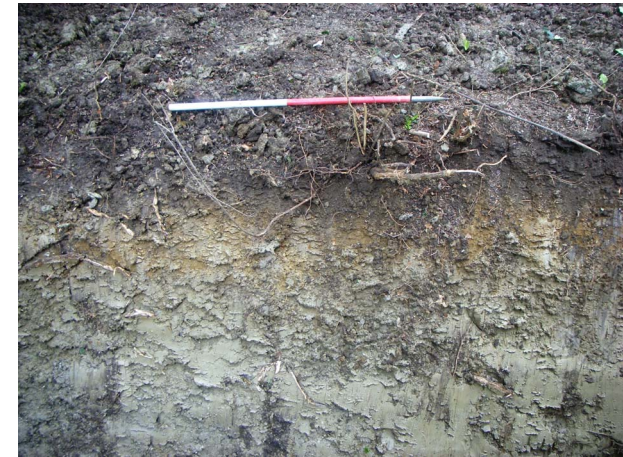
Many of the observed path layers relate to paths that are no longer in use, or routes that are no longer surfaced. For instance, a path layer observed in Area 50 ties in with an east-west aligned path marked on the Lawrence map dated to 1719 (Fig. 18 and 24). The remains of three paths were observed in the trenches excavated in the grassed area near Broadwater (Area 51; Fig. 7). The most northerly observed path layer (2283) appears to represent a north-east-south-west orientated path marked on the historic maps from Lawrence onwards, though its depicted size and orientation varies slightly. Path (2268), also observed in Trench 36, correlates well with a north-south aligned path marked on the Rocque maps of 1735 and 1737 (Fig. 25). The La Rocque maps also depict a path adjacent to Broadwater, which may correlate with the most southerly observed path layer (2243). Interestingly, there are also several linear ditches visible as earthworks between Broadwater and the Archer Pavilion which are probably defining paths belonging to an earlier garden layout (Figs. 24-27). It is possible one of these may be the same as path layer (2243). Some of the earthworks can be related to the historic maps, most notably a path heading southwards from the pavilion which only appears on the Rocque maps of 1735 and 1737. The approximate locations of these earthworks have been plotted from shadow-marks visible on aerial photographs and are shown on Fig. 25.

Path layer in Area 50. Scale 1m

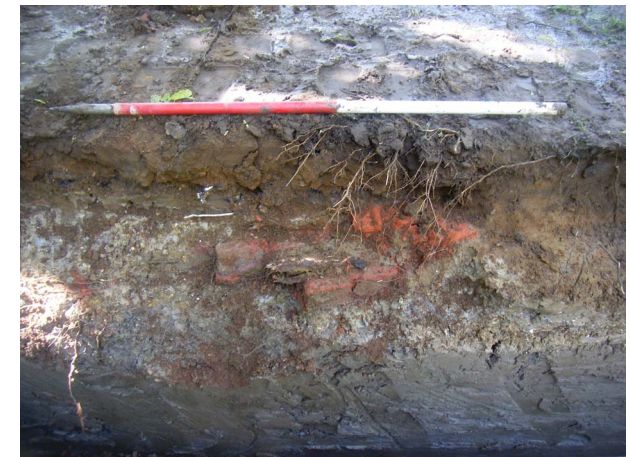
Area 53

53. crossover	<p><i>Path</i> Layer (0.08m thick) of clinker, grey clay and stones located beneath the topsoil and current path.</p> <p><i>Culvert</i> Badly damage brick drain aligned NW-SE and measuring 0.16m wide and 0.16m deep. Constructed with 4 'L-shaped' red bricks so that the central hollow forms a pipe.</p>	H8 H8	0.15 0.2	50.65 50.6	Path predating current path. Most likely to be 19 th century onwards.
54	Fragments of ceramic pipes and brick rubble were	H4			-

Culvert 2259 in Area 53. Scale 1m

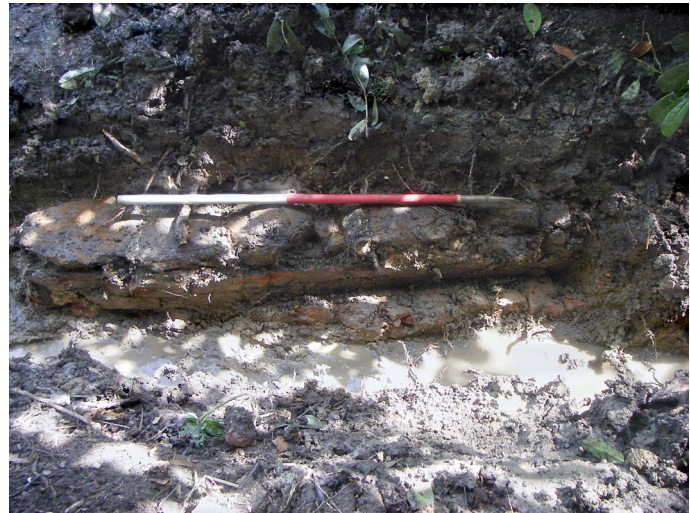
Area 31

Culvert 2052 in Area 31. Scale 1m

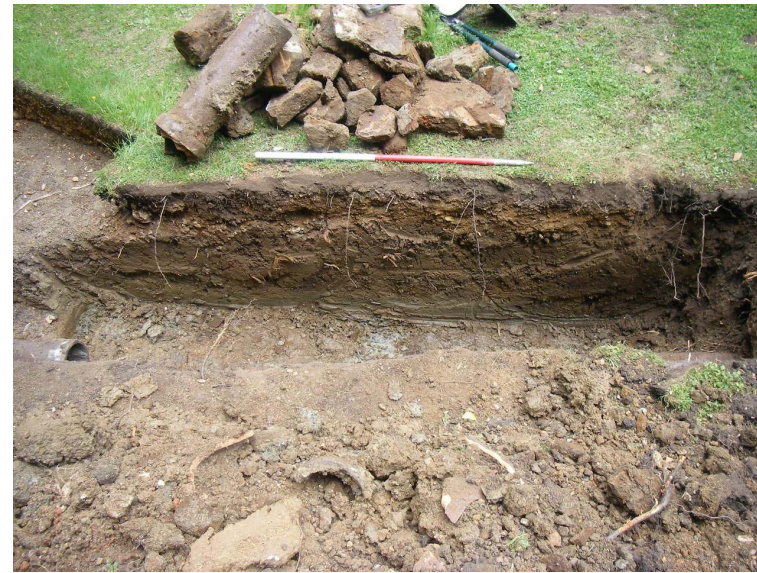
Trench 37 after extension showing path layer 2095. Looking south west. Scale 1m

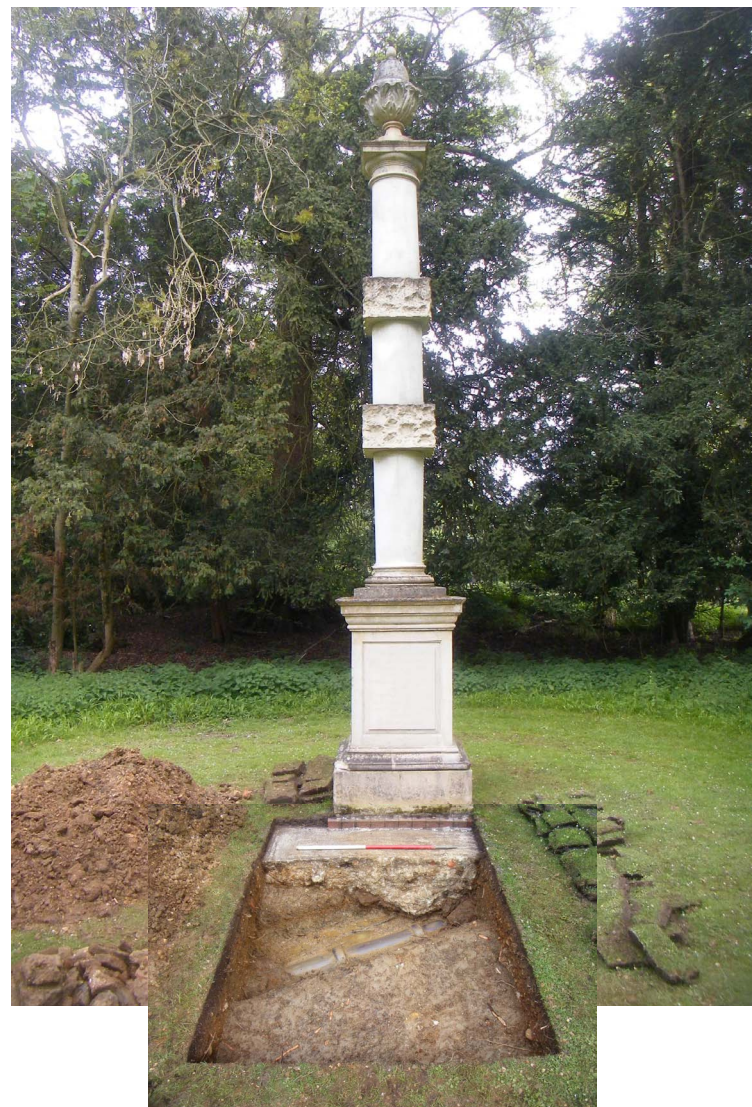
Composite photograph of Trench 37 and Capability Brown monument. Looking north. Scale 1m

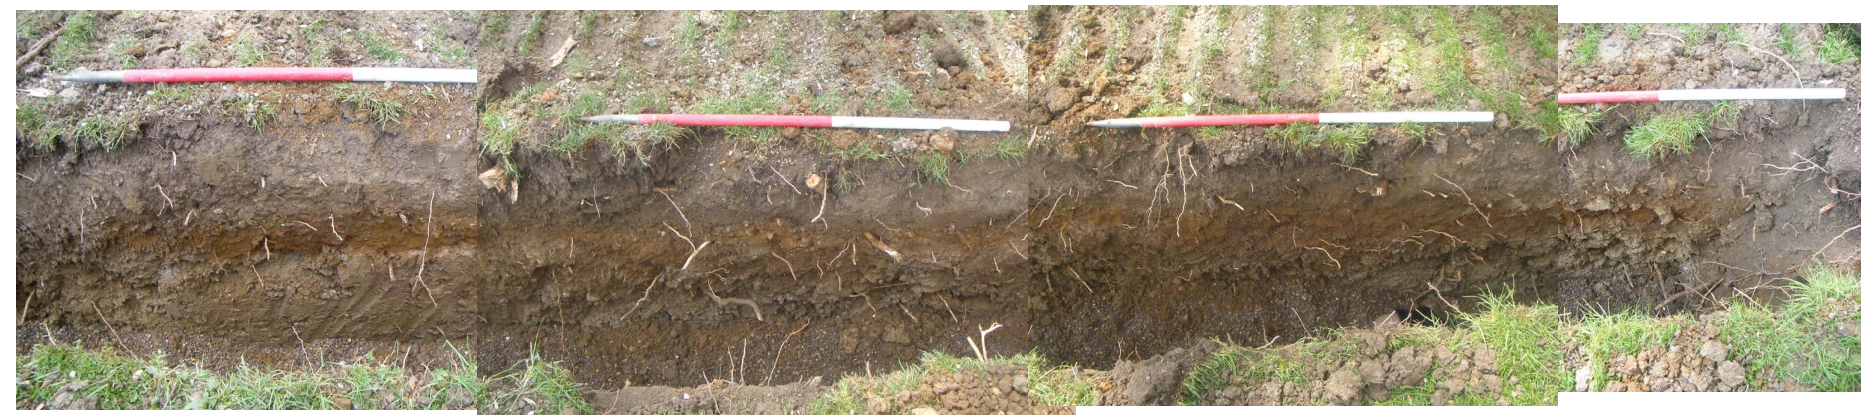
Trench/ Area	Archaeological Features	Location	Depth (BGL) (m)	m AOD	Possible Map Correlations
39. existing pipe replaced	<i>Paths</i> Layers (of up to 0.2m thick) aligned NE-SW consisting of red brown silty sand and gravel located beneath the topsoil.	J2	0.2	50.00	Path layers correlate with NE-SW path on all historic maps from <i>Lawrence</i> onwards. The culvert may be associated with a N-S path on the <i>Rocque</i> maps.

Composite photograph of Area 39. Scales 1m

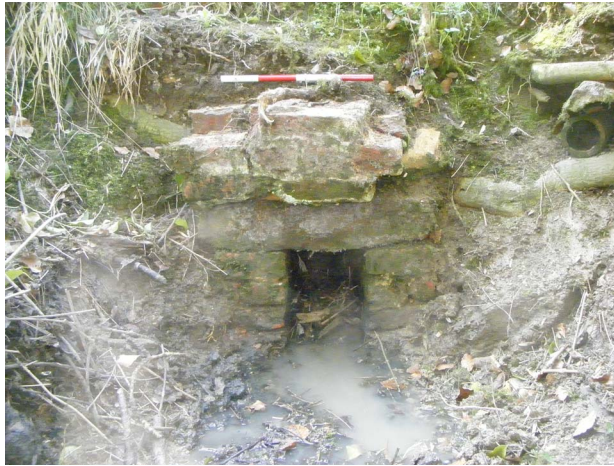
Ditch G1-E

The earlier headwalls varied greatly in their size and form, but were mostly brick built around a ceramic pipe, often with a capping of sandstone blocks. A typical example is shown on Fig. 23: E2-S. These are likely to be associated with improvements to the drainage system from the 19th century onwards, many probably replacing earlier headwalls, an example being the culvert revealed in Area 29 referred to above. However, a few possibly earlier examples not built around ceramic pipes were observed in ditches F and G (Fig. 23: F8-E, G1-E and W and G2-W).

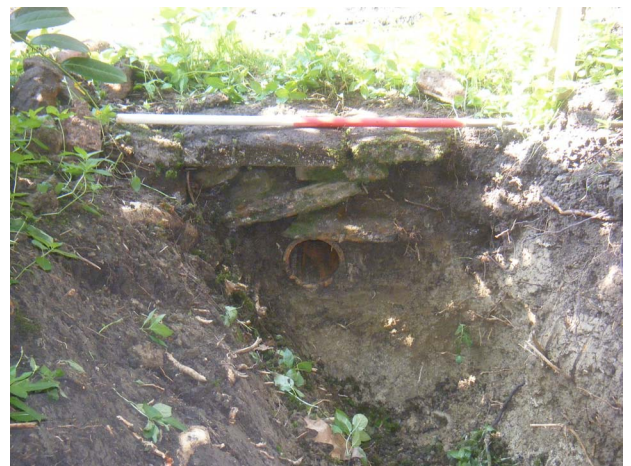
Ditch B4-SE

Figure 23: Selected headwalls
(Labels refer to locations on Figures 5, 11, 12 and 14)

The locations of surviving headwalls constructed prior to the 20th century are shown on Figs. 2 to 22 with examples shown on Fig. 23.
