**REMEDICATION AND DREDGING WORKS  
OLD PARK WEIR AND OLD PARK WATER  
WREST PARK  
BEDFORDSHIRE**

**ARCHAEOLOGICAL INVESTIGATION  
AND OBSERVATION**

Project: WP1221

Document: 2009/114  
Version 1.1

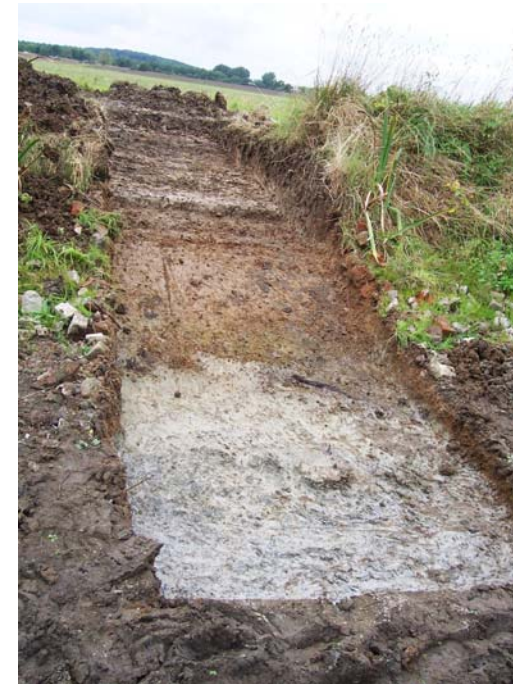
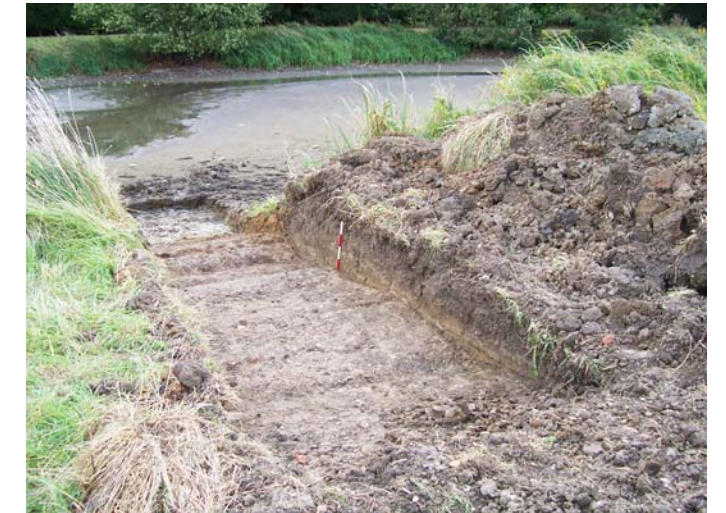
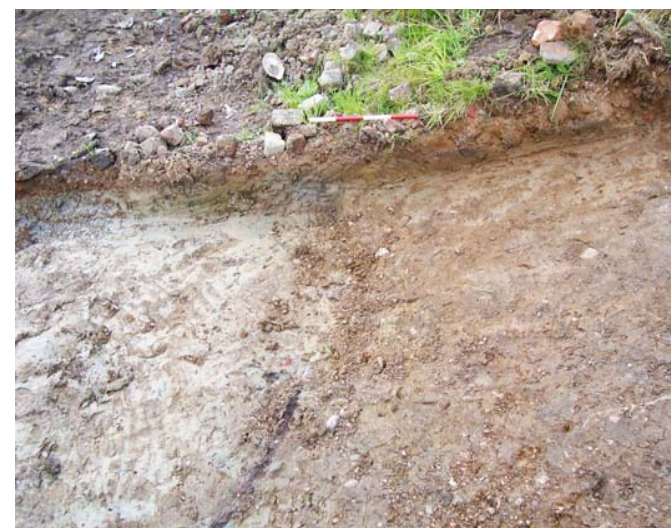
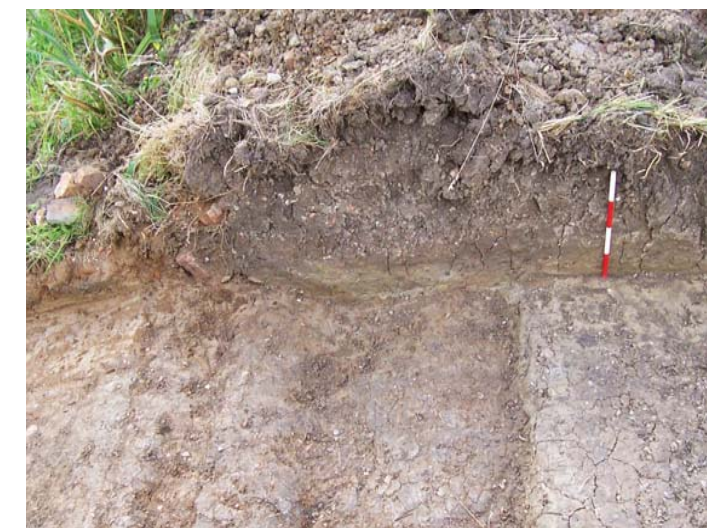
Figure 3: Trench 1

Trench 1, looking west

Trench 1, looking east. scale 40cm

Interface between layers 107 and 105. scale 40cm

Interface between layers 102 and 107. scale 40cm

Three trenches (1-3) had previously been excavated along the edges of Old Park Water in order to investigate the impact of previous dredging works (Trench 1) (Fig. 3) and in order to investigate elements of the Weir structure (Trenches 2-3). The overall objective of the current work was to assess the potential impact of dredging works on below-ground archaeological and structural remains associated with Old Park Water, to record any archaeological remains revealed by the subsequent dredging and to record the weir structure as revealed during remediation works. In order to achieve this, the following investigative works were undertaken:-

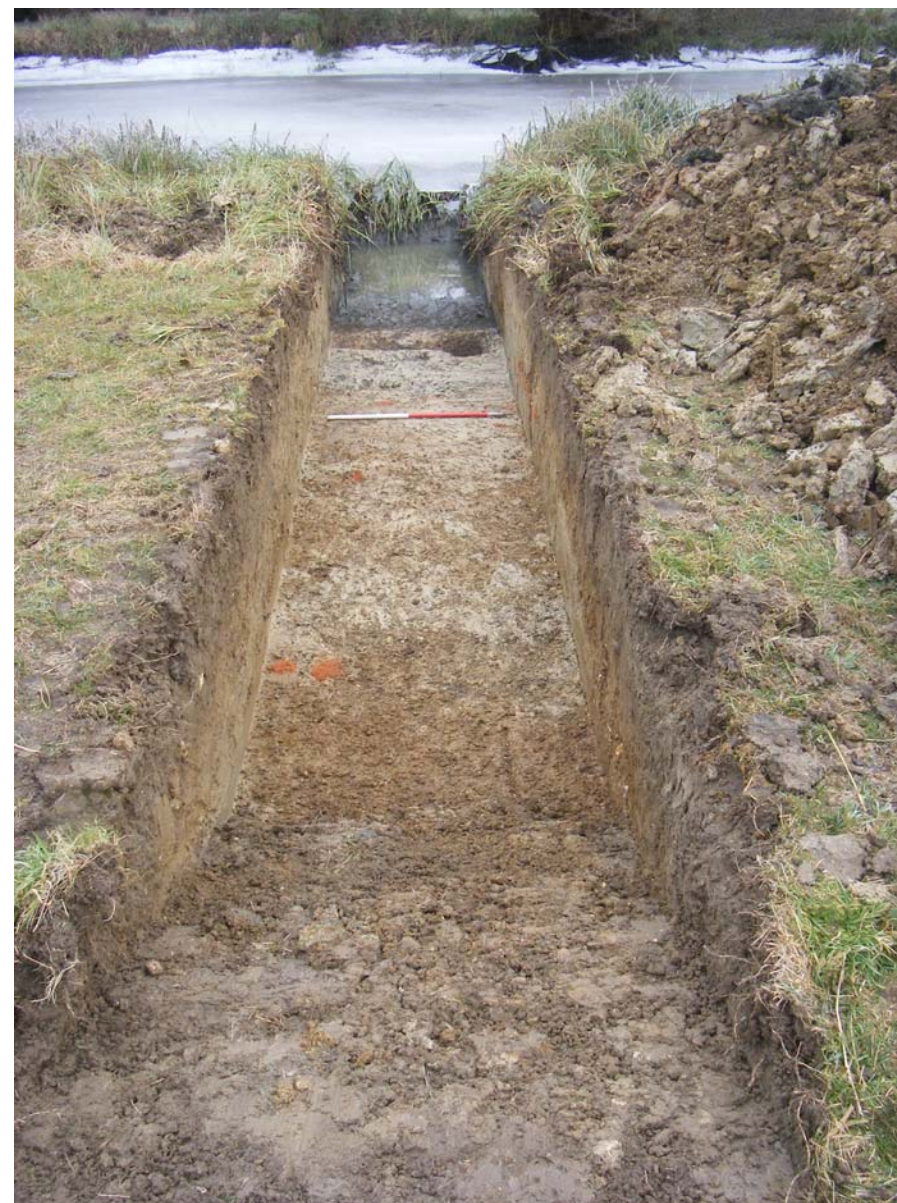
**Figure 4: Trench 6**

Trench 6 (Fig. 4) was excavated towards the southern end of Old Park Water. A 0.65m thick make up layer (60003) of re-deposited natural subsoil containing occasional brick fragments was observed, extending 10m from the western end of the trench. The bricks within it were from 5.5 to 6.8cm thick. Some of them may date to the 17th century, although others were considerably later. It is probable that this material was brought in and deposited here in order to fill in or consolidate the edge of the lake or, alternatively, to level a natural depression in the landscape. The eastern edge of deposit (60003) was truncated by a ditch-like, linear feature [60004]. The deposit (60005) within the ditch was clean, re-deposited natural clay. This suggests that the feature was backfilled shortly after it was dug. It may have been formed to create an impermeable barrier within the bank. On the eastern side of it there was an earlier alluvial deposit (60007) representing part of the former extent of the lake. This was overlain by a series of dumped deposits which formed the core of the current bank (60008, 60009, 60010 and 60013.) The dumped deposits were truncated by the linear feature [60004] and overlain by a later alluvial deposit (60011.)

Photograph of Trench 6, pre-excavation. Looking east. Scale 40cm

Photograph of ditch [60004], looking south. Scale 40cm

Photograph of bank material, looking south. Scale 1m

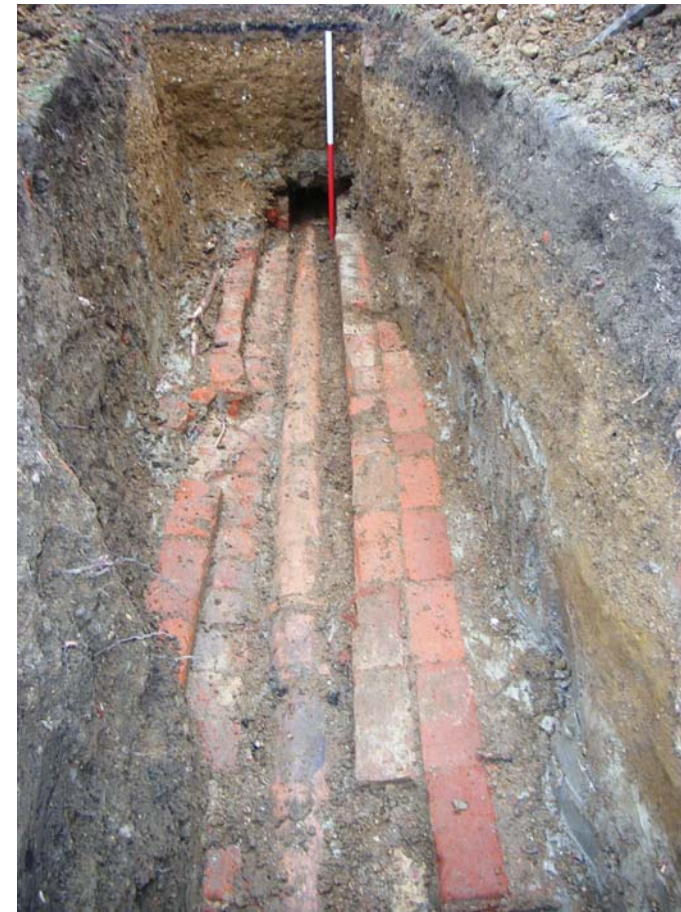
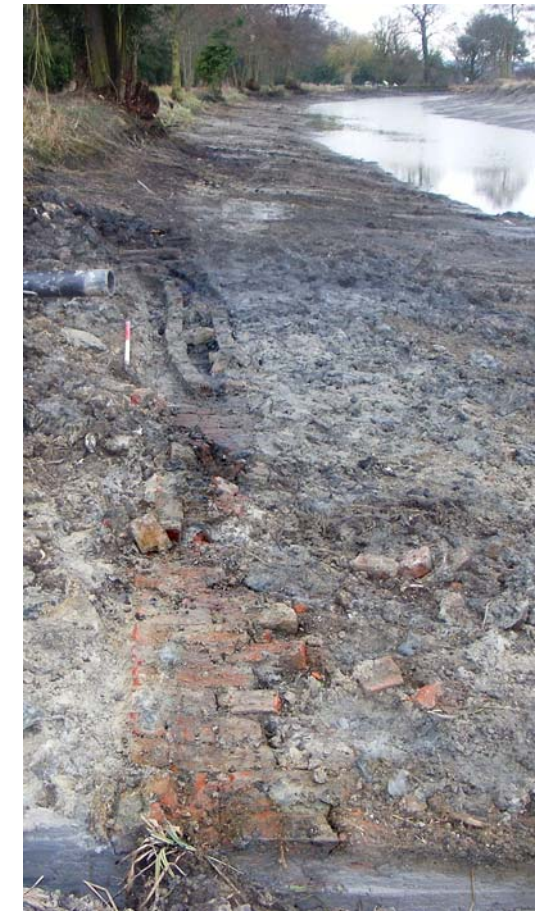
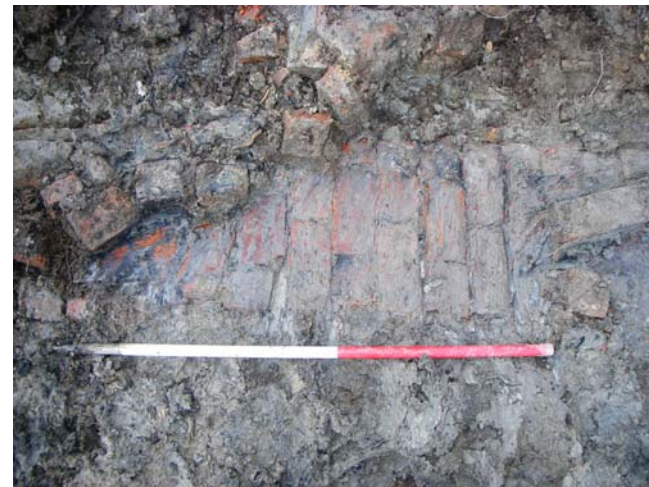
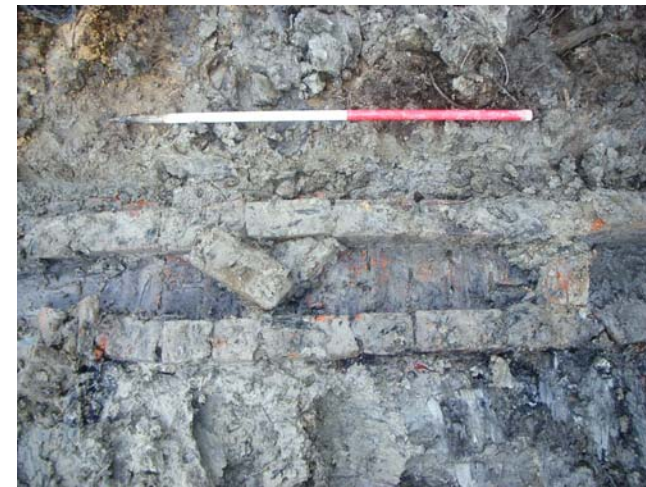
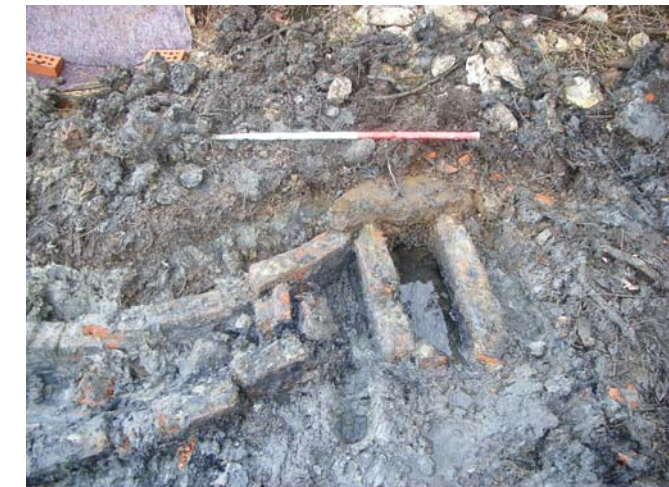
**Figure 5: Leg O'Mutton off-take channel**

Three brick culverts were revealed during the dredging of Old Park Water. Two of these (1081 and 1082) were located close to the Leg O' Mutton off-take channel (Fig. 5). Groundworks associated with the renewal of the off-take channel revealed remnants of an earlier brick culvert capped with ironstone slabs, although a modern pipe has been inserted, presumably as a result of restoration works in the 1970s or late 1980s (Dawson 2001).

Culvert (1082) entered the eastern bank of Old Park Water from the direction of the Leg O'Mutton Lake, suggesting that it represents a former alignment of the nearby off-take channel. This culvert cuts through another culvert (1081) aligned parallel with the bank, a 7.5m stretch of which was revealed during the dredging works. It turned towards the bank at its southern end, possibly suggesting it too is associated with a precursor to the Leg O'Mutton off-take or alternatively could be associated with the draining of features associated with an earlier garden layout. Both culverts had brick sides and bases, with culvert (1082) being capped with ironstone slabs.

Leg O'Mutton off-take channel, looking east. Scale 1m

Culvert (1081), looking south. Scale 1m

Middle part of culvert (1081), looking east. Scale 1m

Where culverts (1081) and (1082) meet. Scale 1m

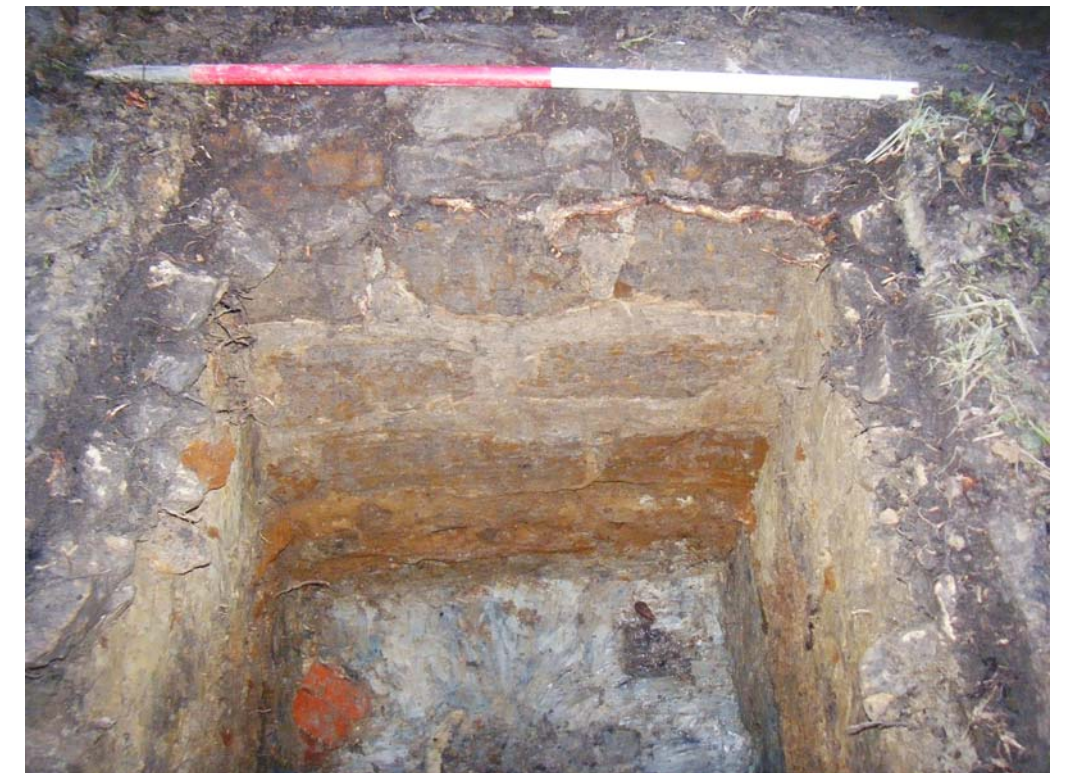
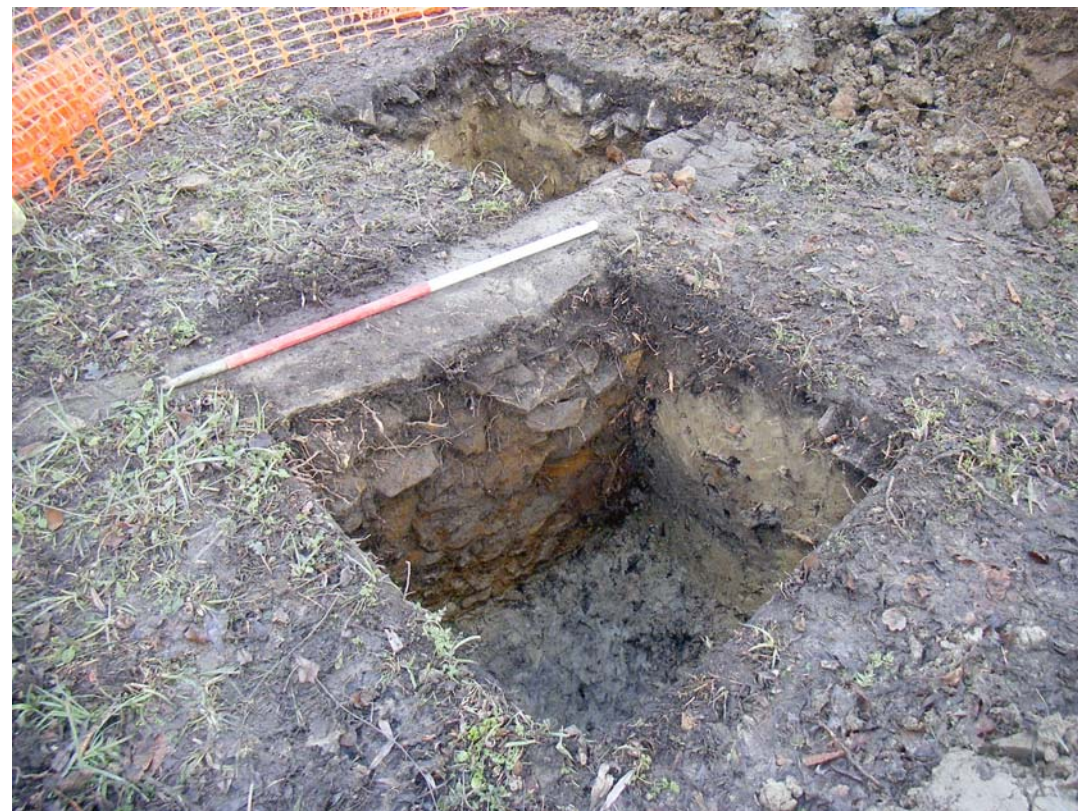
Figure 7: Trench 7

The 2007 archaeological investigation (Albion Archaeology 2007b) established that this section of wall was similar in character to the weir itself and was, therefore, probably contemporary. It was constructed using rough-hewn random coursed ironstone blocks and sat on foundations of coursed rough hewn ironstone blocks, smaller than that used in the wall and bonded together with a yellow sand and lime mortar. It was contained within a foundation trench that was cut into the puddled clay on the lake bed. It was noted that the puddled clay, an imported blue clay was only found at the southern, downstream end of the lake where the need to maintain a watertight seal was, perhaps, greatest.

In this latest investigation, where both sides of the wall were examined, it was discovered that the wall was set against a steep bank of material which included an upper component of re-deposited natural subsoil (70008). It is likely that this was brought in to build up the ground level on the upstream side of the weir. The upstream side of the training wall had a smooth face. Whereas, on the other side where it abutted the bank, the blocks of sandstone were more unevenly formed. The smooth face had later been re-pointed using cement mortar from 0.10m above its foundations. Since no cut was visible in the bank deposits excavated in order to examine this face of the wall, it can be assumed that the bank deposits had built up after the wall had been re-pointed.

Trench 7, Inner face of training wall. Looking west. Scale 1m

Trench 7, Outer face of training wall. Looking south-east. Scale 1m

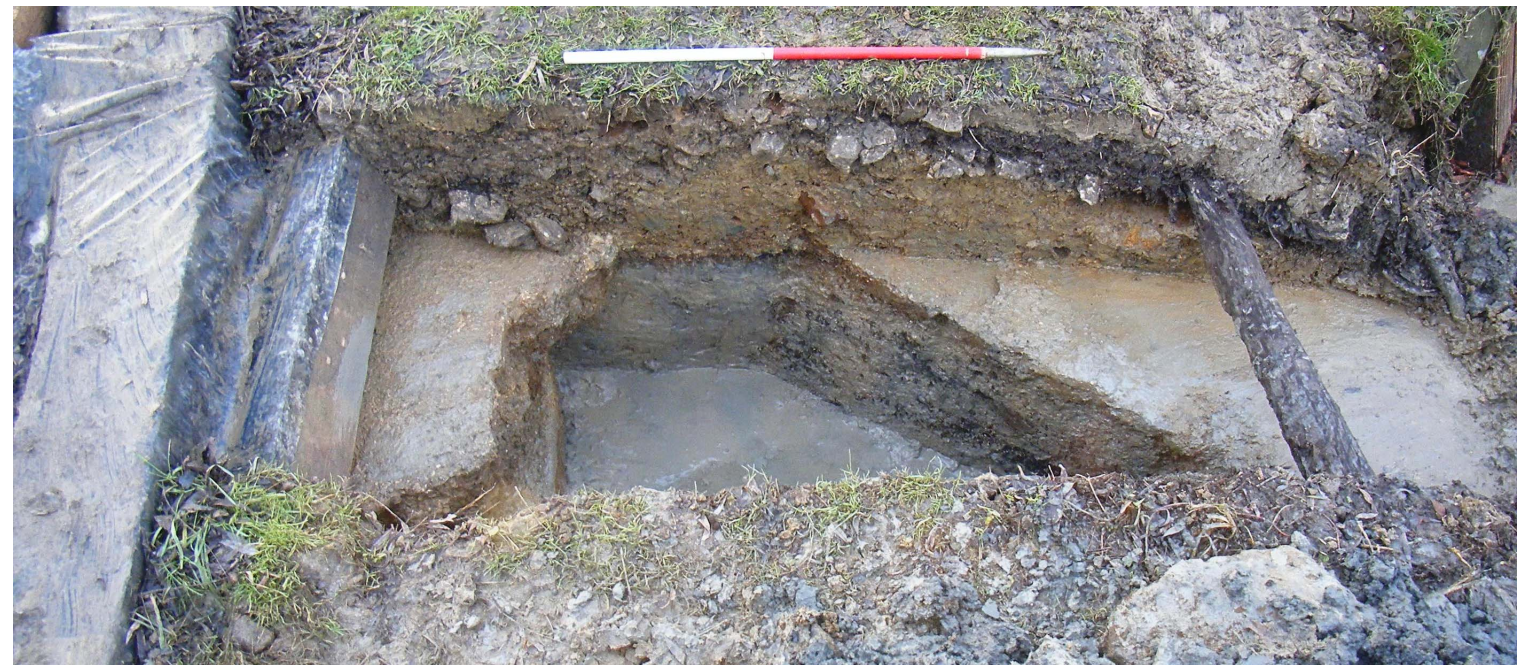
Figure 8: Trench 8

A concrete slab (80014) and foundations (80013) associated with the modern wall that was added to the northern face of the weir were revealed in Trench 8 (Fig. 8). Because of its position and orientation, the concrete slab was identified as being associated with the drain for Old Park Water. This replaced an earlier wooden sluice gate in the latter half of the 20th century (Albion Archaeology 2007a). The concrete was embedded in an alluvial deposit (80002) which extended to the maximum depth of the excavation (1.2m.) This alluvial deposit was not found within Trench 7 and was probably a localised accumulation of clay on the upstream side of weir. The excavation of this trench confirmed that 20th-century alterations to the weir had included the insertion of a separate piece of wall on the upstream side of the weir structure; no doubt with the intention of strengthening the weir and preventing water leakage.

Trench 8, looking west. Scale 1m

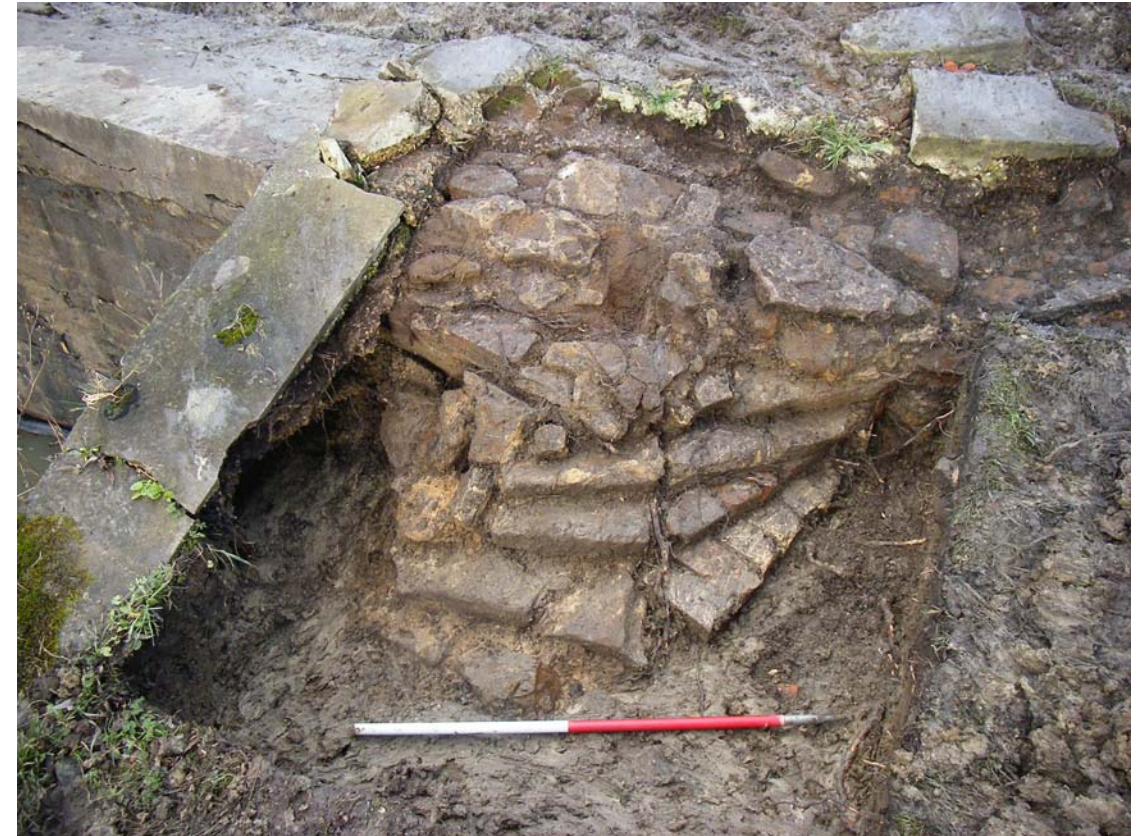
**Figure 9:** Trench 9

The main structure of the weir was investigated thoroughly during the previous evaluation (Albion 2007b). The previous work had suggested that along the south eastern edge of Old Park Water, the former training wall ran behind a more recently inserted cement mortared training wall sitting on concrete foundations. Trench 9, in this investigation, was situated in the

corner where the weir's eastern wing wall abutted the 20th-century concrete, eastern training wall (Fig. 9). It was designed to ascertain whether or not the earlier, eastern training wall survived in this area and, if so, how it was linked to the main weir structure. The investigation revealed the former training wall (90005) which was almost certainly contemporary with the main weir structure. It also revealed a buried 'buttress' (90004), rather crudely constructed using ironstone blocks and bricks, and likely to have been built to reinforce the weir and the training wall.

Trench 9. 'Buttress', looking north west. Scale 1m

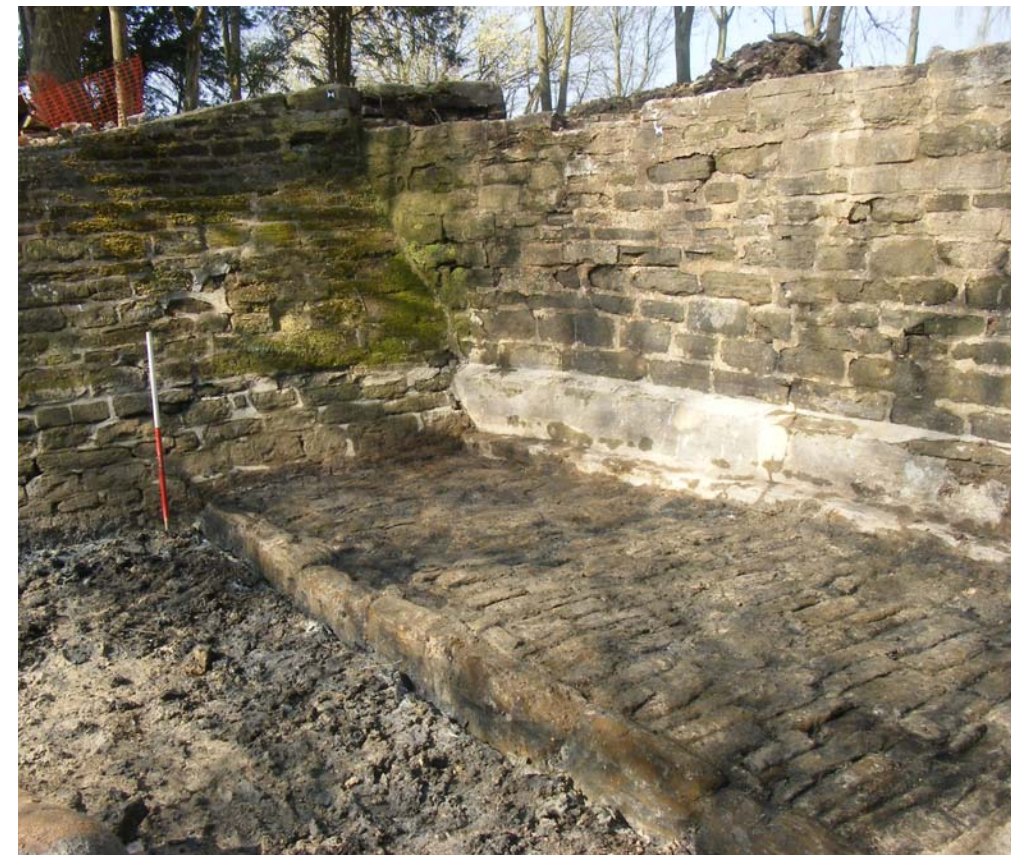
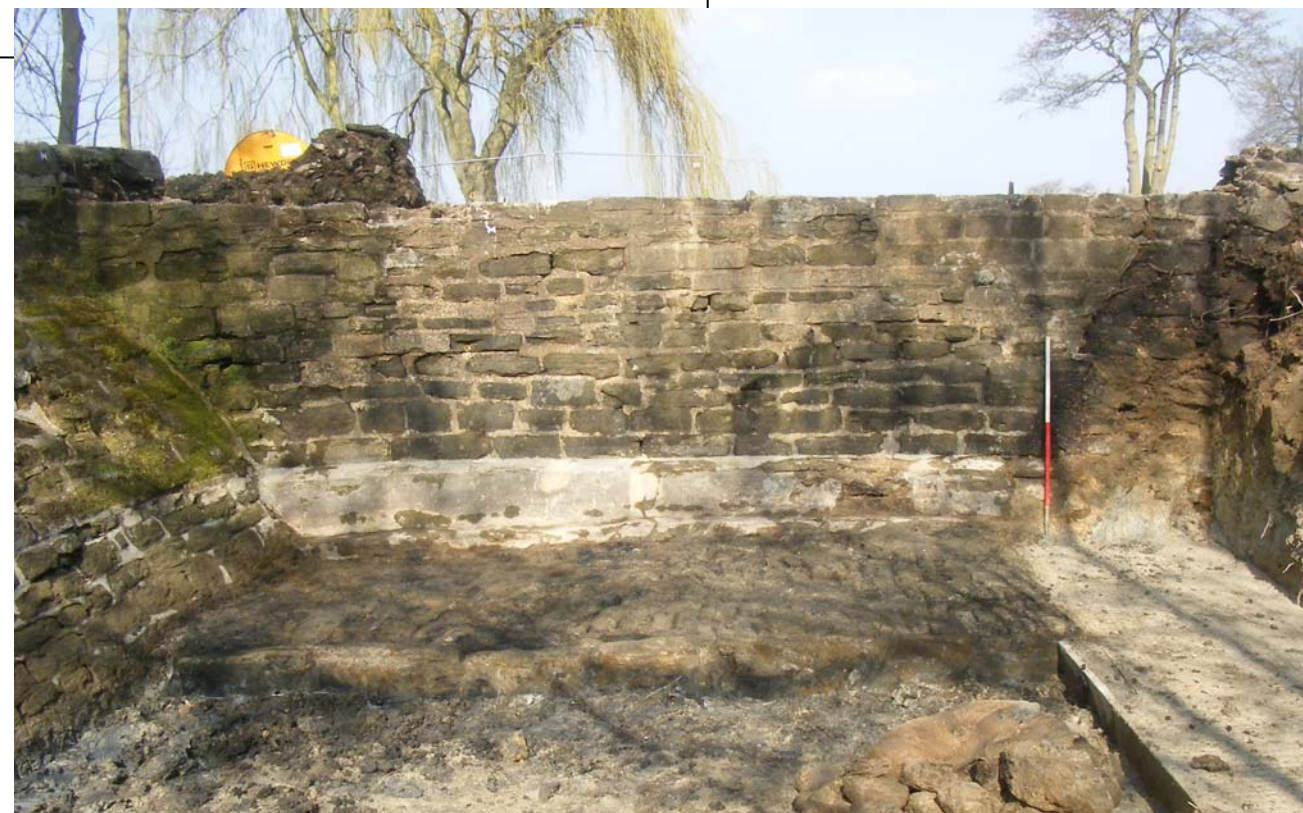
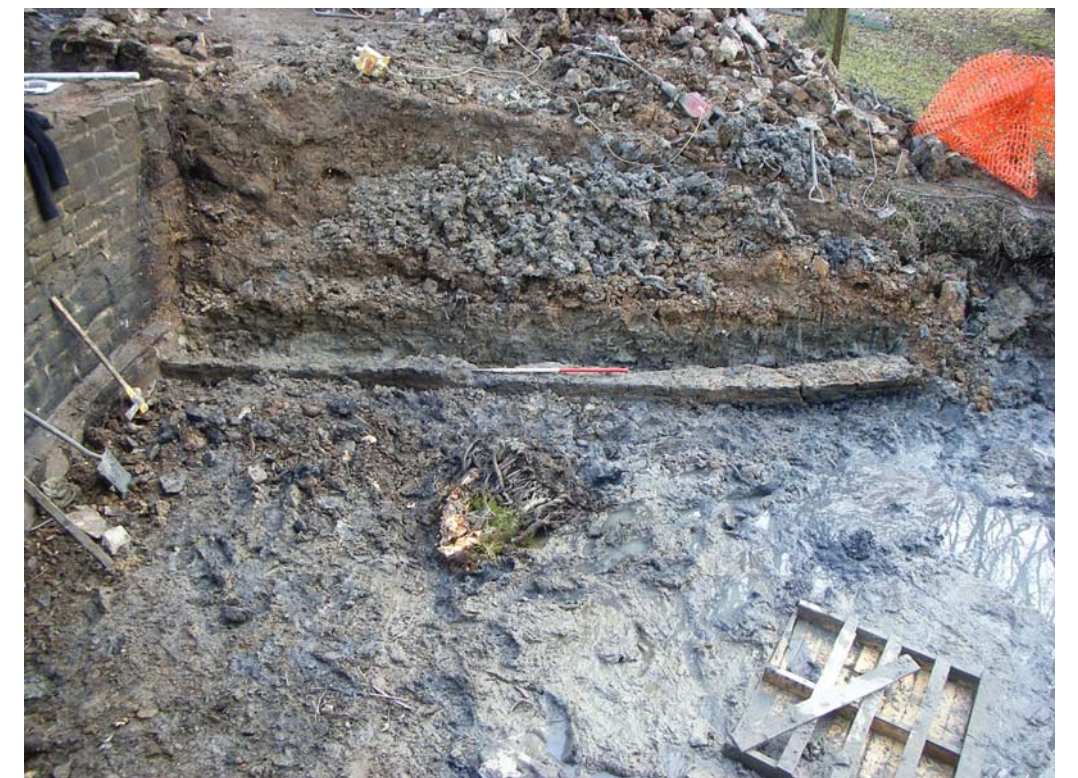
**Figure 10: Weir remediation**

During remediation works the downstream side of Old Park Weir was drained and silt deposits were removed prior to the placing of 'rip-rap' stone. The structural works carried out on the weir comprised the dismantling and re-building of the top courses of the weir wall, the reconstruction of the eastern wing wall of the weir, a section of the southern sluice wall and part of the western wing wall, the last mentioned in order to facilitate the works on the sluice wall. In addition tree roots were removed from the training walls and banks and trenches were dug alongside each of the wing walls in order to consolidate their foundations.

Confirming the results of Trench 9 and previous archaeological investigation (2007b), the current eastern training wall was shown to be a modern insertion running along the northern side of the earlier, and probably original, training wall. Although in a poor state of preservation the earlier wall continues for the full extent of its modern replacement. The 'buttress' revealed in Trench 9, was observed at the junction between the 18th-century weir wall, the earlier training wall and the wing wall retaining the eastern bank. This appears to be a later addition.

A distinct change between the lower and upper levels of the eastern and western wing walls suggests the level from which the wing walls were re-built either during the early 20th century, or as part of the 1971 works (Albion Archaeology 2007a). The eastern wing wall appeared to have been almost completely re-built using sandstone blocks bonded with cement mortar. Only a couple of courses at its base were bonded with yellow lime mortar and presumably a remnant of the original construction (Fig. 10). The western wing wall appeared to have been rebuilt to a lesser extent; the earlier lime mortared construction surviving up to the base of the sluice *c.* 1m from the base of the wall. The rebuilt sections of both wing walls were supported by concrete that had been poured behind the walls. Neither of the wing walls were tied into the main weir wall.

Removal of silt at the base of the Serpentine on the downstream side of Old Park Weir revealed a layer of closely placed, randomly-sized rectangular ironstone sets, enclosed within a row of larger rectangular curb stones (Fig. 10). Some 0.24m thick, the stones extended 2m from the base of the weir wall. These stones would have been laid in order to reduce erosion on the downstream side of the weir.

Stones at base of weir. Looking north west.  
Scale 1m

Stones at base of weir. Looking north. Scale 1m

Foundations revealed after removal of east wing wall Scale 1m

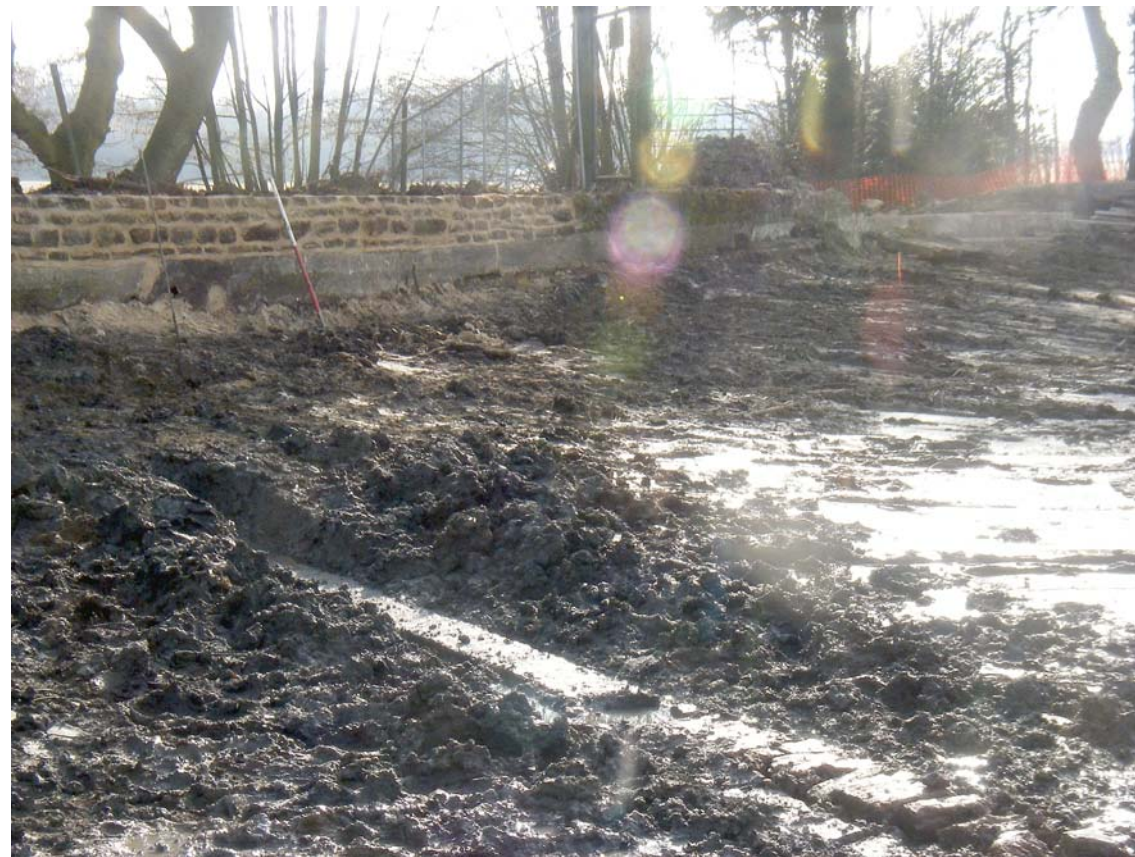
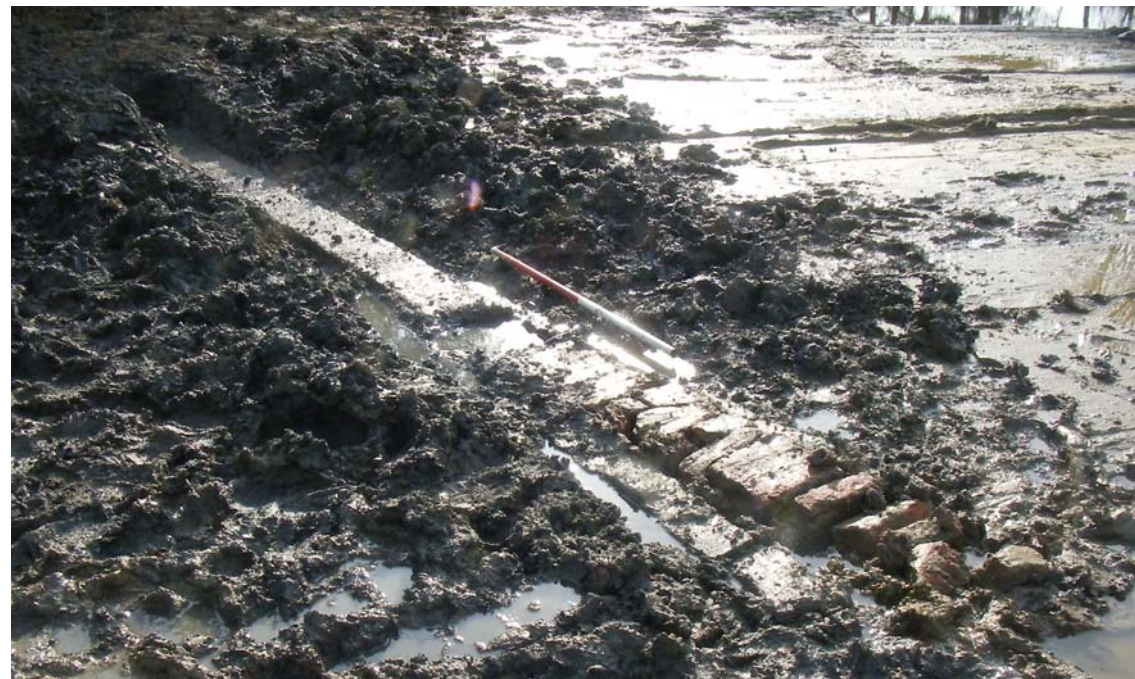
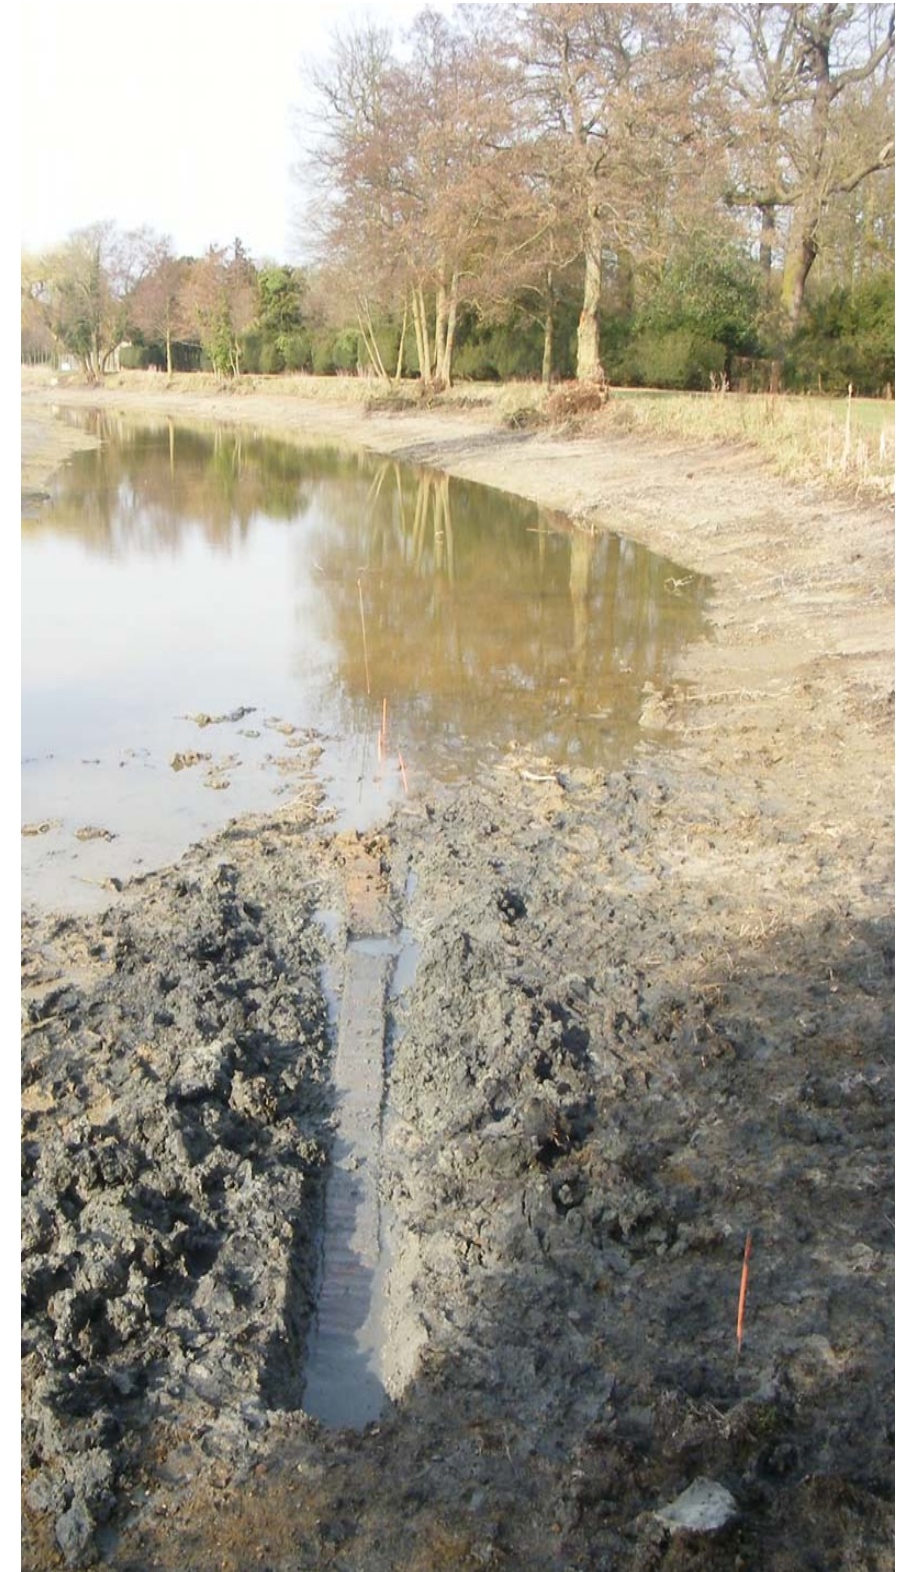
**Figure 11: Culvert (1100)**

A further brick culvert (1100) was revealed at the southern end of Old Park Water aligned approximately north-south (Fig.6 and 11). Its precise function is unknown, though its location suggests that like culvert (1081), that it could be associated with the draining of features associated with an earlier garden layout. Interestingly, it is located approximately where a path is shown crossing Old Park Water on early 18th-century maps.

Culvert, training wall of weir in the background, looking south west. Scale 1m

Culvert, looking south west. Scale 1m

Culvert, looking north east.
