**BEDFORD ACADEMY  
MILE ROAD  
BEDFORD**

**ARCHAEOLOGICAL OBSERVATION,  
INVESTIGATION, RECORDING, ANALYSIS AND  
PUBLICATION**

Project: BA1789  
Bedford Museum accession no. BEDFM:2011.44  
OASIS ref: albionar1-100648

Document: 2013/175  
Version 1.0

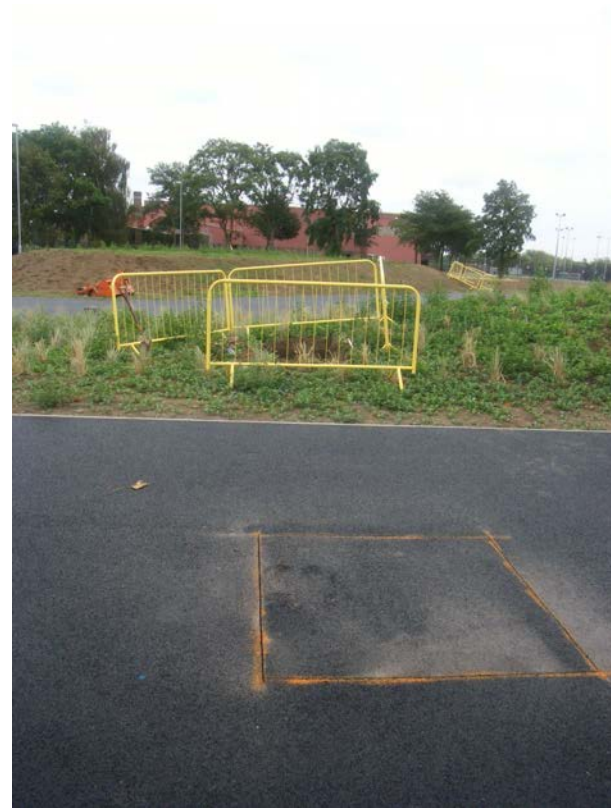
**General view:**  
Tree planting pits; looking E

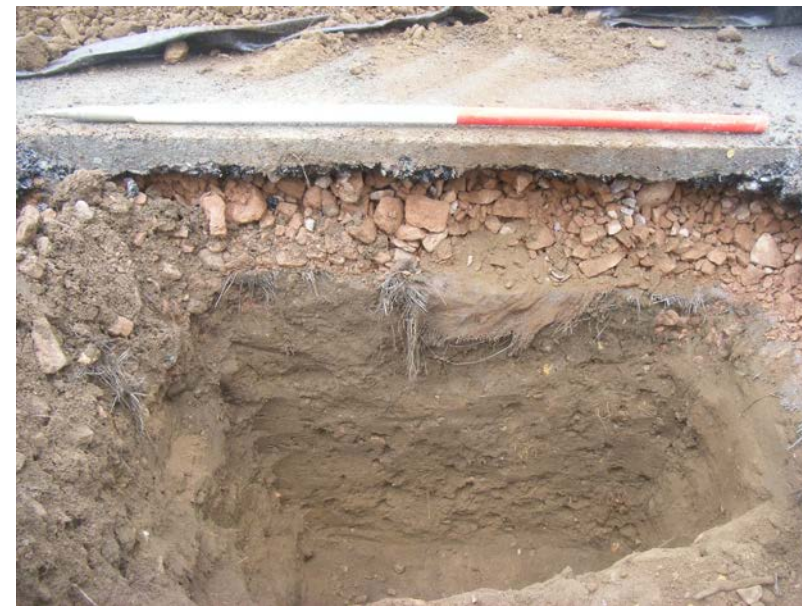
**Tree Pit 7:** 1m x 1m x 1.00m deep

Context	Thickness (m)	Description
4	0.06	Tarmac car park surface
5	0.24	Crushed stone — laid down following demolition of old school
8	0.50	Buried topsoil
3	0.20+	Buried subsoil

**Pit 7:** Looking  
NW; 1m scale

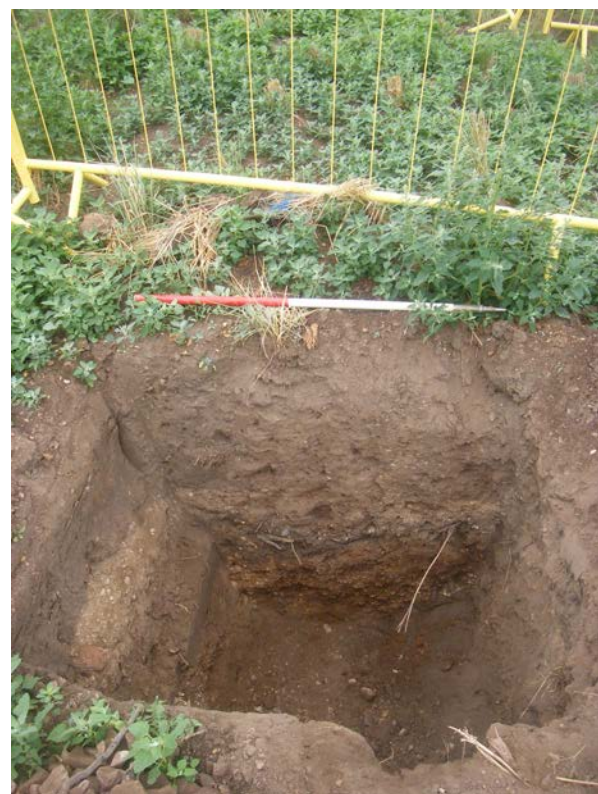
**Tree Pit 2:** 1m x 1m x 1.35m deep (see Figure 2)

Context	Thickness (m)	Description
1	0.55	Topsoil — re-deposited during landscaping works
2	0.35	Demolition rubble
3	0.10	Buried subsoil
9	0.35+	Geological deposit — river terrace sand/gravel

**Pit 2:**  
Looking SE;  
1m scale

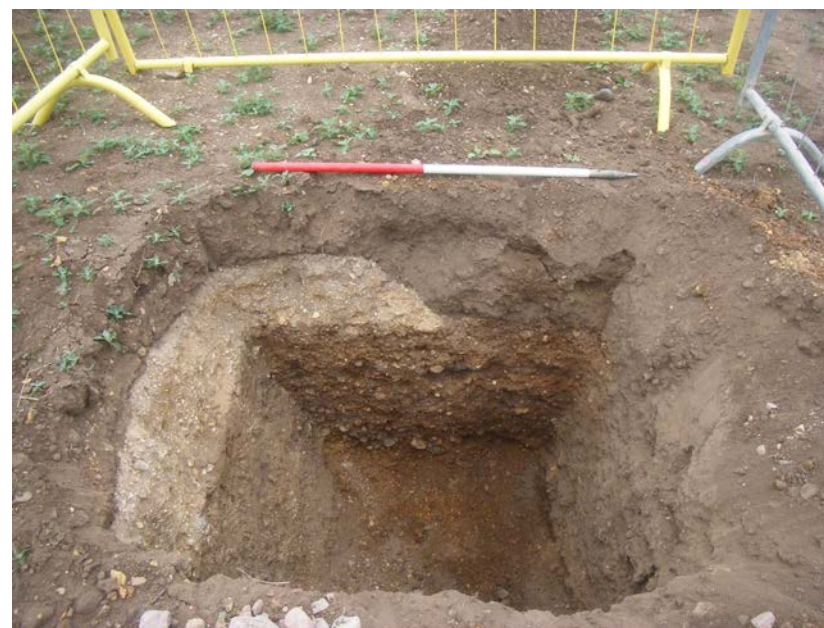
**Tree Pit 3:** 1m x 1m x 1.30m deep (see Figure 2)

Context	Thickness (m)	Description
1	0.25	Topsoil — re-deposited during landscaping works
2	0.20	Demolition rubble
7	0.70	Gravel – probably associated with construction of former school
9	0.15+	Geological deposit — river terrace sand/gravel

**Pit 3:** Looking NW;  
1m scale
