**LAND REAR OF EASTCOTTS ROAD
BEDFORD
(OPEN SPACE)**

ARCHAEOLOGICAL FIELD EVALUATION

Project: ER2268

Document: 2014/34
Version 1.1

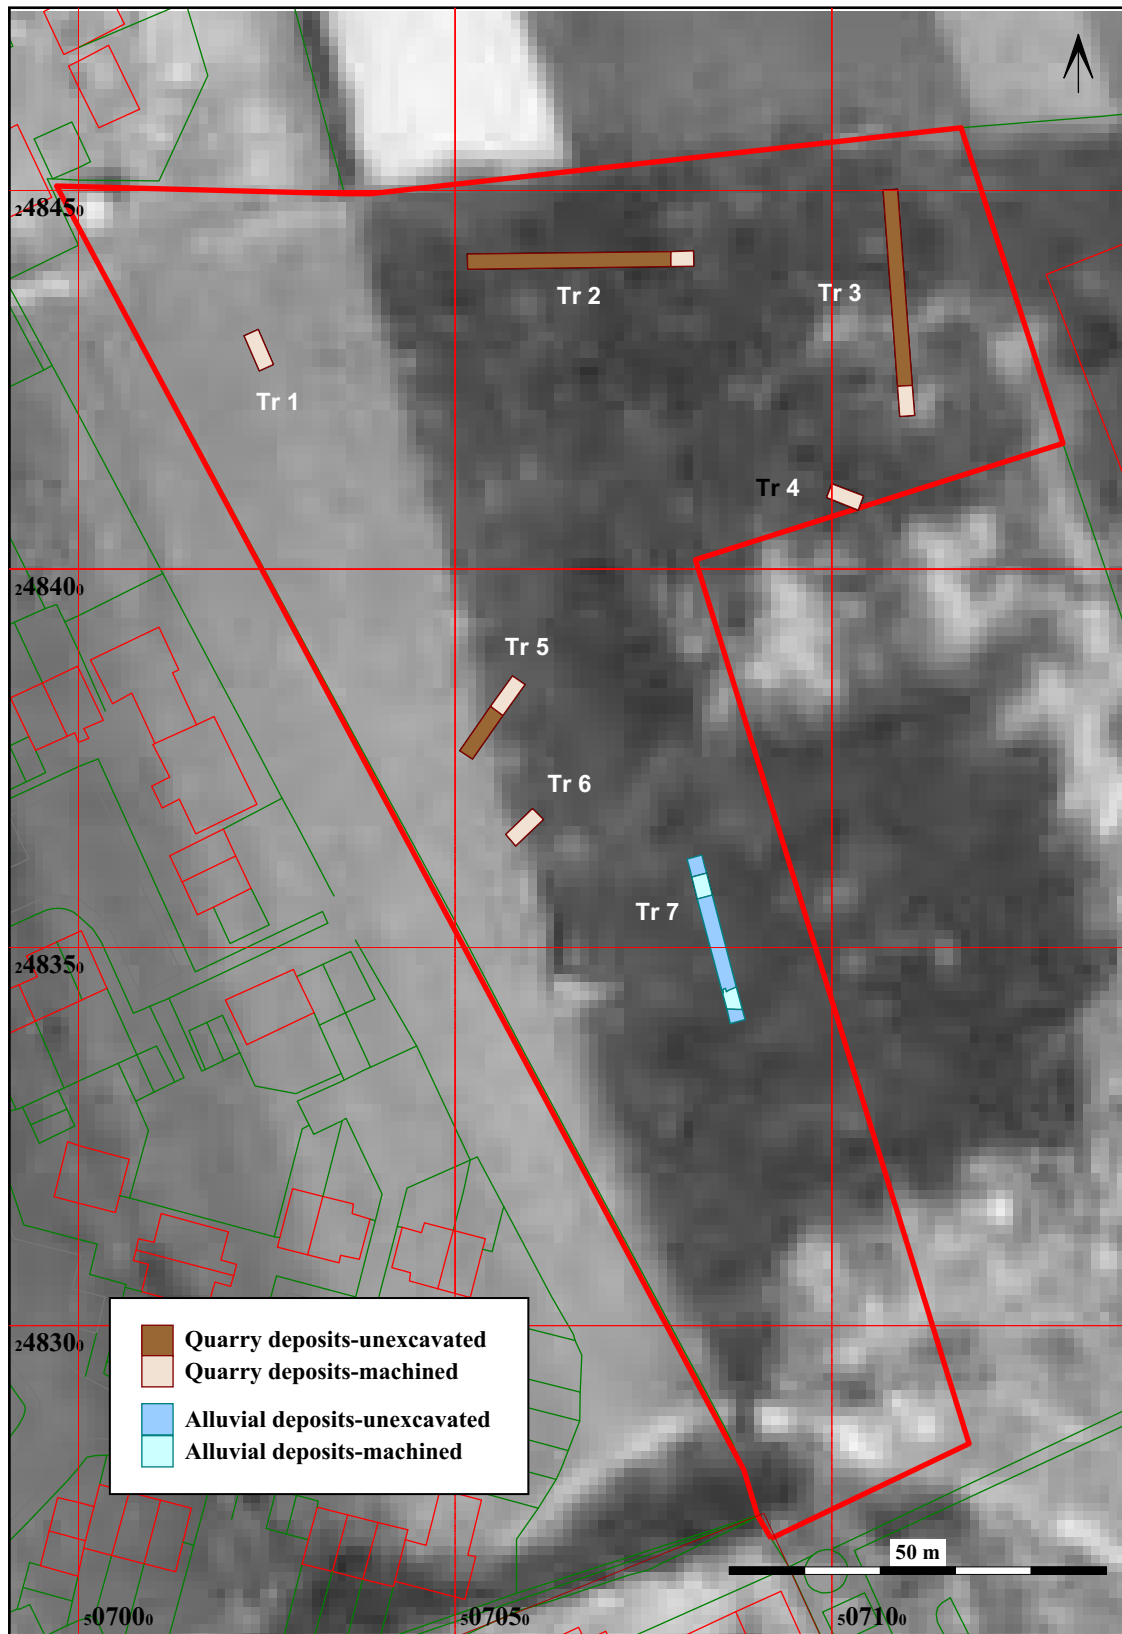
Figure 3: All features overlaid onto 1969 aerial photograph

Prior to the present evaluation, the evidence for quarrying on the site was derived from historical maps and aerial photographs. The Ordnance Survey 1:10,000 scale map published in 1971 depicts the majority of the site within a large expanse of open land with localised amorphous water bodies that are suggestive of water-filled quarries. However, aerial photographs from 1949² and 1969³ give a better record of the extent of extraction. In 1949 the south end of the site is clearly being quarried and, by 1969 a mass of scrub and disturbed ground covers most of the site. It should be noted that in 1969 the western edge of the site still lies within a separate land parcel and has not been quarried. This land parcel is depicted on the 1971 map edition, and the site boundary as it now exists is first shown on the 1978 edition of the 1:10,000 map.

The site topography suggested some tipping might have occurred. There appeared to be a raised area of undulating ground at the northern end of site (pls. 11, 12) which showed clear disturbance prior to machining. The lower, flatter area at the south end of the site appeared to be undisturbed ground. However, it was noted during the evaluation that there was a distinct scarp along the west boundary of the site and that the land beyond the western boundary was up to c. 0.75m higher. This suggests that reinstatement after quarrying had not restored the southern part to its pre-extraction height. Consequently, the disturbed ground at the north end of the site suggests not 'positive' dumping, but backfilling of a quarry void. The steep scarp along the western boundary is therefore likely to indicate the edge of the quarry, indicating that quarrying was extended westwards after the laying out of the present site boundary.

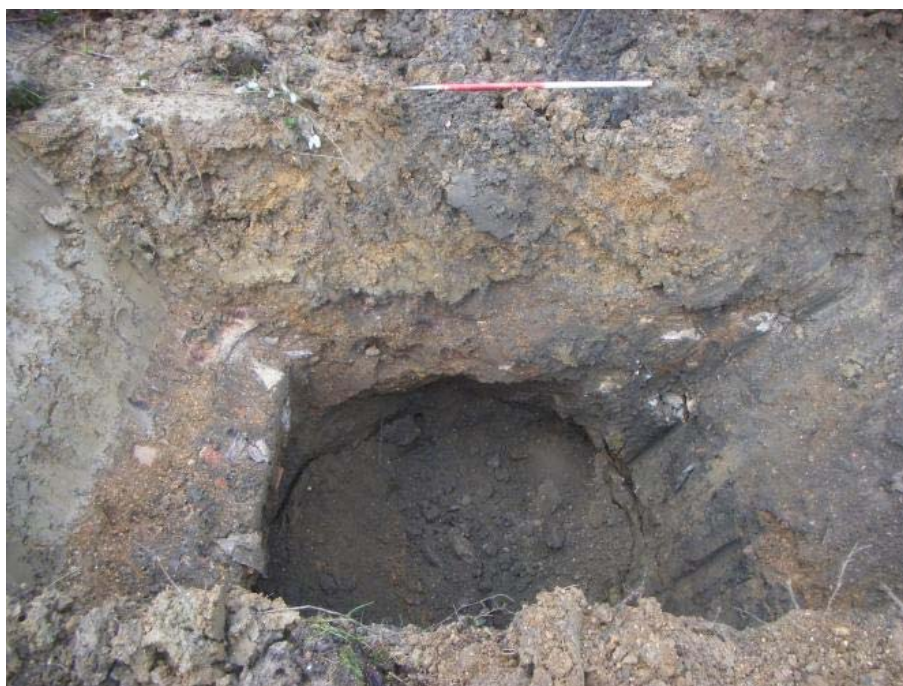
Plate 1: Trench 1

Trench 1 (pl.1) was aligned north to south, 5m long, 2m wide and excavated to a depth of 3.3m (24.65m OD). The deposits existed to a depth of 3.2m and comprised:

- (100) Mixed light grey and black clay with lenses of gravel to a maximum thickness of 3.2m, quarry backfill.
- [102] Quarry cut, to a depth of 3.2m below ground level (24.75m OD)
- (101) Mid brown-orange sandy gravel. Natural geological deposit.

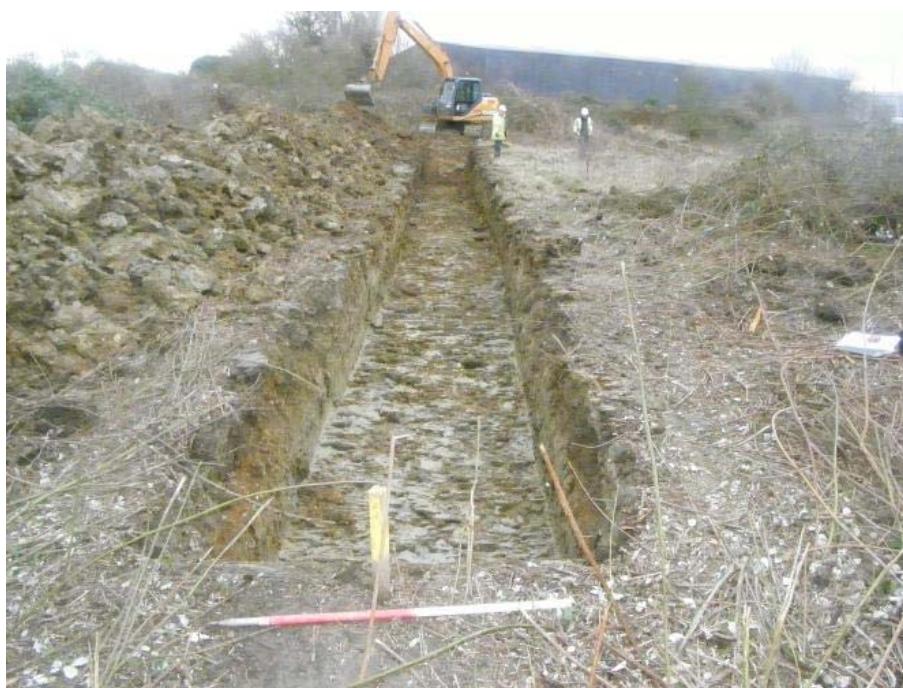
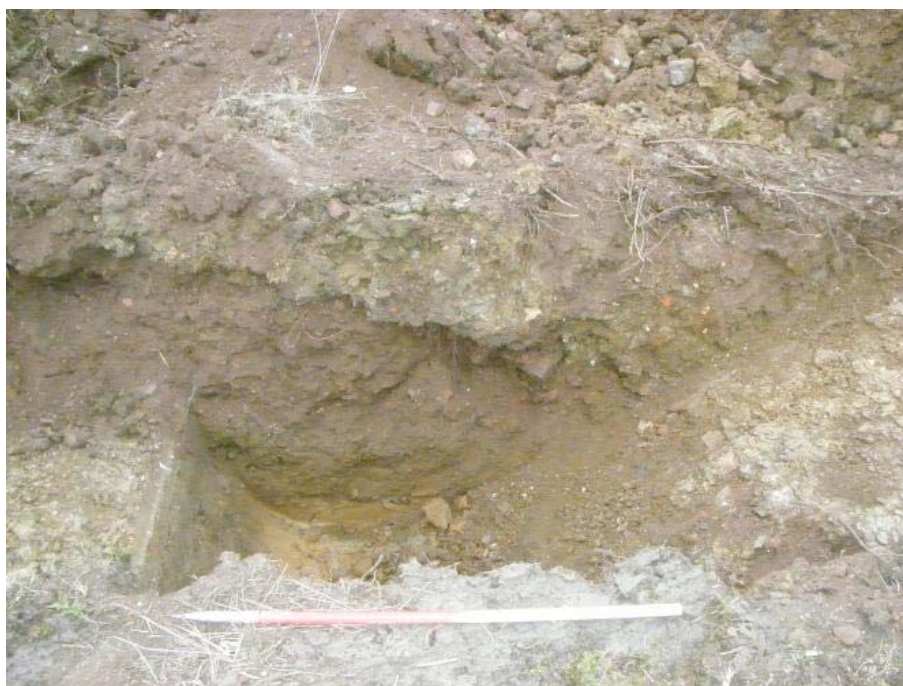
Plate 2: Trench 2

Trench 2 (pl.2, 3) was aligned east to west, 30m long, 2m wide and initially excavated to a depth of 1.2m (26.58 m OD) without reaching natural. A sondage was excavated at the south end and was 3m in length and machined to a depth of 2.2m where natural was identified. Quarry backfill existed to a depth of 2.2m and the trench comprised:

- (200) Mixed mid grey/ blue clay with gravel lenses and occasional brick and tile rubble inclusions. Quarry backfill
- [202] Quarry cut, to a depth of 2.2m (24.58m OD)
- (201) Mid orange sandy silty firm clay. Natural geological deposit

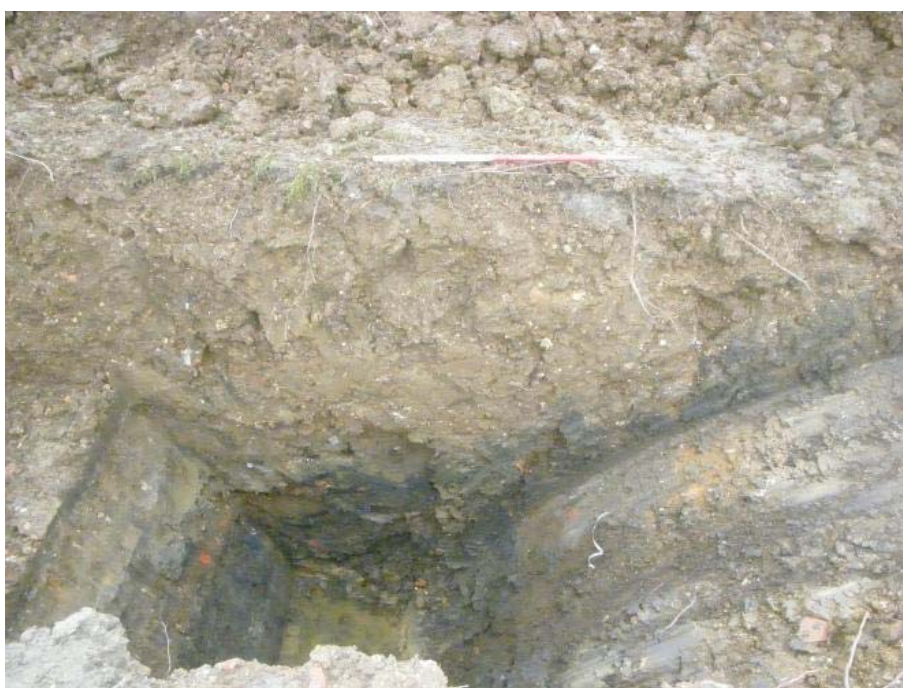
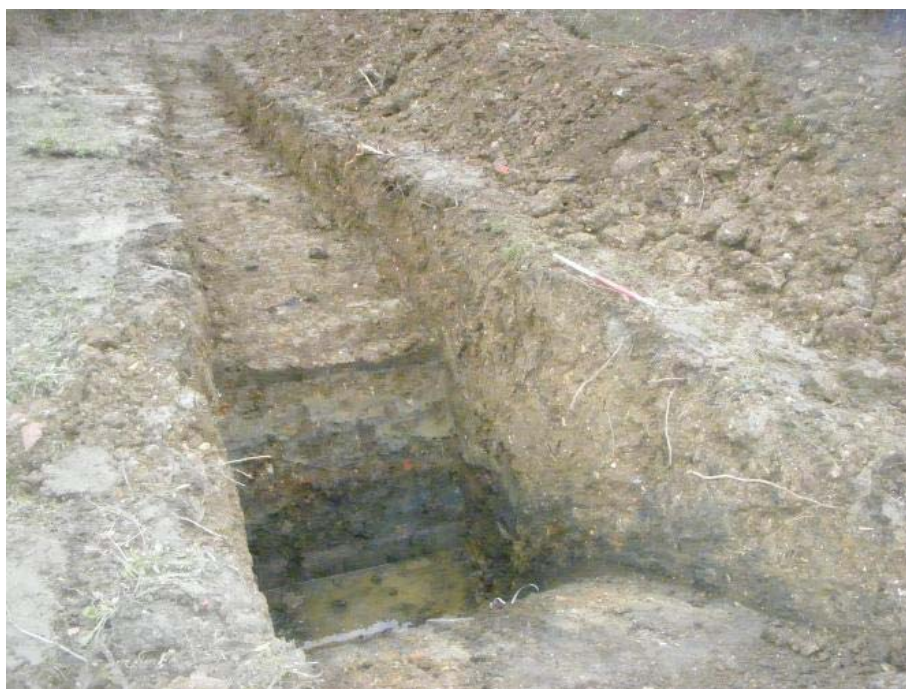
Plate 4: Trench 3

Trench 3 (pl. 4, 5) was aligned north to south, 30m long, 2m wide and, initially excavated to a depth of 1.2m (27.12m OD) without reaching natural. A sondage was excavated at the east end and was 4m in length and machined to a depth of 2.7m where natural was identified. Quarry backfill existed to a depth of 2.7m and the trench comprised:

- (300) Mixed mid grey/ blue clay with gravel lenses and occasional brick and tile rubble inclusions. Quarry backfill
- [302] Quarry cut, to a depth of 2.7m (25.62m OD)
- (301) Mid orange sandy silty firm clay (as Trench 2). Natural geological deposit

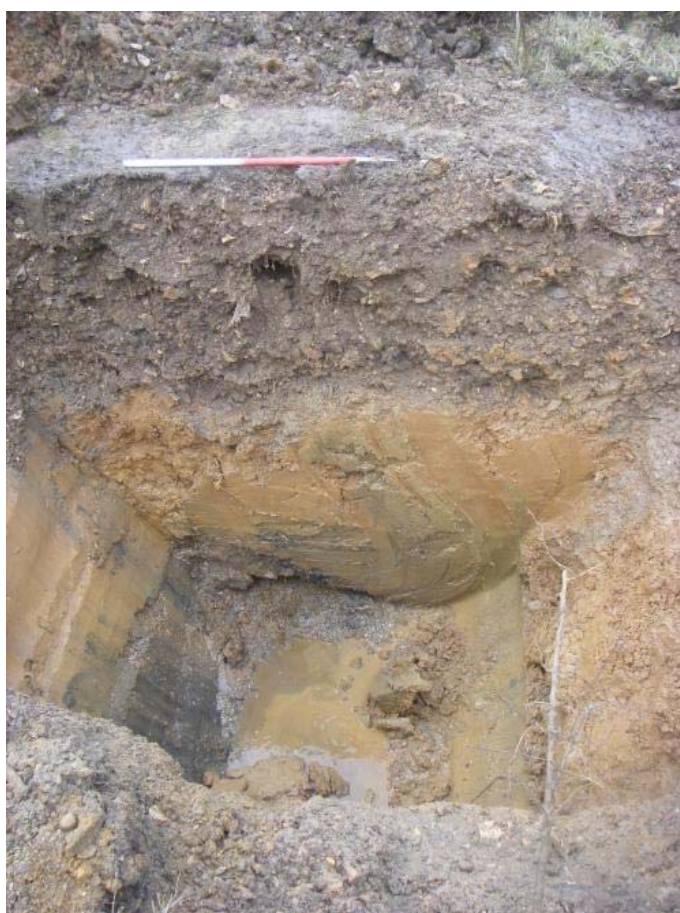
Plate 6: Trench 4

Trench 4 (pl. 6) was aligned north-west to south-east, 4.5m long, 2m wide and excavated to a depth of 2.5m (25.80m OD). Quarry backfill existed to a depth of 2.4m and the trench comprised:

- (400) Mixed mid grey/ blue clay with gravel lenses and occasional brick and tile rubble inclusions. Quarry backfill
- [402] Quarry cut, to depth of 2.4m (25.90m OD)
- (401) Mid orange sandy silty firm clay (as Trench 2). Natural geological deposit.

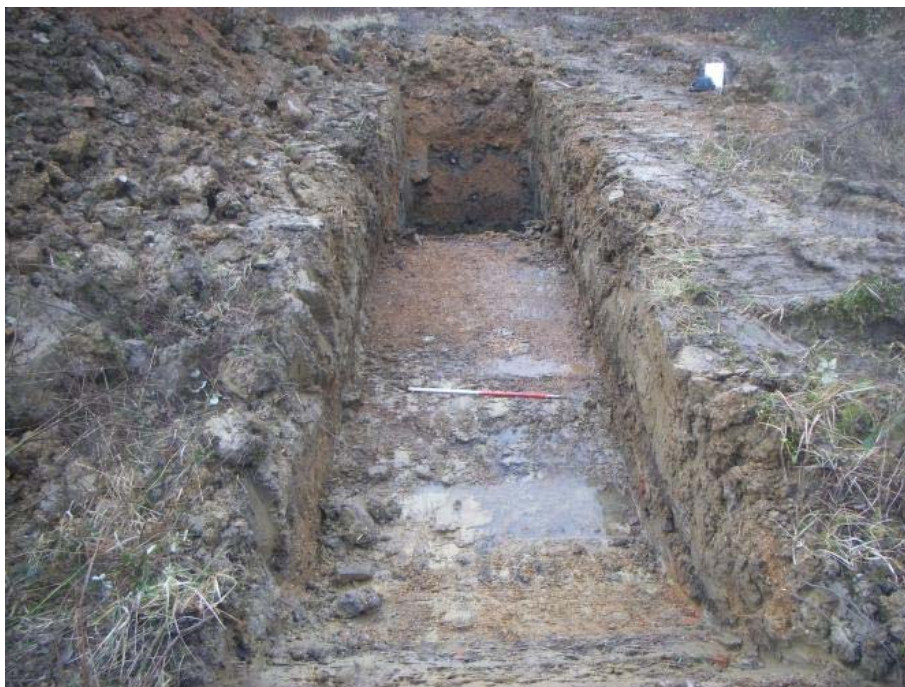
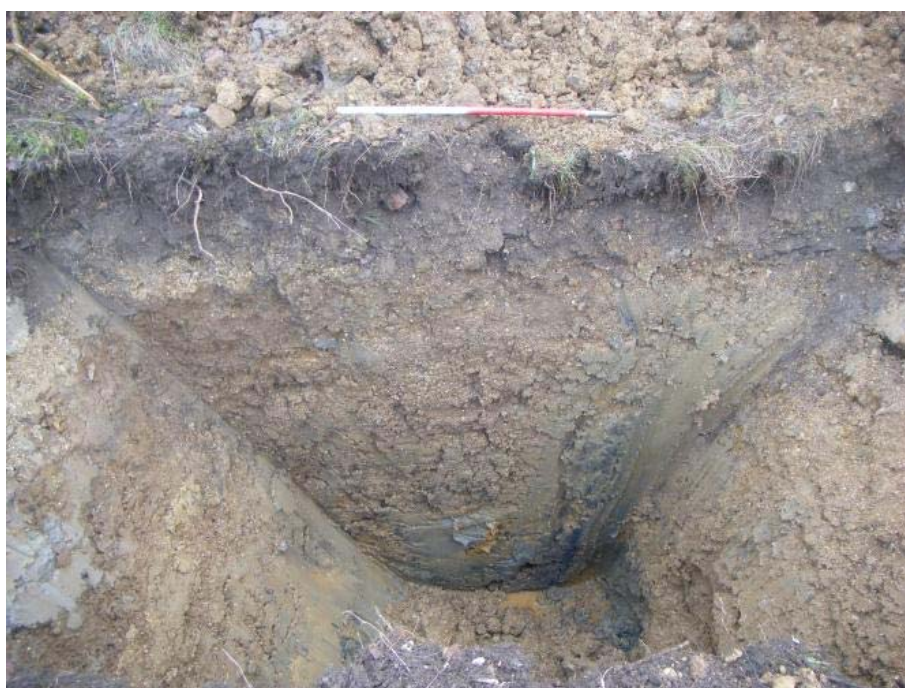
Plate 8: Trench 5

Trench 5 (pls.7, 8) was aligned north-east to south-west, 12m long, 2m wide. A sondage was dug from the northeast end and was 5m long and 2.7m deep (25.96m OD). Quarry backfill existed to a depth of 2.4m and the trench comprised:

- (500) Mixed mid grey/ blue clay with gravel lenses and occasional brick and tile rubble inclusions. Quarry backfill
- [502] Quarry cut, to a depth of 2.4m (26.26m OD)
- (501) Mid orange sandy silty firm clay (as Trench 2). Natural geological deposit.

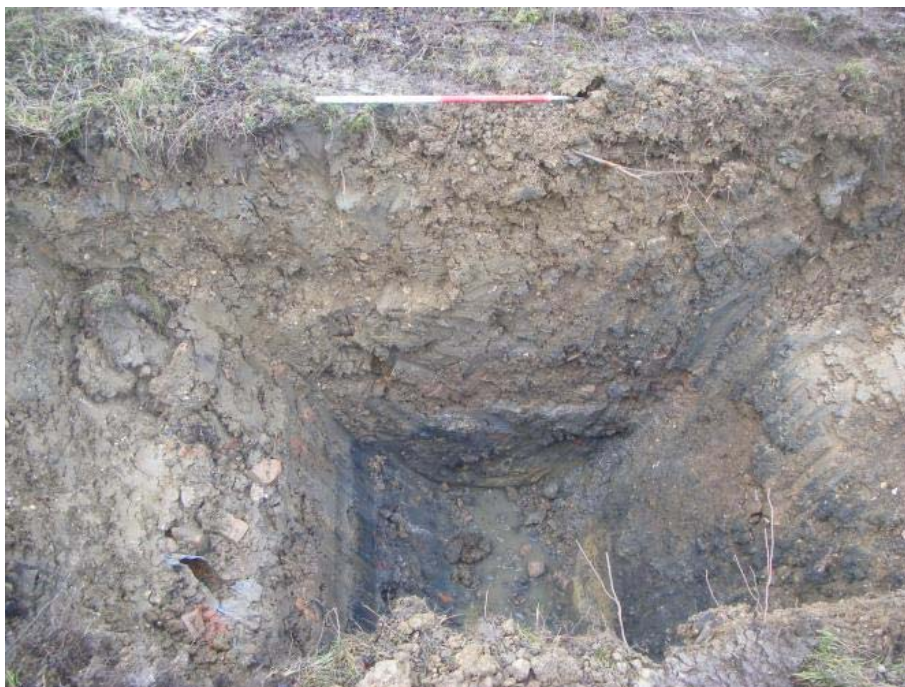
Plate 9: Trench 6

Trench 6 (pl. 9) was aligned north-east to south-west aligned, 5m long, 2m wide and excavated to a depth of 2.9m (25.60m OD). Quarry backfill existed to a depth of 2.8m and the deposits comprised:

- (600) Mixed mid grey/ blue clay with gravel lenses and occasional brick and tile rubble inclusions. Quarry backfill
- [602] Quarry cut, to depth of 2.8m (25.70m OD)
- (601) Mid orange sandy silty firm clay (as Trench 2). Natural geological deposit.

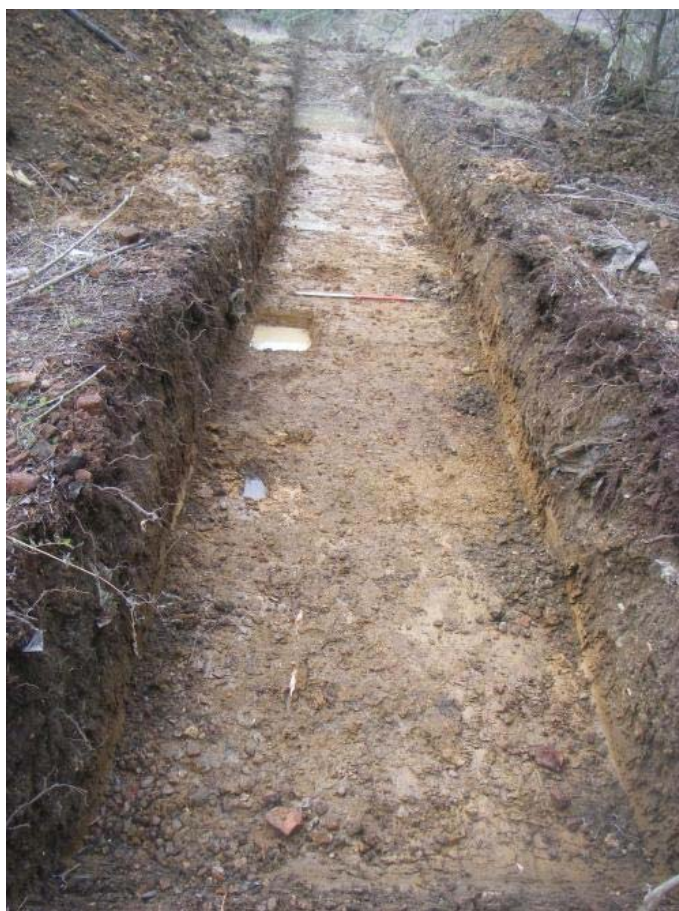
Plate 10: Trench 7

Trench 7 (pl.10) was aligned north to south, 22.5m long, 2m wide and was initially dug to a depth of 1.2m. A sondage was dug from the north end and was 5.5m in length and 3m deep (24.18m OD). Deposits existed to a depth of 1.75m and comprised:

- (700) Mid brownish grey gravel with frequent brick and tile rubble inclusions. Made ground/ quarry backfill to depth of 0.9m (26.28m OD)
- (701) Light brown orange silty clay. Alluvial layer. Maximum thickness of 0.55m (25.63m OD)
- (702) Dark brownish grey silty sand with moderate small stones. Alluvial layer. Maximum thickness 0.3m (25.33m OD)
- (703) Mid grey brown firm clay silt. Alluvial layer, not fully excavated.

These silty deposits are interpreted as palaeochannel alluvium that was left *in situ* during quarrying. However, it is possible that they comprised a secondary deposit of natural material created during the quarry operations.
