**CROWTHORNE FENCING AND SUPPLIES
CAMBRIDGE ROAD
BEDFORD**

**ARCHAEOLOGICAL OBSERVATION,
INVESTIGATION, RECORDING, ANALYSIS AND
PUBLICATION**

Project: CF2321
Bedford Museum accession no.: BEDFM 2014.13
OASIS ref. no.: albionar1-171829

Document: 2014/61
Version 1.0

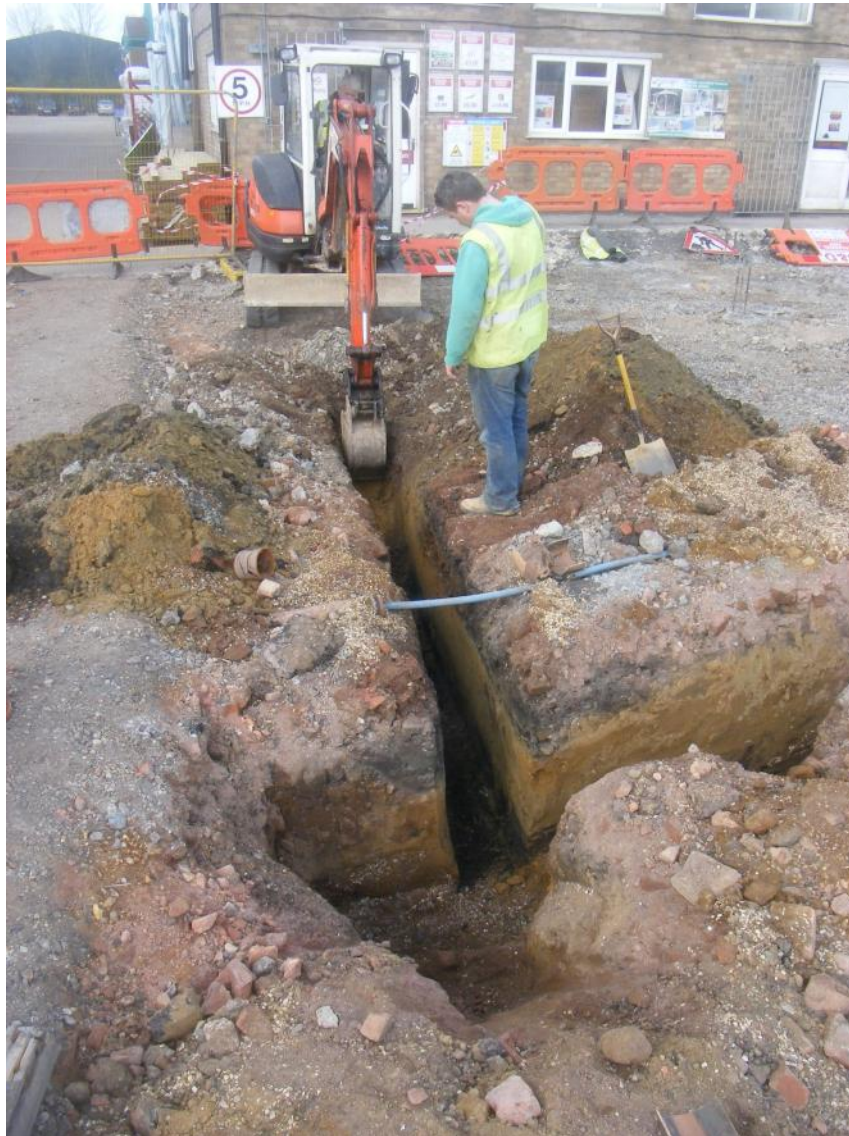
Figure 6: Photo 3
(for location, see Figure 2)

Towards the western side of the development area, a distinct, compact mid to light brownish-yellow silty sand (03) (up to 0.74m thick) was observed (Figures 6 and 7).

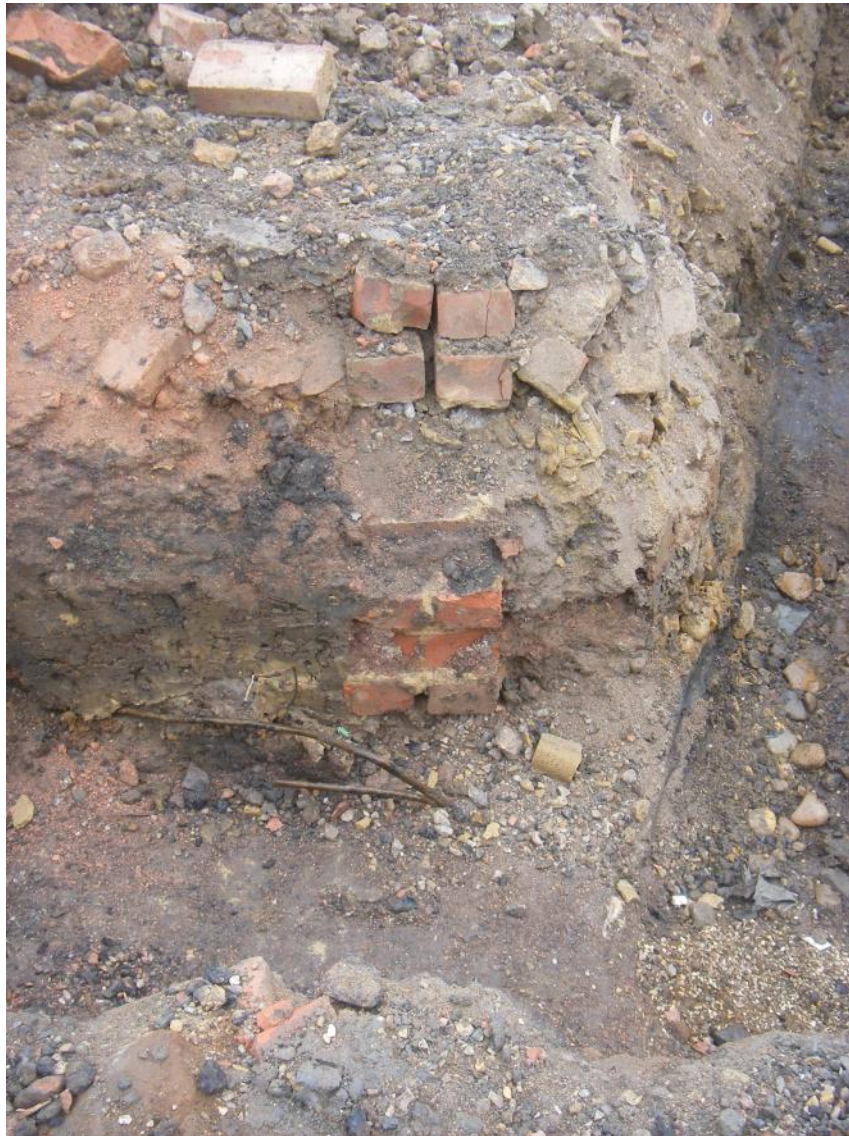
Figure 8: Photo 5
(for location, see Figure 2)

A buried brick wall (07) was discovered on the line of piles 33, 39 and 45, which were, therefore, off-set by *c.* 0.60m to the north-west. The wall also observed in the service trench and ground-beam trench (Figure 8).

An *in-situ* brick wall (07) was recorded towards the eastern end of the central pipe trench. Seven brick courses (up to 0.88m depth) and a concrete foundation (0.85m wide) were observed. The foundation was exposed to its full depth in the trench.

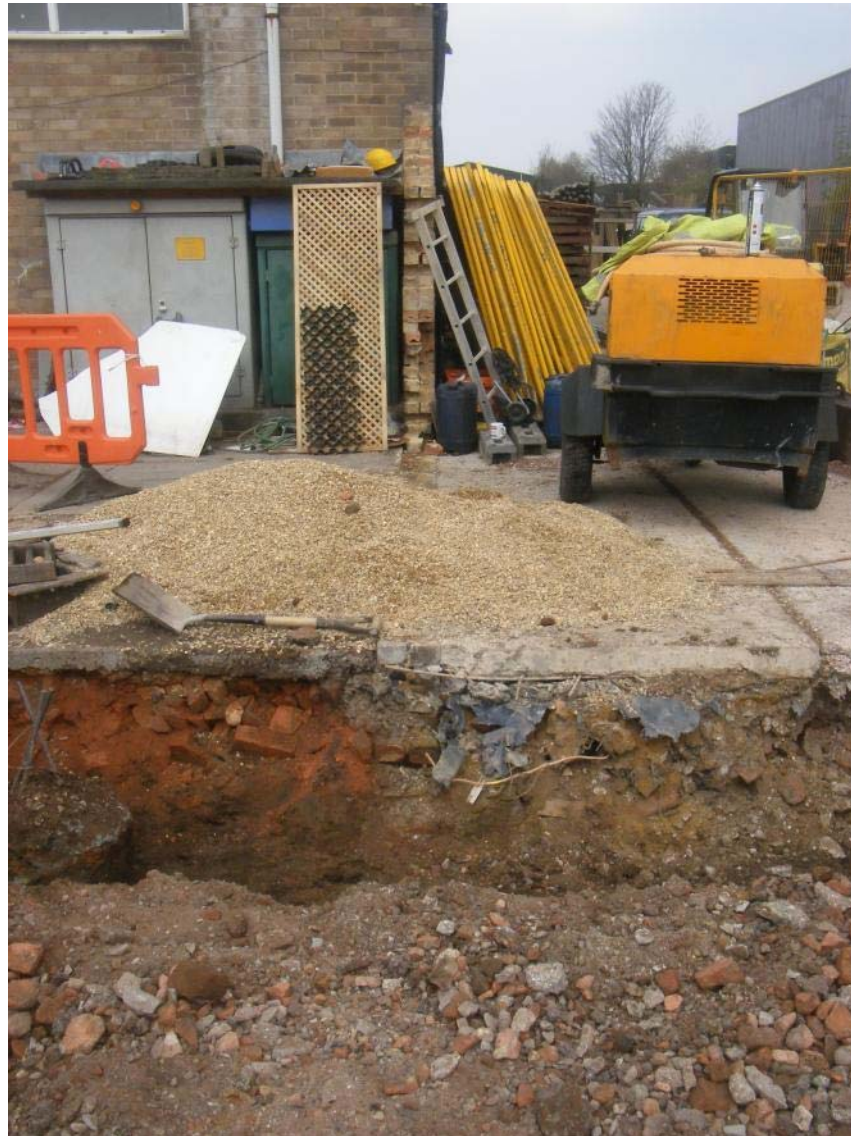
Figure 11: Photo 8
(for location, see Figure 2)

overlay a series of relatively recent (post-1900) dump/back fill deposits (02) to (06). The *in-situ* brick wall with concrete foundation (07) was probably of similar date; a 'scar' on the south-east corner of the existing building indicated that it had once been attached to the building (Figure 11).

The only structure encountered was the foundation (07) of a wall that appeared to have once been attached to the existing office/workshop. The 1968 Ordnance Survey map indicates a boundary on the line of the wall, marking the perimeter of a small yard south of the existing building. It is most likely, therefore, that the wall was not part of a building, but rather a free-standing wall that was constructed at the same time as the existing building.

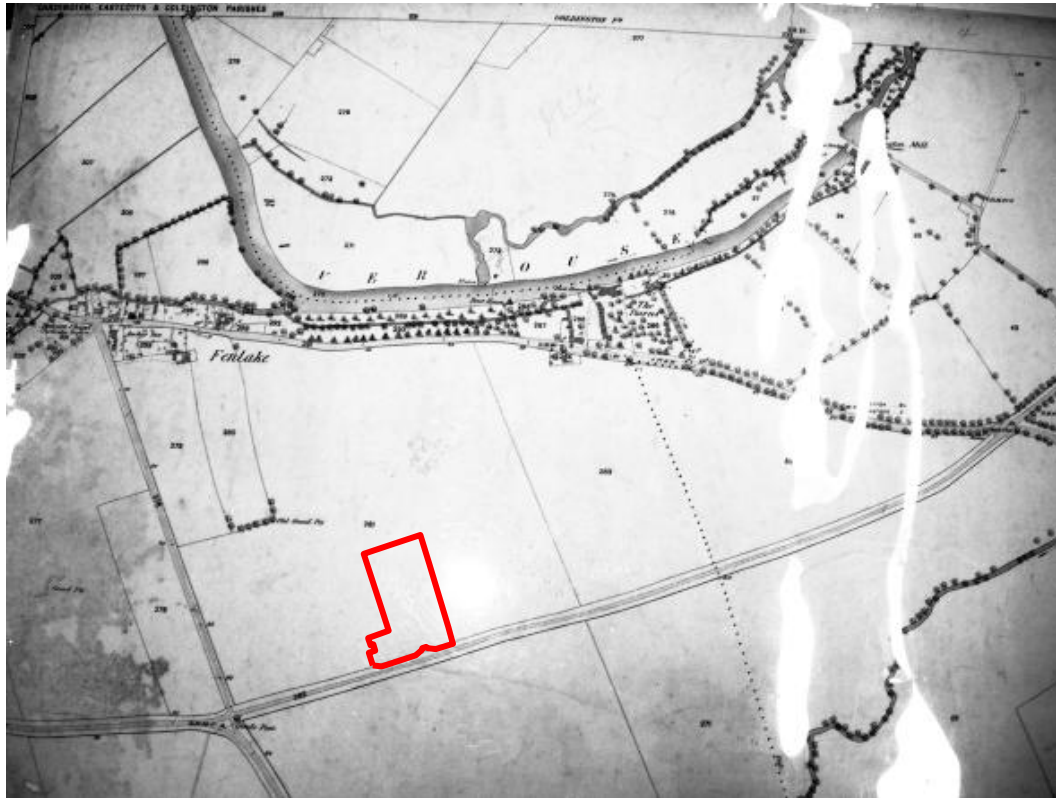
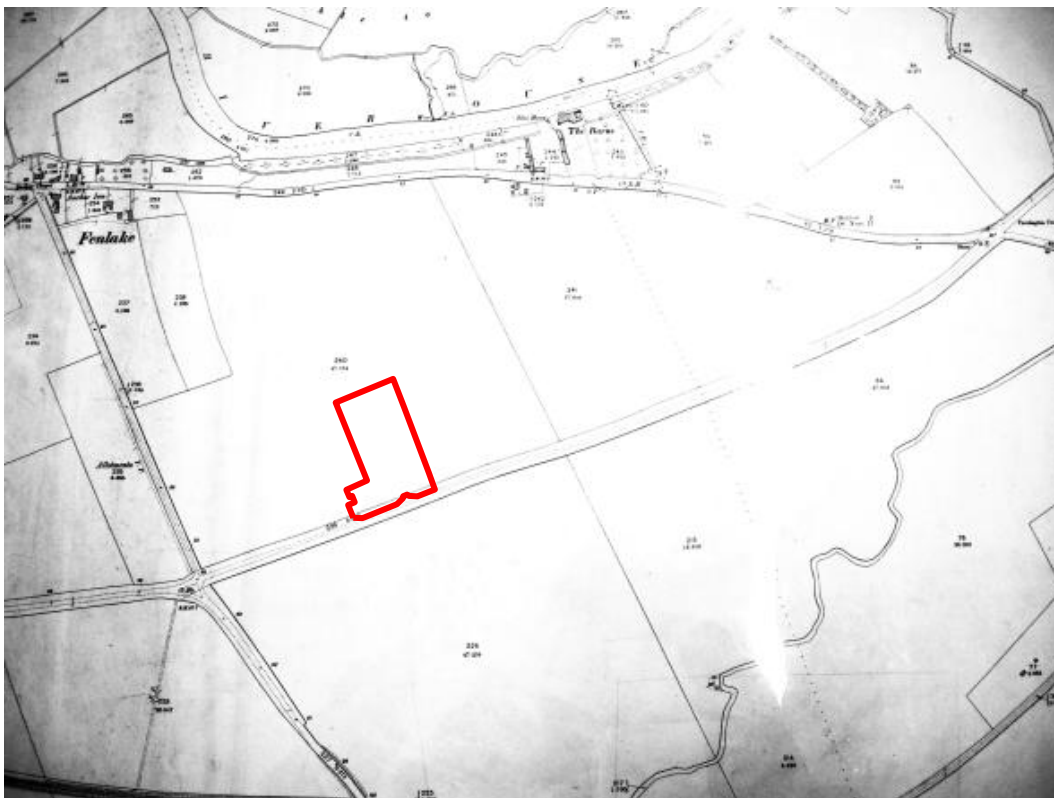
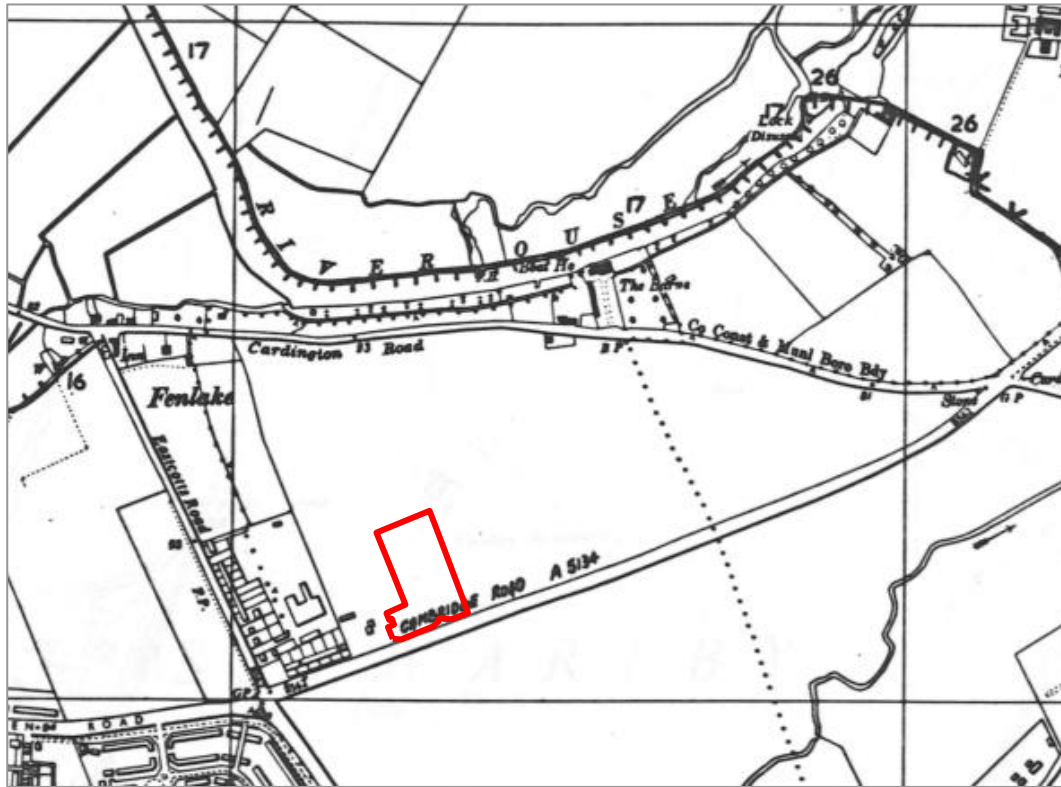
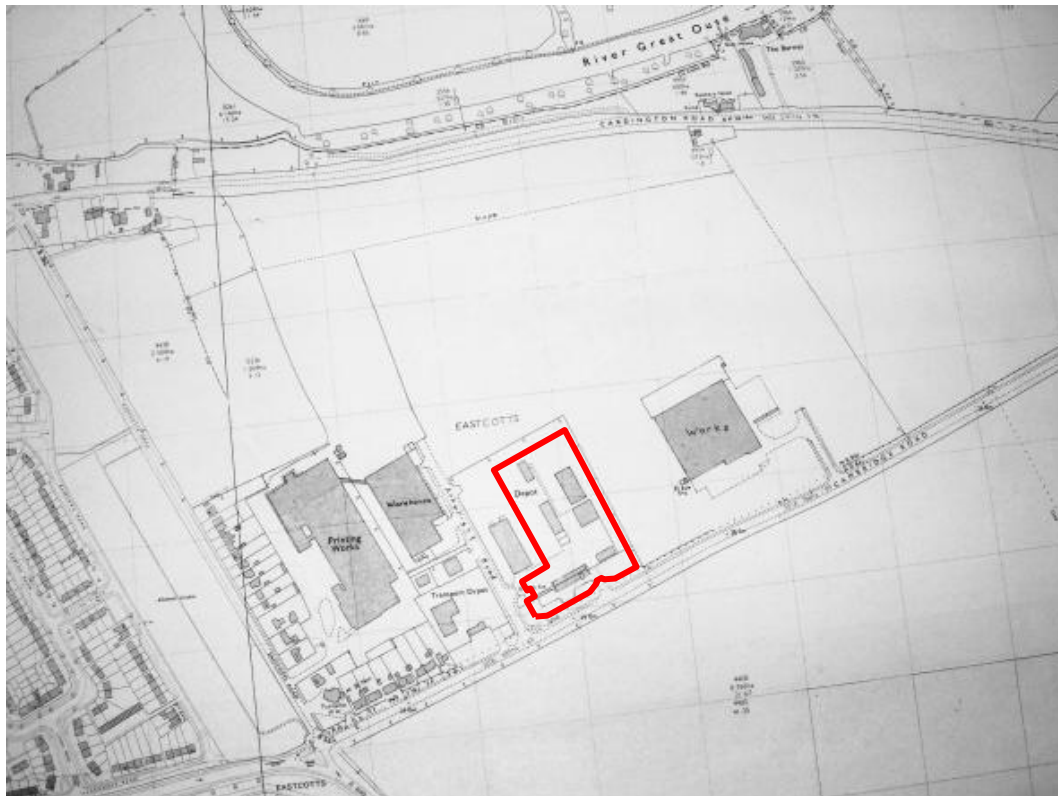
Historical maps record that the development site was open land until the late 1960s, (see Figures 13–16). The construction of the existing buildings and associated hard standings, alone, ought not to have completely truncated the natural subsoil (and any archaeological features that might have once lain beneath it). It is known that the land east of Fenlake was subjected to quarrying at least from the end of the 19th century, so it is possible that the development site had been subjected to mineral extraction prior to the erection of the buildings.
